**CEDD CONTRACT NO. CV/2012/05 –
BATHING BEACH AT LUNG MEI, TAI PO**

**POST-CONSTRUCTION MONITORING AND AUDIT
REPORT (MARCH TO APRIL 2022)**

PREPARED FOR
WELCOME CONSTRUCTION CO., LTD.

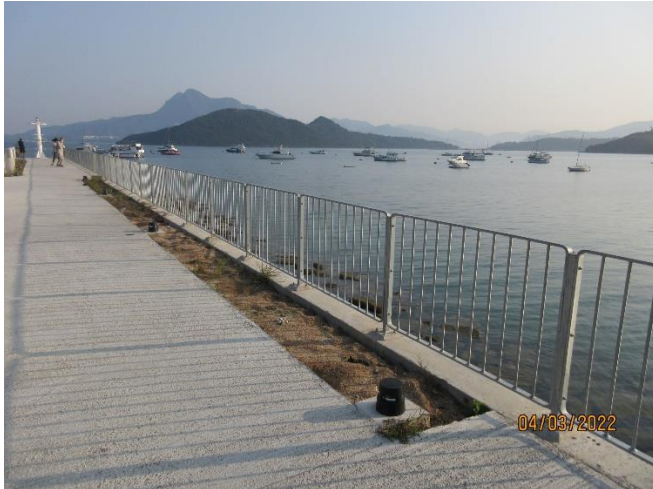
Photo I.

1.3	Any potential incursion, fire, pollution, and surface erosion, etc.		✓		Some of the plants in the planters on the Western groyne were wilted without replacement.

1. Some of the plants in the planters on the Western groyne were wilted and should be removed. (Photo I)
2. Poor soil drainage is found in one planter in Eastern Groyne which should be urgently mitigated. (Photo J)
3. Some ties and stakes were detached at Western Box Culvert. (Photo K)
4. The planters at the Eastern box culvert were repaired and enlarged and the plants in the planters were removed. (Photo L)
5. Some ties and stakes already girdled and affected the growth of the trees. (Photo M and Photo N)
6. The Contractor should handle the prolonged outstanding follow-up works as soon as possible.

Some of the plants in the planters on the Western groyne were wilted and removed

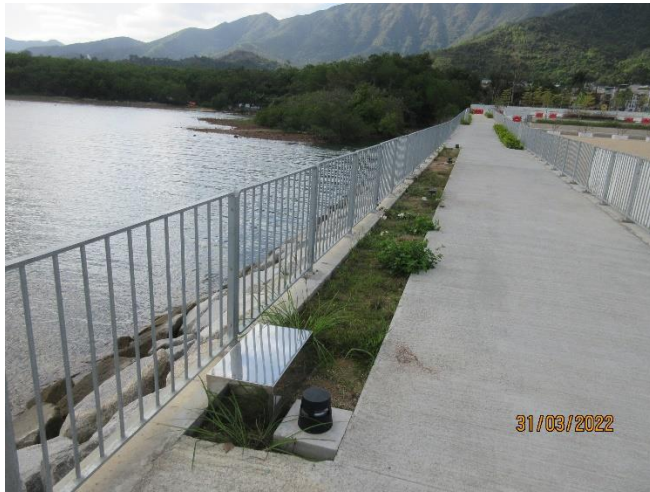
Photo I.

1.3	Any potential incursion, fire, pollution, and surface erosion, etc.		✓		Some of the plants in the planters on the Western groyne were wilted without replacement.

1. Some of the plants in the planters on the Western groyne were wilted and should be removed. (Photo I)
2. Poor soil drainage is found in one planter in Eastern Groyne which should be urgently mitigated. (Photo J)
3. More ties and stakes were detached at Western Box Culvert (Photo K).
4. The planters at the Eastern box culvert were repaired and enlarged and the plants in the planters were removed. (Photo L)
5. Some ties and stakes already girdled and affected the growth of the trees. (Photo M and Photo N)
6. The Contractor should handle the prolonged outstanding follow-up works as soon as possible.

Some of the plants in the planters on the Western groyne were wilted and removed

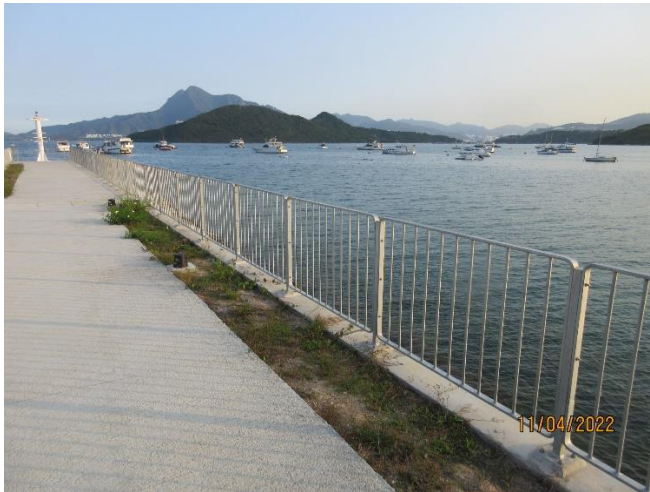
Photo I.

Some of the plants in the planters on the Western groyne were wilted and removed

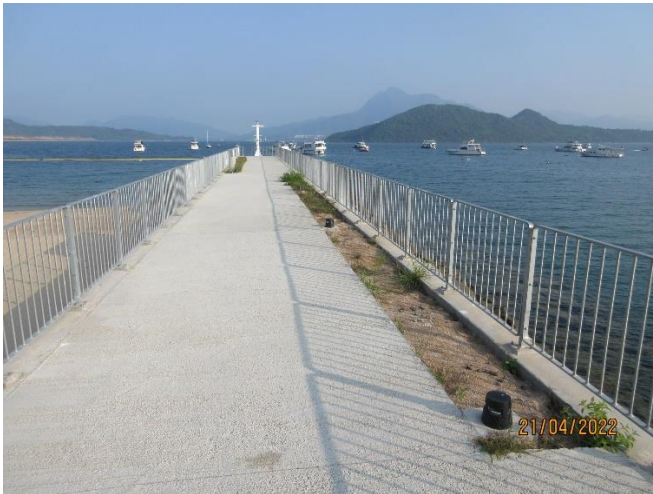
Photo I.

Some of the plants in the planters on the Western groyne were wilted and removed

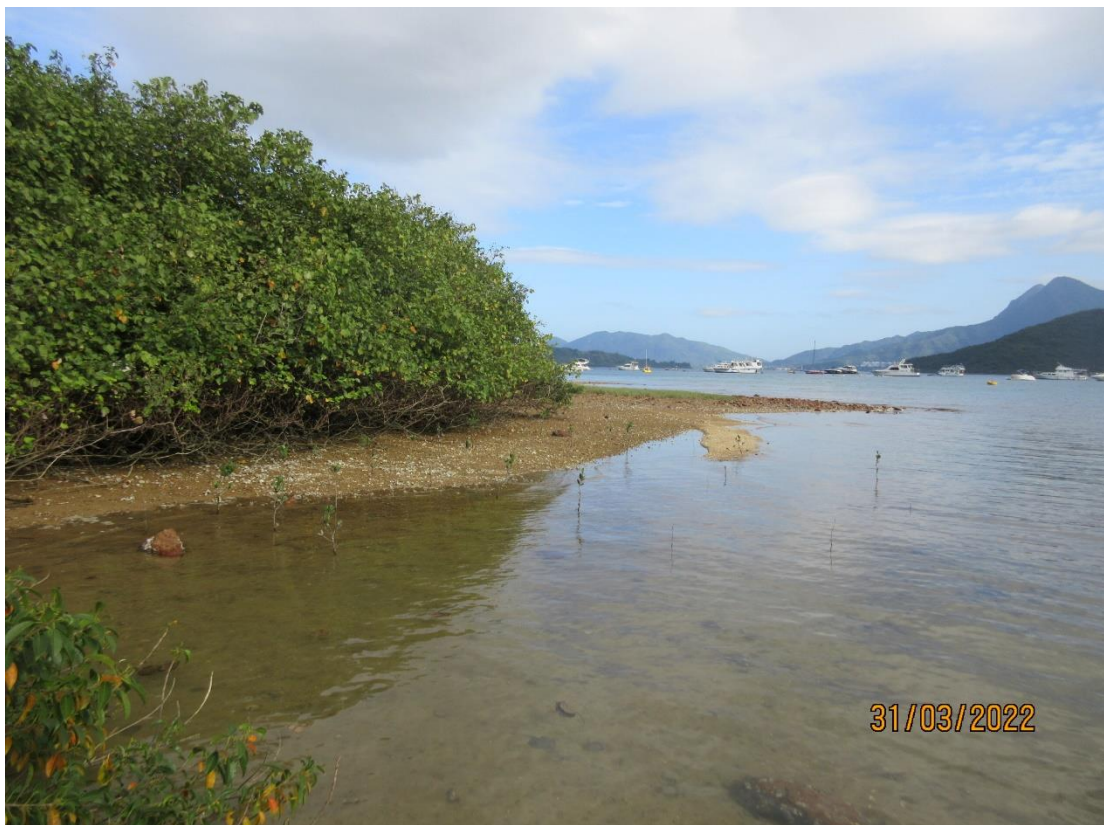
Photo 2.1 General view of the mangrove in location 1

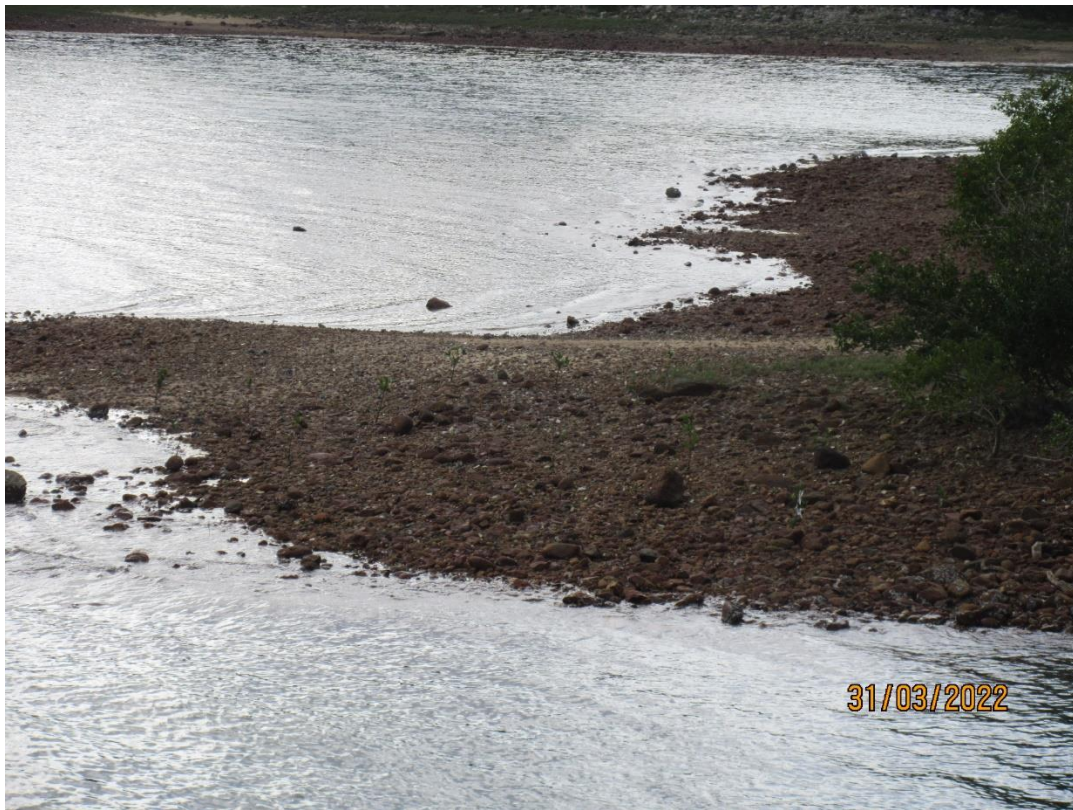
Photo 2.2 General view of the mangrove in location 2

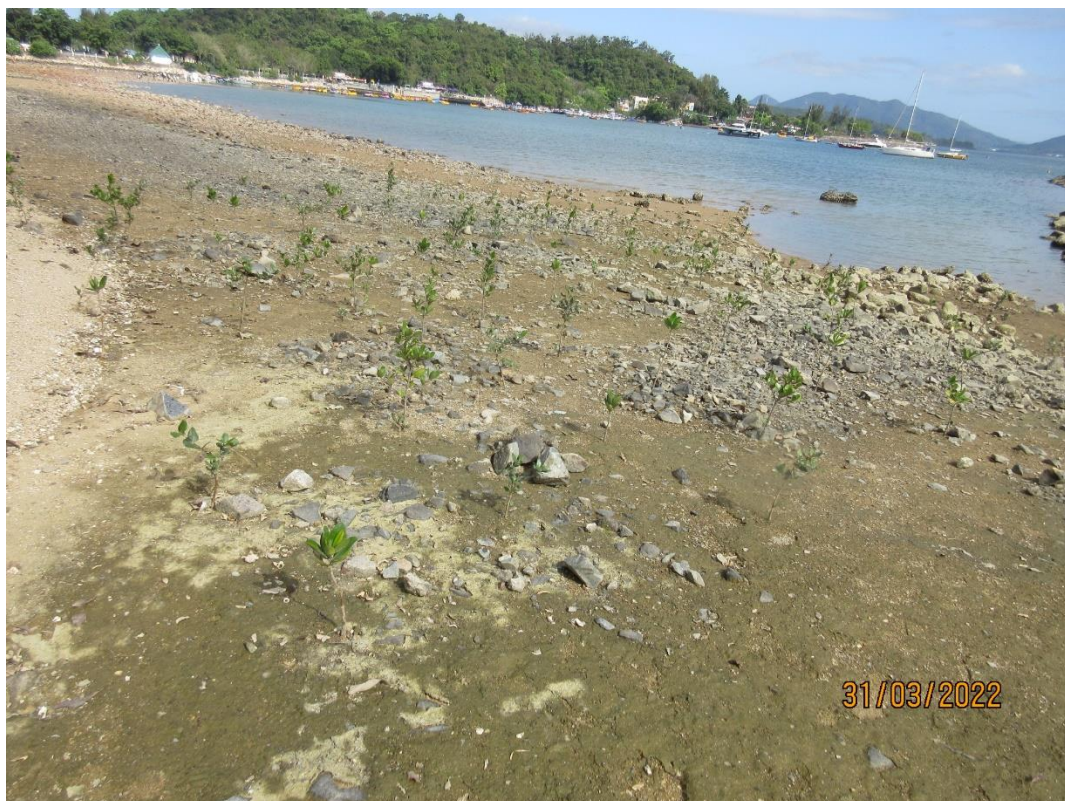
Photo 2.3 General view of the mangrove in location 3

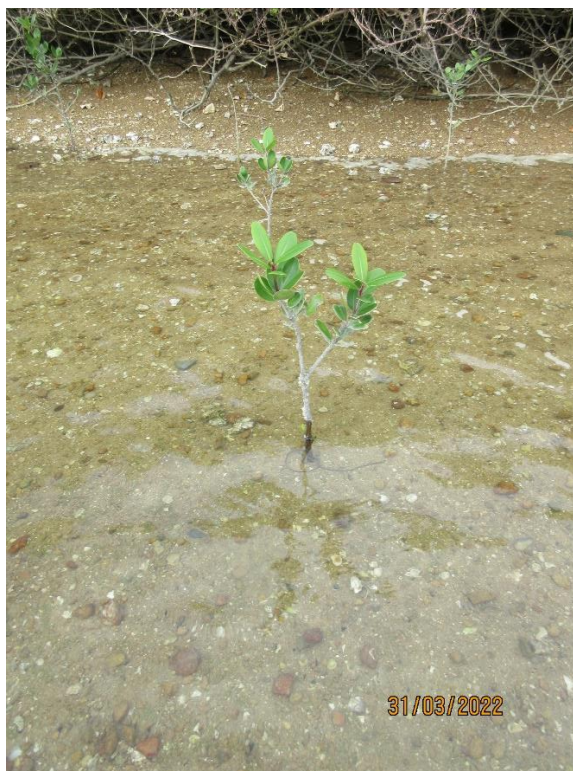
For location 1, only around 25% of the seedlings were alive and only the seedlings on the most landward side have leaves (Photo 3.1). The poor health seedlings (no leaves but still alive) are gradually declining and most of the seedlings were dead or washed away.

Photo 3.1 The seedling on the most landward side has leaves and is in good condition

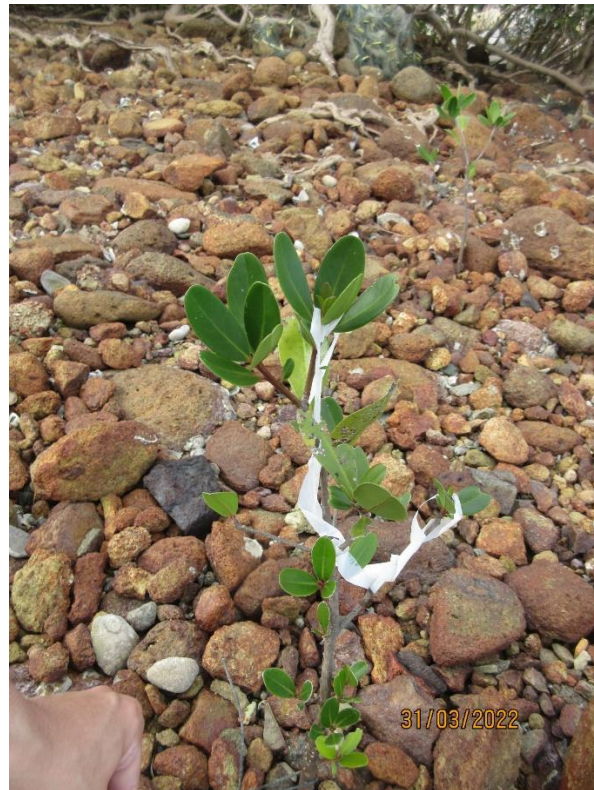
For location 2, A large amount of the seedlings were dead (Photo 3.2) and washed away, some of them with very short dead stem remain. A certain amount of the dead seedlings was disappeared, it is suspected that the dead seedling is dried out, decayed and washed away by the tidal wave. Only the seedlings on the most landward side have leaves (Photo 3.3) and several poor health seedlings (no leaves but still alive) are also gradually declining.

Photo 3.3 The seedling on the most landward side has leaves and is in good condition

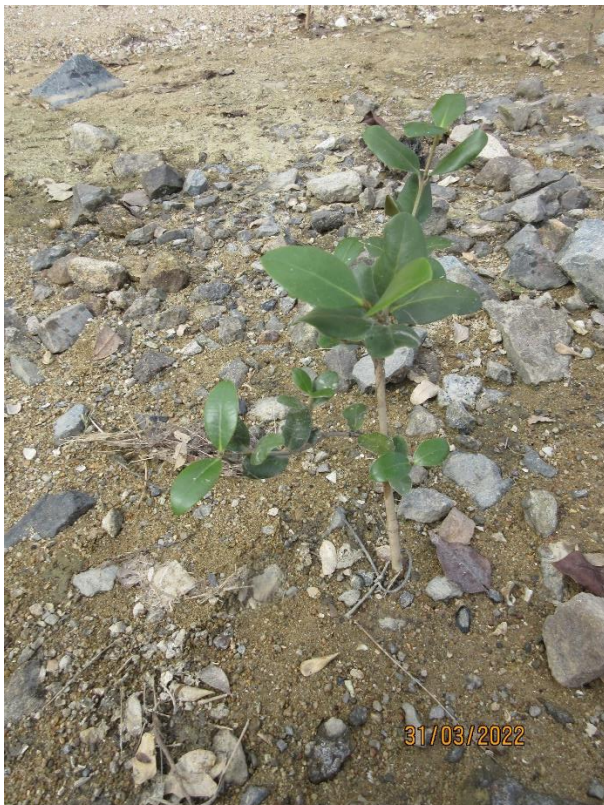
For location 3, most of the seedlings have normal foliage density and are in good condition (Photo 3.4). A small portion of the seedlings at the seaward side was in poor condition (no leaves but still alive) and dead (Photo 3.5).

Photo 3.4 Seedling with good condition

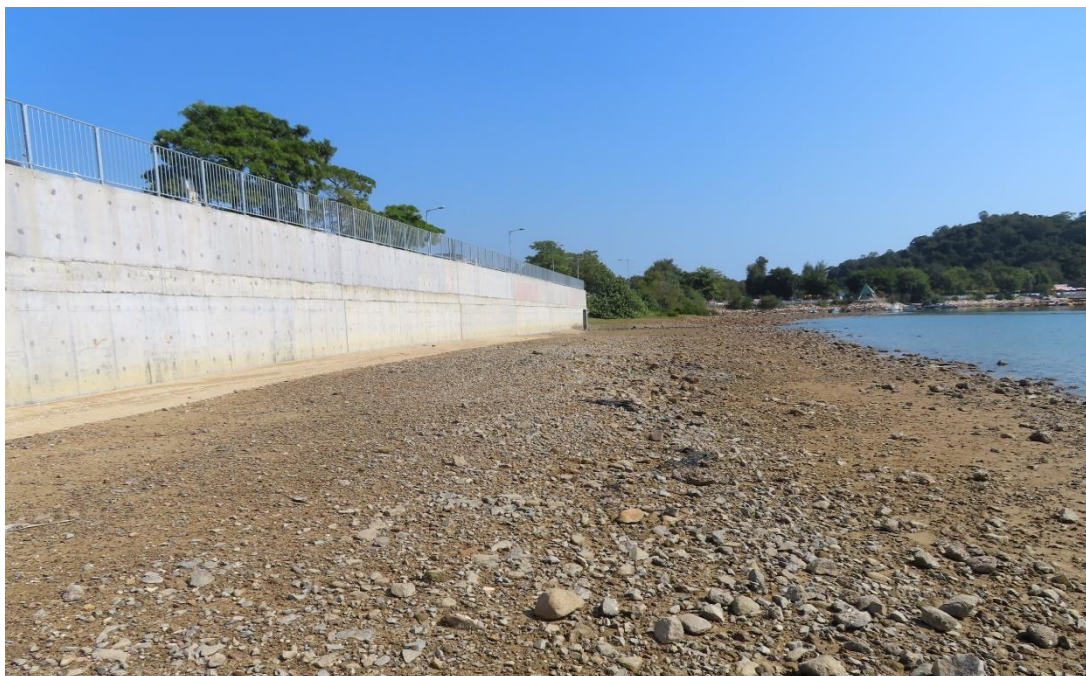
Photo 3.6 The area next to location 3

Since the mangrove distribution and survival is primarily determined by sea level and its fluctuations, other secondary factors are air temperature, salinity, ocean currents, storms, shore slope, and soil substrate also affect the establishment rate. Both *Aegiceras corniculatum* and *Avicennia marina* are mostly at the outer fringe (seaward) among other mangroves and *Avicennia marina* is also a pioneer species, however, even those species fail to establish at location 1 and location 2. From our observation, it is suspected that the condition of location 1 and location 2, especially the seaward side is not optimal for the seedlings to establish and grow. The contractor is recommended to replant the seedlings and review if the planting location should be moved to a more landward side or other locations (like next to location 3 (Photo 3.6) which the current condition of the seedlings is good) to improve the survival rate.

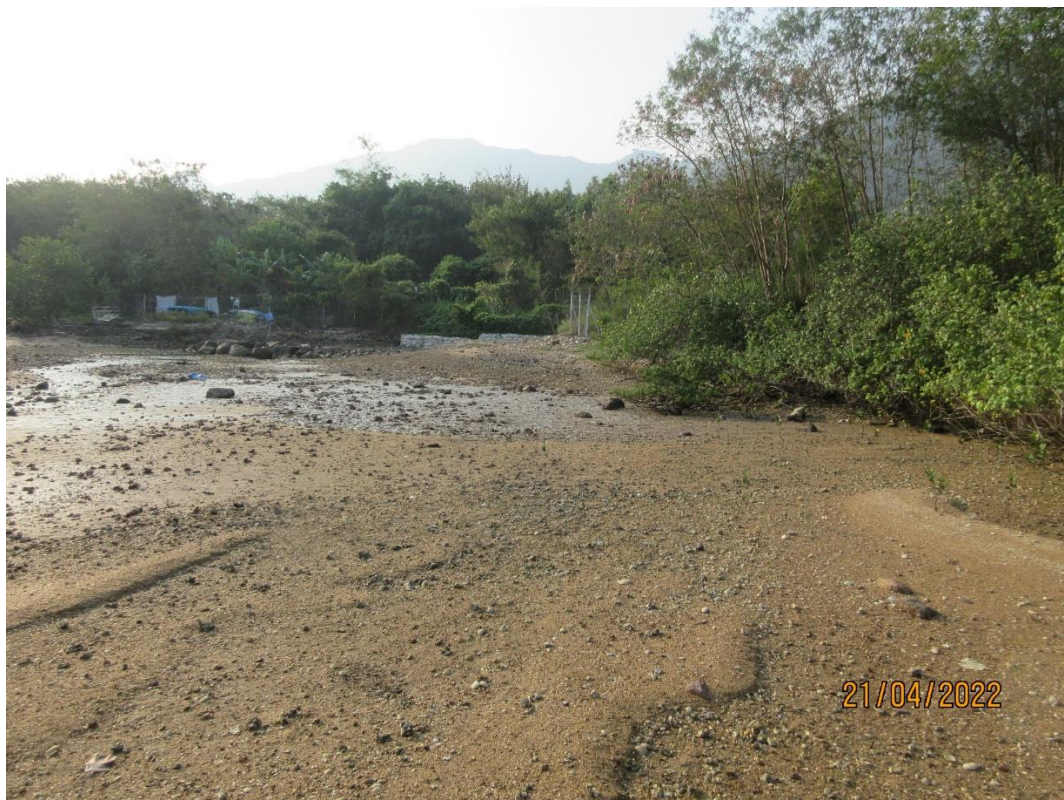
Photo 2.1 General view of the mangrove in location 1

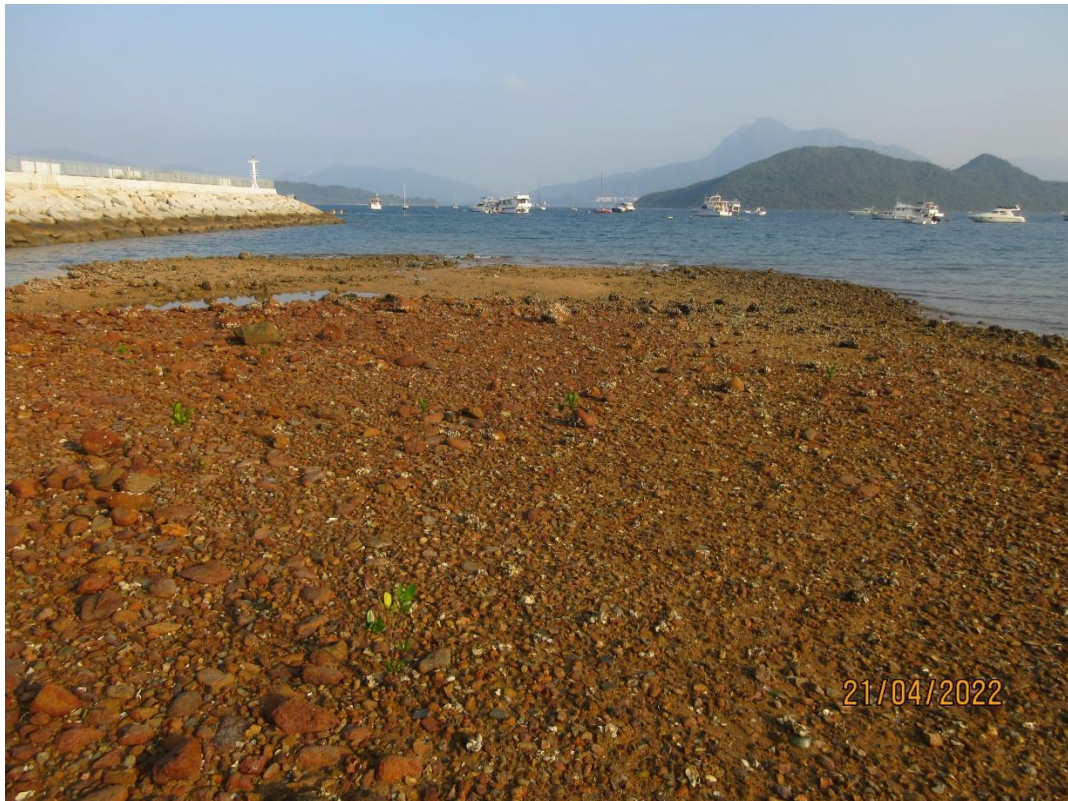
Photo 2.2 General view of the mangrove in location 2

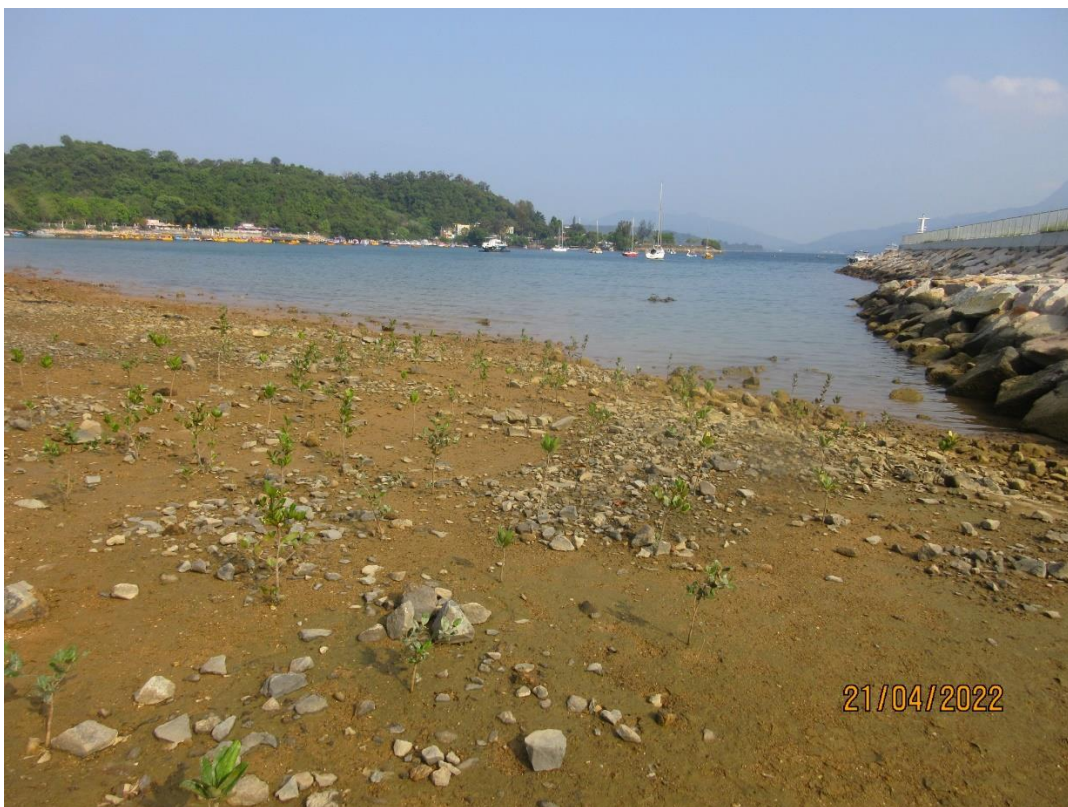
Photo 2.3 General view of the mangrove in location 3

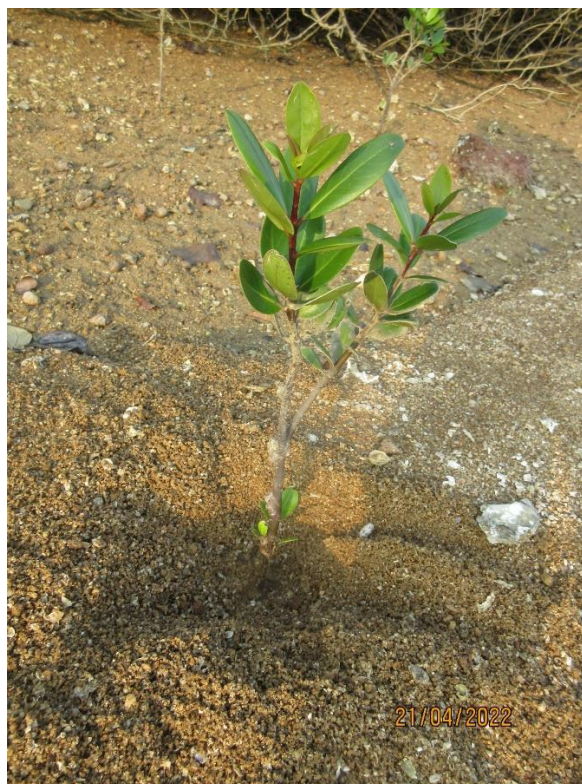
For location 1, only around 20% of the seedlings were found alive and only the seedlings on the most landward side have leaves (Photo 3.1). The poor health seedlings (no leaves but still alive) are gradually declining and most of the seedlings were dead or washed away.

Photo 3.1 The seedling on the most landward side has leaves and is in good condition

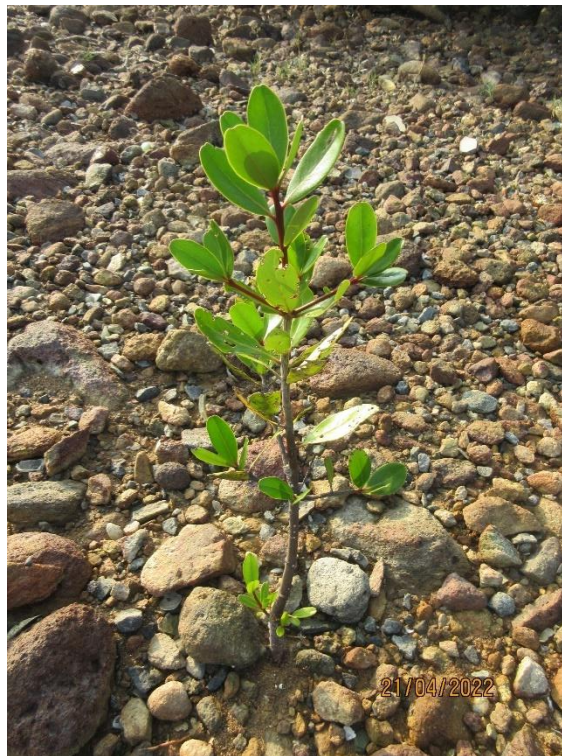
For location 2, A large amount of the seedlings were dead (Photo 3.2) and washed away, some of them remain very short dead stem and other disappeared. It is suspected that the dead seedling is dried out, decayed and washed away by the tidal wave. Only the seedlings on the most landward side have leaves (Photo 3.3) and several poor health seedlings (no leaves but still alive) are also gradually declining.

Photo 3.3 The seedling on the most landward side has leaves and is in good condition

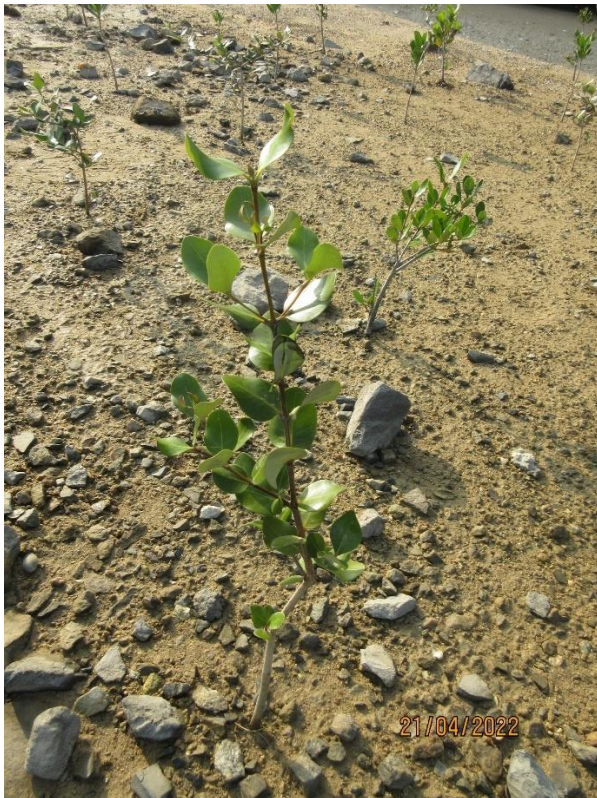
For location 3, most of the seedlings have normal foliage density and are in good condition (Photo 3.4). A small portion of the seedlings at the seaward side was in poor condition (no leaves but still alive) and dead (Photo 3.5).

Photo 3.4 Seedling with good condition
