PROJECT No.: TCS/00874/16

**CEDD CONTRACT NO. CV/2012/05 –
BATHING BEACH AT LUNG MEI, TAI PO**

**POST-CONSTRUCTION MONITORING AND AUDIT
REPORT (MAY TO JUNE 2022)**

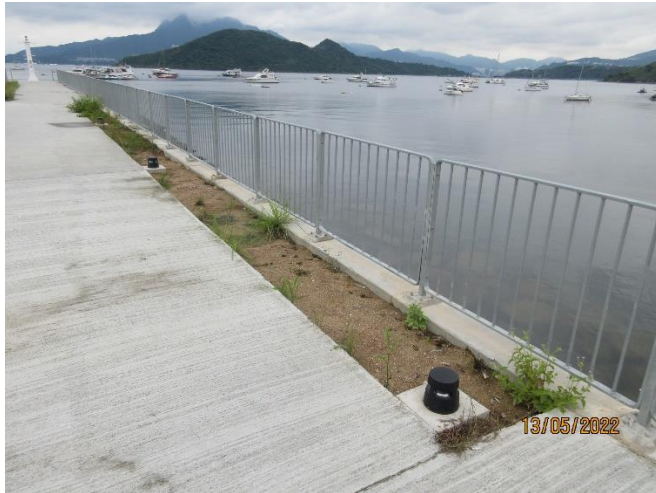
Photo I.

1.3	Any potential incursion, fire, pollution, and surface erosion, etc.	✓			Some of the plants in the planters on the Western groyne were wilted for several months without replacement.

Some of the plants in the planters on the Western groyne were wilted and removed.

1. Some of the plants in the planters on the Western groyne were wilted and should be removed (Photo I).
2. Poor soil drainage is found in one planter on the Eastern groyne which should be urgently mitigated (Photo J).
3. More ties and stakes were detached at Western box culvert (Photo K).
4. The plants in the Eastern box culvert planters were removed without replacement (Photo L).
5. Some ties and stakes are already girdled and affected the growth of the trees and some unnecessary ties are attached to the trees (Photo M and Photo N).
6. Some of the *Angelonia angustifolia* in the planters along the Ting Kok Road were wilted and removed (Photo O).
7. *Mikania micrantha* and weeds were found in the planters on the Western groyne (Photo P).
8. The Contractor should handle the prolonged outstanding follow-up works as soon as possible.

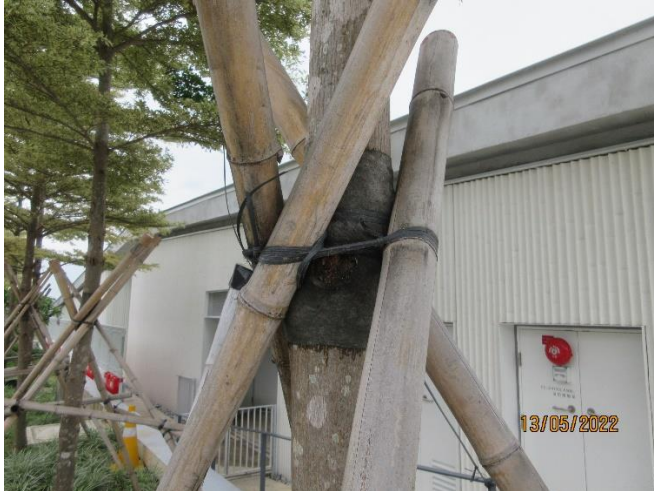
Photo M.

Some ties and stakes already girdled and affected the growth of the trees.

1. Girdling by the ties and stakes was observed on some of the trees. The Contractor(s) is/are required to adjust the ties and remove the unnecessary ties to avoid damage to the tree as a matter of urgency or tree replacement may be required before rejection from maintenance authority during handover.
2. The Contractor(s) is/are reminded to check the guying and staking of all retained/newly planted trees to ensure the tree supporting systems are properly installed, in order and not causing any damage to the trees.
3. The Contractor(s) is/are reminded to replant the plants at the Western groyne and the Eastern box culvert, and tackle the poor soil drainage issue on the Eastern groyne.

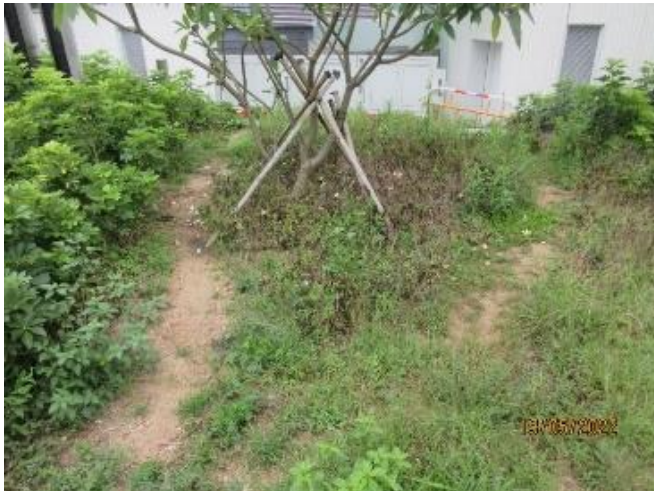
Photo O.

Some of the *Angelonia angustifolia* in the planters along the Ting Kok Road were wilted and removed.

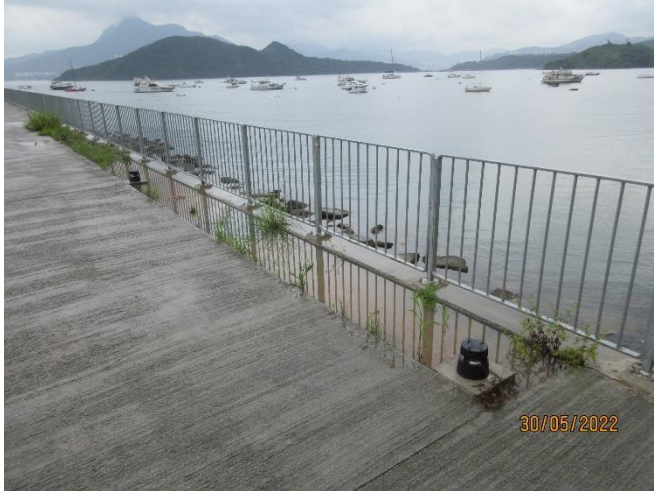
Photo I.

1.3	Any potential incursion, fire, pollution, and surface erosion, etc.	✓			Some of the plants in the planters on the Western groyne were wilted for several months without replacement.

Some of the plants in the planters on the Western groyne were wilted and removed.

1. Some of the plants in the planters on the Western groyne were wilted and should be removed (Photo I).
2. Poor soil drainage is found in one planter on the Eastern groyne which should be urgently mitigated (Photo J).
3. More ties and stakes were detached at Western box culvert (Photo K).
4. The plants in the Eastern box culvert planters were removed without replacement (Photo L).
5. Some ties and stakes are already girdled and affected the growth of the trees and some unnecessary ties are attached between the trees (Photo M and Photo N).
6. Some of the *Angelonia angustifolia* in the planters along the Ting Kok Road were wilted and removed (Photo O).
7. *Mikania micrantha* and weeds were found in the planters on the Western groyne (Photo P).
8. The Contractor should handle the prolonged outstanding follow-up works as soon as possible.

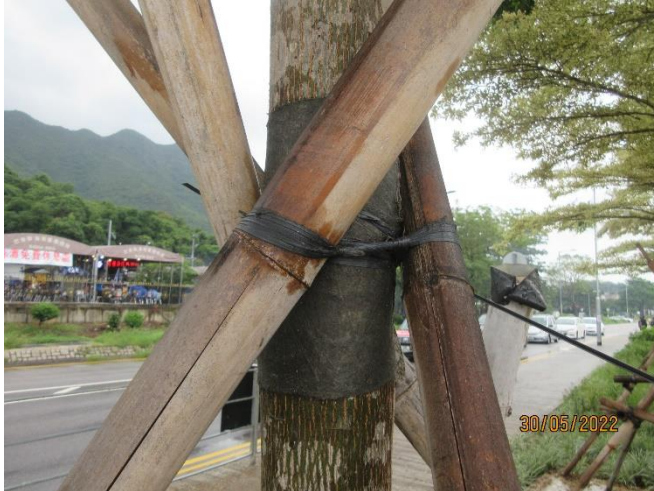
Photo M.

Some ties and stakes already girdled and affected the growth of the trees.

1. Trunk Girdling by the ties and stakes was observed on some of the trees. The Contractor(s) is/are required to adjust the ties and remove the unnecessary ties to avoid damage to the tree as a matter of urgency or tree replacement may be required before rejection from maintenance authority during handover.
2. The Contractor(s) is/are reminded to adjust or remove if necessary the guying and staking of all retained/newly planted trees to ensure the tree supporting systems are properly installed, in order

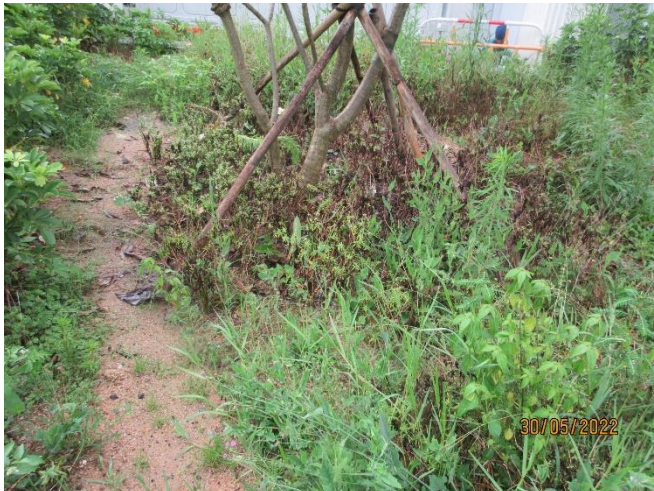
Photo O.

Some of the *Angelonia angustifolia* in the planters along the Ting Kok Road were wilted and removed.

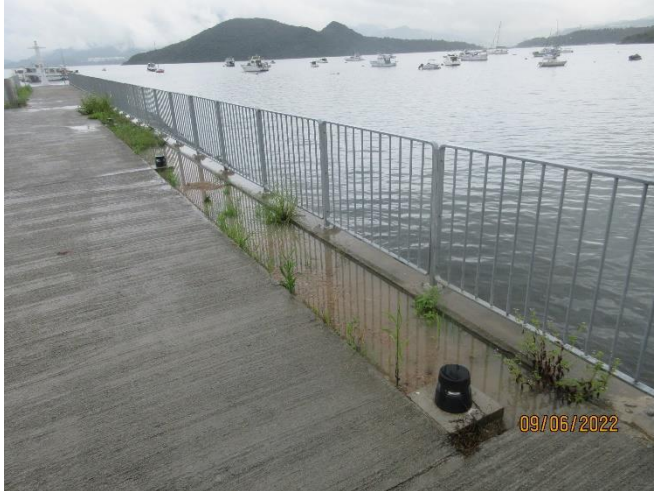
Photo I.

Some of the plants in the planters on the Western groyne were wilted and removed.

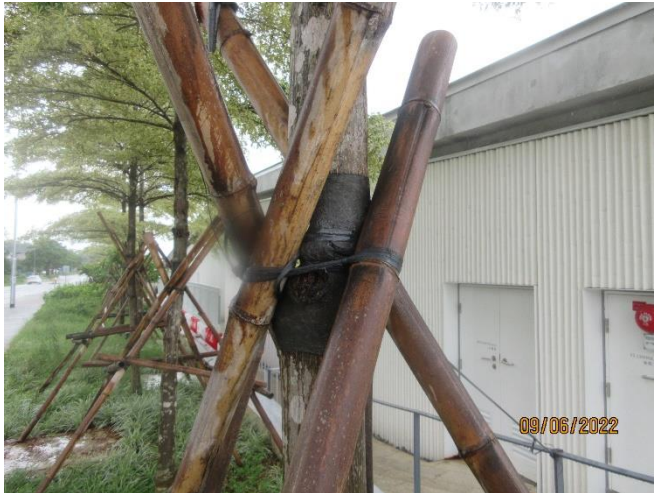
Photo M.

Some ties and stakes already girdled and affected the growth of the trees.

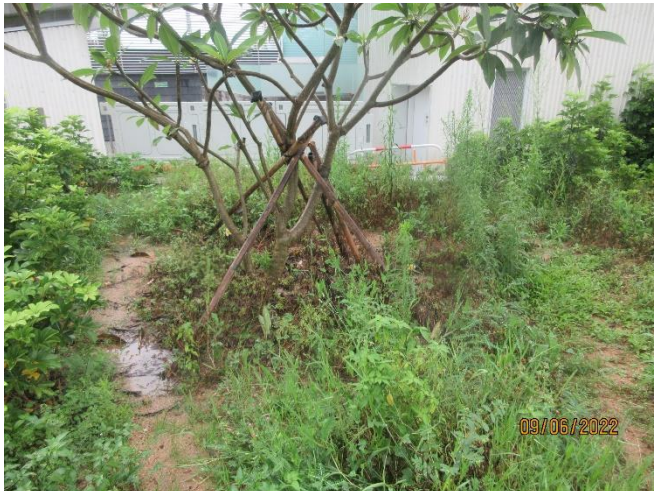
Photo O.

Some of the *Angelonia angustifolia* in the planters along the Ting Kok Road were wilted and removed.

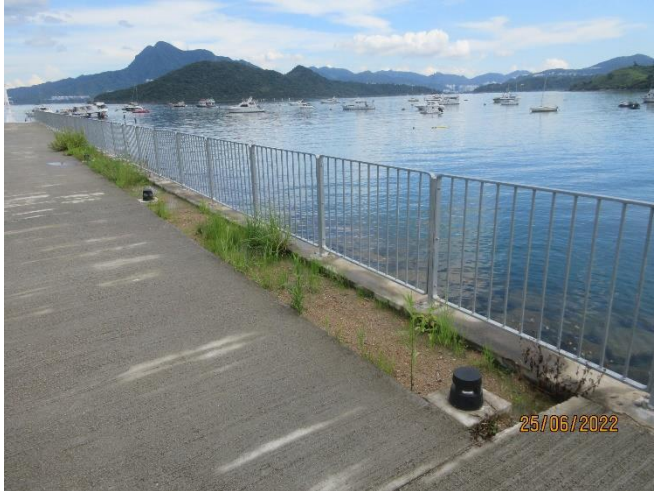
Photo I.

1. Some of the plants in the planters on the Western groyne were wilted and should be removed (Photo I).
2. Poor soil drainage is found in one planter on the Eastern groyne which should be urgently mitigated (Photo J).
3. More ties and stakes were detached at Western box culvert (Photo K).
4. The plants in the Eastern box culvert planters were removed without replacement (Photo L).
5. Some ties and stakes are already girdled and affected the growth of the trees and some unnecessary ties are attached between the trees (Photo M and Photo N).
6. Some of *Angelonia angustifolia* in the planters along the Ting Kok Road were wilted and removed (Photo O).
7. Undesirable species like *Mikania micrantha* and weeds were found in the planters on the Western groyne (Photo P).
8. The Contractor should handle the prolonged outstanding follow-up works as soon as possible.

Some of the plants in the planters on the Western groyne were wilted and removed.

- to avoid further damage of newly planted trees or the final maintenance department(s) will not accept during handover stage.
3. The Contractor(s) is/are reminded to replant the plants at the Western groyne and the Eastern box culvert, and tackle the poor soil drainage issue on the Eastern groyne.
 4. The Contractor(s) is/are reminded to remove the *Mikania micrantha* and other weeds on the Western groyne.
 5. The Contractor(s) is/are reminded to replant *Angelonia angustifolia* at the planters along the Ting Kok Road following the landscape plan.
 6. Urgent rectification by the Contractor(s) is required to achieve sufficient establishment for plantings

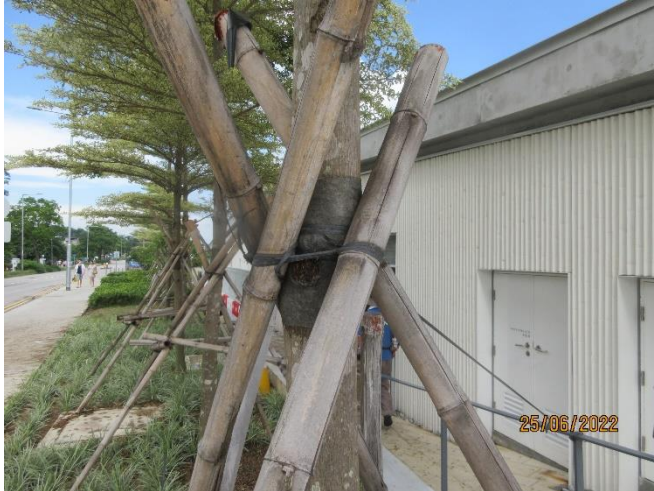
Photo M.

Some ties and stakes already girdled and affected the growth of the trees.

1. Trunk Girdling by the ties and stakes was observed on some of the trees. The Contractor(s) is/are required to adjust the ties and remove the unnecessary ties to avoid damage to the tree as a matter of urgency or tree replacement may be required before rejection from maintenance authority during handover.
2. The Contractor(s) is/are reminded to adjust or remove if necessary the guying and staking of all retained/newly planted trees to ensure the tree supporting systems are properly installed, in order

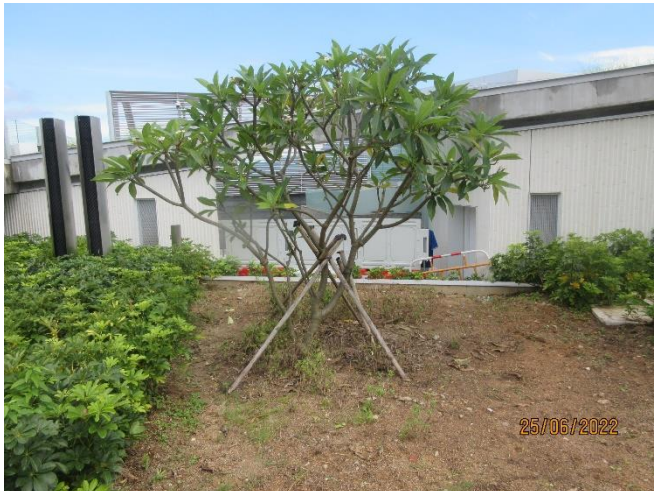
Photo O.

Some of the *Angelonia angustifolia* in the planters along the Ting Kok Road were wilted and removed.

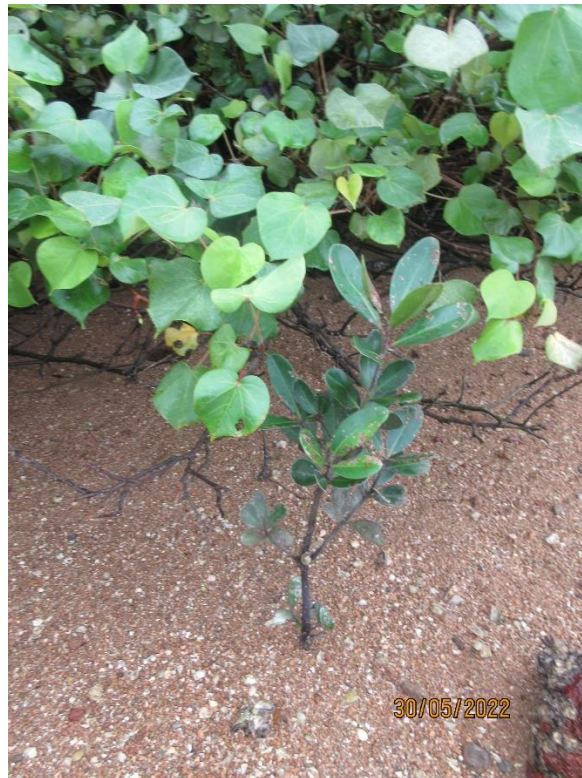
For location 1, only around 20% of the seedlings were found alive and only the seedlings on the most landward side have leaves (Photo 3.1). The poor health seedlings (no leaves but still alive) are gradually declining and most of the seedlings were dead or washed away.

Photo 3.1 The seedling on the most landward side has leaves and is in good condition

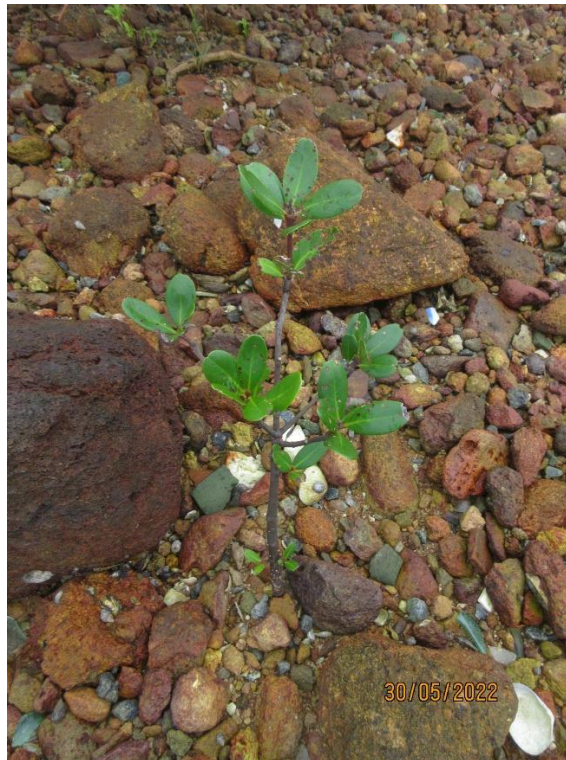
For location 2, A large amount of the seedlings were dead (Photo 3.2) and washed away, some of them remain very short dead stem and other disappeared. It is suspected that the dead seedling is dried out, decayed and washed away by the tidal wave. Only the seedlings on the most landward side have leaves (Photo 3.3) and several poor health seedlings (no leaves but still alive) are also gradually declining.

Photo 3.3 The seedling on the most landward side has leaves and is in good condition

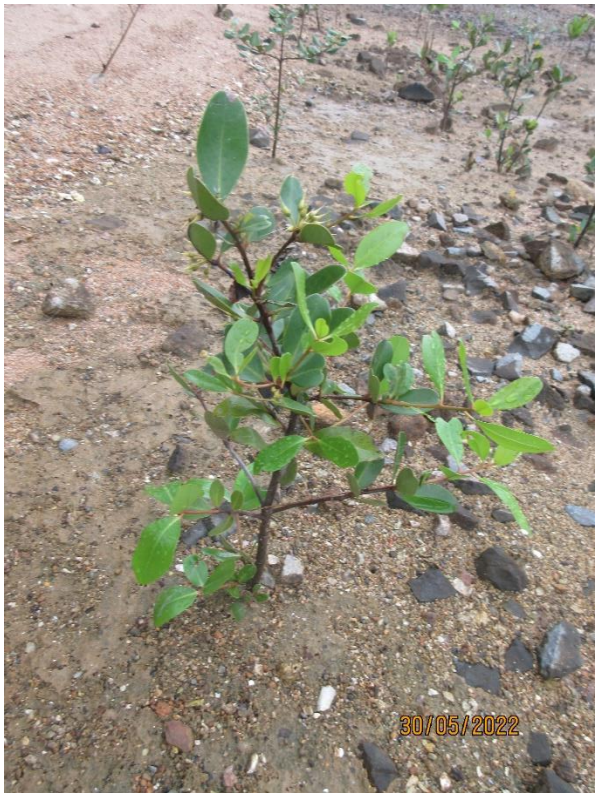
For location 3, most of the seedlings have normal foliage density and are in good condition (Photo 3.4). A small portion of the seedlings at the seaward side was in poor condition (no leaves but still alive) and dead (Photo 3.5).

Photo 3.4 Seedling with good condition

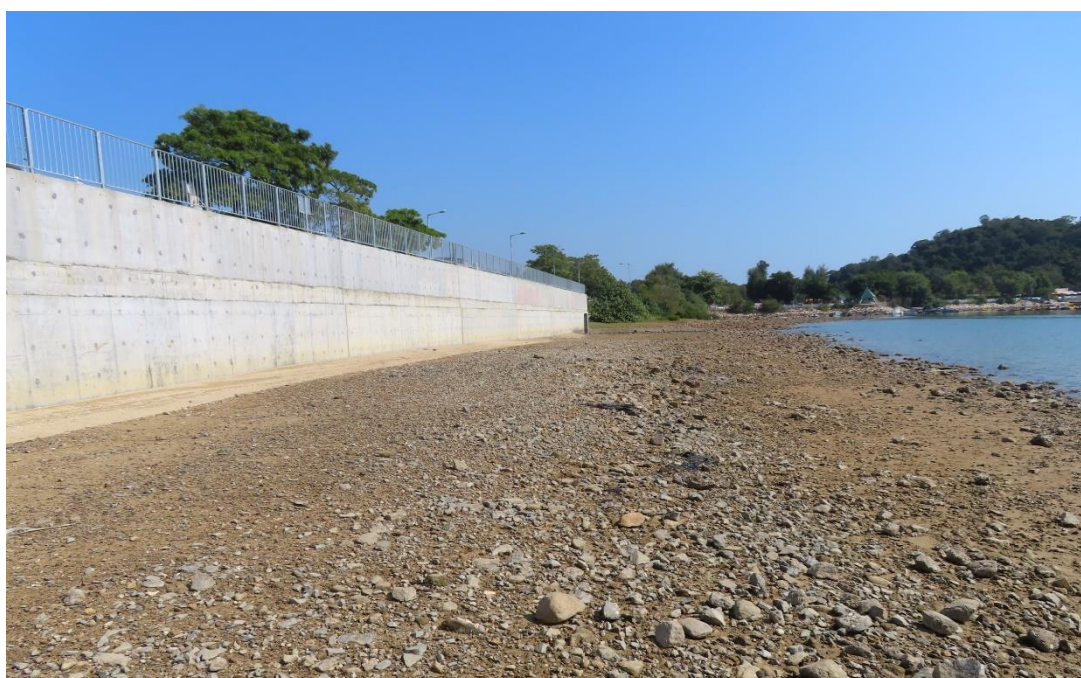
Photo 3.6 The area next to location 3

Since the mangrove distribution and survival is primarily determined by sea level and its fluctuations, other secondary factors are air temperature, salinity, ocean currents, storms, shore slope, and soil substrate also affect the establishment rate. Both *Aegiceras corniculatum* and *Avicennia marina* are mostly at the outer fringe (seaward) among other mangroves and *Avicennia marina* is also a pioneer species, however, even those species fail to establish at location 1 and location 2. From our observation, it is suspected that the condition of location 1 and location 2, especially the seaward side is not optimal for the seedlings to establish and grow. It is highly recommended that the contractor should replant the seedlings and the planting locations should be further landward side or other locations (like next to location 3 (Photo 3.6) which the current condition of the seedlings is good) to improve the survival rate.

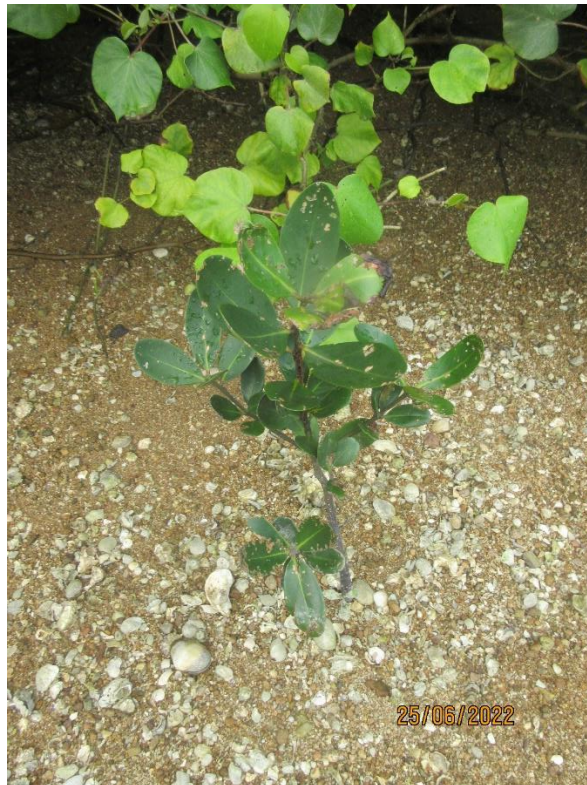
For location 1, only around 20% of the seedlings were found alive and only the seedlings on the most landward side have leaves (Photo 3.1). The poor health seedlings (no leaves but still alive) are gradually declining and most of the seedlings were dead or washed away.

Photo 3.1 The seedling on the most landward side has leaves and is in good condition

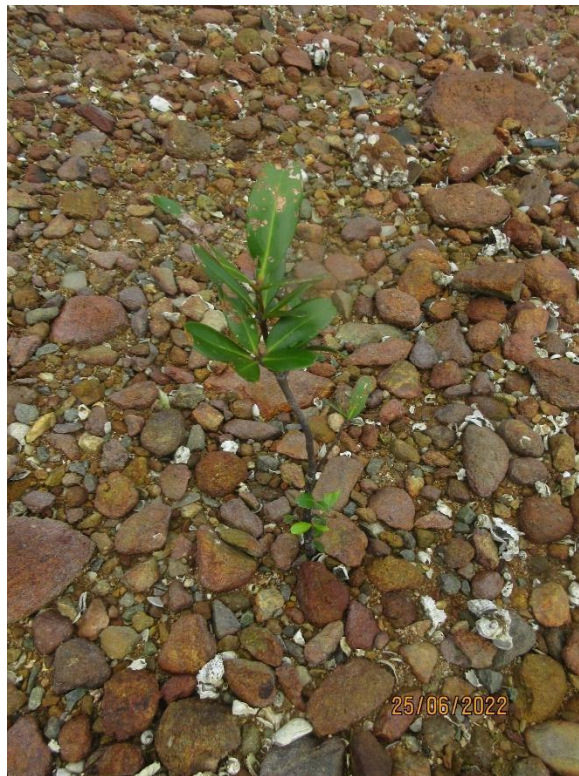
For location 2, A large amount of the seedlings were dead (Photo 3.2) and washed away, some of them remain with very short dead stems and others disappeared. It is suspected that the dead seedling is dried out, decayed and washed away by the tidal wave. Only the seedlings on the most landward side have leaves (Photo 3.3) and several poor health seedlings (no leaves but still alive) are also gradually declining.

Photo 3.3 The seedling on the most landward side has leaves

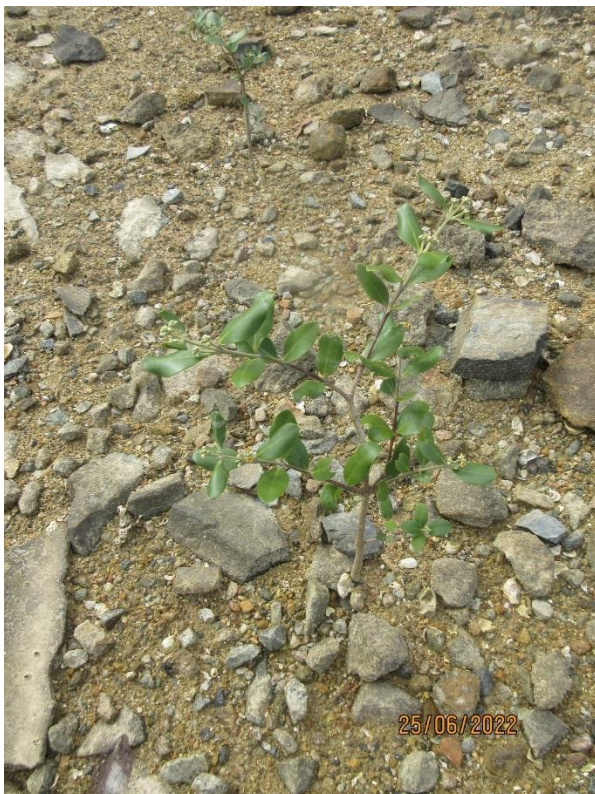
For location 3, most of the seedlings have normal foliage density and are in good condition (Photo 3.4). A small portion of the seedlings at the seaward side was in poor condition (no leaves but still alive) and dead (Photo 3.5). Pest infestation is observed in all 3 species (approximate 15 seedlings) (Photo 3.6 and Photo 3.7).

Photo 3.4 Seedling in good condition
