**CEDD CONTRACT NO. CV/2012/05 –
BATHING BEACH AT LUNG MEI, TAI PO**

**POST-CONSTRUCTION MONITORING AND AUDIT
REPORT (JULY TO AUGUST 2022)**

PREPARED FOR
WELCOME CONSTRUCTION CO., LTD.

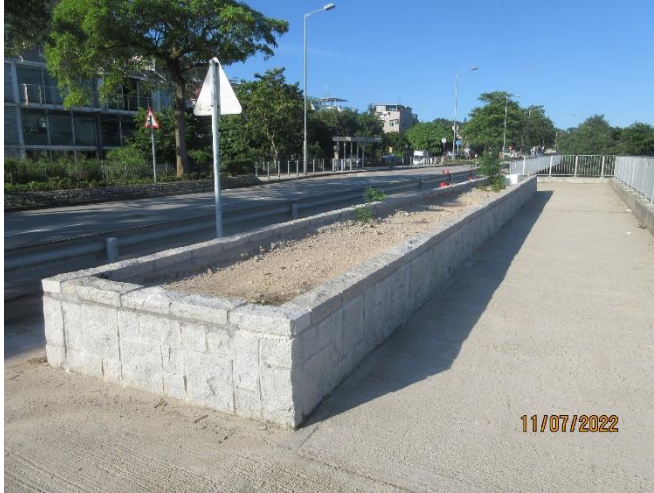
Photo I.

- The plants in the Eastern box culvert planter were removed without replacement (Photo I).
- Some ties and stakes were detached at the Western box culvert (Photo J).
- Some ties and stakes already girdled and affected the growth of the trees (Photo K and Photo L).
- Some of *Angelonia angustifolia* in the planters along the Ting Kok Road were still missing (Photo M).
- The Railing & debris damage the planters at the planter near Ting Kok Road (Photo S)
- The Contractor should handle the prolonged outstanding follow-up works as soon as possible.

No plants in the Eastern box culvert planter.

- to avoid further damage of newly planted trees or the final maintenance department(s) will not accept during handover stage.
3. The Contractor(s) is/are reminded to replant *Scaevola taccada* in the Eastern box culvert planters following the landscape plan.
 4. The Contractor(s) is/are reminded to keep replanting *Angelonia angustifolia* at the planters along the Ting Kok Road following the landscape plan.
 5. The Contractor(s) is/are reminded to clear and re-arrange the railing & debris at the planter near Ting Kok Road.
 6. Urgent rectification by the Contractor(s) is required to achieve sufficient establishment for plantings

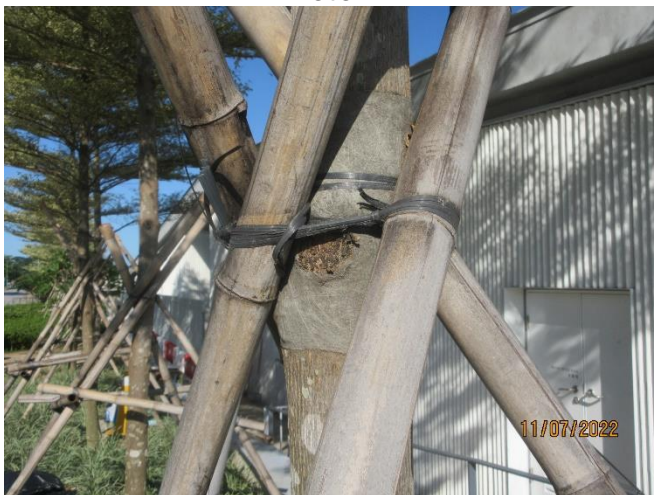
Photo K.

Some ties and stakes already girdled and affected the growth of the trees.

- Trunk Girdling by the ties and stakes was observed on some of the trees. The Contractor(s) is/are required to adjust the ties and remove the unnecessary ties to avoid damage to the tree as a matter of urgency or tree replacement may be required before rejection from maintenance authority during handover.
- The Contractor(s) is/are reminded to adjust or remove if necessary the guying and staking of all retained/newly planted trees to ensure the tree supporting systems are properly installed, in order

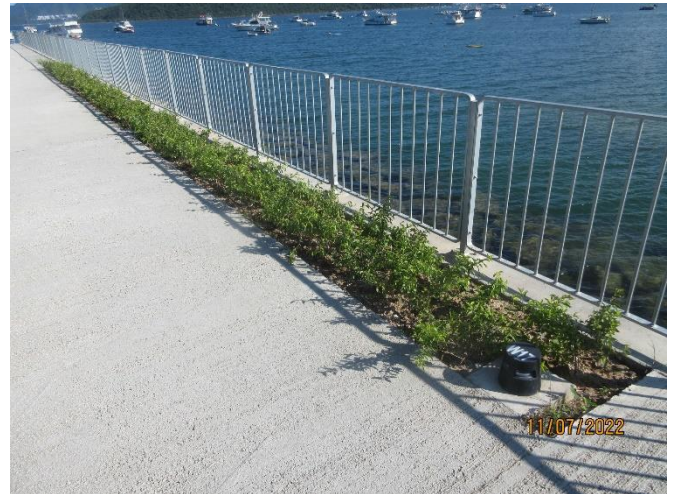
Photo N.

Plants in the planters on the Western groyne were replaced.

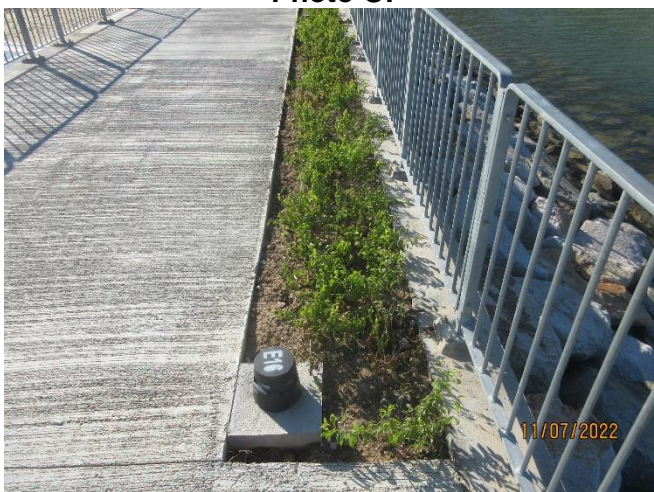
Photo O.

No water logging is observed in the planters on the Eastern groyne.

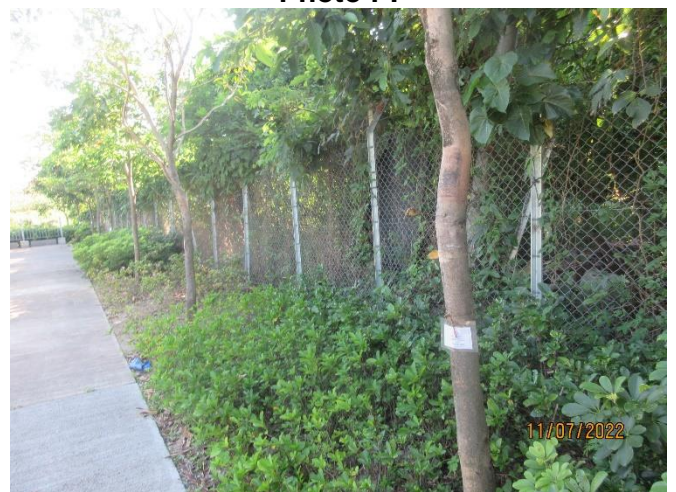
Photo P.

Some ties and stakes were removed at the Western box culvert.

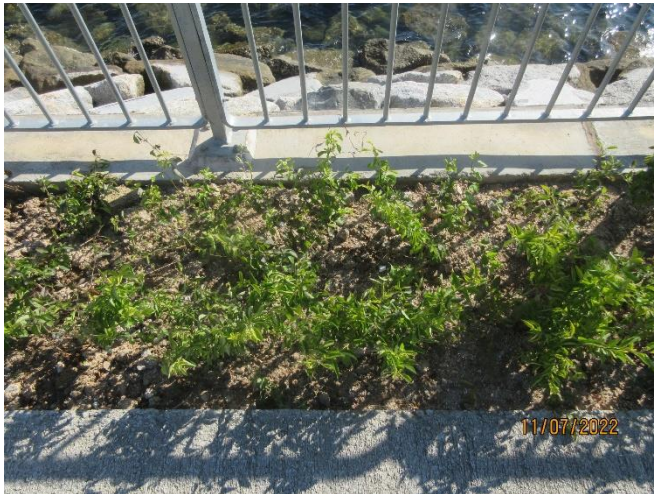
Photo Q.

Undesirable species like *Mikania micrantha* and weeds were removed in the planters on the Western groyne.

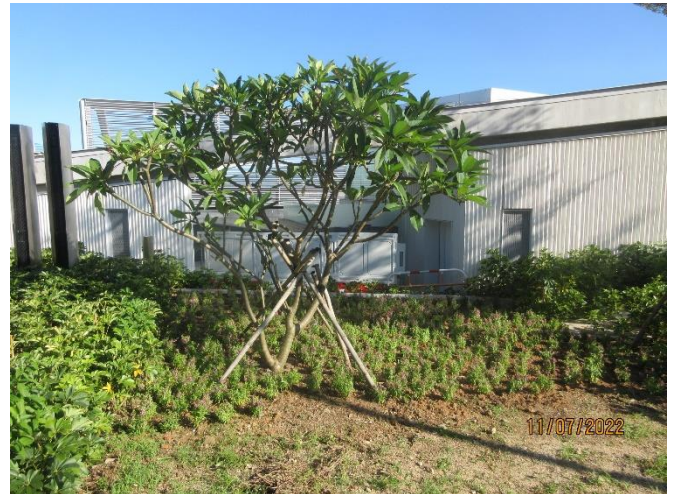
Photo R.

Some *Angelonia angustifolia* were replanted in the planters along the Ting Kok Road.

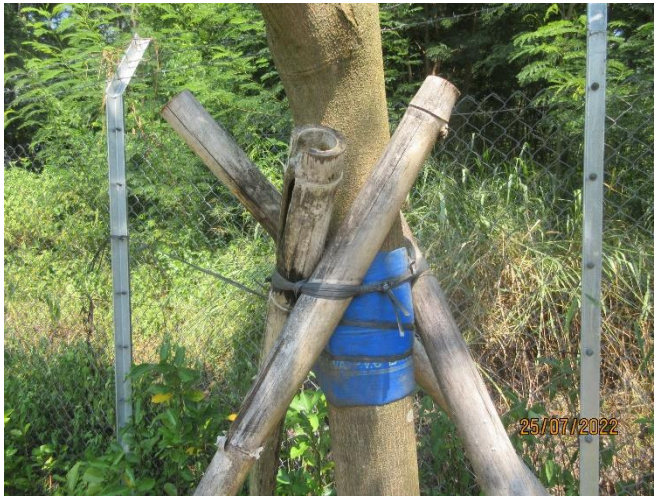
Photo I.

1. The ties and stakes issue is partly resolved as some staking was removed, but some staking still affects the growth of the trees (Photo I).
2. The plants in the Eastern box culvert planter were removed without replacement (Photo J).
3. *Pennisetum alopecuroides* in the outdoor shower was replaced with *Bougainvillea spectabilis* (Photo K and Photo L).
4. The Railing & debris damage the planters at the planter near Ting Kok Road (Photo Q).
5. The Contractor should handle the prolonged outstanding follow-up works as soon as possible.

Some ties and stakes still girdled and affected the growth of the trees.

1. Trunk Girdling by the ties and stakes was observed on some of the trees. The Contractor(s) is/are required to adjust the ties and remove the unnecessary ties to avoid damage to the tree as a matter of urgency or tree replacement may be required before rejection from maintenance authority during handover.
2. The Contractor(s) is/are reminded to adjust or remove if necessary the guying and staking of all retained/newly planted trees to ensure the tree supporting systems are properly installed, in order to avoid further damage of newly planted trees or the final maintenance department(s) will not accept during handover stage.

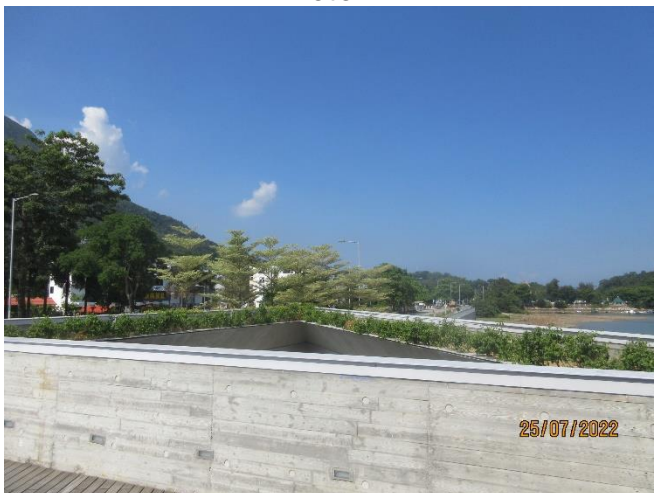
Photo K.

Pennisetum alopecuroides at outdoor shower was replaced with *Bougainvillea spectabilis*.

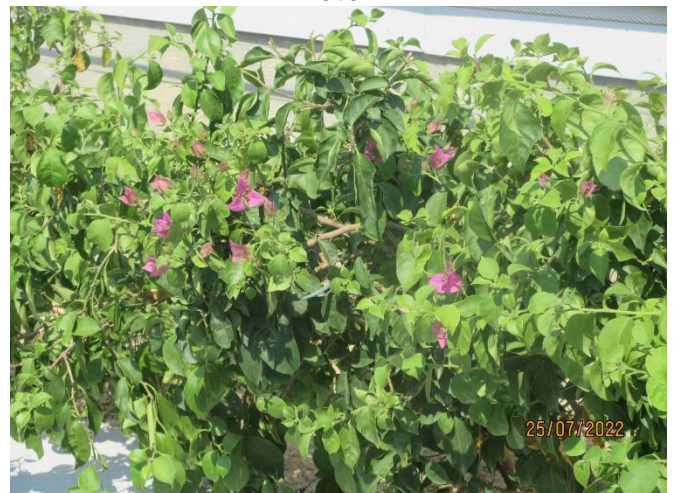
Photo L.

Pennisetum alopecuroides at outdoor shower was replaced with *Bougainvillea spectabilis*.

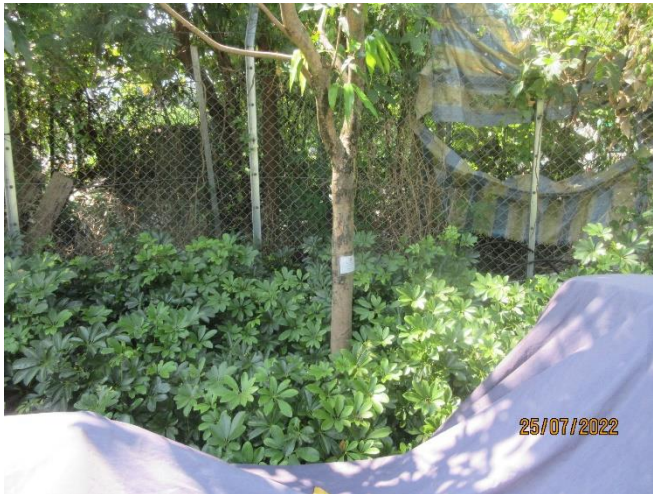
Photo M.

Some ties and stakes were removed at the Western box culvert.

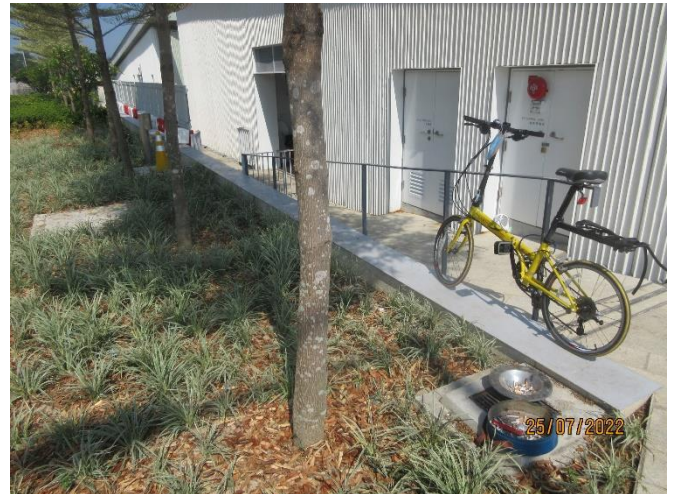
Photo N.

Some ties and stakes were removed along the Ting Kok Road.

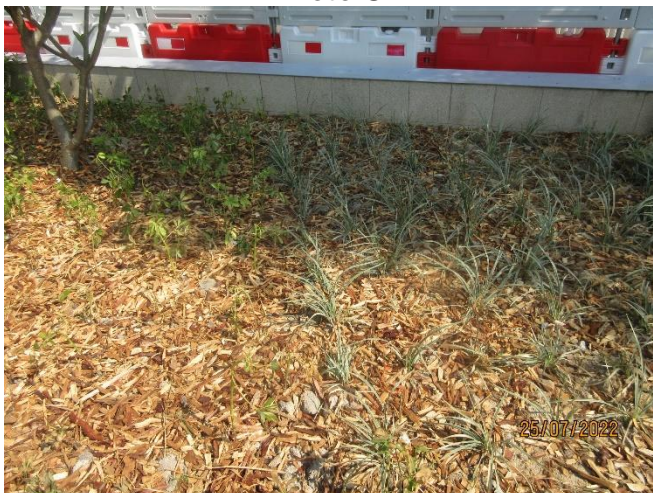
Photo O.

Some of the *Angelonia angustifolia* in the planters along the Ting Kok Road were replaced with *Ophiopogon jaburan* and *Schefflera arboricola*.

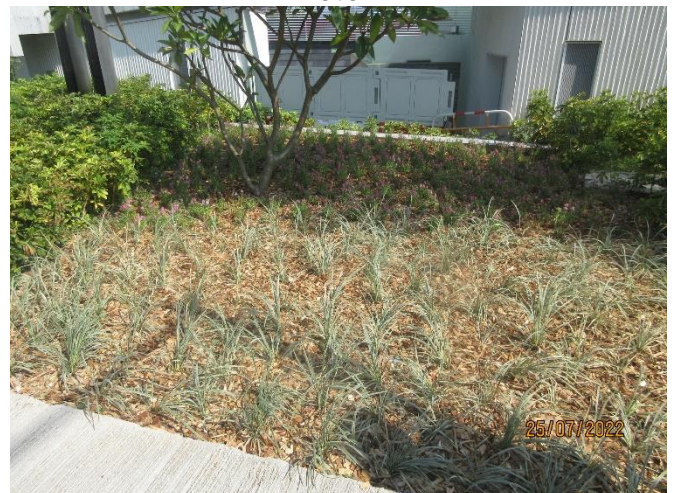
Photo P.

Some of the *Angelonia angustifolia* in the planters along the Ting Kok Road were replaced with *Ophiopogon jaburan*.

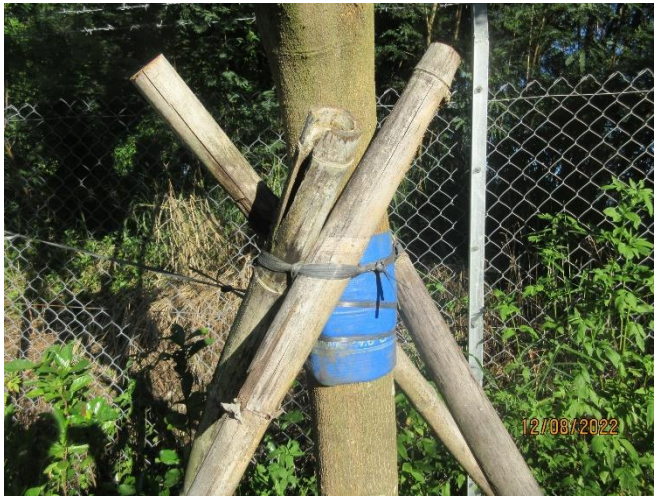
Photo I.

Some ties and stakes still girdled and affected the growth of the trees.

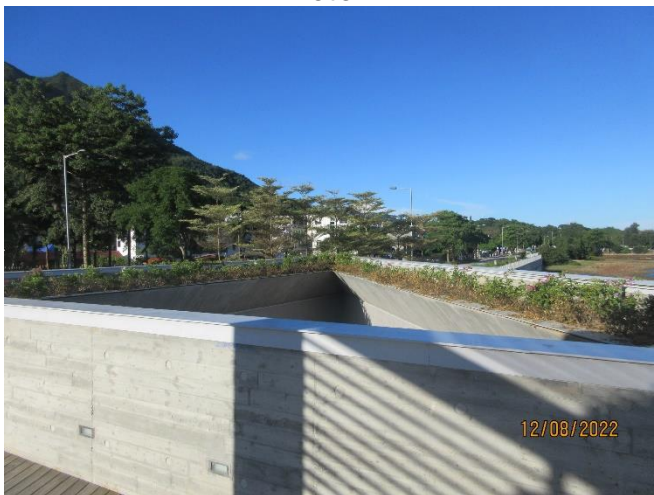
Photo K.

Pennisetum alopecuroides in the outdoor shower were replaced with *Bougainvillea spectabilis*.

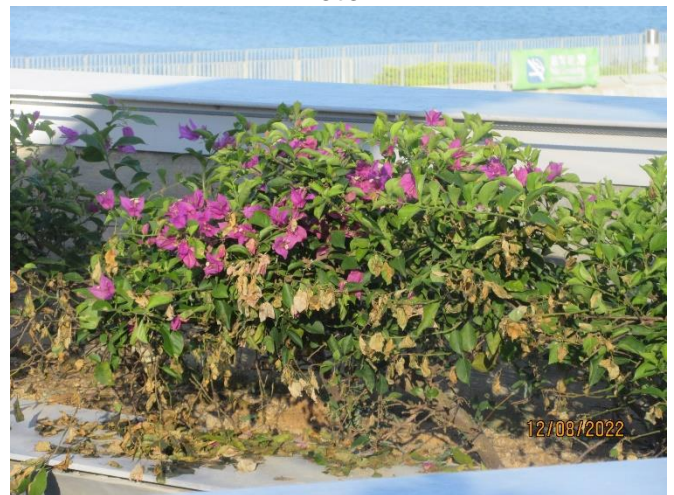
Photo L.

Pennisetum alopecuroides in the outdoor shower were replaced with *Bougainvillea spectabilis*.

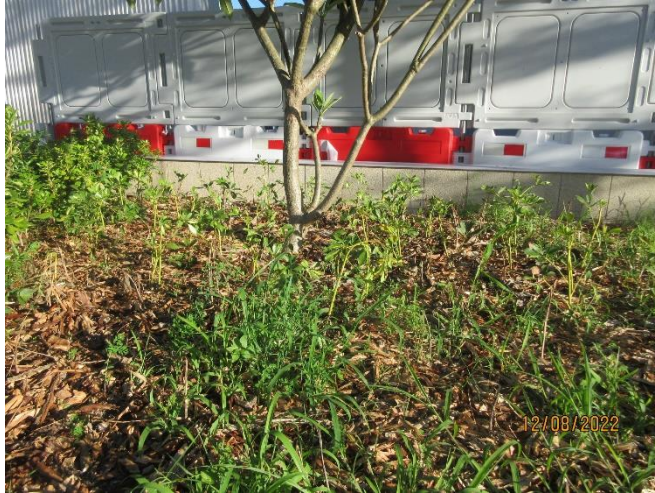
Photo M.

Some of the *Angelonia angustifolia* in the planters along the Ting Kok Road were replaced with *Ophiopogon jaburan* and *Schefflera arboricola*.

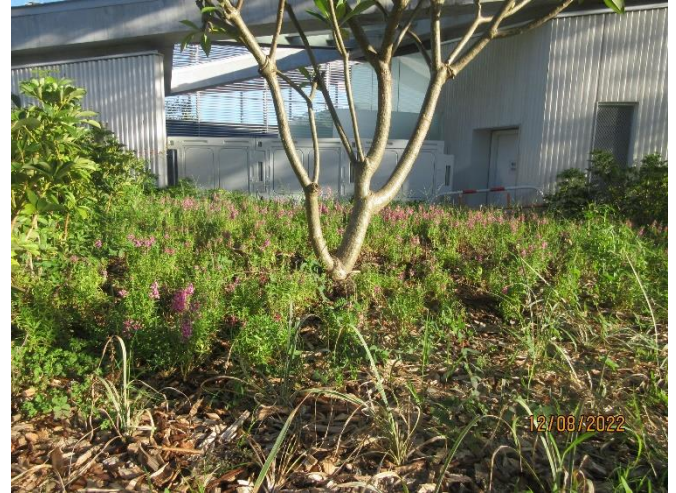
Photo N.

Some of the *Angelonia angustifolia* in the planters along the Ting Kok Road were replaced with *Ophiopogon jaburan*.

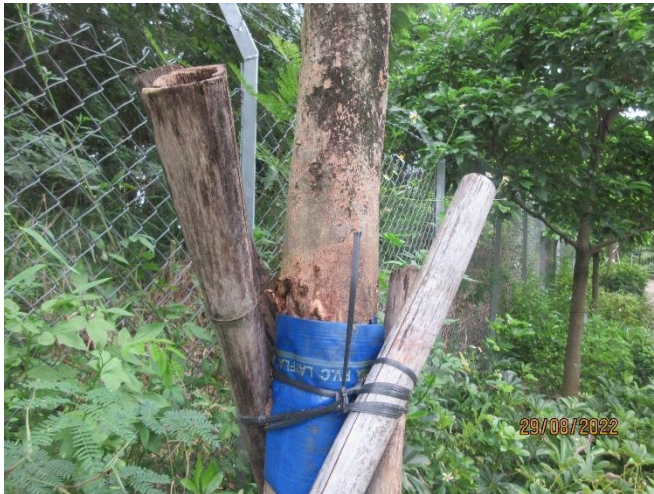
Photo I.

Some ties and stakes still girdled and affected the growth of the trees.

1. Trunk Girdling by the ties and stakes still observed on some of the trees. The Contractor(s) is/are required to adjust the ties and remove the unnecessary ties to avoid damage to the tree as a matter of urgency or tree replacement may be required before rejection from maintenance authority during handover.

2. The Contractor(s) is/are reminded to adjust or remove if necessary the guying and staking of all retained/newly planted trees to ensure the tree supporting systems are properly installed, in order to avoid further damage to newly planted trees or the final maintenance department(s) will not accept during handover stage.

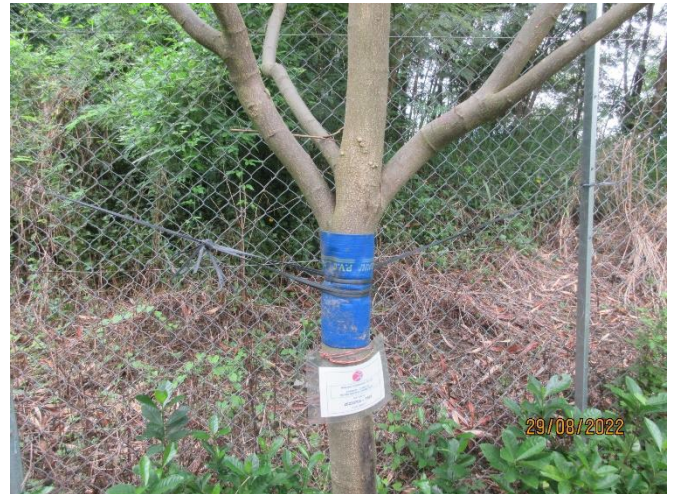
Photo J.

Some unnecessary ties and stakes are attached between the trees.

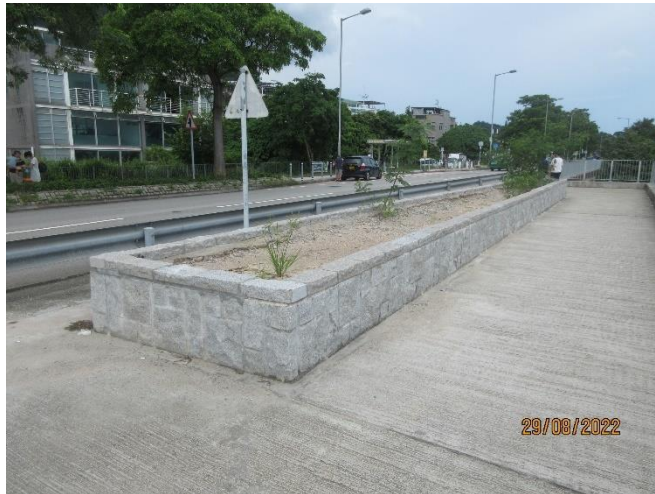
Photo M.

3. Some stakes were broken (Photo K).
4. A *Michelia x alba* (T047) in the car park was found slightly tilted (Photo L).
5. The plants in the Eastern box culvert planter were removed without replacement (Photo M).

No plants in the Eastern box culvert planter.

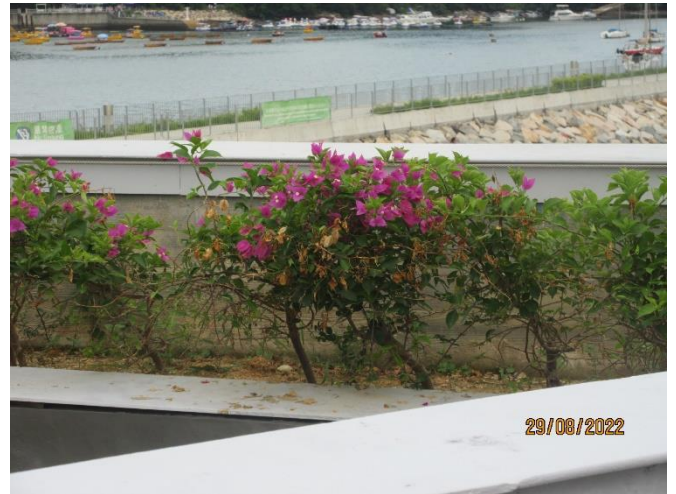
Photo N.

6. *Pennisetum alopecuroides* in the outdoor shower were replaced with *Bougainvillea spectabilis* (Photo N).
7. Some of the newly planted *Ophiopogon jaburan* were found dead (Photo Q).

Pennisetum alopecuroides in the outdoor shower were replaced with *Bougainvillea spectabilis*.

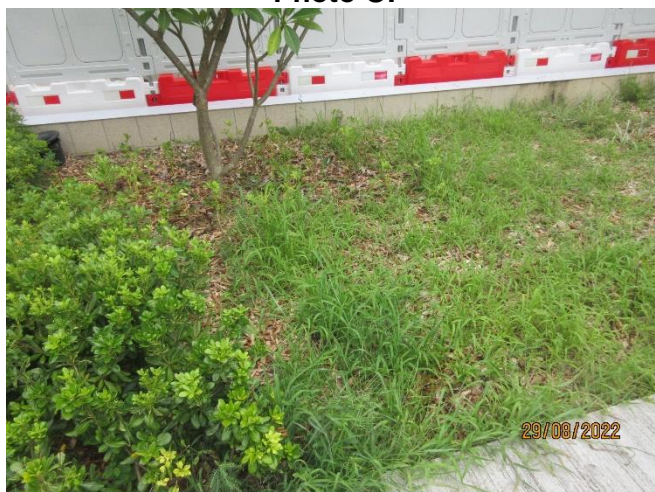
Photo O.

1. Some of the *Angelonia angustifolia* in the planters along the Ting Kok Road were replaced with *Ophiopogon jaburan* and *Schefflera arboricola*. (Photo O and Photo P).
2. The Contractor was seriously reminded to urgently follow up in accordance with the above mentioned observations/remarks provided in the checklist with their horticulture sub-contractor.

Some of the *Angelonia angustifolia* in the planters along the Ting Kok Road were replaced with *Ophiopogon jaburan* and *Schefflera arboricola*.

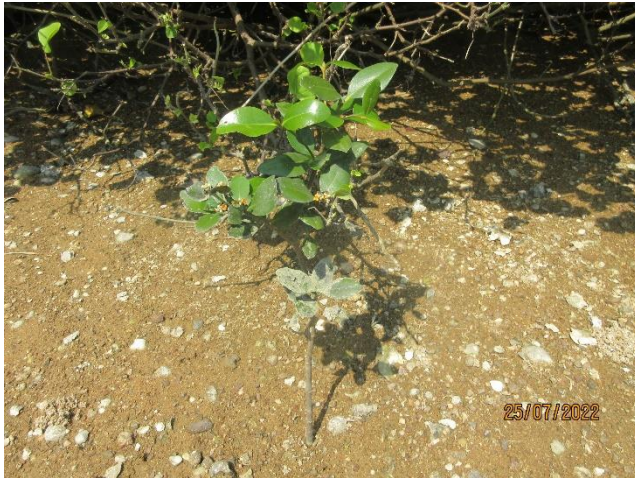
For location 1, only the seedlings on the most landward side have leaves (Photo 3.1). The poor health seedlings (no leaves but still alive) are gradually declining.

Photo 3.1 The seedling on the most landward side has leaves and is in good condition

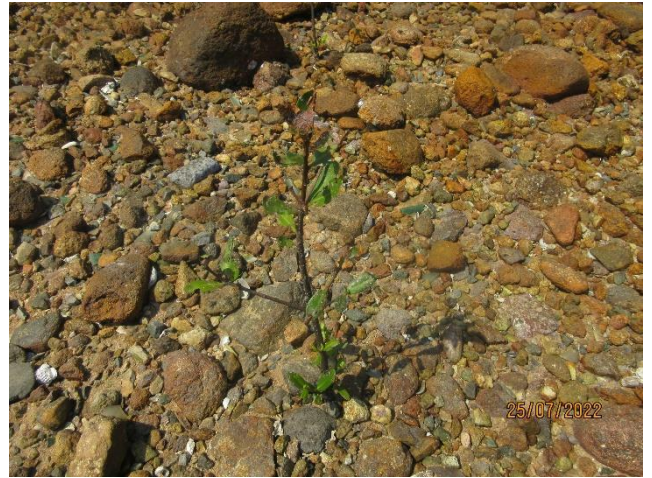
For location 2, similar to location 1, only the seedlings on the most landward side have leaves (Photo 3.2) and several poor health seedlings (very few leaves but still alive (Photo 3.3)) are also gradually declining.

Photo 3.2 The seedling on the most landward side has leaves

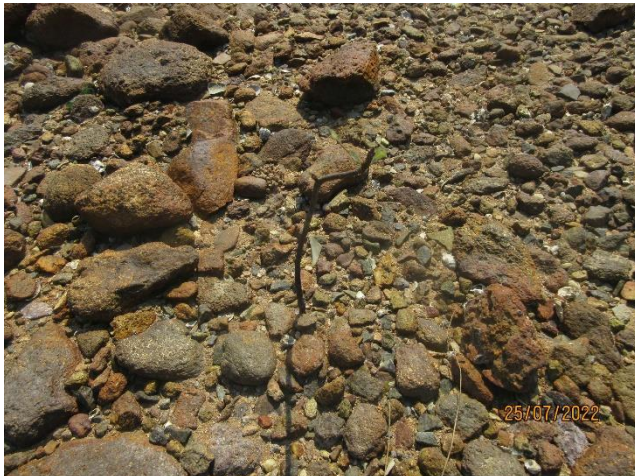
Photo 3.3 The seedling with very few leaves but still alive

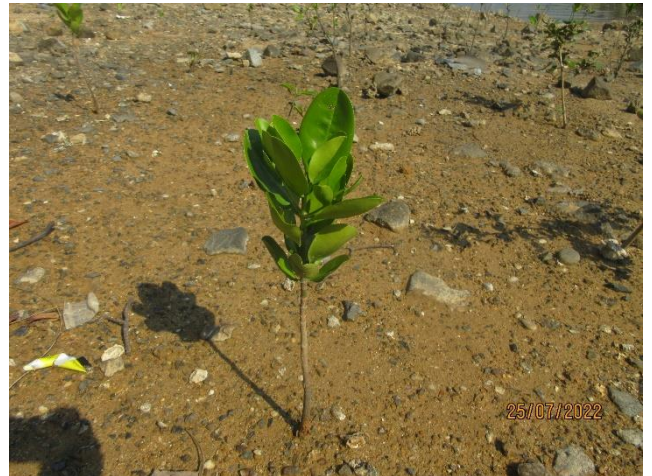
For location 3, most of the seedlings have normal foliage density and are in good condition (Photo 3.4). The replanting seedlings are in fair condition (Photo 3.5).

Photo 3.4 The seedling is in good condition

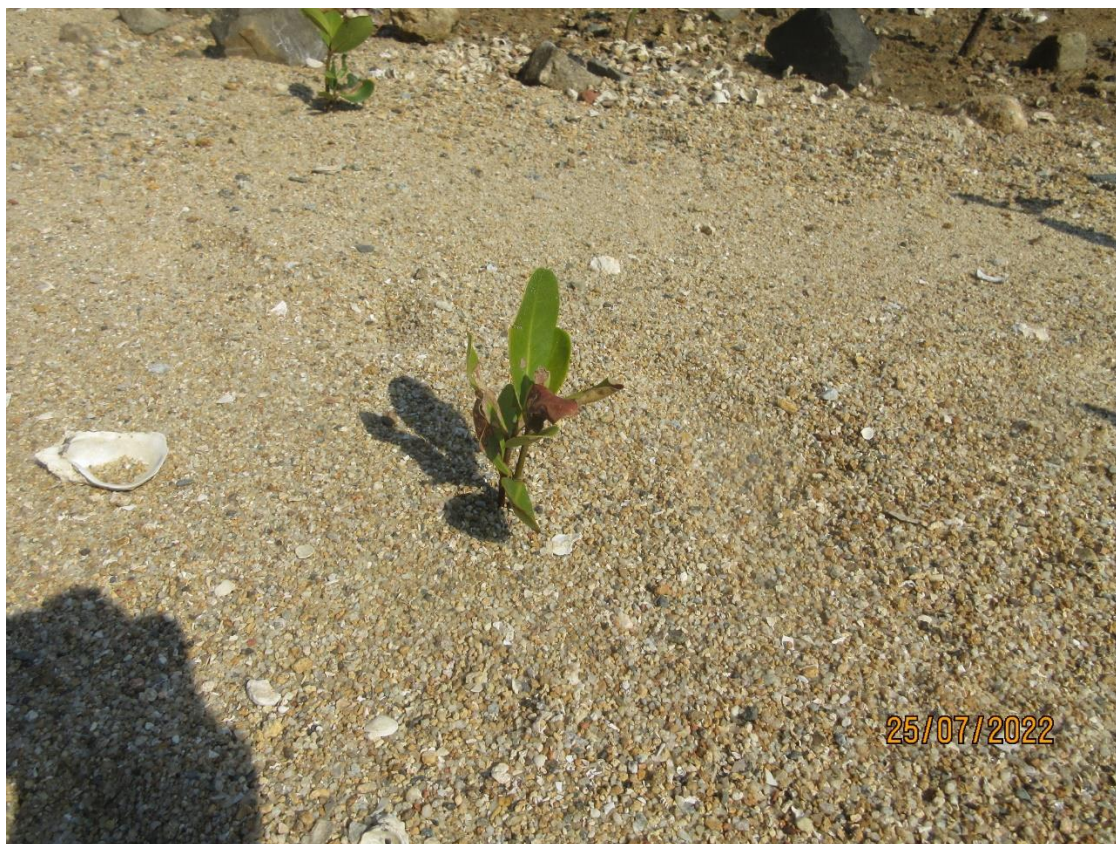
Photo 3.5 The replanting seedling is in fair condition

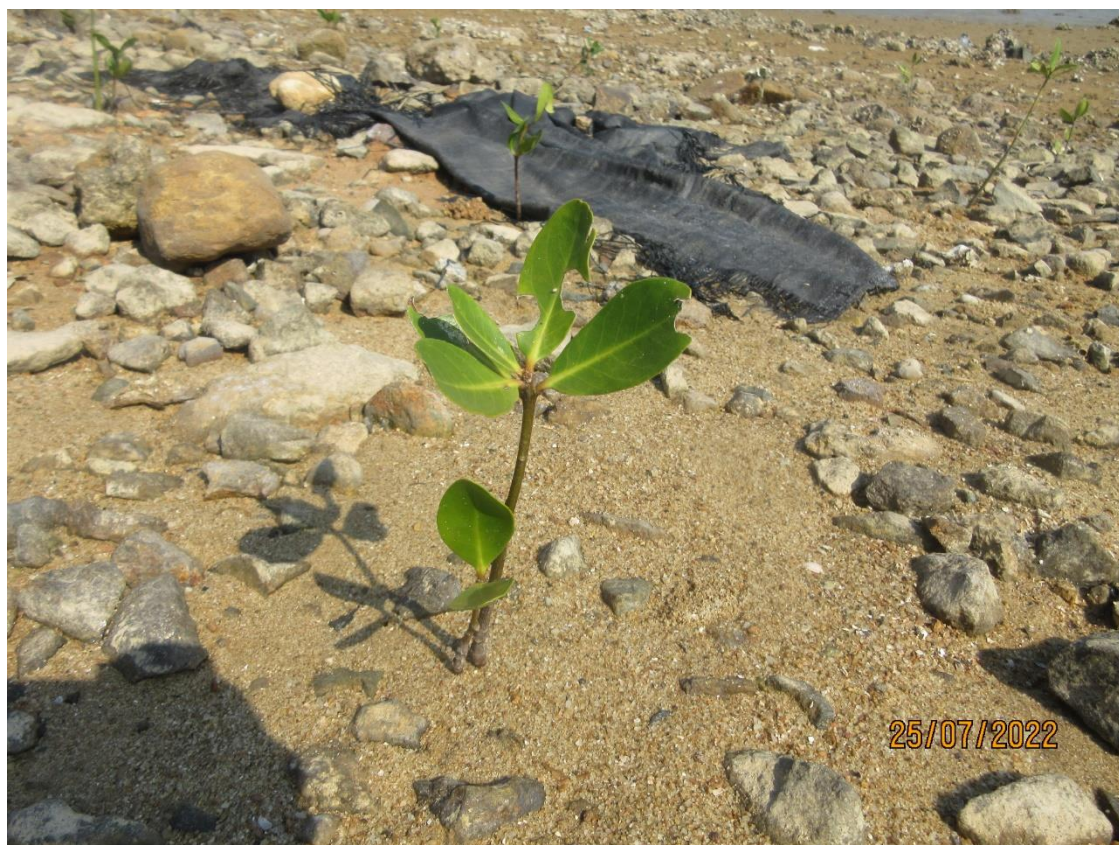
For location 4, Nearly all of the seedlings have normal foliage density and are in fair condition (Photo 3.6). Only a few of them are declining or dead (Photo 3.7 and 3.8).

Photo 3.6 The replanting seedling is in fair condition

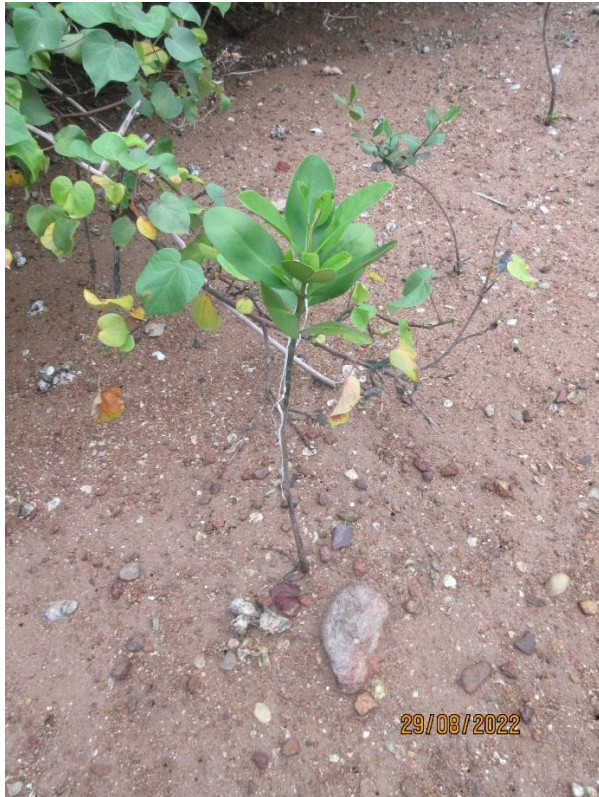
For location 1, only the seedlings on the most landward side have leaves (Photo 3.1). The poor health seedlings (no leaves but still alive) are gradually declining.

Photo 3.1 The seedling on the most landward side has leaves and is in good condition

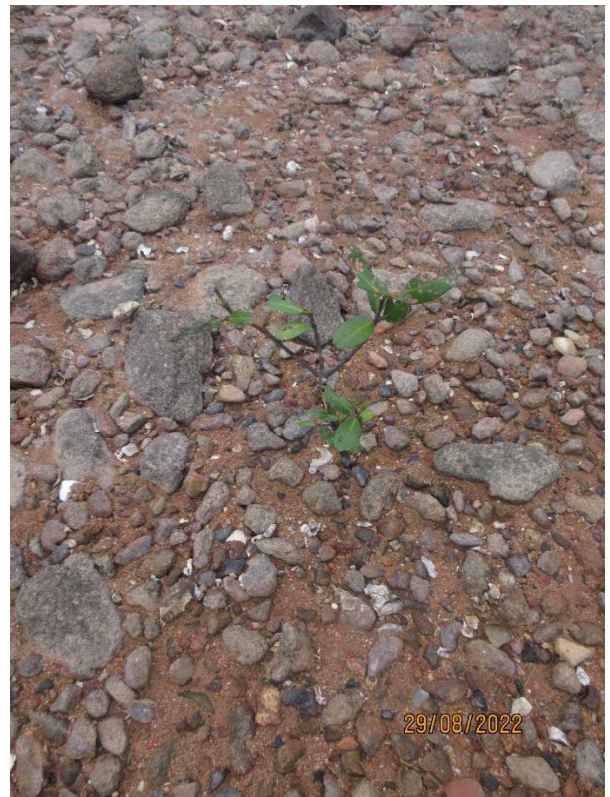
For location 2, similar to location 1, only the seedlings on the most landward side have leaves (Photo 3.2) and several poor health seedlings (very few leaves but still alive (Photo 3.3)) are also gradually declining.

Photo 3.2 The seedling on the most landward side has leaves

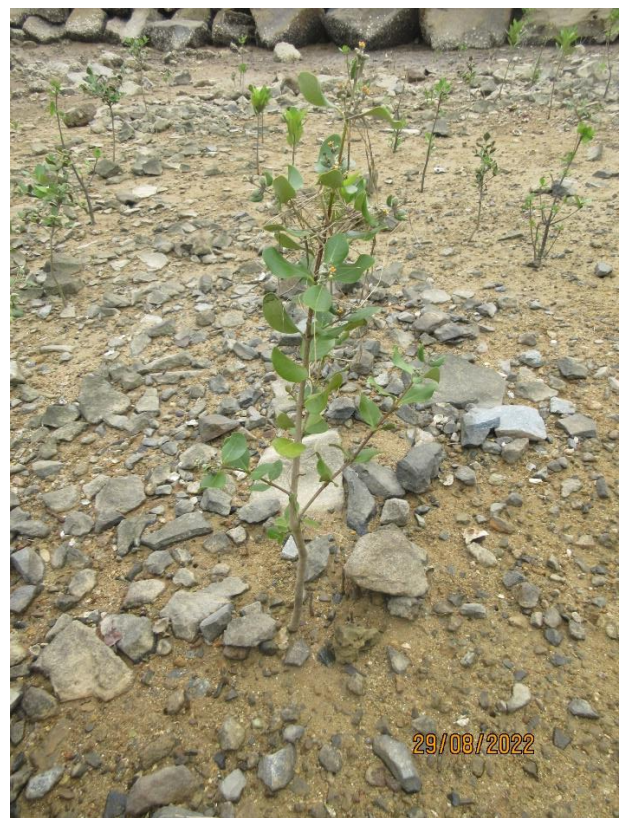
Photo 3.3 The seedling with very few leaves but still alive

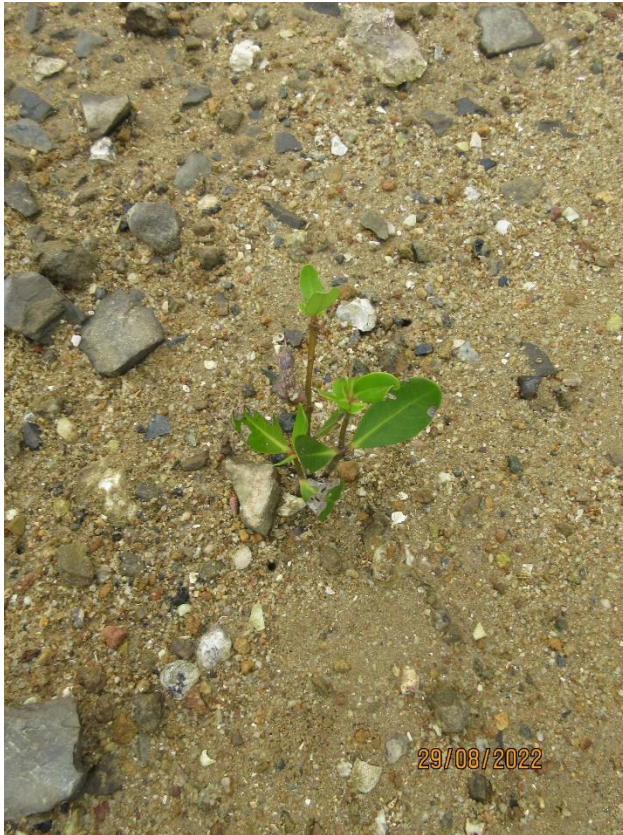
For location 3, most of the seedlings have normal foliage density and are in good condition (Photo 3.4). The replanting seedlings are in fair condition (Photo 3.5).

Photo 3.5 The replanting seedling is in fair condition

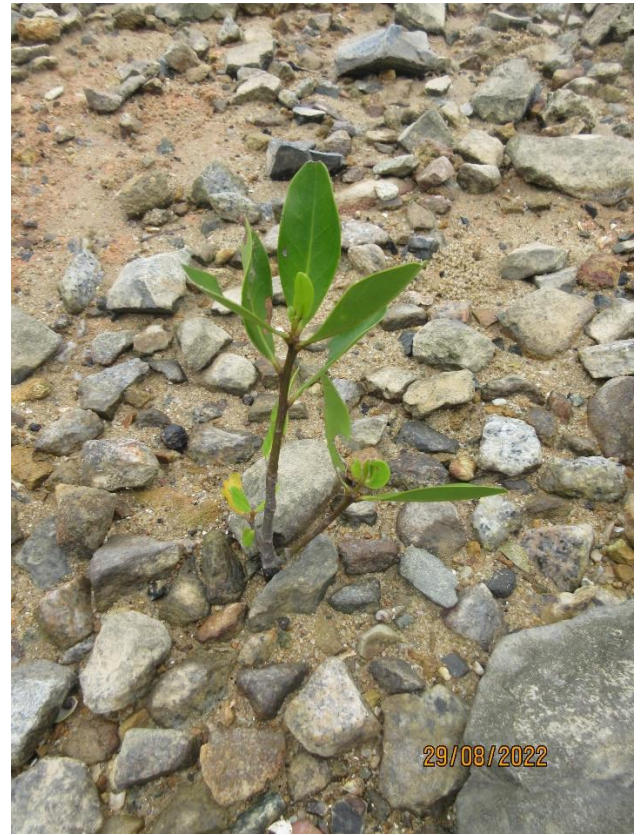
Photo 3.4 The seedling is in good condition
