ANNUAL AUDIT REPORT
For
PERMANENT AVIATION FUEL FACILITY
Environmental Permit
EP-262/2007/B

Date of Audit :		1-7 March 2024
Prepared By :	Ip Siu On, HSE Officer	8 March 2024
Approved By :	Sylvia Har, General Manager	18 March 2024

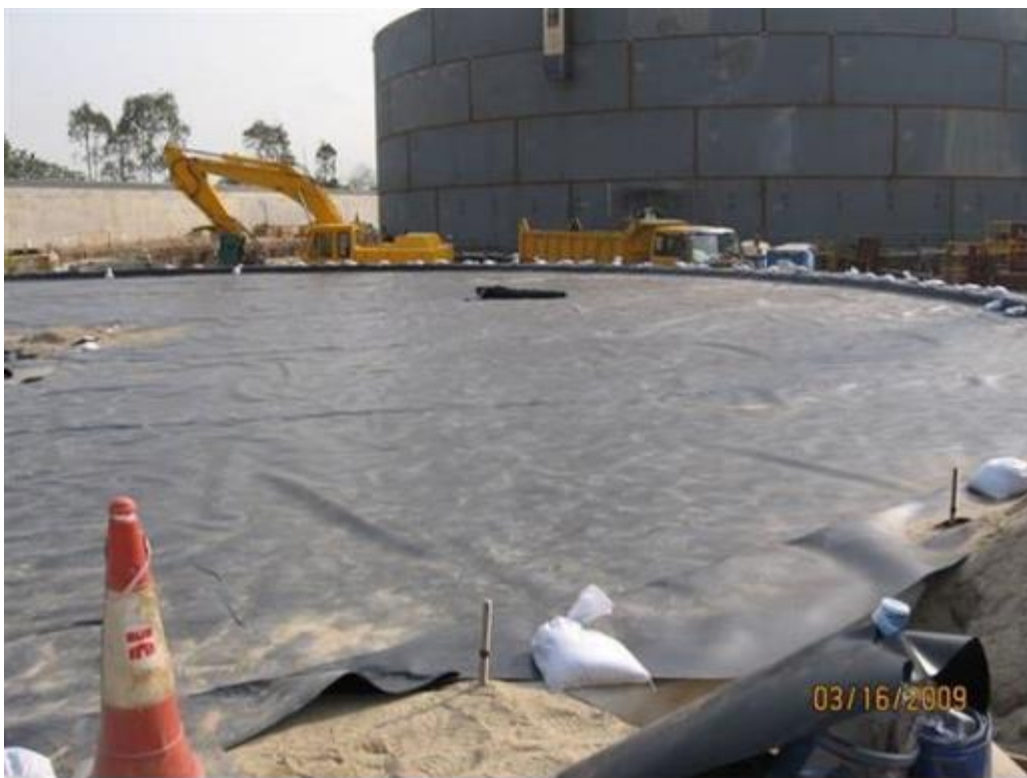
(22) Record photo shows impervious membrane being installed on top of tank foundation

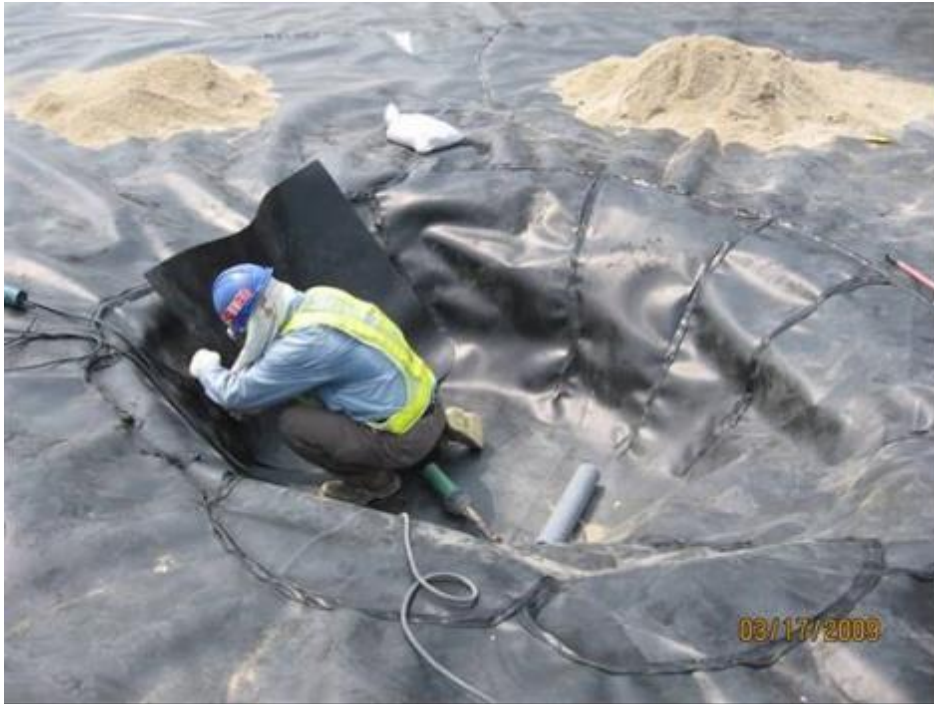
(23) Record photo shows imperious membrane laid at tank center sump with tell-tale pipe embedded for leak detection

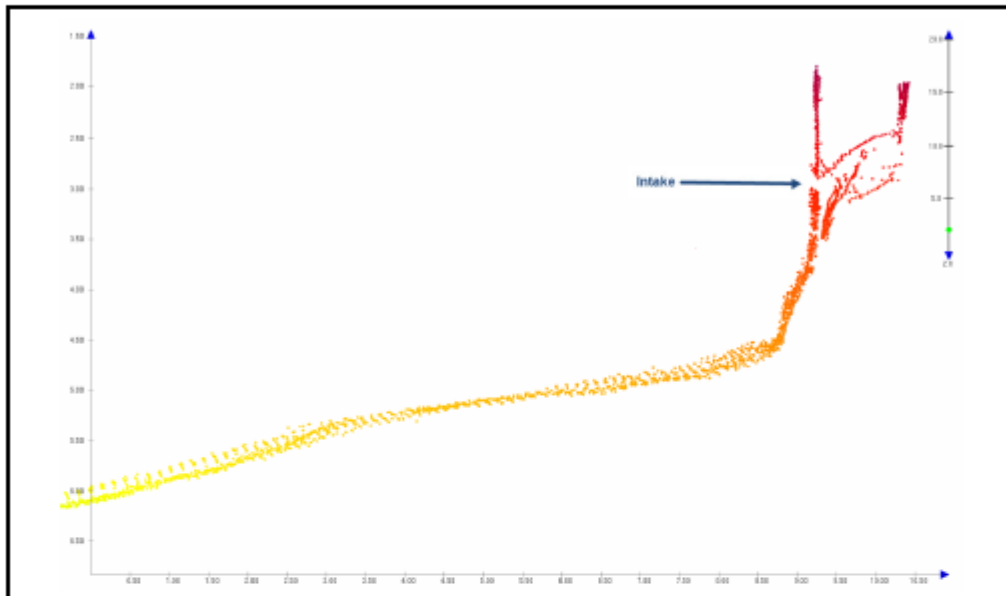
From these images in which the fire services intakes are clearly measured by the system however the storm-water outfall is not able to be measured due to the rough weather. Distinct objects or

Figure 5: Cross section image at the intake location showing no sediment accumulation

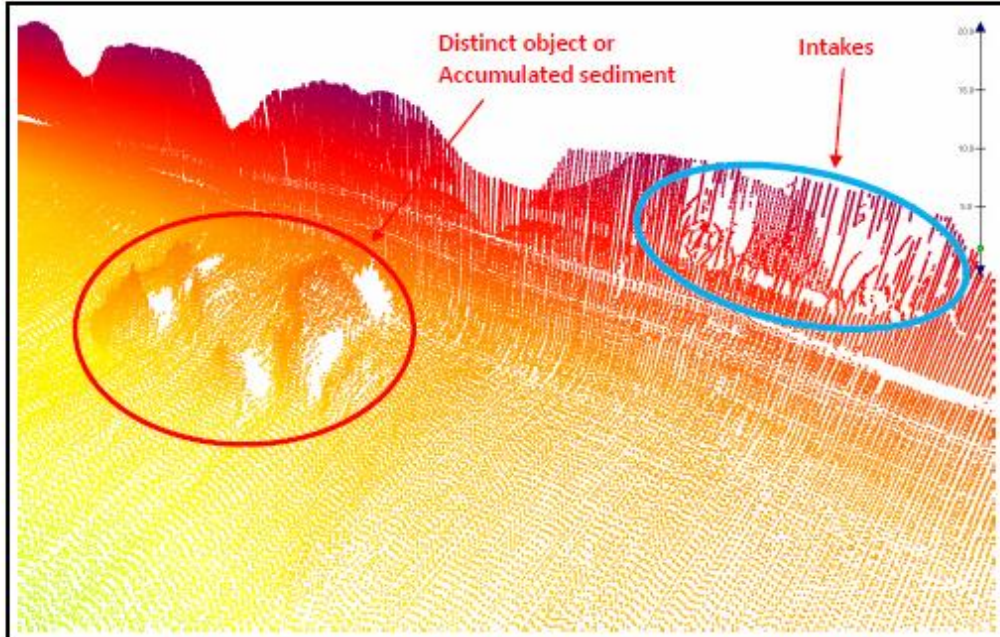
accumulated sediments are observed below the storm-water outfall position with the highest spot at about -4.0mPD while there is not accumulation of sediment or object observed around the intakes position. Refers to the design drawing, the invert level of the storm-water outfall is +0.154mPD therefore there is about 4m distance from the outfall to the top of the accumulated sediment.

Figure 7: 3D perspective view of raw MBES soundings at intakes and outfall location
