Contract No. : DC/2007/06
**River Improvement Works in Upper Lam Tsuen,
She Shan River and Upper Tai Po River**

ENVIRONMENTAL MONITORING AND AUDIT

MONTHLY EM&A REPORT of

UPPER TAI PO RIVER

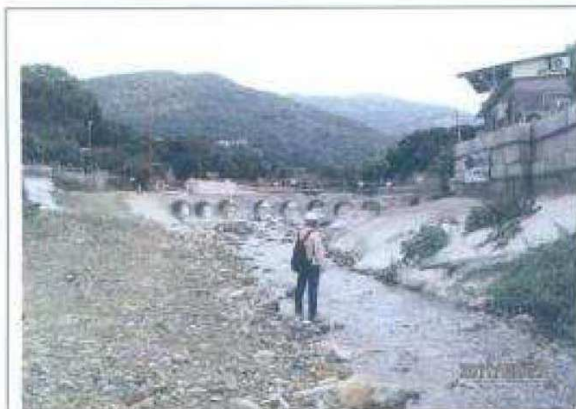
- Field ecological monitoring was undertaken on 21st July 2011;
- Stream habitat at most sections of Upper Tai Po River (Photo 1,2) was changed due to drainage works; and

Photo 1: General view of the works area

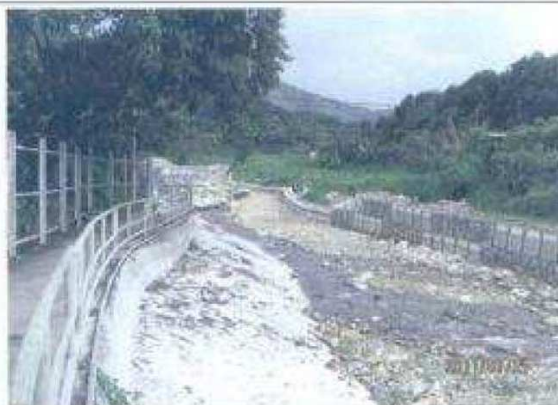
Photo 2: General view of the works area
