Contract No. : DC/2007/06
**River Improvement Works in Upper Lam Tsuen,
She Shan River and Upper Tai Po River**

ENVIRONMENTAL MONITORING AND AUDIT

MONTHLY EM&A REPORT of

for October 2011

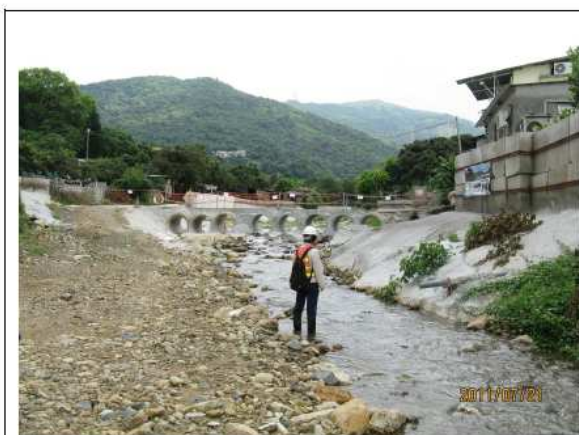
- Field ecological monitoring was undertaken on 21st July 2011;
- Stream habitat at most sections of Upper Tai Po River (Photo 1,2) was changed due to drainage works; and

Photo 1: General view of the works area

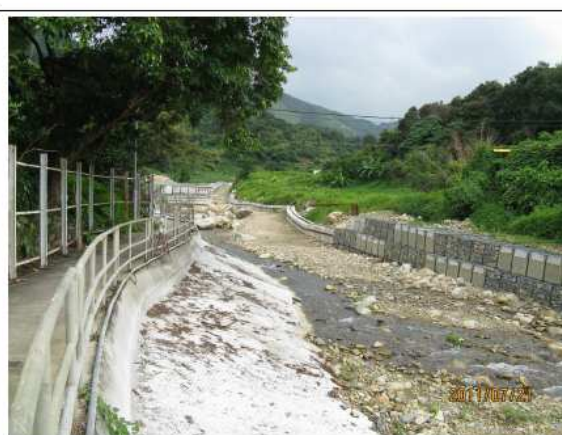
Photo 2: General view of the works area
