Contract No. HY/2010/02

Hong Kong – Zhuhai – Macao Bridge Hong Kong Boundary Crossing Facilities – Reclamation Works

Monthly EM&A Report for October 2013

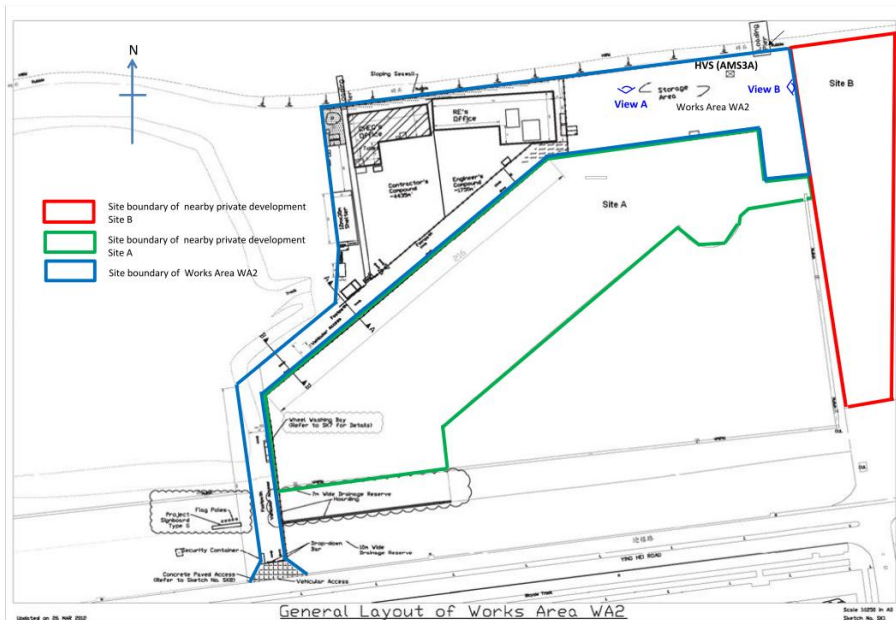
Conditions of the construction sites near Works Area WA2:

2.7.3.4 As refer to the wind data collected at wind station at Works Area WA2 during the monitoring period on 15 and 16 Oct 13 (as attached) East South East winds was prevailing during the monitoring period. Traffics at construction sites of nearby private development project which are close to the monitoring station AMS3A but beyond the site boundary of Works Area WA 2 may contribute to the measured dust levels at the monitoring station AMS3A.

View A: (Canvas was used to cover sand material stored at WA2):

View B: (Traffic on dusty surface observed at nearby construction site which do not belongs to this Contract)

- 2.7.3.9 The Contractor was recommended to continue implementing existing dust mitigation measures.
- 2.7.5 For the 24Hr TSP Action Level exceedance recorded at AMS3A, a result of $194\mu\text{g}/\text{m}^3$ was recorded on 19 Oct 13 (24-hr TSP).

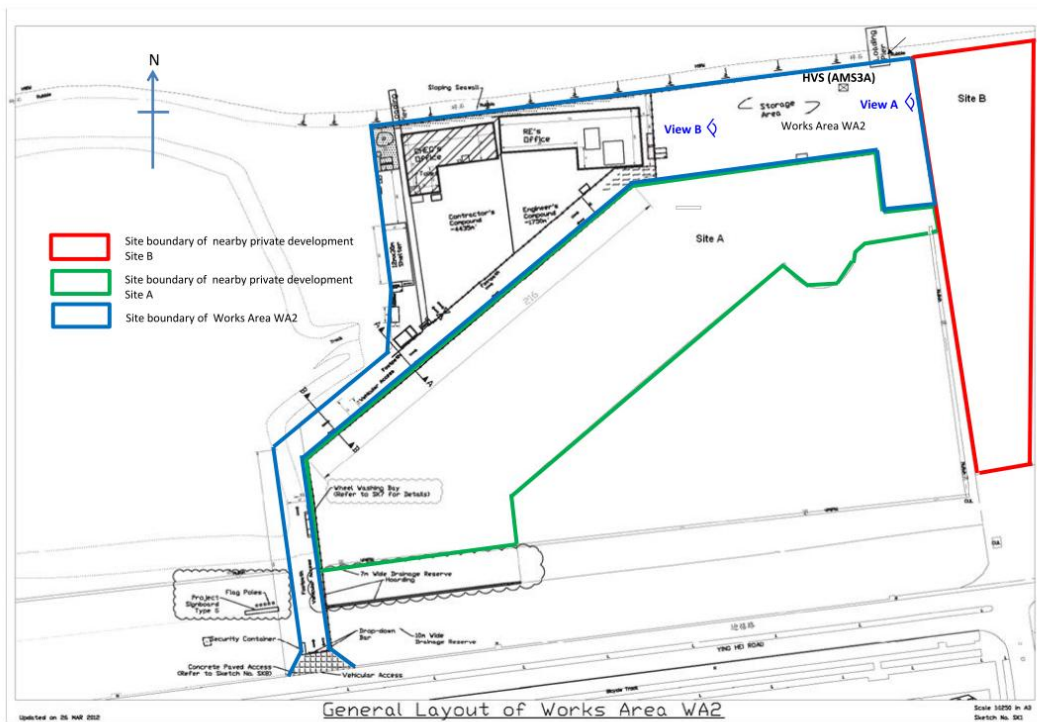
Photo record:

- 2.7.5.3 Photo records shows that vehicle would travel on exposed soil surfaces at those construction sites of nearby private development project which are close to the monitoring station AMS3A but beyond the site boundary of Works Area WA2. (Please also see photo and layout map attached for reference of site conditions (View A.)

View A (Traffic on dusty surface observed at nearby construction site which do not belongs to this Contract)

View B (Hard paved surface observed at Works Area WA2)

- 2.7.5.8 The dust exceedance was therefore considered not to be due to the Project works.
- 2.7.5.9 The Contractor was recommended to continue implementing existing dust mitigation measures.

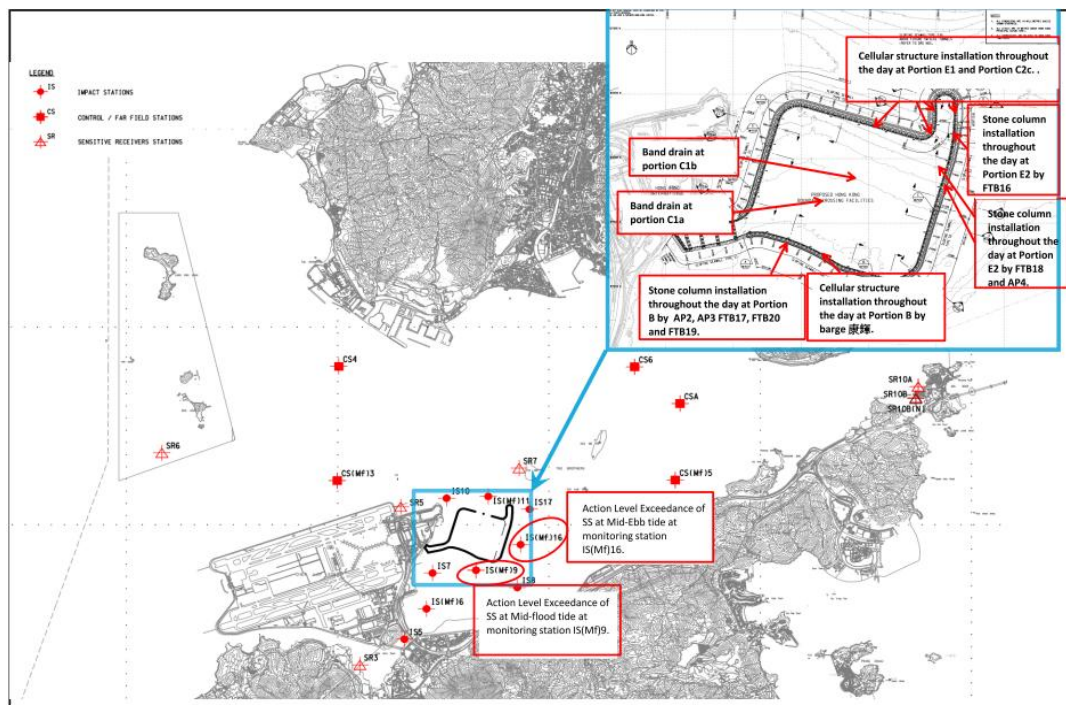
4.7.5 Two (2) Action Level exceedances at measured Suspended Solids (mg/L) were recorded on 04 Oct 2013 at monitoring station IS(Mf) 16 and IS(Mf)9 at Mid-Ebb tide and Mid-Flood tide respectively. For Action Level exceedances at measured Suspended Solids (mg/L), 32.9 mg/L and 25.4 mg/L was recorded at Monitoring Station IS(Mf)16 and IS(Mf)9 respectively.

- 4.7.5.1 For locations and type of active works carried out on 4 Oct 13, please refer to the above layout map.
- 4.7.5.2 Impact Stations IS10 and IS(Mf)11 are downstream and closer to the active works at Portion E1 and E2 than monitoring station IS(Mf)9 during flood tide. Suspended solids value recorded on 4 Oct 13 at Impact Stations IS10 and IS(Mf)11 is 9.1mg/L and 7.5mg/L during flood tide respectively which were below the action and limit level. Hence active works from portion E1 and E2 were unlikely to cause SS exceedance at monitoring station IS(Mf)9 during mid flood tide.

- 4.7.5.3 IS(Mf)9 was considered upstream to active works at Portion B during flood tide which SS level were unlikely to be adversely affected by active works at Portion B.

- 4.7.5.6 When impact water quality monitoring was carried out at IS(Mf)16 during mid ebb tide and at IS(Mf)9 during mid flood tide, no discoloration of sea water was observed and no silty plume were observed to flow from the inside to the outside of the site boundary.

- 4.7.5.10 Nevertheless, the Contractor was reminded to ensure provision of ongoing maintenance to the silt curtains and to carry out maintenance work once defects were found.

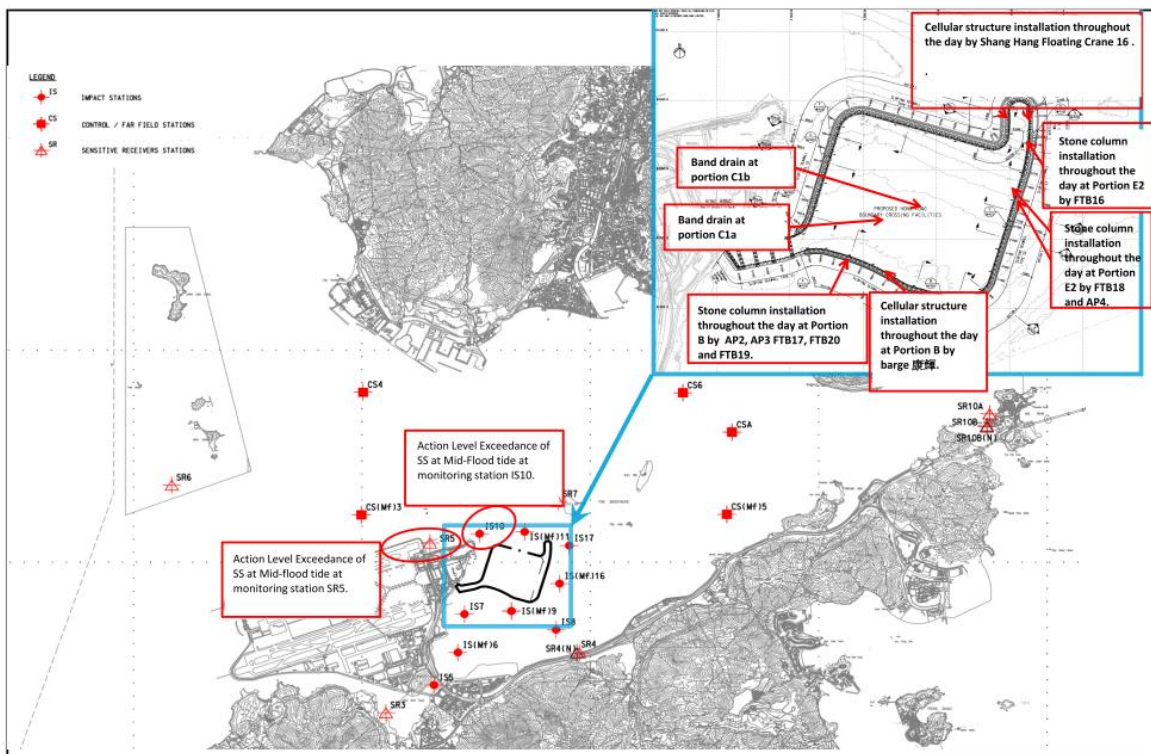
- 4.7.5.11 Maintenance work of the silt curtain was carried out by the Contractor on a daily basis except Sunday and public holiday.
- 4.7.6 Two (2) Action Level exceedances at measured Suspended Solids (mg/L) were recorded on 7 Oct 2013 during mid-flood tide at monitoring station IS10 and SR5. For Action Level exceedances at measured Suspended Solids (mg/L), 25 mg/L and 24.8 mg/L were recorded at Monitoring Station IS10 and SR5 respectively.

- 4.7.6.1 Please refer attached Layout Map for work activity carried out on 7 Oct 13.
- 4.7.6.2 No active works were carried out at portion C2a, C2c and Portion A. Installation of band drain was carried out at Portion C1b & Portion C1a and Cellular Structure installation was carried out at Portion E1 and C2b on 7 Oct 13. These works were unlikely to generate silt plumes or suspended solid. Stone column installation was conducted at Portion B, E1 and E2 which are far away from IS10 and SR5. (For location of each portion please refer to attached Layout - Portion of Marine Work)

- 4.7.6.3 IS(Mf)11 and IS17 which are closer to the active works at Portion E2 than it is for monitoring station IS10 and SR5 and the suspended solid value of IS(Mf)11 and IS17 at mid flood tide were below the action and limit level which indicates that active works from portion E2 were unlikely to cause SS exceedance at monitoring station IS10 and SR5.

4.7.6.5 Turbidity level (NTU) result recorded at IS10 and SR5 is 11.7 NTU and 12.6 NTU respectively during flood tide on 7 Oct 13 which was below the Action and Limit Level which indicates turbidity level was not adversely affected. (Please see attached photo record of the sea condition taken on 7 Oct 13)

4.7.6.7 Strong wind and rough sea condition were experienced during impact water quality monitoring conducted during mid flood tide at monitoring. (Please see photo record which shows the sea condition recorded on 7 Oct 13.)

4.7.6.10 Nevertheless, the Contractor was reminded to ensure provision of ongoing maintenance to the silt curtains and to carry out maintenance work once defects were found.

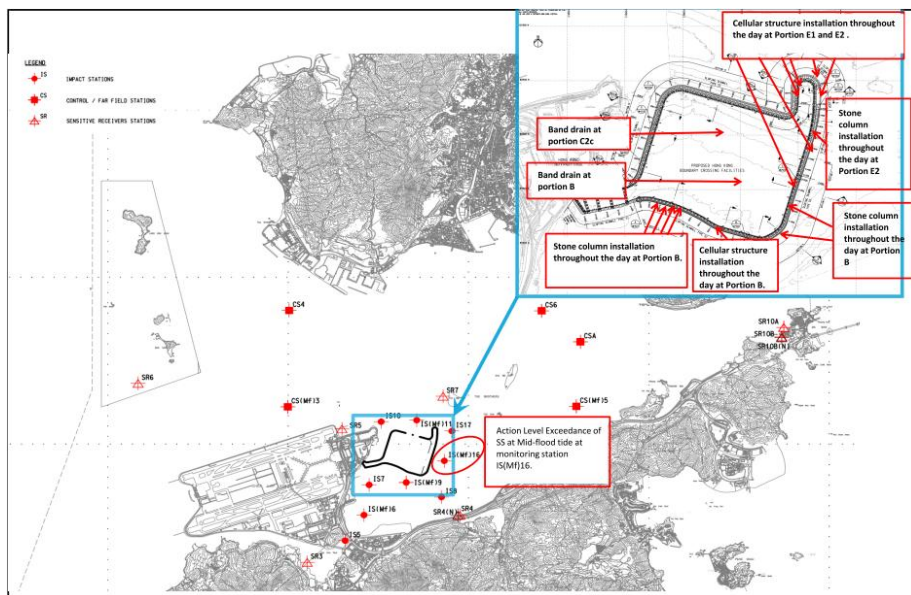
4.7.7 One (1) Action Level exceedance at measured Suspended Solids (mg/L) where recorded on 16 Oct 13 2013 during mid-flood tide at monitoring station IS(Mf)16. For Action Level exceedance at measured Suspended Solids (mg/L), 32 mg/L was recorded at Monitoring Station IS(Mf)16

4.7.7.1 Please refer the above layout map for activity carried out on 16 Oct 13.

4.7.7.2 Impact Stations IS10 and IS(Mf)11 are downstream and closer to the active works at Portion E1 and E2 than monitoring station IS(Mf)16 during flood tide. Suspended solids value recorded on 16 Oct 13 at Impact Stations IS10 and IS(Mf)11 is 4.2mg/L and 6.4mg/L during flood tide respectively. The recorded suspended solids values are below the action and limit level which indicate that active works at Portion E1 and E2 on 16 Oct 13 were unlikely to cause SS exceedance at monitoring station IS(Mf)16 during mid flood tide.

4.7.7.3 IS(Mf)16 is considered upstream to active works during flood tide, therefore active works is unlikely to cause SS exceedance at monitoring station IS(Mf)16 during mid flood tide.

4.7.7.4 Turbidity level (NTU) result recorded on 16 Oct 13 at IS(Mf)16 is 20.5 NTU during flood tide which were below the Action and Limit Level, this indicates turbidity level was not adversely affected. (Please see below photo record of the sea condition taken on 16 Oct 13.)

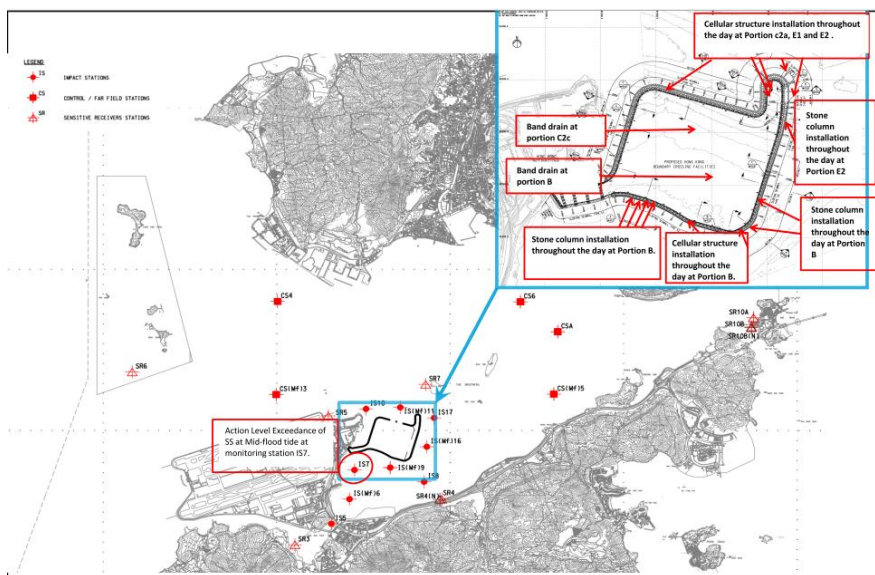
4.7.8 One (1) Action Level exceedance at measured Suspended Solids (mg/L) was recorded on 18 Oct 13 during mid-flood tide at monitoring station IS7. For Action Level exceedance at measured Suspended Solids (mg/L), 27.6 mg/L was recorded.

4.7.8.1 Please refer the above layout map for activity carried out on 18 Oct 13.

4.7.8.2 Same type of works were carried out at the same location on 16 and 21 Oct 13 but Suspended Solids values recorded at IS7 on 16 and 21 Oct 13 are all below the Action and Limit Level during the same tide.

4.7.8.3 Turbidity level (NTU) result recorded on 18 Oct 13 at IS7 is 8.7 NTU during flood tide which was below the Action and Limit Level, this indicates turbidity level was not adversely affected. (Please see attached photo record of the sea condition taken on 18 Oct 13.) Turbidity level (NTU) results recorded at IS10 and SR5 were 14.2 NTU and 20.4 NTU respectively during flood tide on 30 Sept 13 which was below the Action and Limit Level which indicates turbidity level was not adversely affected.

4.7.8.4 When impact water quality monitoring was carried out at IS7 during mid flood tide on 18 Oct 13, no discoloration of sea water was observed and no silty plume were observed to flow from the inside to the outside of the site boundary.

4.7.8.8 Nevertheless, the Contractor was reminded to ensure provision of ongoing maintenance to the silt curtains and to carry out maintenance work once defects were found.

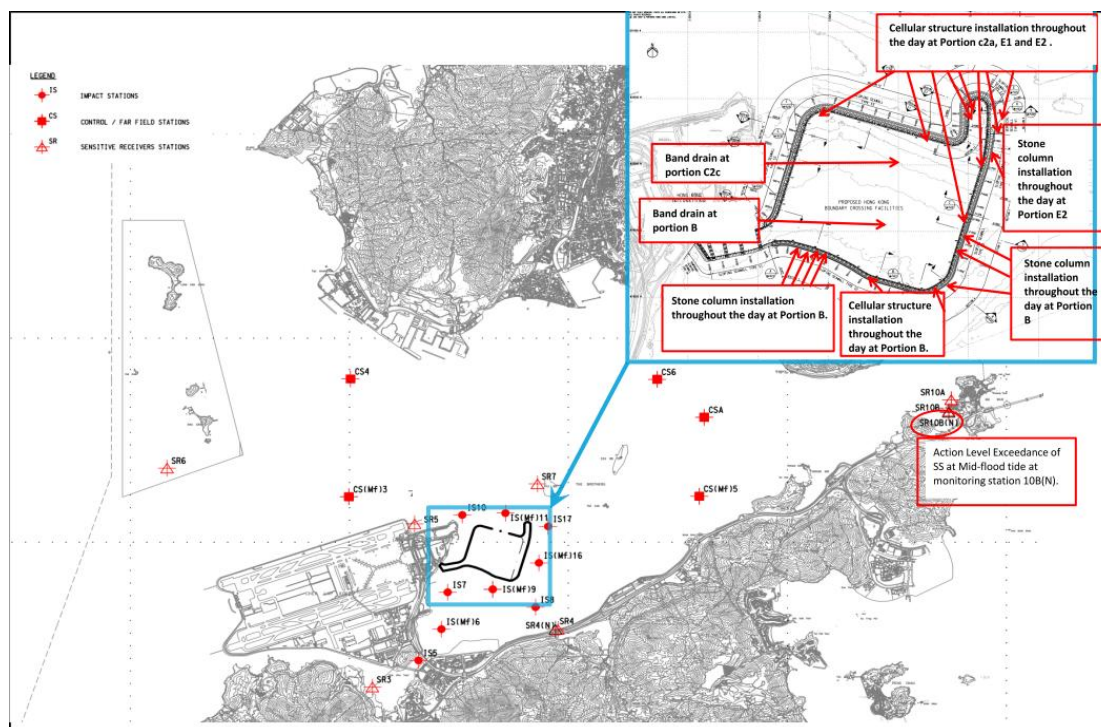
4.7.9 One (1) action level exceedance of SS was recorded on 21 Oct 13 at monitoring station SR10(B)N and SS level of 23.8 mg/L was recorded.

4.7.9.1 Please refer the below layout map for activity carried out on 21 Oct 13.

4.7.9.2 IS(Mf)11 and IS10 are located downstream and closer to the active works than monitoring station SR10B(N) during flood tide. Depth Averaged Suspended Solids (SS) values (in mg/L) recorded during flood tide on the same day at IS(Mf)11 and IS10 were below the Action and Limit Level which indicates project work is unlikely to contribute to the action level exceedance recorded at SR10B(N)

4.7.9.3 The monitoring location of monitoring station SR10B(N) are considered upstream and remote to the active works of this project during flood tide. Therefore it was unlikely that the exceedance recorded at SR10B(N) during flood tide was due to active construction activities of this project.

4.7.9.6 Nevertheless, the Contractor was reminded to ensure provision of ongoing maintenance to the silt curtains and to carry out maintenance work once defects were found.

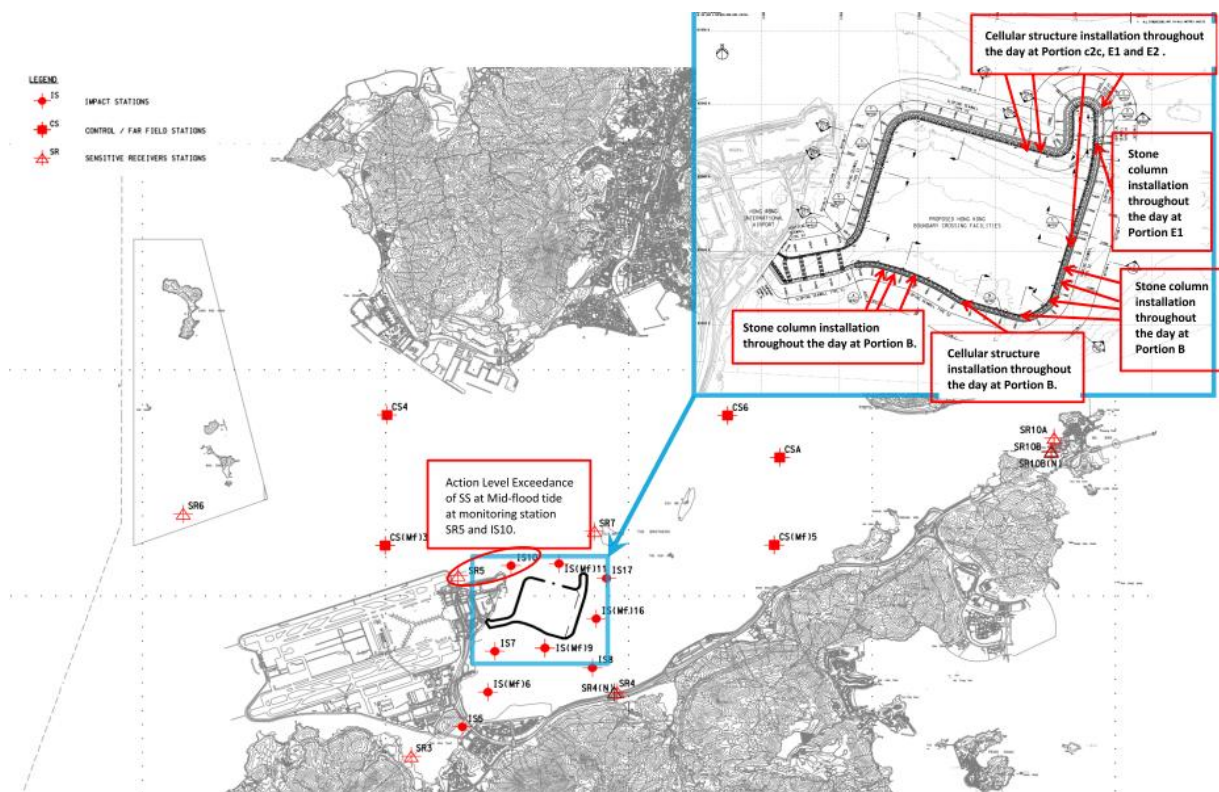
4.7.10 Two (2) Limit level exceedance of SS was recorded on 25 Oct 13 at monitoring station IS10 and SR5. SS level of 54.7mg/L and 36.8mg/L was recorded for IS10 and SR5 respectively.

4.7.10.1 Please refer attached Layout Maps for work activity carried out on 25 Oct 13.

4.7.10.2 No active works were carried out portion A, C2a, C1a and C1b. Cellular Structure installation was carried out at Portion C2c, E1, E2 and B on 25 Oct 13 and stone column installation was conducted at Portion B and E1 which is relatively far away from IS10 and SR5.

4.7.10.3 The location and type of active works conducted were almost the same on 23, 25 and 28 Oct 13 at mid flood tide but no exceedance was recorded at IS10 and SR5 on 23 and 28 Oct 13. This indicates that the exceedances at monitoring station IS10 and SR5 were unlikely to be contributed by active works.

4.7.10.4 Impact Stations IS(Mf)11 and IS7 is located closer to the active works of Portion E2 and B respectively than monitoring station IS10 and SR5 on 25 Oct 13, suspended solids values recorded at IS(Mf)11 and IS7 were below the action and limit level which indicates that active works from portion C2c, E1, E2 and B were unlikely to cause SS exceedances at monitoring station IS10 and SR5.

4.7.10.5 When impact water quality monitoring was carried out during mid flood tide at monitoring location IS10 and SR5, appearance of sea water was relatively turbid than it is for other monitoring stations but no silt plume was observed to flow from the inside to the outside of the site boundary. Hence, on-site observations did not support that the elevated SS was due project works.
