**TUEN MUN - CHEK LAP KOK LINK
CONTRACT NO. HY/2013/12 –
NORTHERN CONNECTION TOLL PLAZA AND
ASSOCIATED WORKS**

BASELINE MONITORING REPORT (REV.03)

PREPARED FOR
CRBC AND KADEN JOINT VENTURE

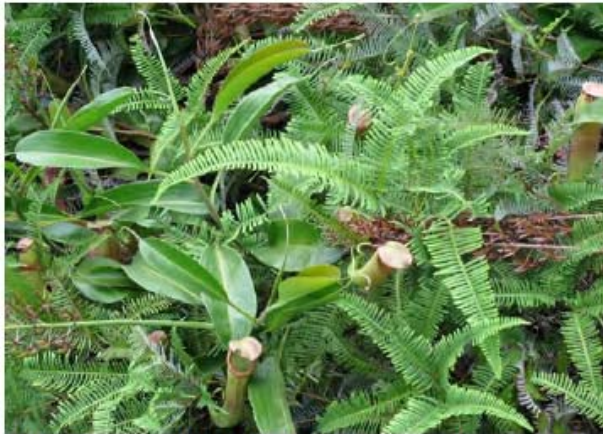
Plate 1: Pitcher Plant (*Nepenthes mirabilis*) in Rocky Slope habitat at the Donor Site

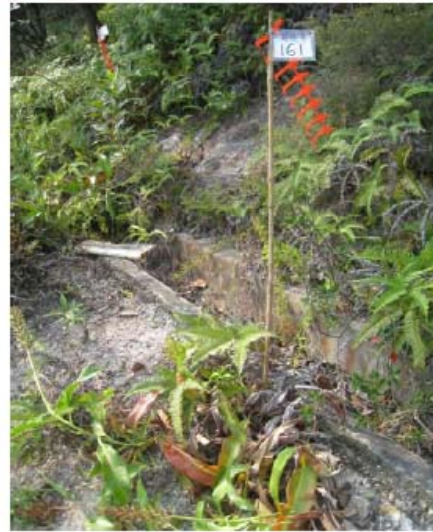
- 3.3.1.6 The health and condition of the Pitcher Plant individuals was assessed and each plant was assessed, tagged and photographed by Pegasus Greenland Ltd.. All plants were assessed as being in "fair" health condition as summarized in **Table 3**. As the plants mostly grew on rock faces with thin soils, the successful removal and transport of the existing individuals is likely to be challenging given the weak nature of the plant's roots.

Plate 3: Tagged Pitcher Plant (Zone 6 in Rocky Slope habitat)

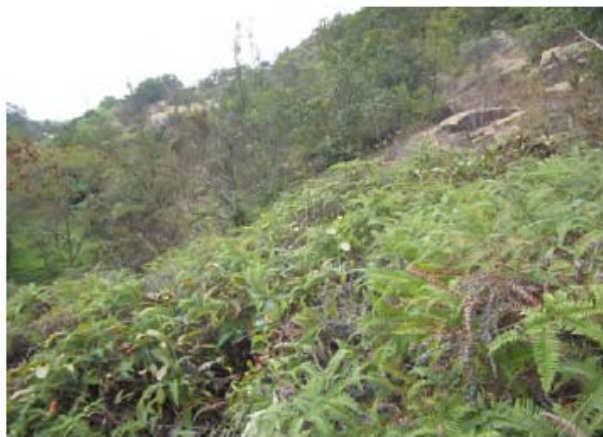
Plate 2: Pitcher Plant population in Donor Site - Zone 6 (looking west)

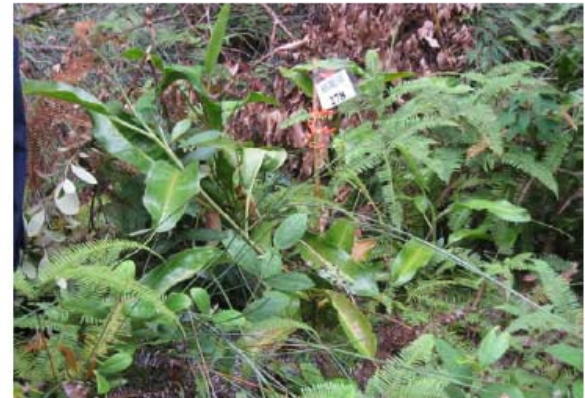
3.3.1.5 In addition, three small areas (see **Zones 8 – 10 in Appendix C**) of Pitcher Plant were recorded along the watercourse in the shrubland habitat (see **Appendix C, Plate 4**). The watercourse comprised a narrow, shallow flow over bedrock with occasional small, very shallow pooled areas. There is evidence that part of the flow is being

Plate 4: Tagged Pitcher Plant (Zone 10 in Shrubland habitat)
