Contract No. HY/2010/02

Hong Kong – Zhuhai – Macao Bridge Hong Kong Boundary Crossing Facilities – Reclamation Works

**Quarterly EM&A Report for
September 2014- November 2014**

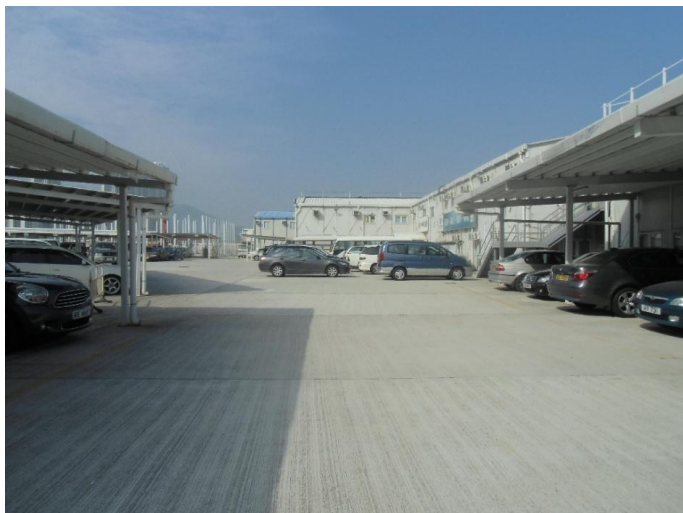
- 1 Works Area WA2's surface was hard-paved, compacted or hydro-seeded (Please refer to above layout map and photo records below (View A))

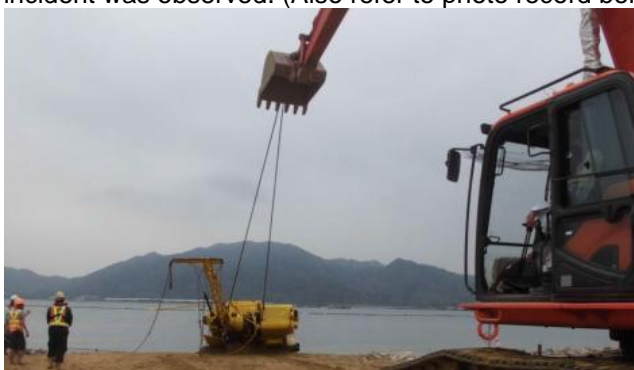
5.1.9.2 The oil spillage was caused by a drilling machine fell into the water near steel cell 51. The drilling machine which caused the oil spillage was lifted up and as informed by the Contractor, the machine was lifted and removed from the water on 12 November 2014 soon after the oil spillage incident was observed. (Also refer to photo record below).

5.1.9.3 The Contractor used absorption booms to enclose and remove the floating oil from water and absorption booms used was collected using disposal bags as part of the spill kits item. The used absorption booms were disposed of as chemical waste (Also refer to photo record below).

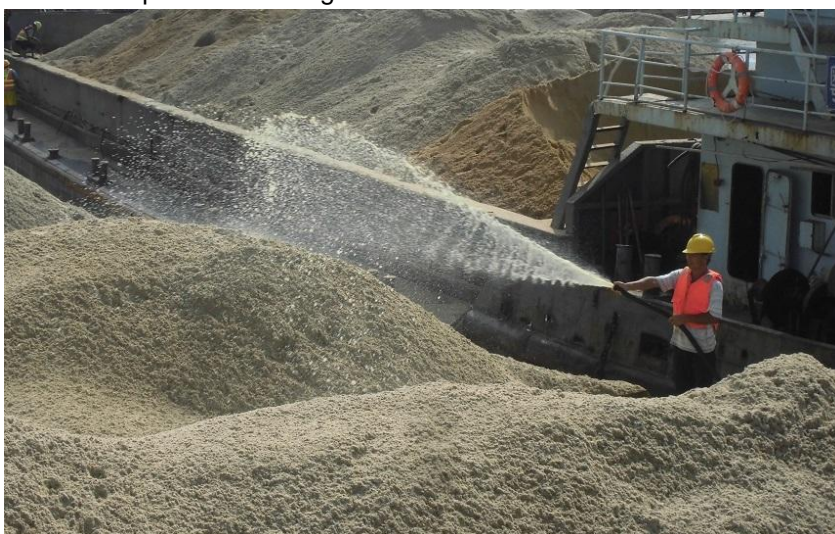
- There is no sufficient information provided by the complainant to make sure that the concerned barges are related to this project.
- Date of the observed impact was not specified by the complainant so the impact air quality monitoring (IAQM) results available for August 2014 and early September 2014 for monitoring stations close to the concerned area – AQMS1, ASR1, ASR5, ASR6 and ASR10 have been reviewed and there was no impact air quality monitoring result that shows 1-hour TSP or 24-hour TSP exceeded the action (AL)/limit level (LL).
- Photo record below shows that sand barges were not covered but they are equipped with watering equipment and in order to prevent generation of fugitive dust, watering equipment was used to keep the sand filling material wet.

- In addition, site inspection has been jointly conducted with the Contractor and RSS on 28 August and 4 September 2014, but no generation of fugitive dust was observed to be caused by barges loaded with filling material. Transfer of sand between vessels was not observed.

- 7.1.3.3 After investigation, there is no adequate information to conclude the observed impact is related to this Contract.
- 7.1.3.4 The Contractor was advised to ensure to continue the provision of fugitive dust mitigation measures to barges loaded with filling material such as watering to sand filling material on sand barges to keep the surface of stockpile of filling material wet.

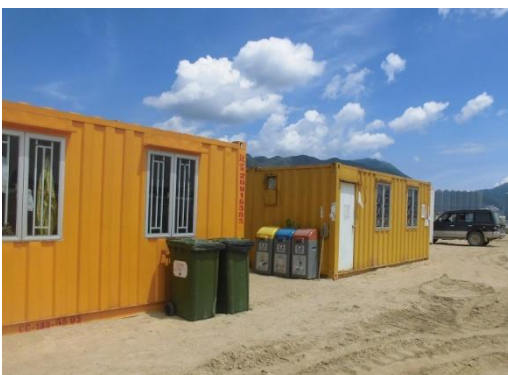
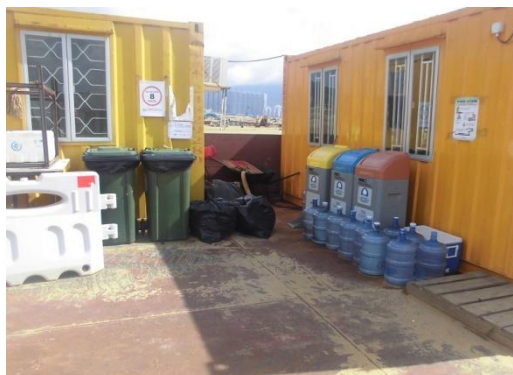
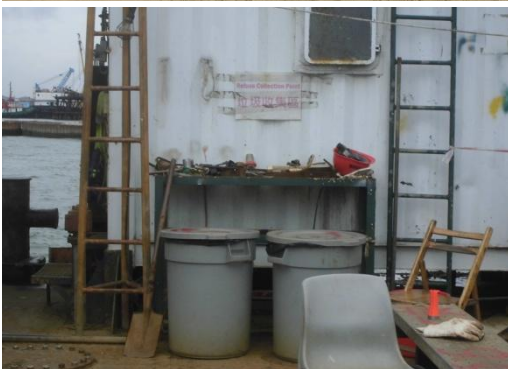
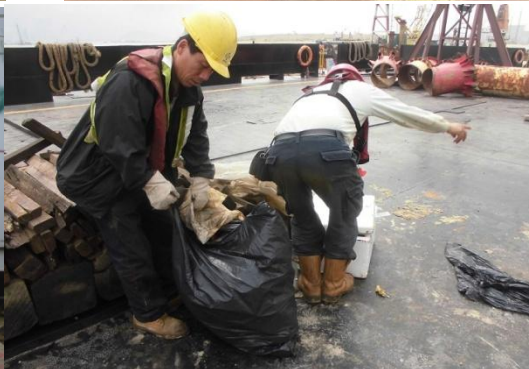
- There is no sufficient information provided by the complainant to make sure that the general refuse such as food container and plastic bottles are related to this project.
- Photo of site condition was reviewed, temporary refuse collection facility/ appropriate containers such as rubbish bins were provided by the Contractor on reclamation and vessel to collect general refuses, please refer to the photo below:

- 7.1.4.5 After investigation, there is no adequate information to conclude the observed impact is related to this Contract.
- 7.1.4.6 The Contractor was advised to ensure to continue the provision of waste mitigation measures to barges on reclamation land and vessels.
- 7.1.4.7 The Contractor was recommended that the site and surroundings shall be kept tidy and litter free. General refuse generated on-site should be stored in enclosed bins or compaction units separately from construction and chemical wastes.

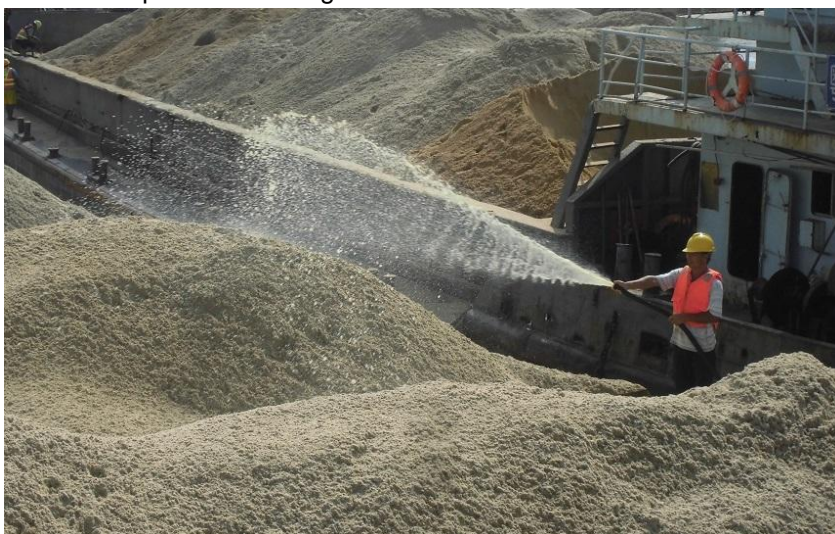
- There is no sufficient information provided by the complainant to make sure that the concerned barges are related to this project.
- Date of the observed impact was not specified by the complainant so the impact air quality monitoring (IAQM) results available for September 2014 for monitoring stations close to the concerned area – AQMS1, ASR1, ASR5, ASR6 and ASR10 have been reviewed and there was no impact air quality monitoring result that shows 1-hour TSP or 24-hour TSP exceeded the action (AL)/limit level (LL).
- Photo record below shows that sand barges were not covered but they are equipped with watering equipment and in order to prevent generation of fugitive dust, watering equipment was used to keep the sand filling material wet.

- In addition, site inspections were conducted jointly with RSS, IEC and the Contractor on 18 September 2014 and jointly with RSS and the Contractor on 25 September 2014, but no generation of fugitive dust was observed to be caused by barges loaded with filling material.
- After investigation, there is no adequate information to conclude the observed impact is related to this Contract.

- 7.1.5.5 The Contractor was advised to ensure to continue the provision of fugitive dust mitigation measures to barges loaded with filling material such as watering to sand filling material on sand barges to keep the surface of stockpile of filling material wet.

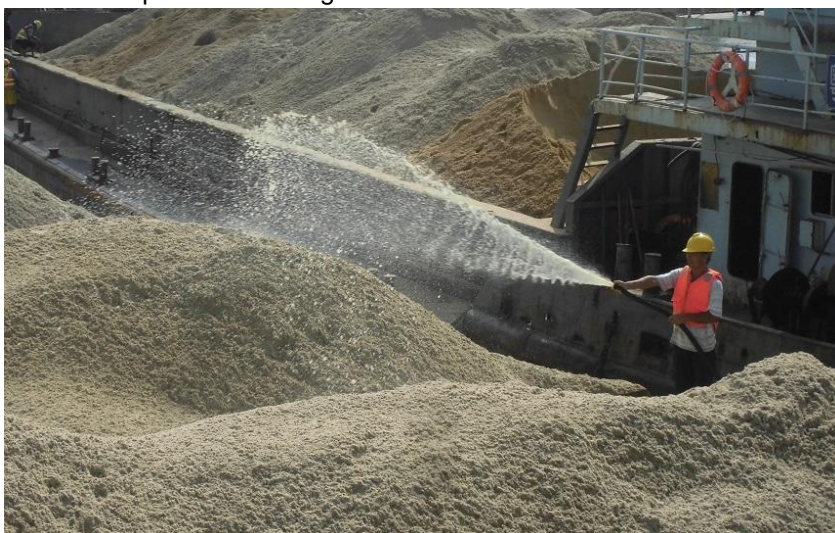
- As informed by the Contractor, the Contractor would continue to provide watering to stockpile of sand on sand delivery barges.
- Photo record below shows that sand barges were not covered but they are equipped with watering equipment and in order to prevent generation of fugitive dust, watering equipment was used to keep the sand filling material wet.

- In addition, site inspections were conducted jointly with RSS, IEC and the Contractor on 16 October 2014 and jointly with RSS and the Contractor on 23 October 2014, but no generation of fugitive dust was observed to be caused by barges loaded with filling material.
- Sand barges usually moor at around Sham Shui Kok anchorage area and the Contractor would continue to provide watering to stockpile of sand on sand delivery barges, therefore the potential impact to resident areas concerned by the complainant is low.
- The Contractor usually moor vessel at around Sham Shui Kok anchorage area (Except upon request by HK government and under this circumstances, then they will moor at Tuen Mun waters shortly for inspection.)

- 7.1.6.3 After investigation, there is no adequate information to conclude the observed impact is related to this Contract.
- 7.1.6.4 The Contractor was advised to ensure to continue the provision of fugitive dust mitigation measures to barges loaded with filling material such as watering to sand filling material on sand barges to keep the surface of stockpile of filling material wet.

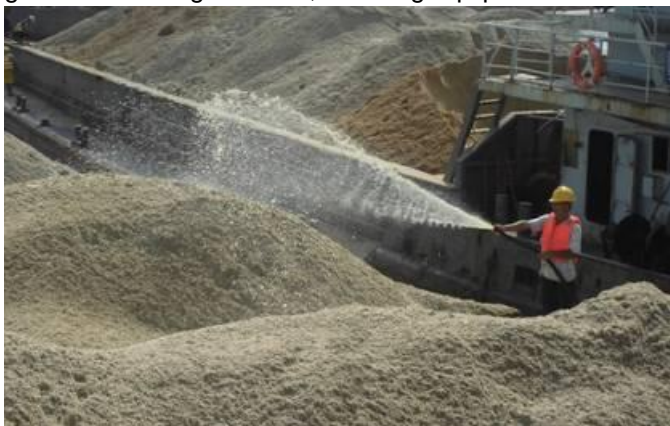
- In addition, site inspections were conducted jointly with RSS, IEC and the Contractor on 16 October 2014 and jointly with RSS and the Contractor on 23 October 2014, but no leakage of sand material or generation of fugitive dust was observed to be caused by barges loaded with sand material.

- In addition, sand delivery barges are equipped with watering equipment and in order to prevent generation of fugitive dust, watering equipment was used to keep the sand filling material wet.

- Nonetheless, as informed by the Contractor, the Contractor would study the feasibility of covering stockpile of sand on sand delivery barges.

- 7.1.7.4 Nonetheless, the Contractor was advised to ensure that all vessels should have regular maintenance to ensure that all Sand Barge functioning well so that any leakage of filling material is prevented.
