Contract No. CV/2013/08
Liantang / Heung Yuen Wai Boundary Control Point
Site Formation and Infrastructure Works – Contract 6

Environmental Permit No. EP-404/2011/C
Condition 2.16 – Photographic and Cartographic Survey Report

Contract No. CV/2013/08
Liantang/Heung Yuen Wai
Boundary Control Point Site
Formation and Infrastructure
Works – Contract 6
*Cartographic and Photographic
Survey Report*

December 2015

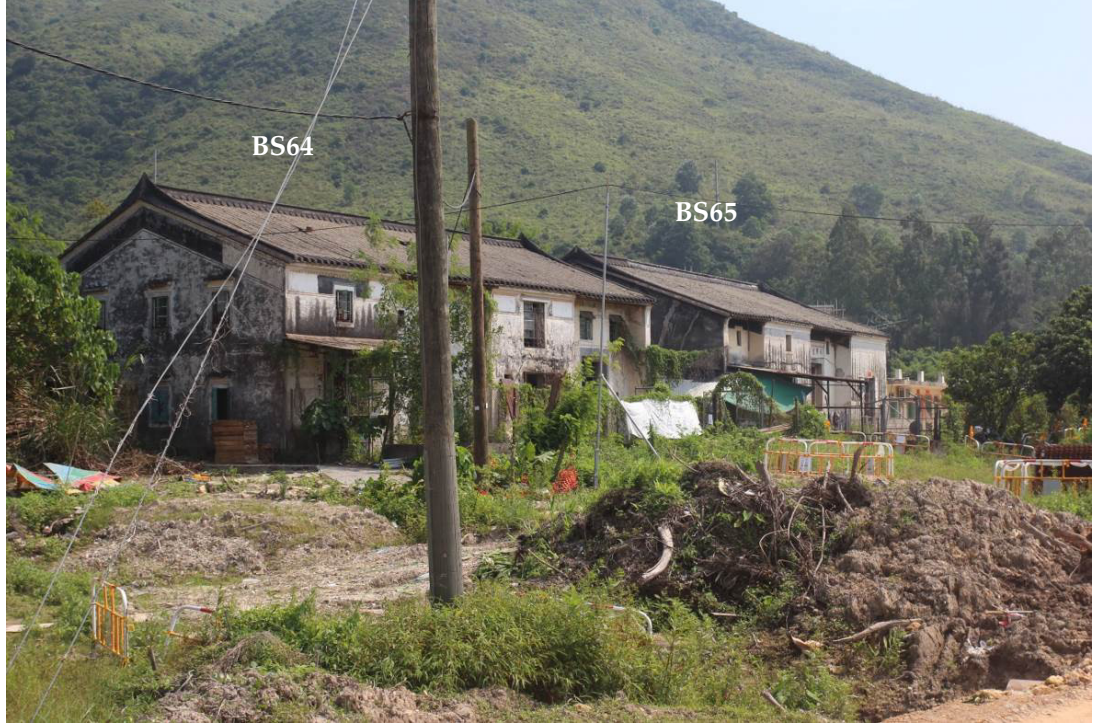
BS65-overall-P1
Surroundings of BS65 (view from northwest) BS65側視圖 (攝自西北方)

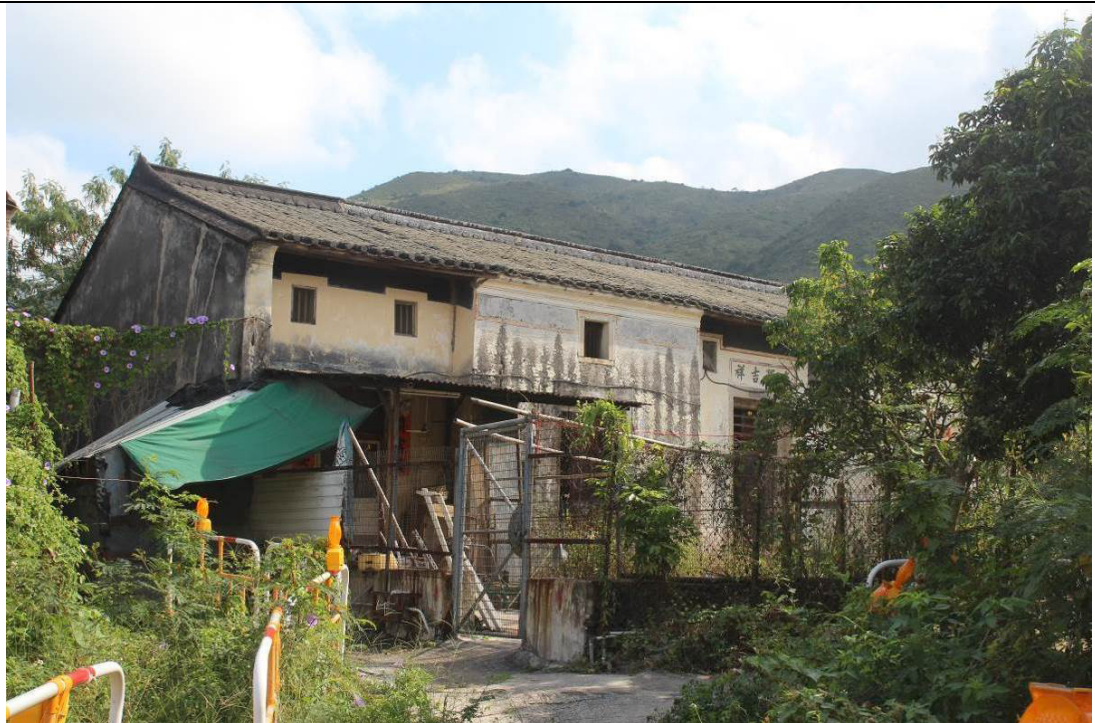
BS65-overall-P2
Oblique view of BS65 (view from northwest) BS65側視圖(攝自西北方)
