TUEN MUN - CHEK LAP KOK LINK  
CONTRACT NO. HY/2013/12 –  
NORTHERN CONNECTION TOLL PLAZA AND  
ASSOCIATED WORKS

12<sup>TH</sup> MONTHLY ENVIRONMENTAL MONITORING AND  
AUDIT (EM&A) REPORT – OCTOBER 2015

PREPARED FOR  
CRBC AND KADEN JOINT VENTURE

Date	Reference No.	Prepared By	Certified By
12 November 2015	TCS00715/14/600/R00144v2

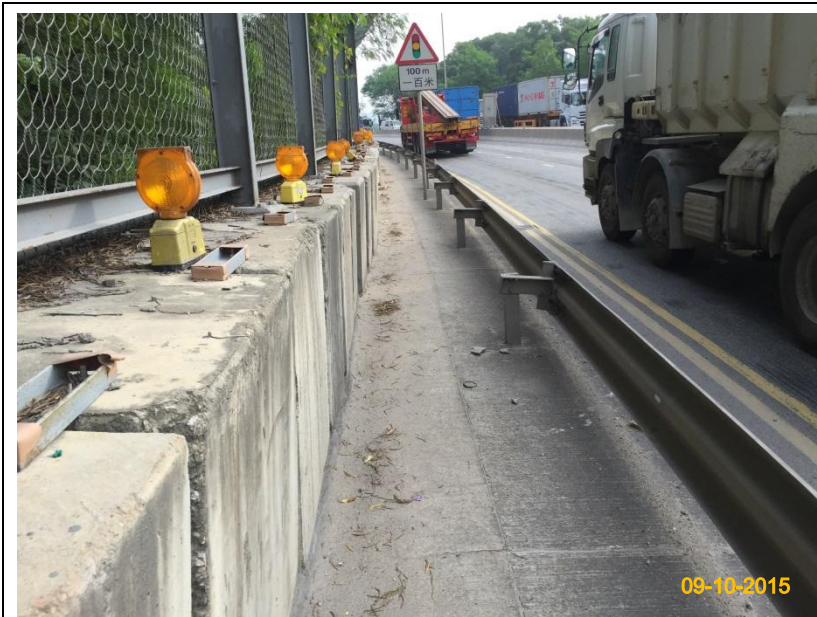
Item 5. Hoarding with panel around works area & Item 6. Temporary traffic management lighting.

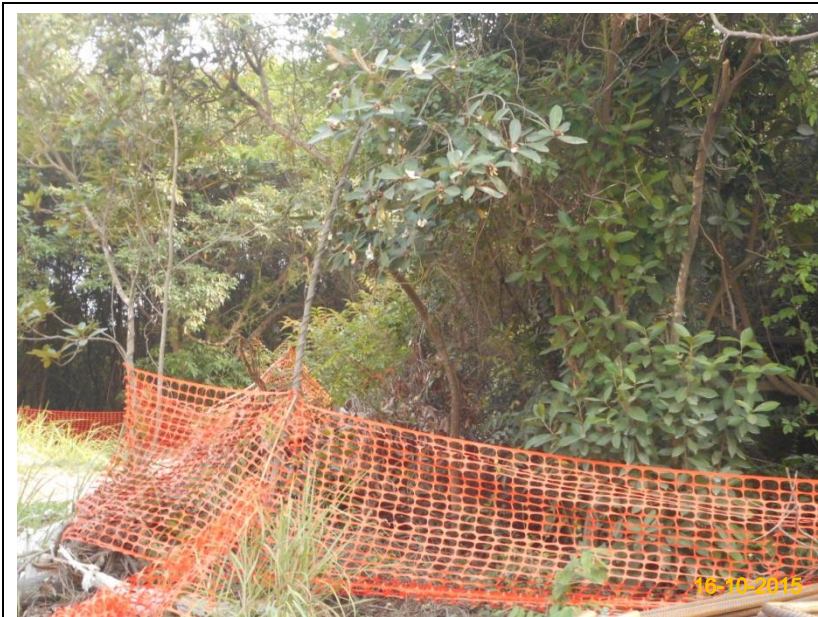
Item 1. Existing trees on boundary of the Project Area have been protected carefully during construction.

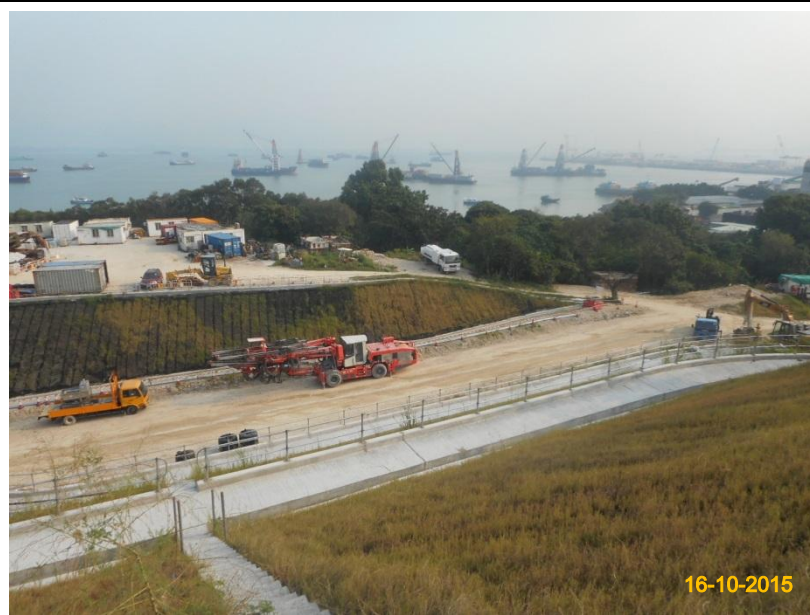
Item 4. Hydro-seeding or sheeting provided at stockpile.

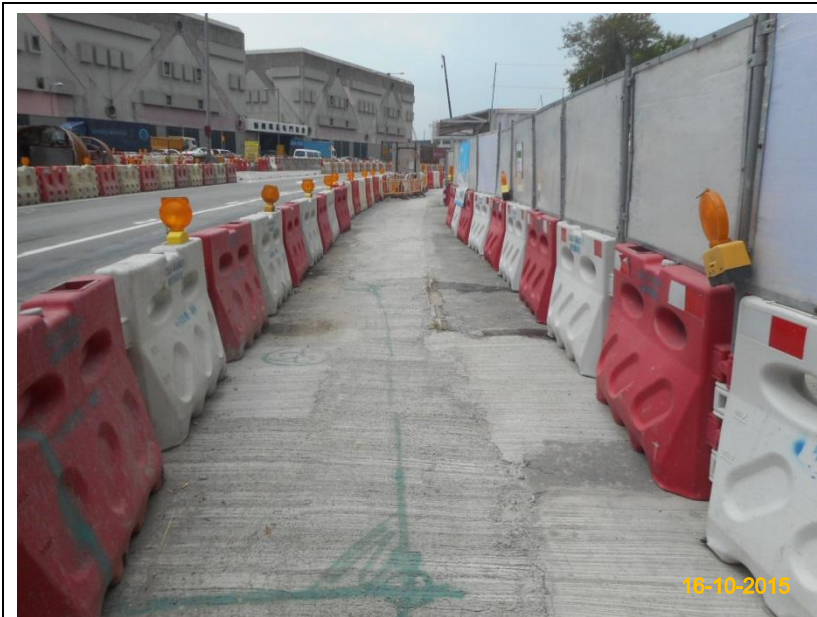
Item 5. Hoarding with panel around works area & Item 6. Temporary traffic management lighting.

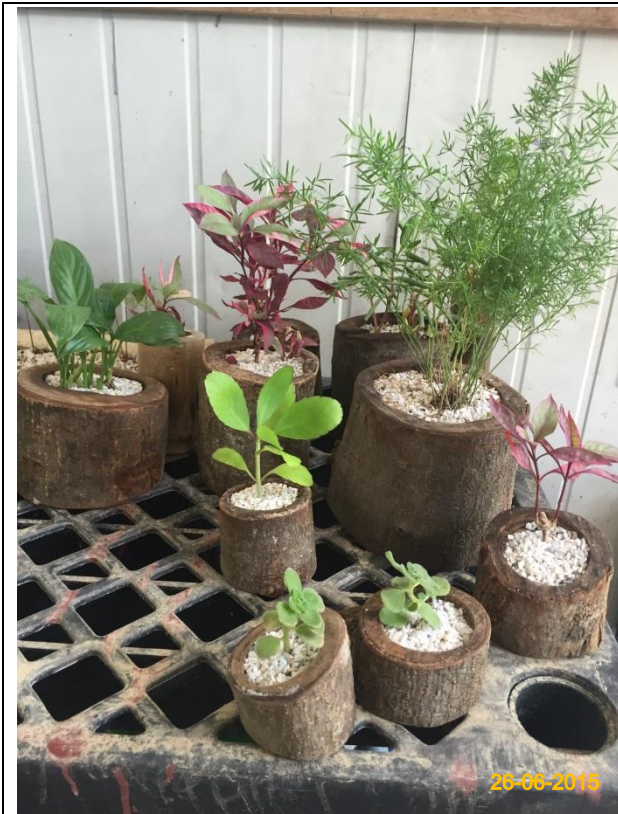
Item 9. Recycle of felled trees as flowerpot with plant and display in school.

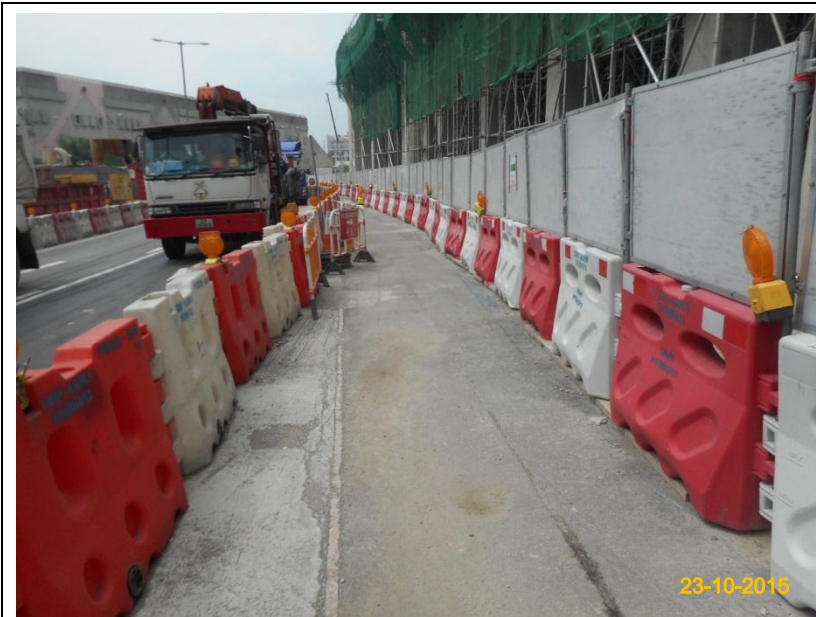
Item 5. Hoarding with panel around works area & Item 6. Temporary traffic management lighting.

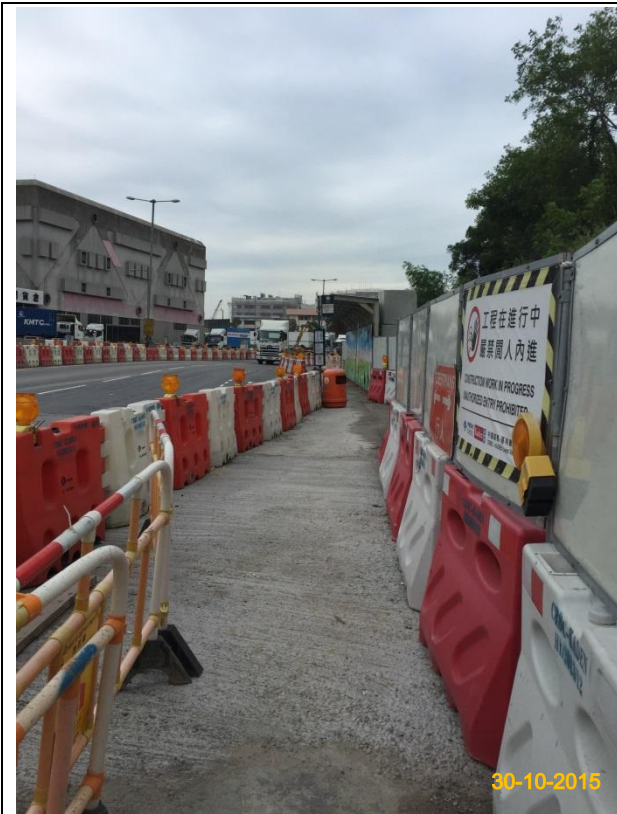
Item 5. Hoarding with panel around works area & Item 6. Temporary traffic management lighting.

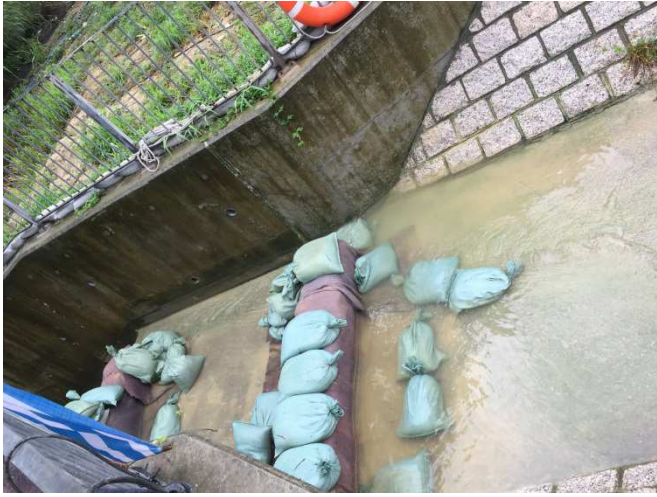
East Portal: Cascade condition

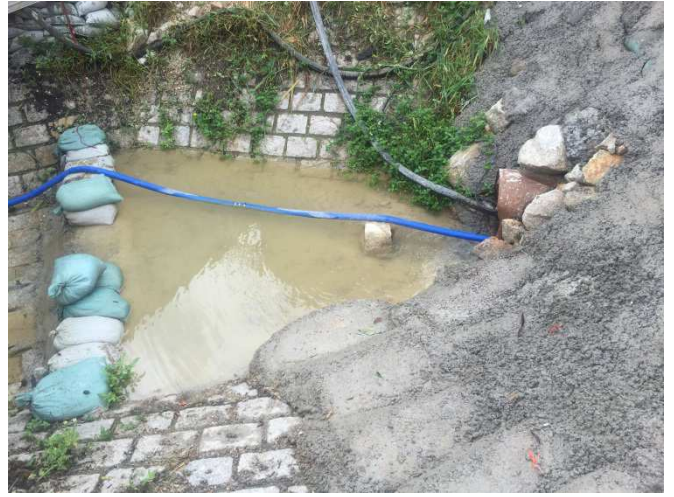
East Portal: Cascade condition

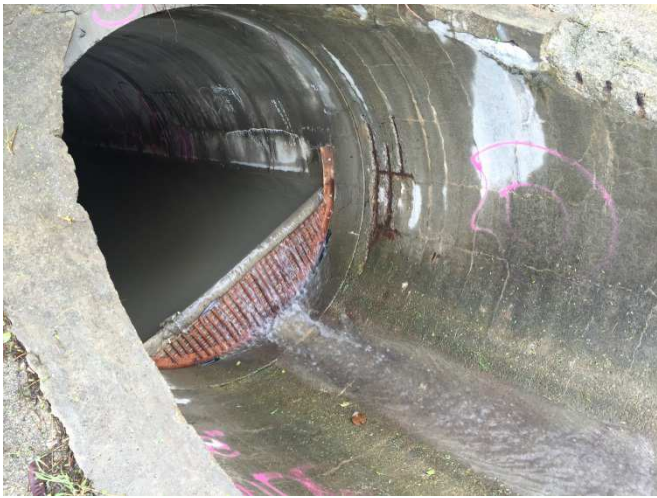
Outfall 1: Outfall condition is OK.

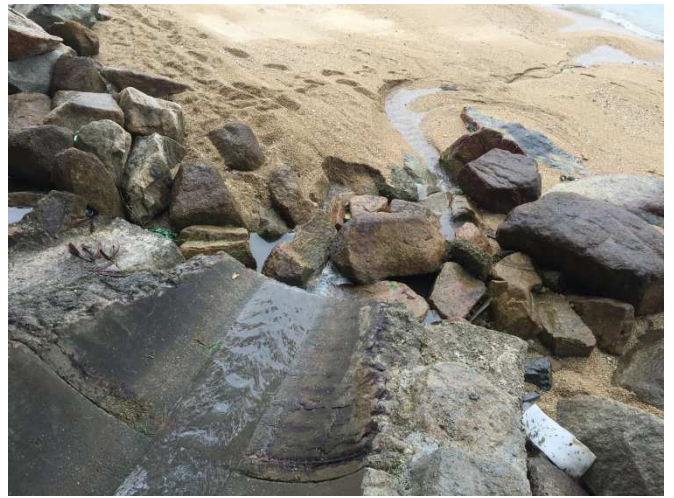
Outfall 1: Clean water is discharging.

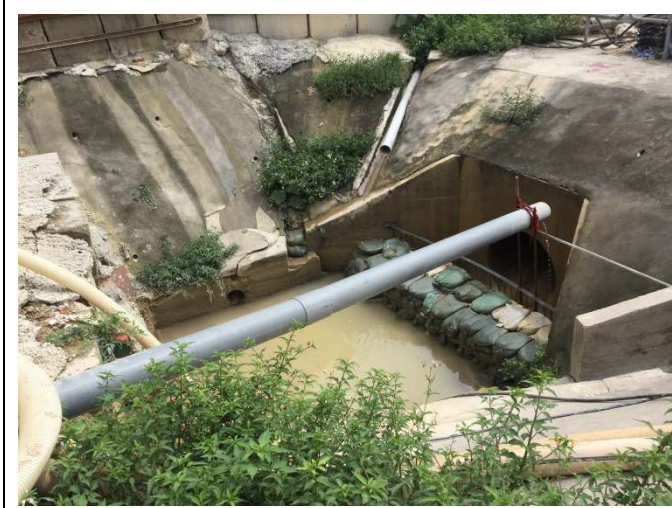
Stream A: Outfall pit in normal condition.

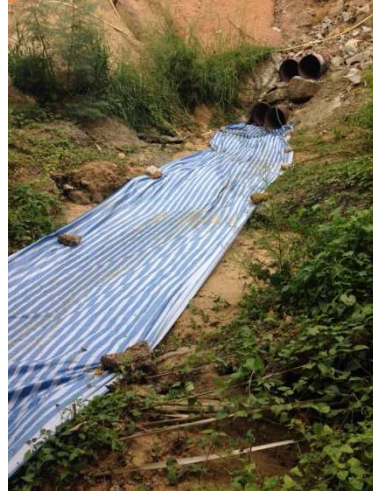
Stream B: Tarpaulin was used to avoid treated water disturbing.

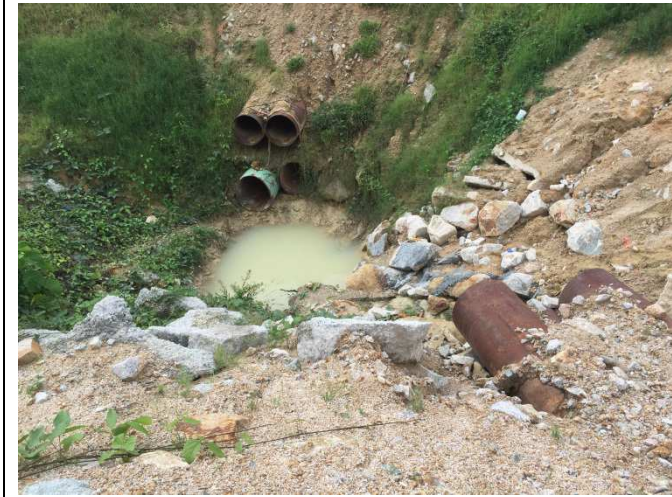
Stream B: Pit 2 in normal condition

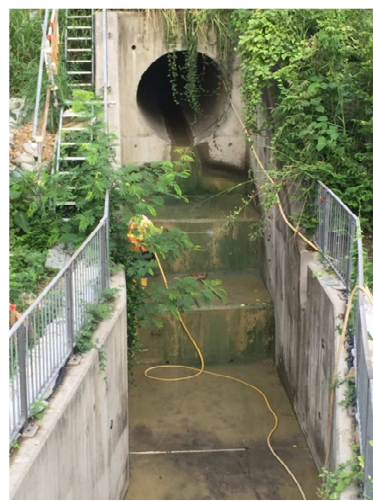
MH5: Cascade condition

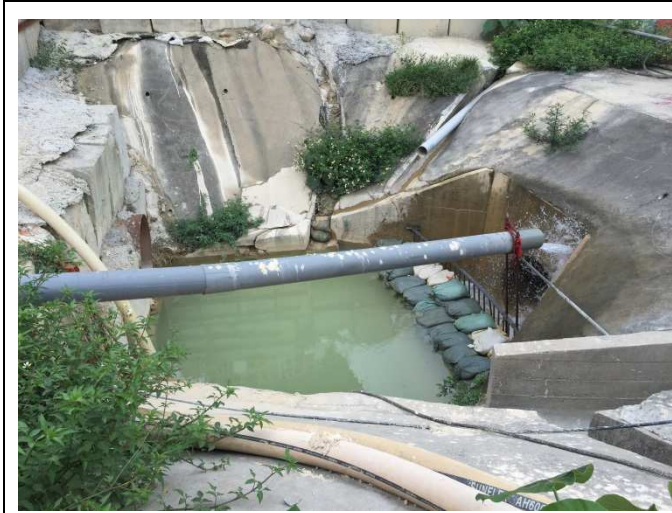
Stream A: Outfall pit was in normal condition.

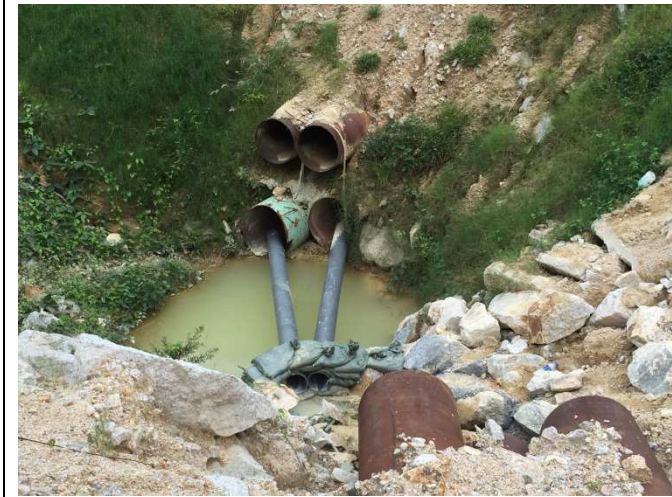
Stream B: Treated water was directly discharged to downstream bypass the Pit 2.

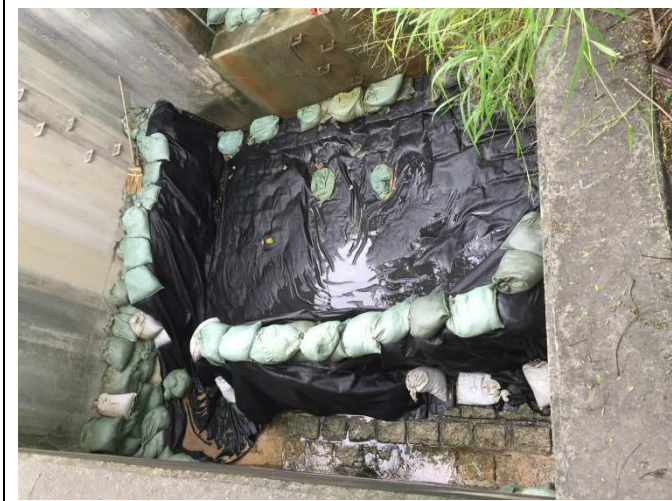
Stream B: Cascade was in normal condition.

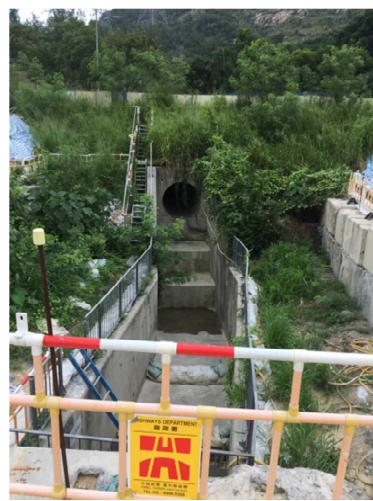
MH5: Cascade condition

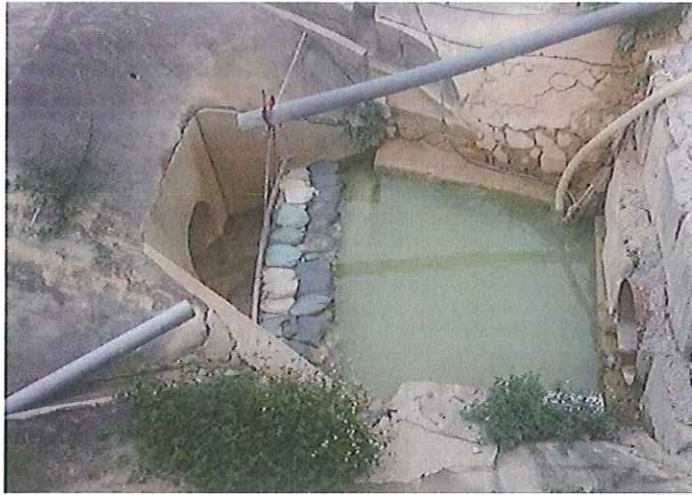
Stream A: Outfall pit was in normal condition.

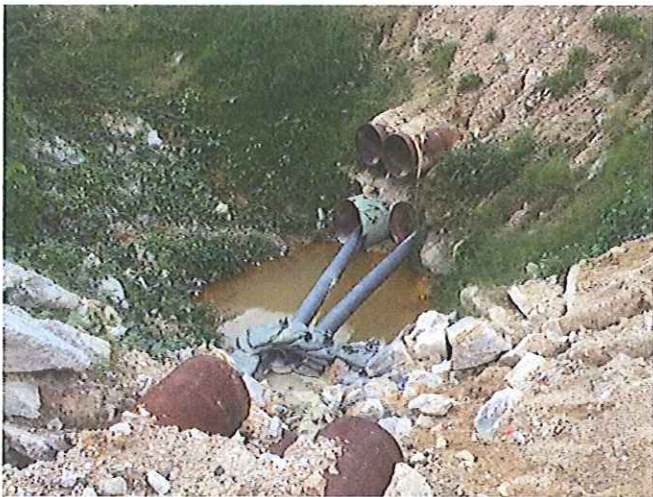
Stream B: Treated water was directly discharged to downstream bypass the Pit 2.

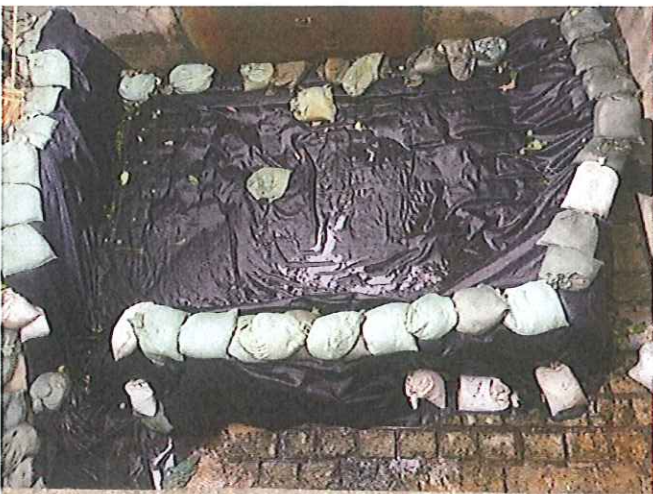
Stream B: Cascade was in normal condition.

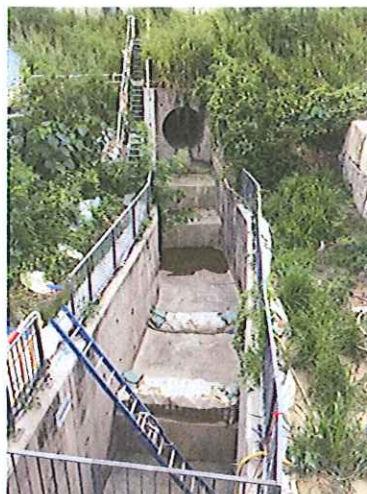
MH5: Cascade condition

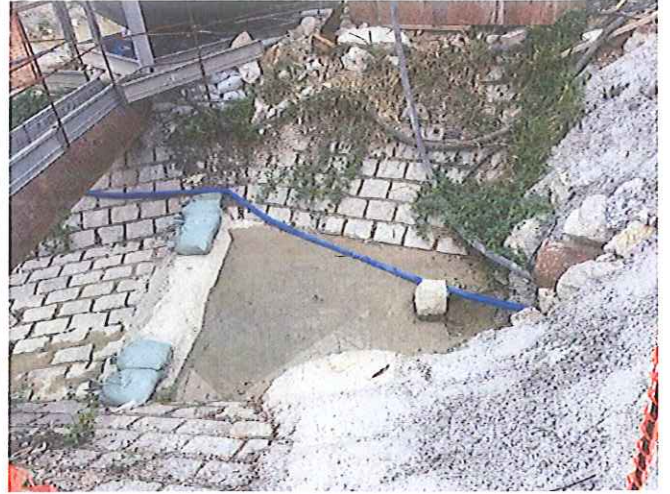
East Portal: Cascade condition

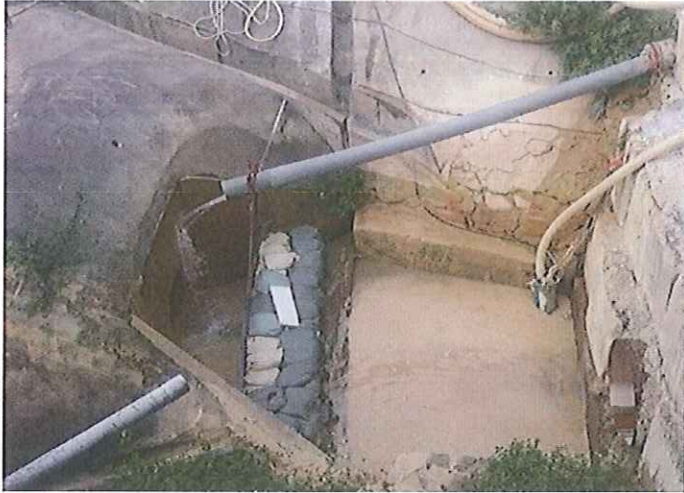
Stream A Outfall: Pumped muddy water to Wetsep and discharging after treatment.

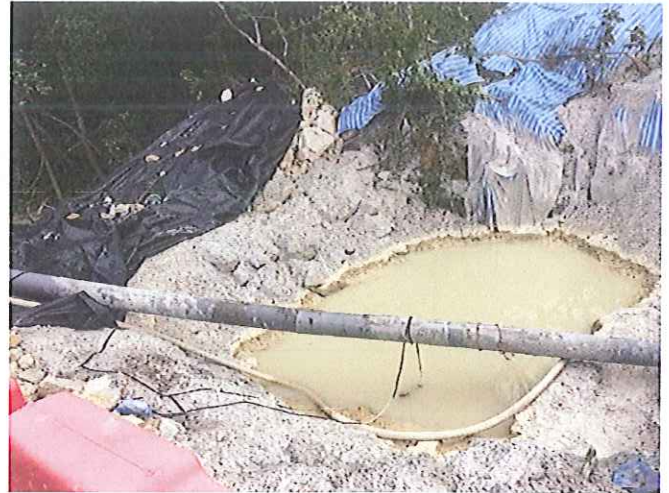
Stream B Pit 1: in normal condition.

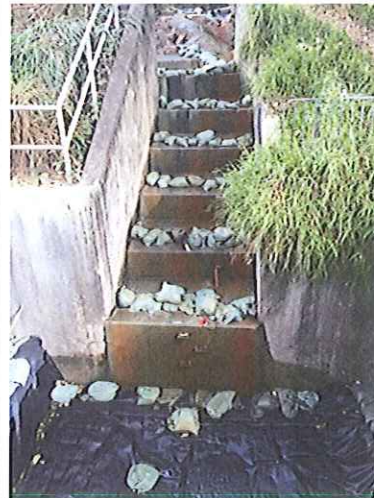
Stream B Outfall: Cascade step channel condition

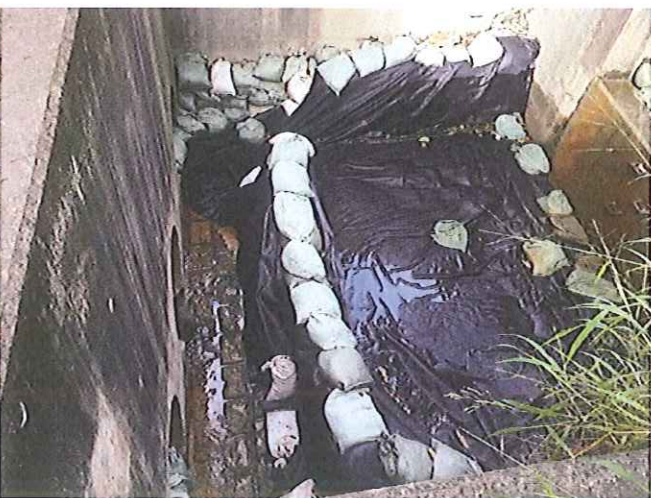
Stream B Outfall: Cascade was in normal condition.

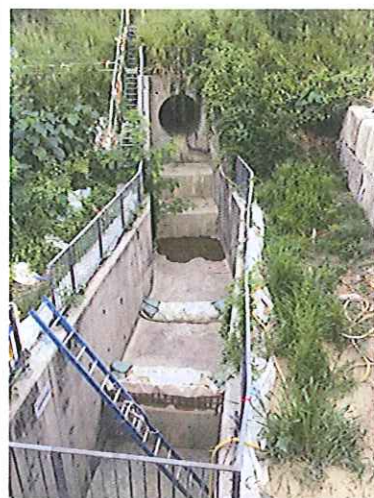
MH5 Cascade: No water is discharging.

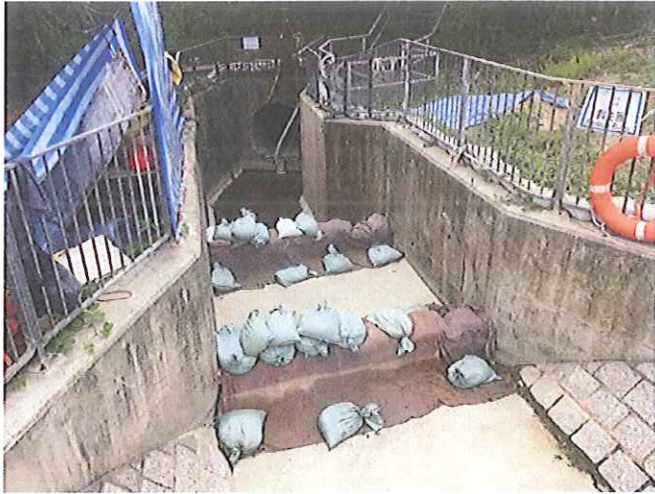
East Portal Cascade: No water is discharged.

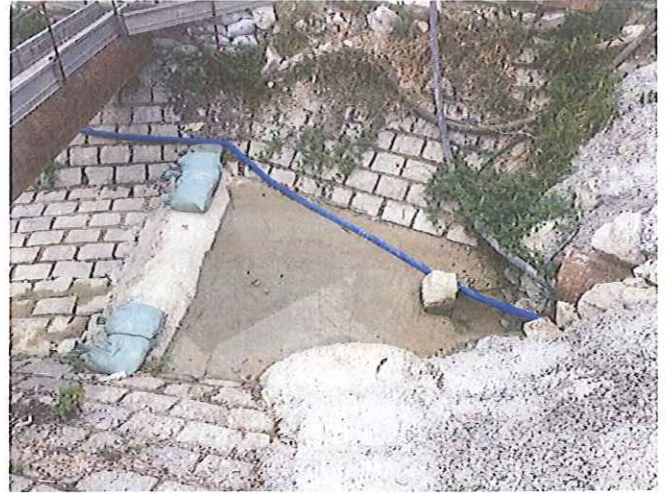
East Portal Cascade condition

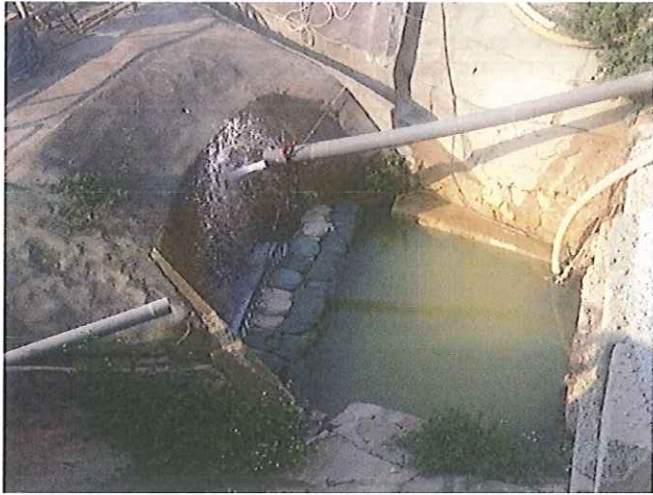
Stream A Outfall: in normal condition.

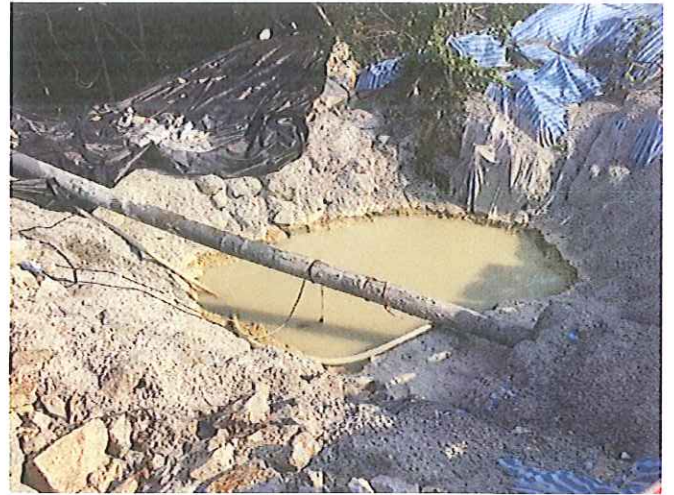
Stream B Pit 1: in normal condition.

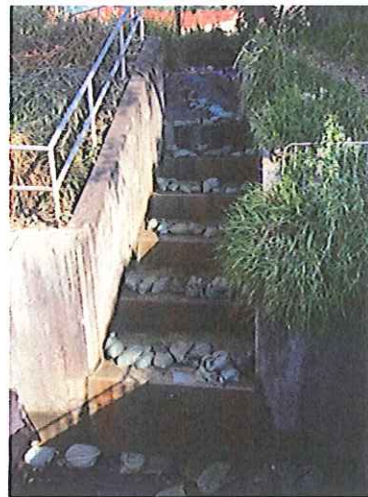
Stream B Outfall: Cascade step channel condition

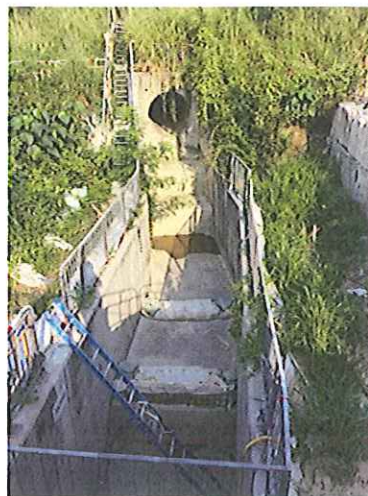
MH5 Cascade: No water is discharging.

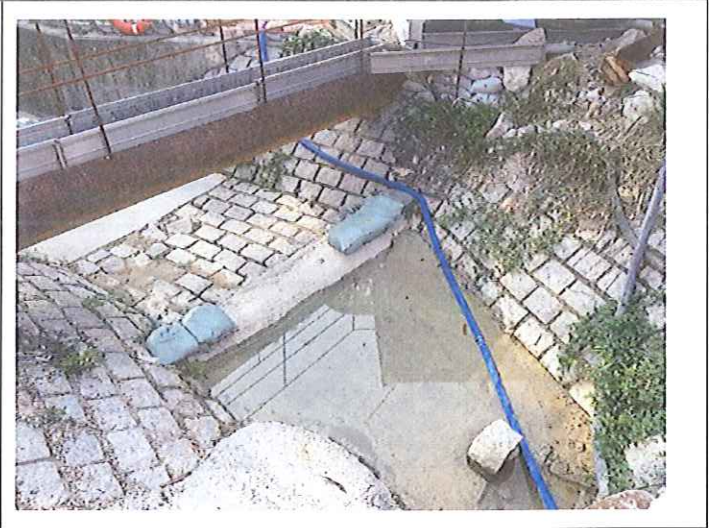
East Portal Cascade condition

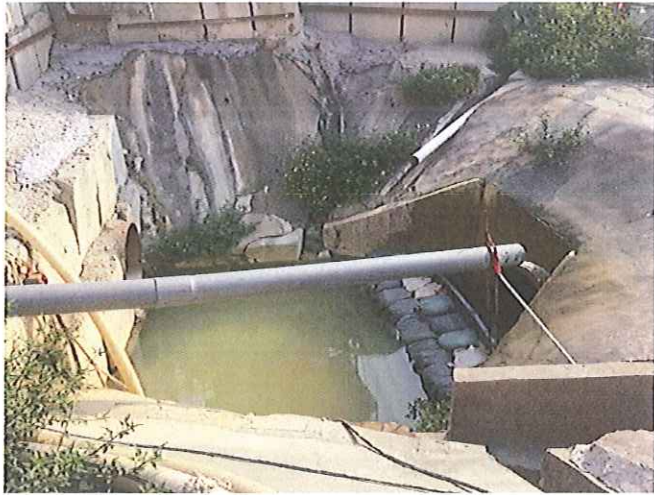
Stream A Outfall: in normal condition.

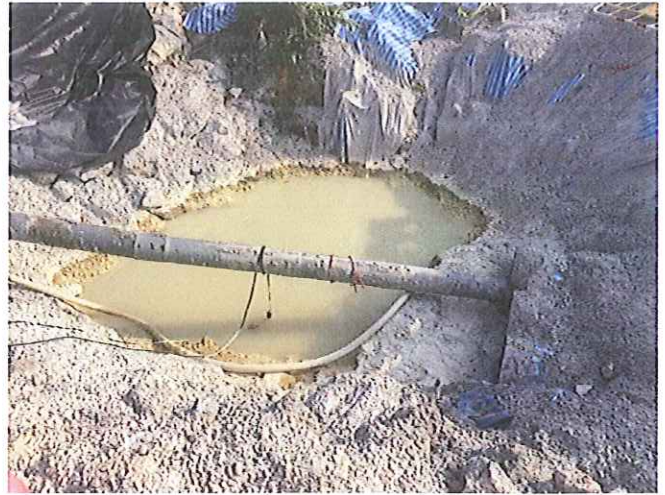
Stream B Pit 1: in normal condition.

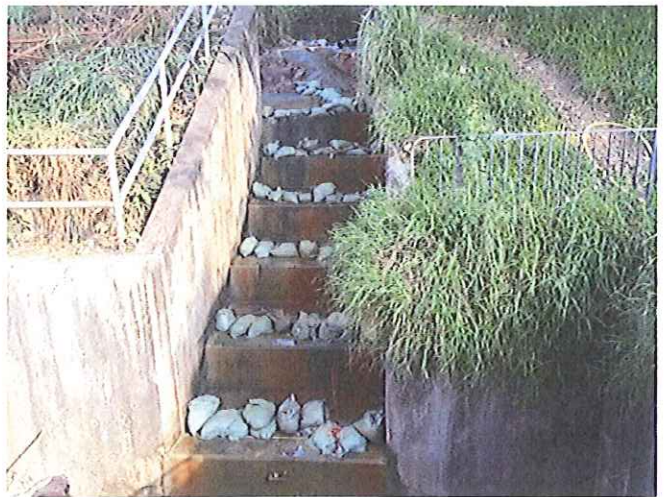
Stream B Outfall: Cascade step channel condition

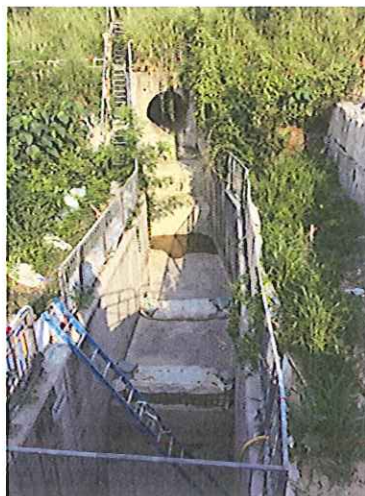
MH5 Cascade: No water is discharging.

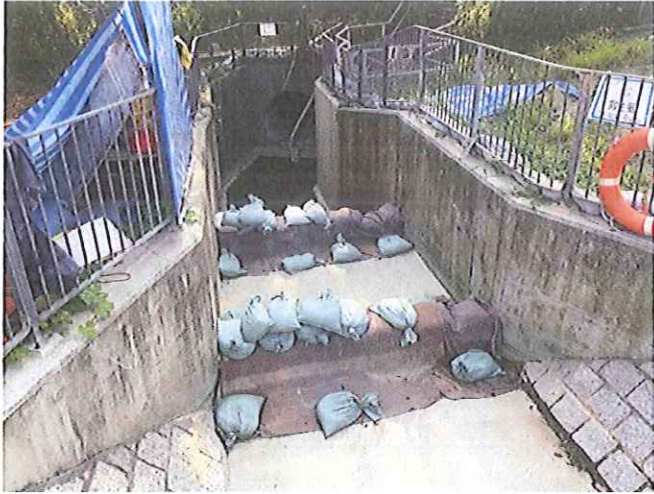
East Portal Cascade: No water is discharged.

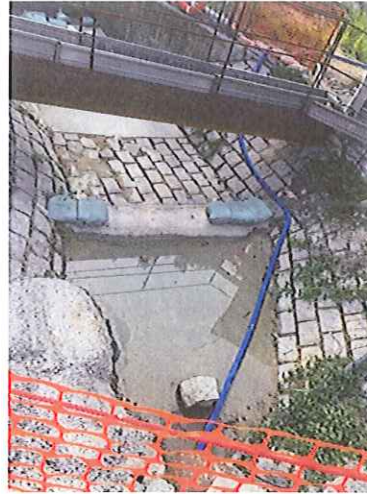
East Portal Cascade condition

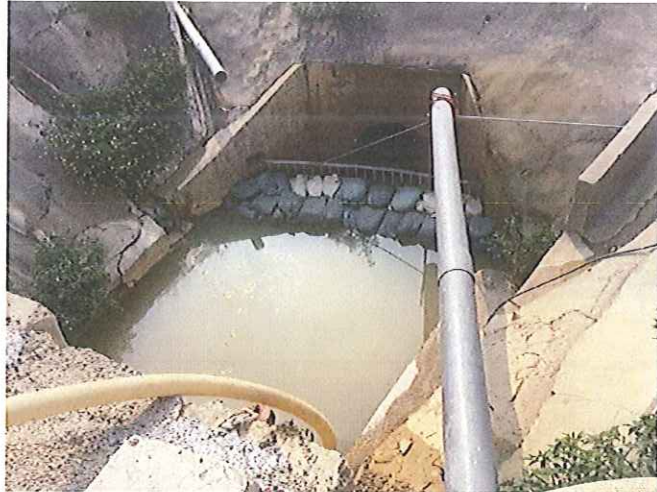
Stream A Outfall: in normal condition.

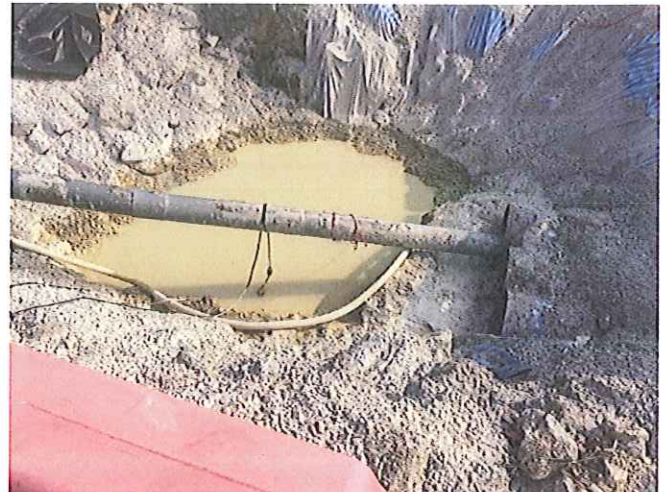
Stream B Pit 1: in normal condition.

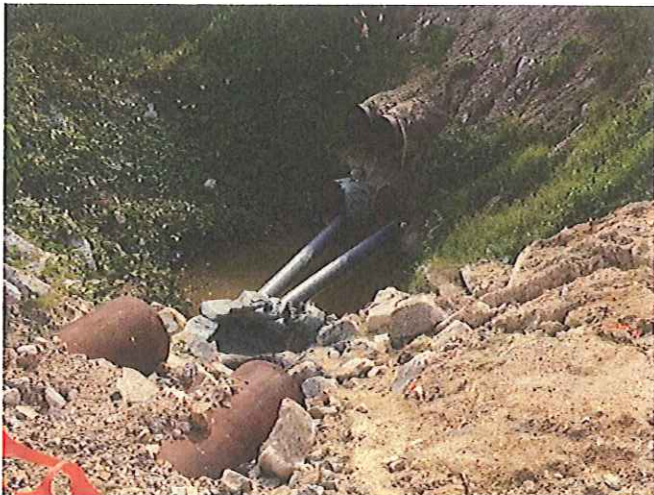
Stream B Pit 2: Treated water was directly discharged to downstream bypass.

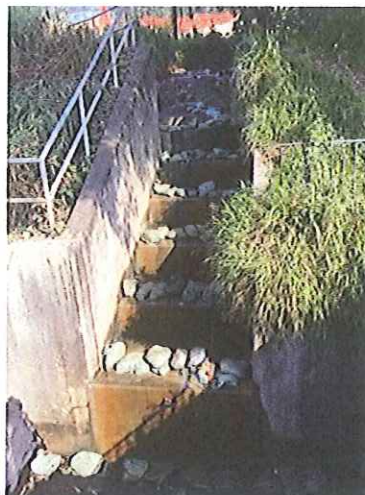
Stream B Outfall: Cascade step channel condition

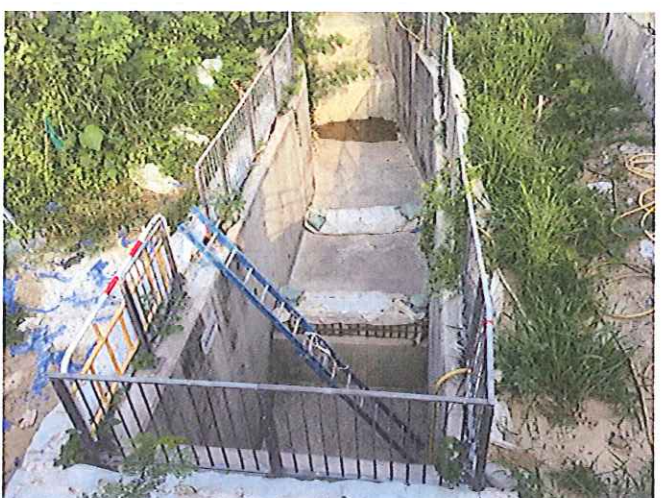
MH5 Cascade: No water is discharging.

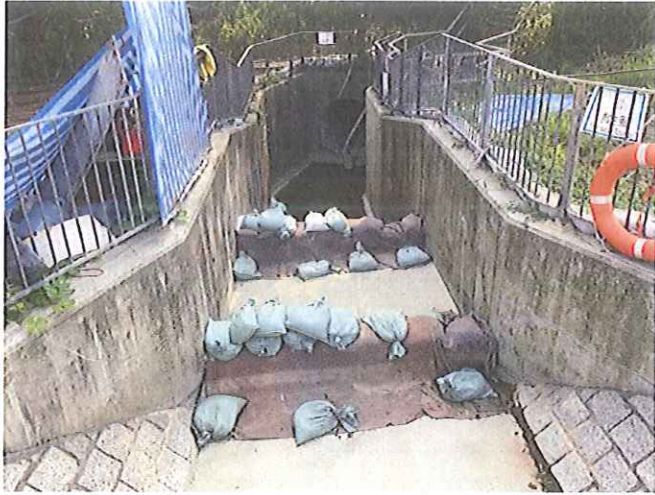
East Portal Cascade: No water is discharged.

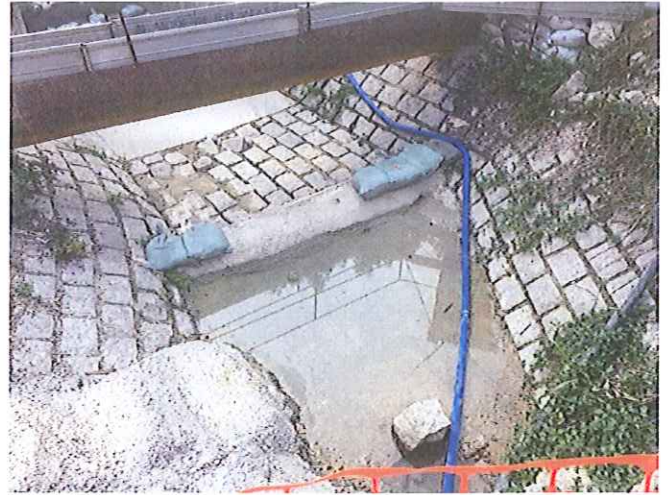
East Portal Cascade condition

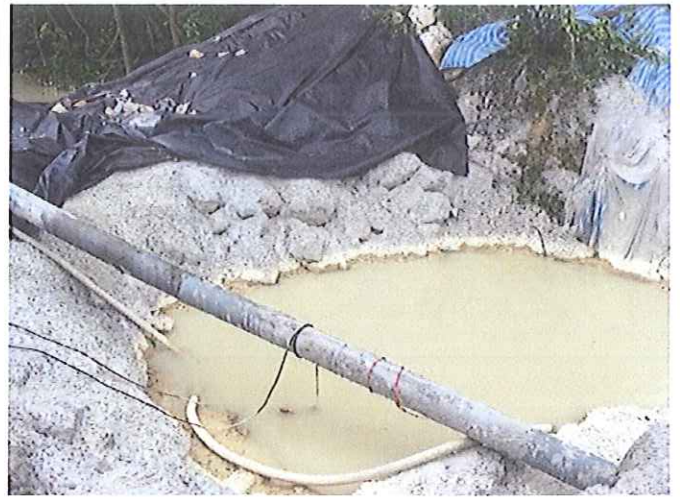
Stream B Pit 1: in normal condition.

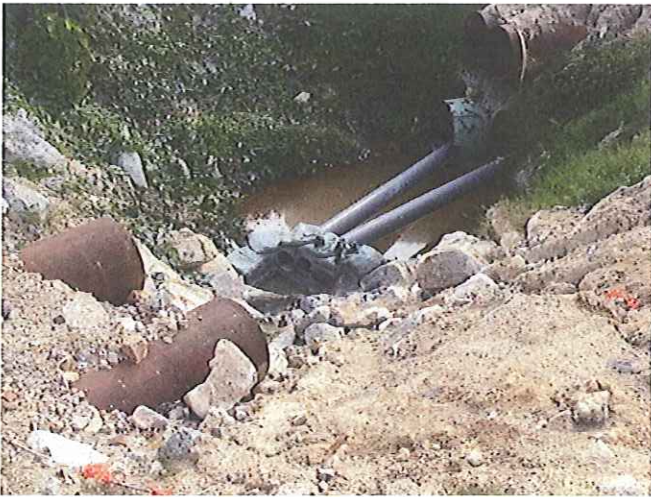
Stream B Pit 2: Treated water was directly discharged to downstream bypass.

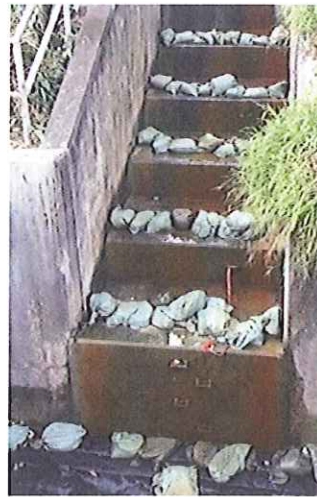
Stream B Outfall: Cascade step channel condition

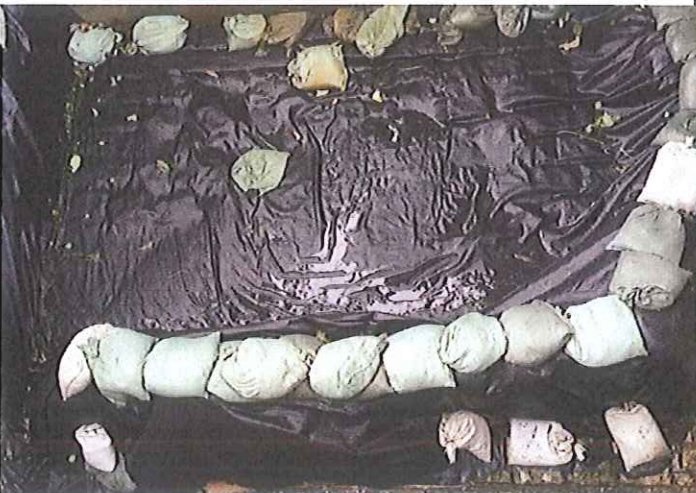
Stream B Outfall: Cascade was in normal condition.

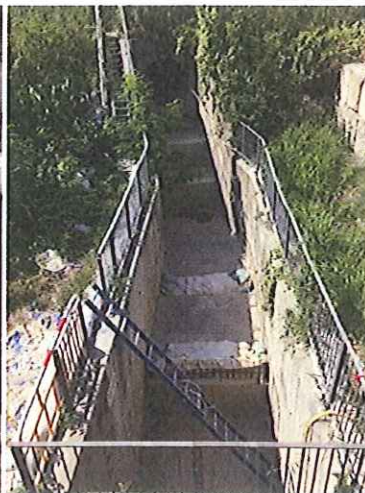
MH5 Cascade: No water is discharging.

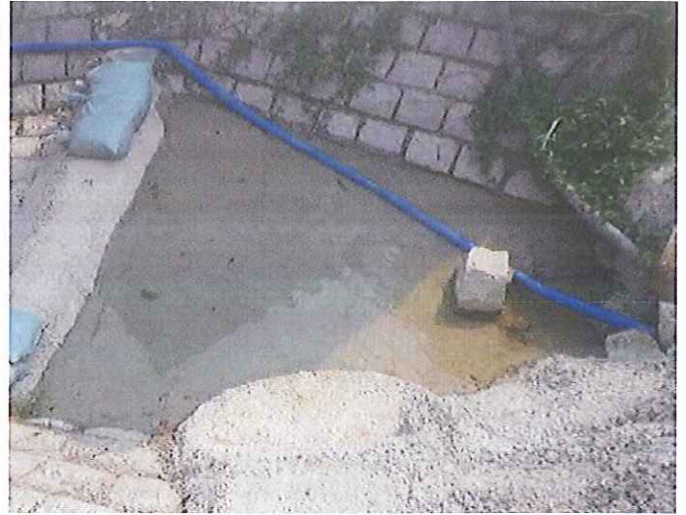
East Portal Cascade condition

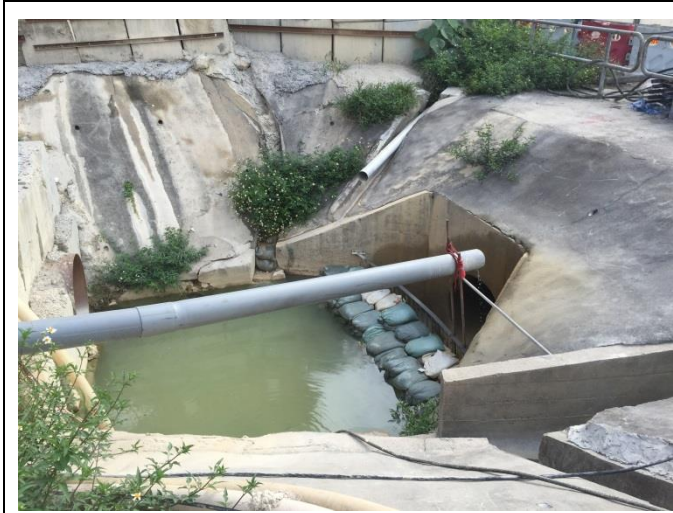
Stream A Outfall: in normal condition.

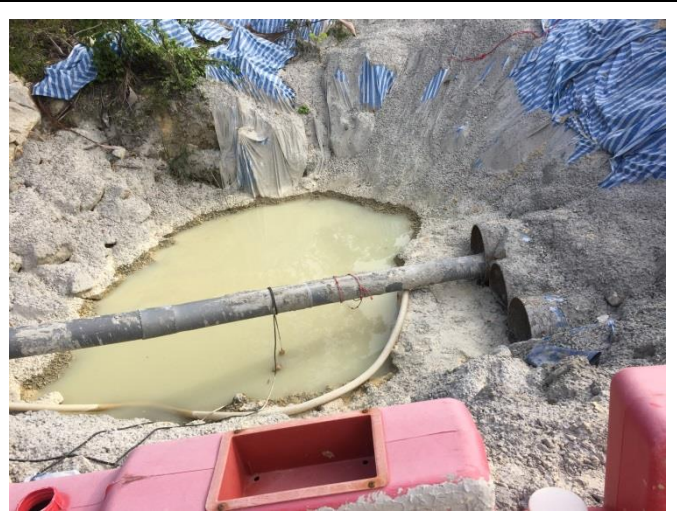
Stream B Pit 1: in normal condition.

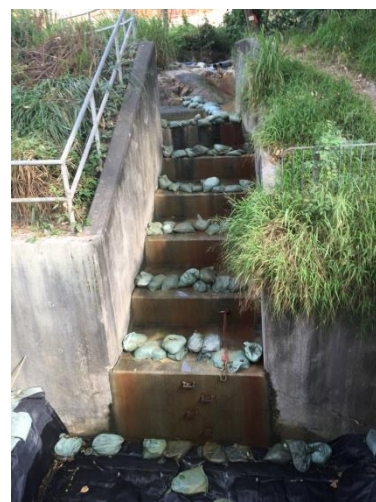
Stream B Outfall: Cascade step channel condition

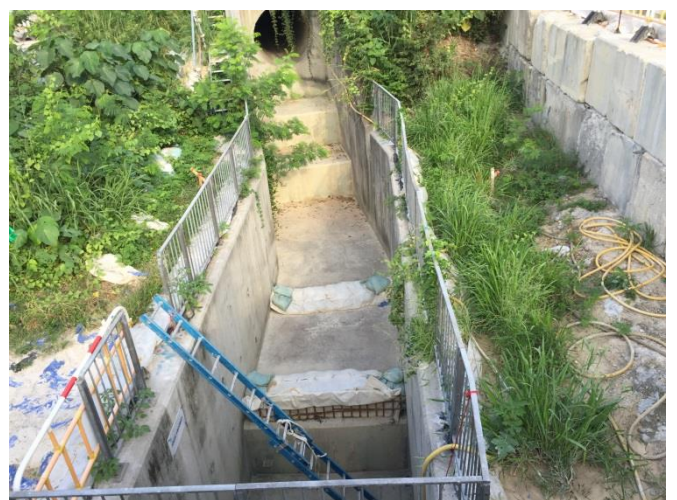
MH5 Cascade: No water is discharging.

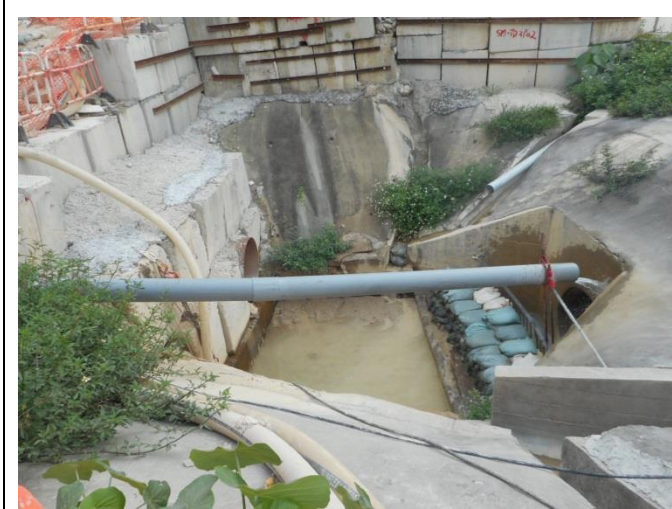
Stream A Outfall: pumped muddy water and discharged after treatment.

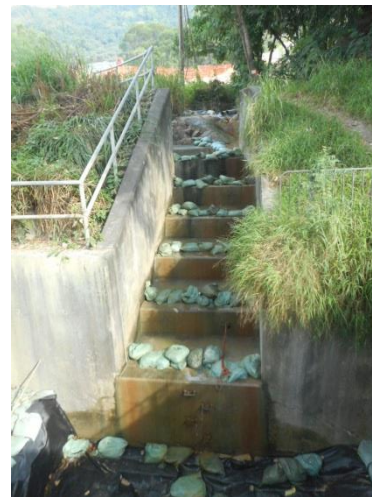
Stream B Pit 2: Treated water was directly discharged to downstream bypass.

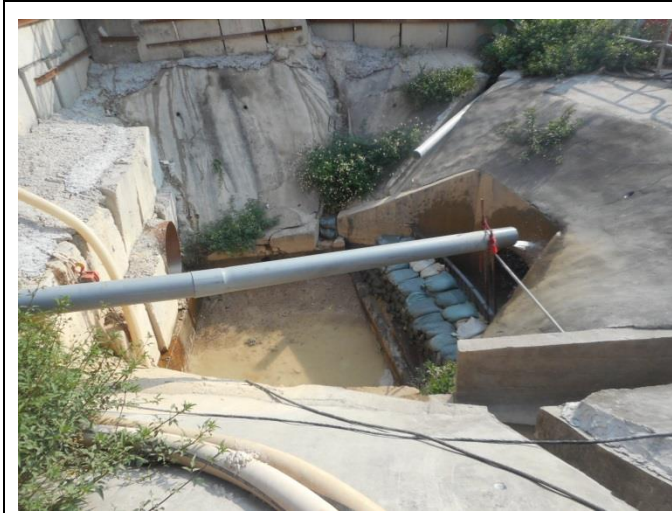
Stream A Outfall: pumped muddy water and discharged after treatment.

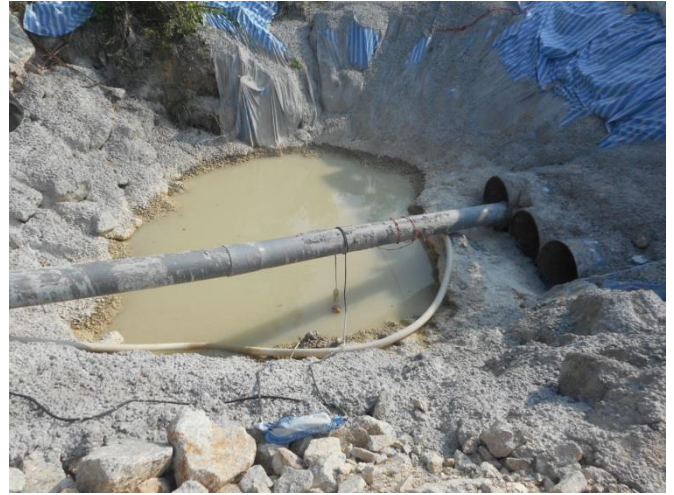
Stream B Pit 1: in normal condition.

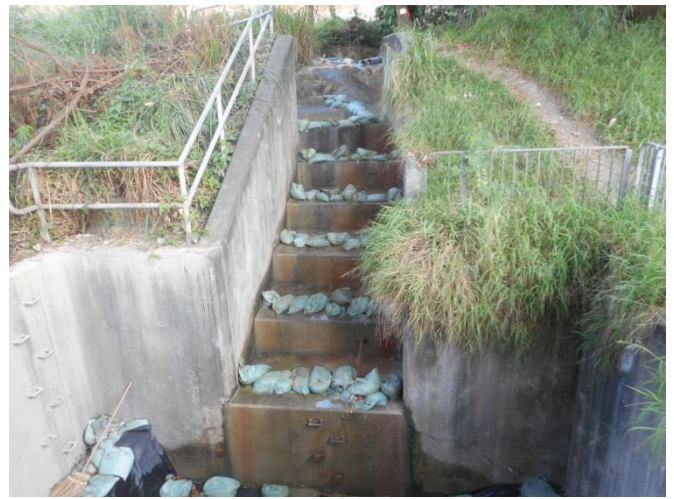
Stream B Outfall: Cascade step channel condition

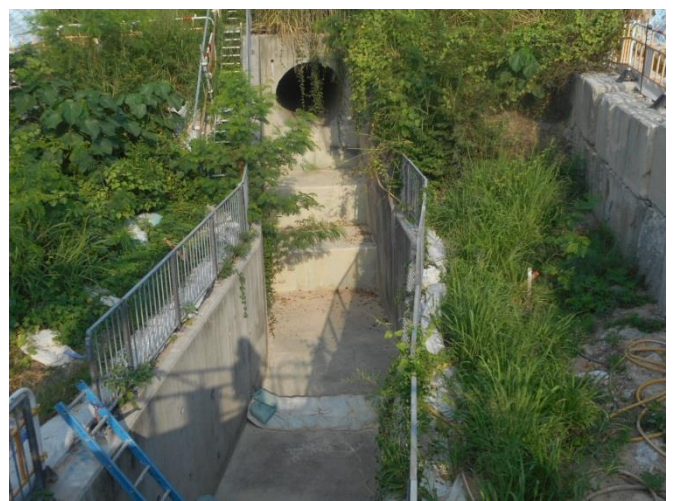
MH5 Cascade: No water is discharging.

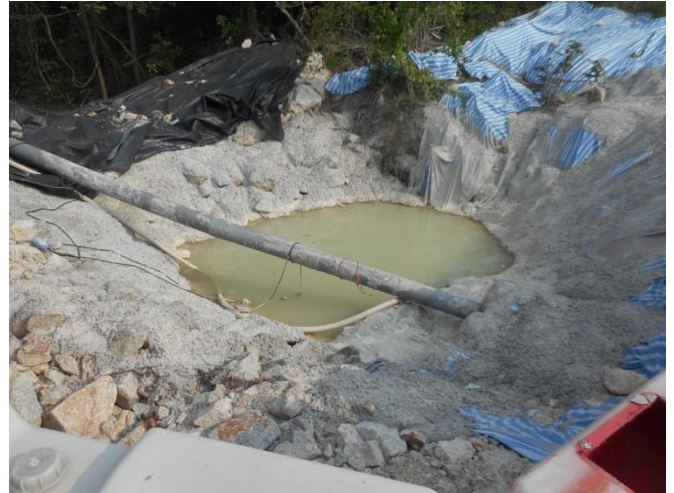
Stream B Pit 1: in normal condition.

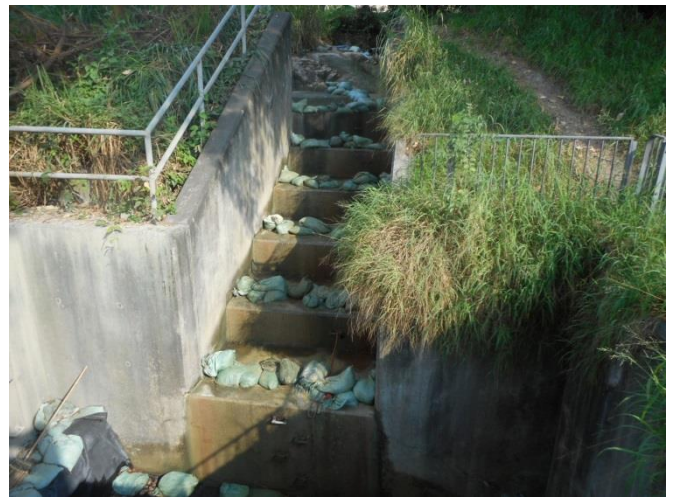
Stream B Outfall: Cascade step channel condition

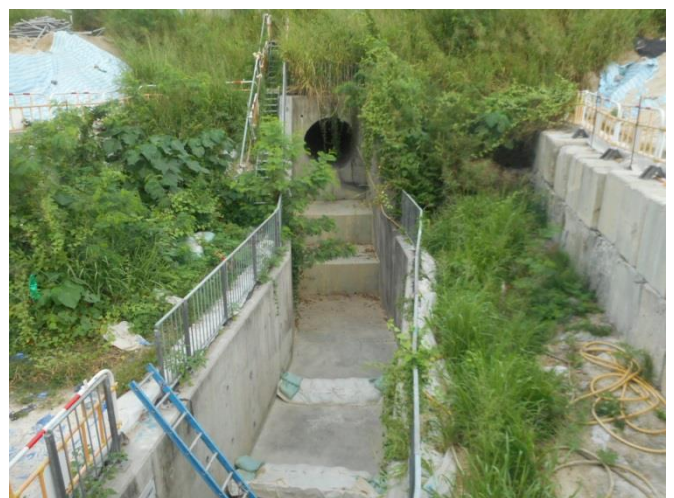
MH5 Cascade: No water is discharging.

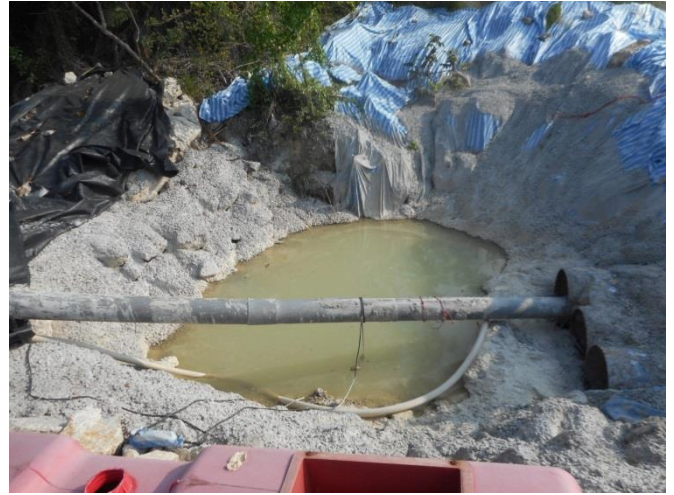
Stream B Pit 1: in normal condition.

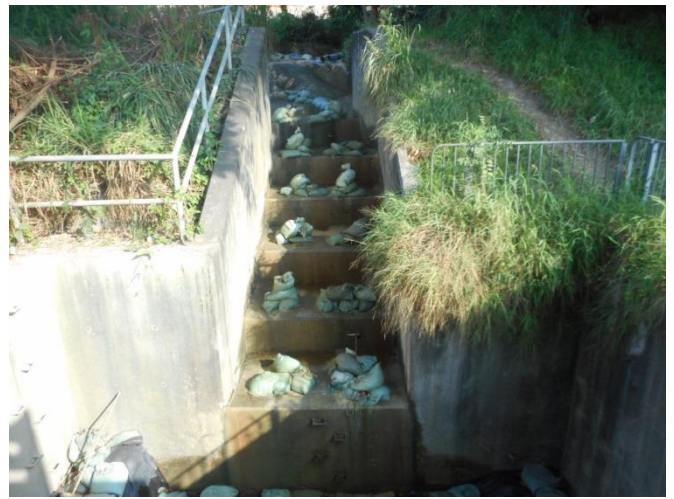
Stream B Outfall: Cascade step channel condition
