TUEN MUN - CHEK LAP KOK LINK  
CONTRACT NO. HY/2013/12 –  
NORTHERN CONNECTION TOLL PLAZA AND  
ASSOCIATED WORKS

12<sup>TH</sup> MONTHLY ENVIRONMENTAL MONITORING AND  
AUDIT (EM&A) REPORT – OCTOBER 2015

PREPARED FOR  
CRBC AND KADEN JOINT VENTURE

Date	Reference No.	Prepared By	Certified By
12 November 2015	TCS00715/14/600/R00144v2

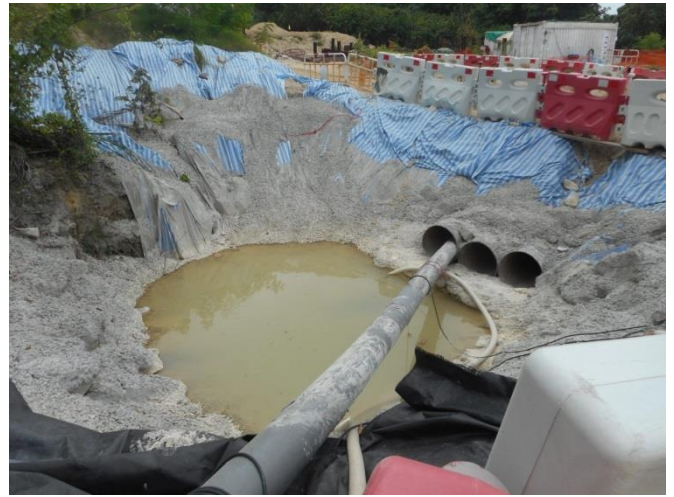
Stream B Pit 1: in normal condition.

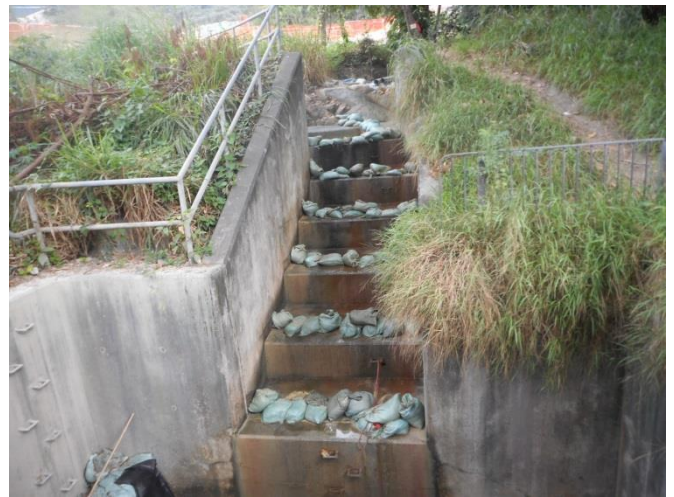
Stream B Outfall: Cascade step channel condition

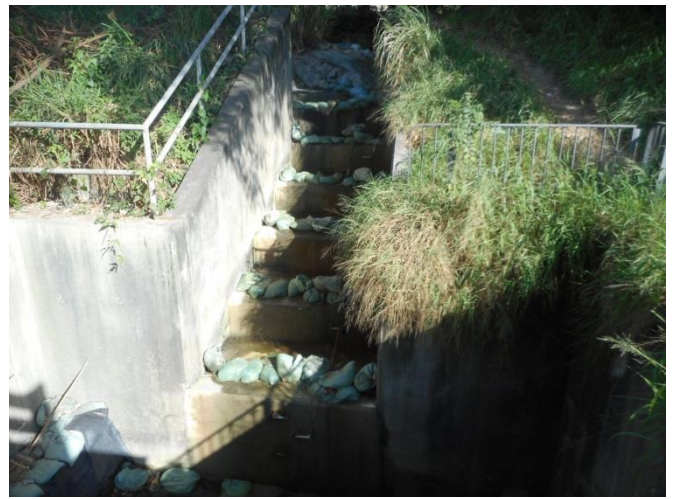
Stream B Outfall: Cascade step channel condition

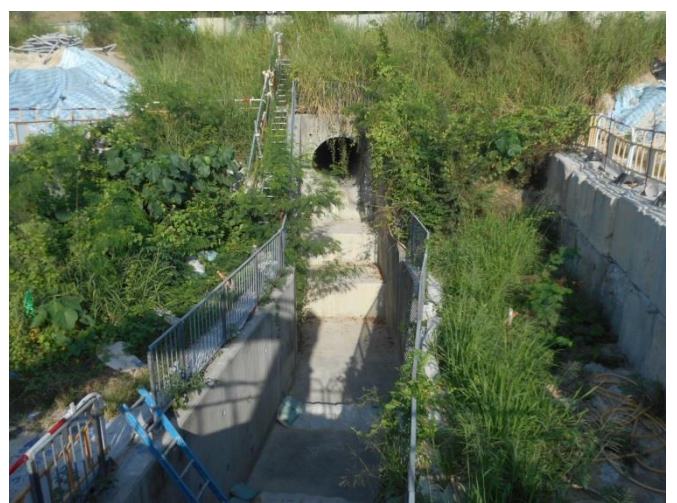
MH5 Cascade: No water is discharging.

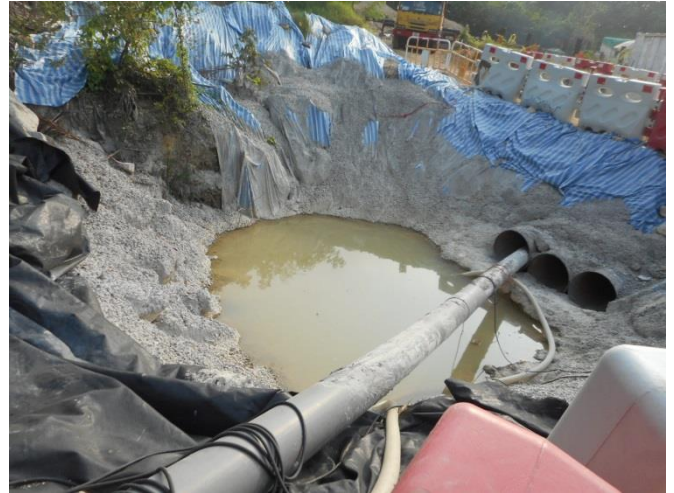
Stream B Pit 1: in normal condition.

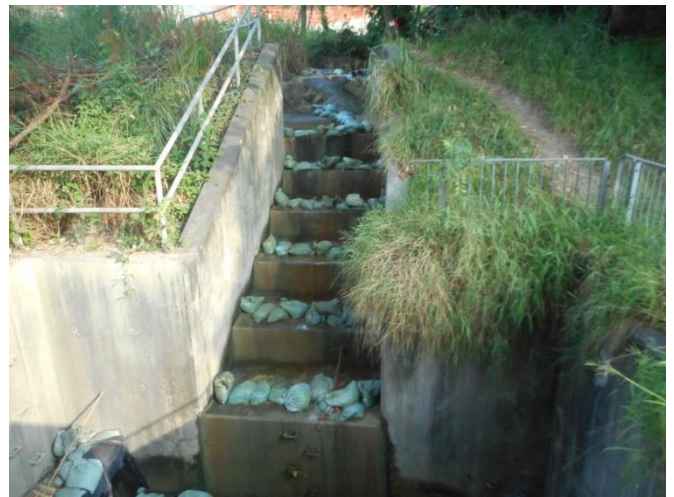
Stream B Outfall: Cascade step channel condition

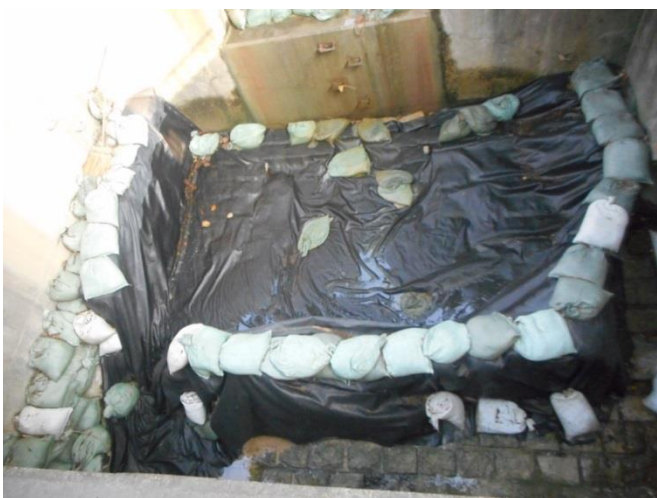
Stream B Outfall: Cascade was in normal condition.

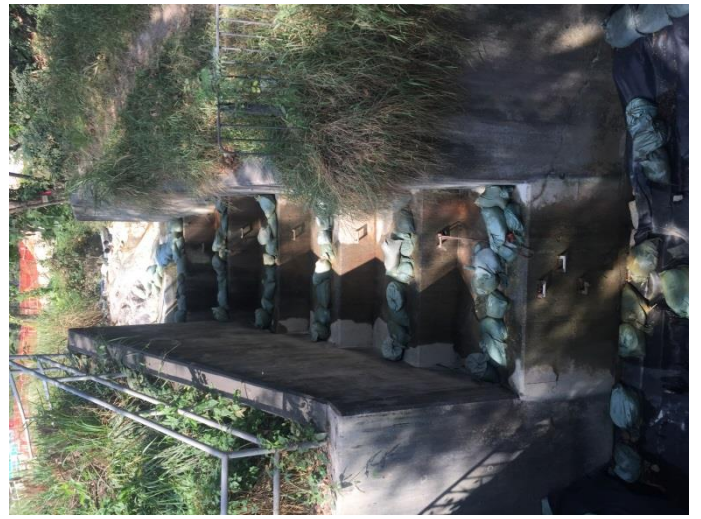
Stream B Outfall: Cascade was in normal condition.

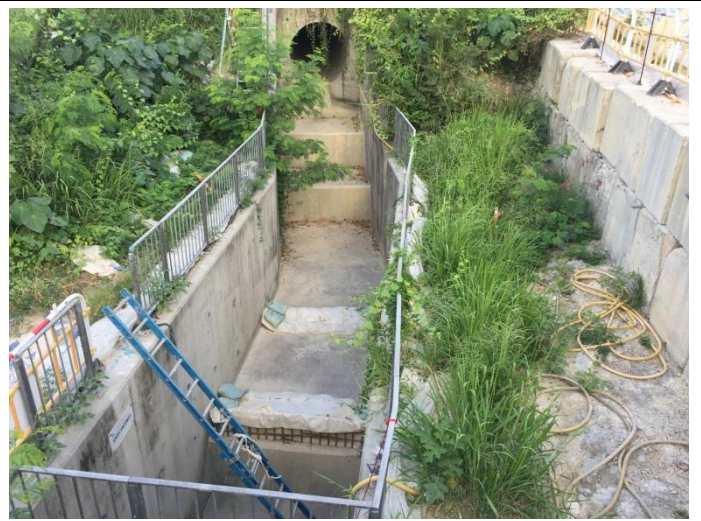
MH5 Cascade: No water is discharging.

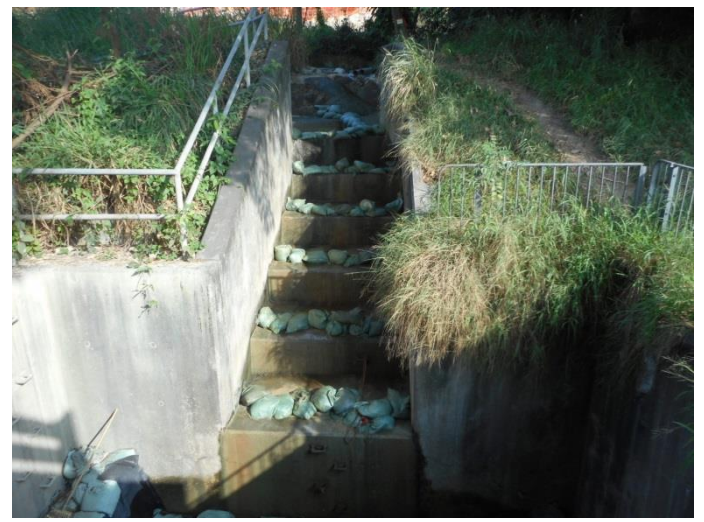
Stream B Outfall: Cascade step channel condition

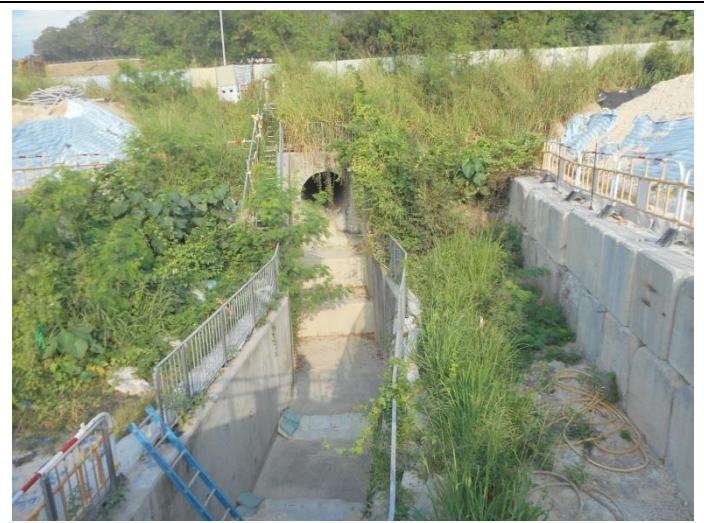
Stream B Outfall: Cascade was in normal condition.

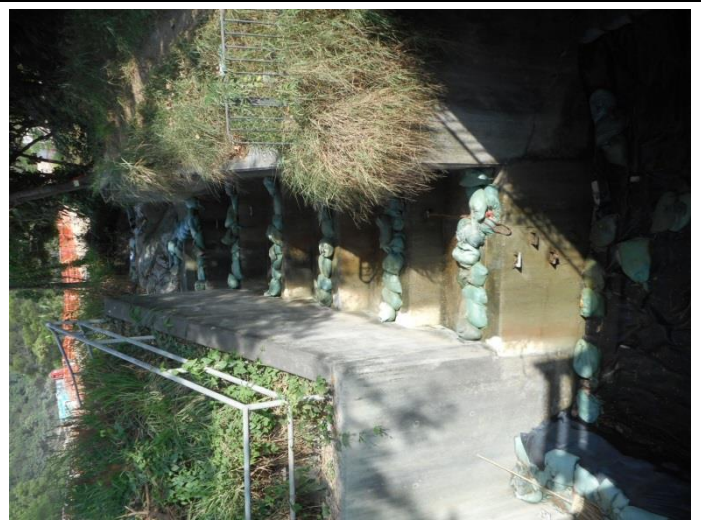
Stream B Outfall: Cascade step channel condition

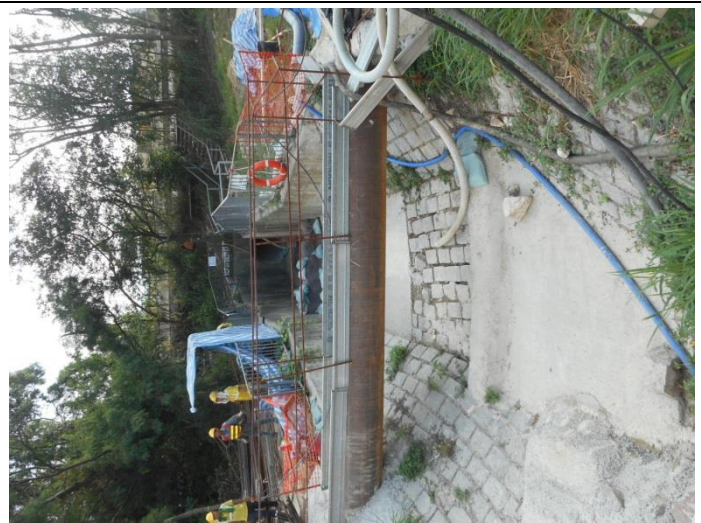
East Portal Cascade: No water is discharged.
