**TUEN MUN - CHEK LAP KOK LINK
CONTRACT NO. HY/2013/12 –
NORTHERN CONNECTION TOLL PLAZA AND
ASSOCIATED WORKS**

**36TH MONTHLY ENVIRONMENTAL MONITORING AND
AUDIT (EM&A) REPORT – OCTOBER 2017**

PREPARED FOR
CRBC AND KADEN JOINT VENTURE

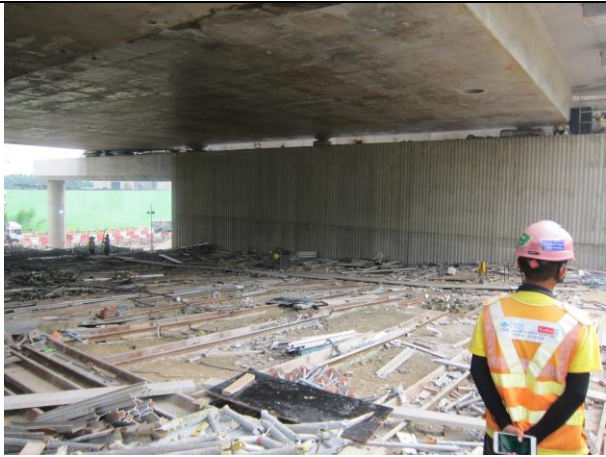
Photo 9 Housekeeping works at TD1 on 12 September 2017.

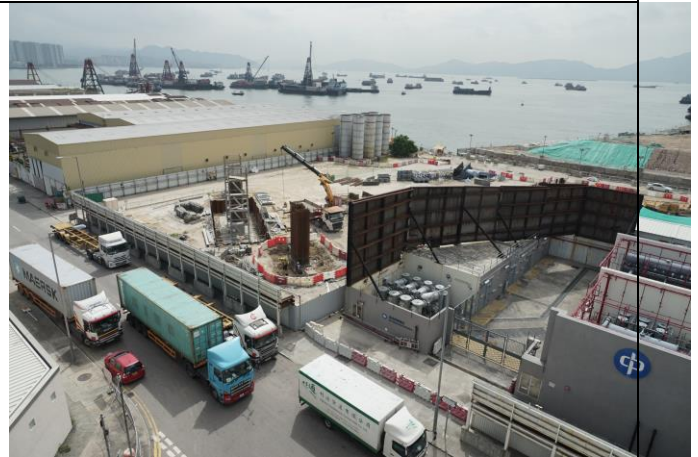
Photo 10 Consecution of column at Portion F on 12 September 2017.

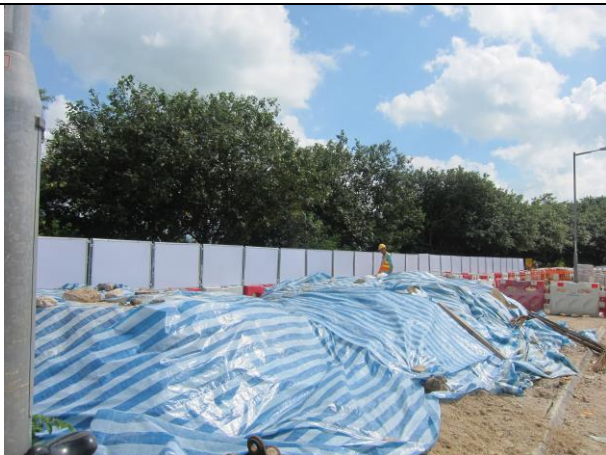
Photo 11 Covered stockpile by tarpaulin sheet at Portion H.

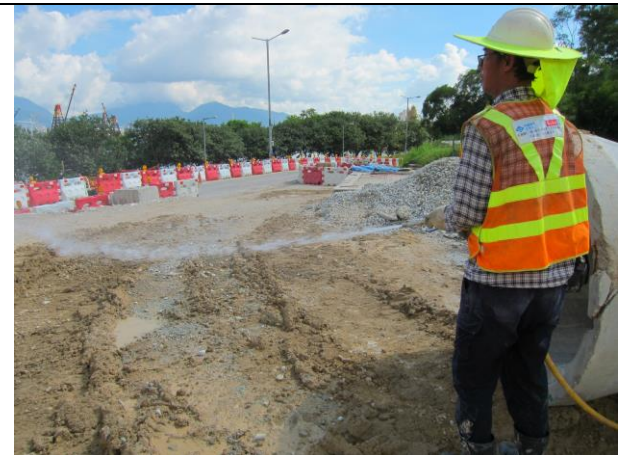
Photo 12 Water spraying for exposed area at Portion H.

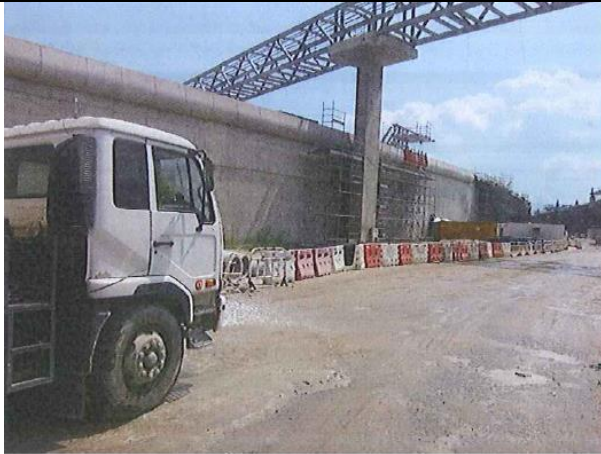
Photo 1 Watering of haul road by water truck to keep road surface wet

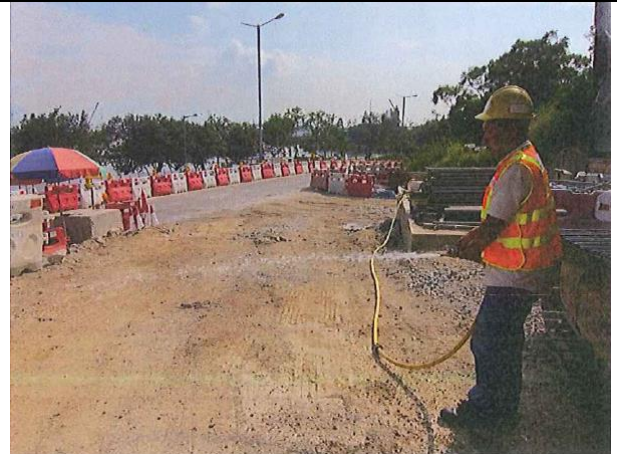
Photo 2 Water spraying by worker for un-accessible area.

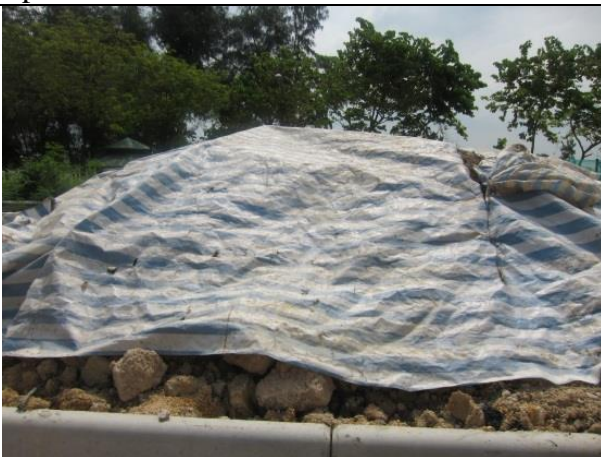
Photo 3 Covered part of the exposed slopes and stockpile by tarpaulin sheet.

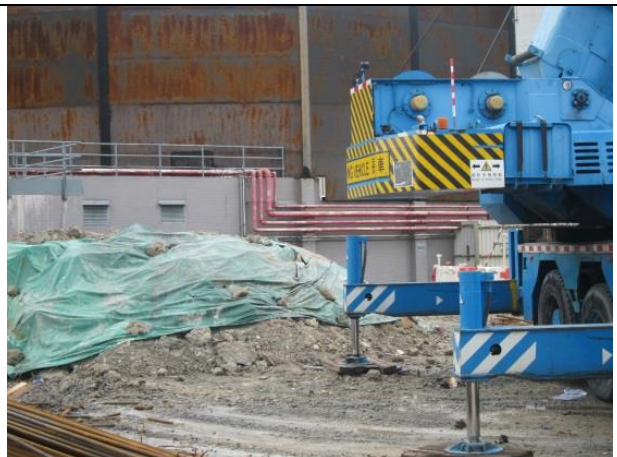
Photo 4 Covered part of stockpile by tarpaulin sheet at Portion F.

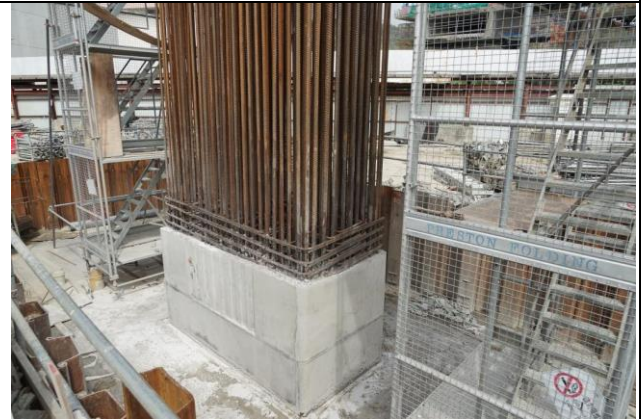
Photo 10 Consecution of column at Portion F on 18 September 2017.

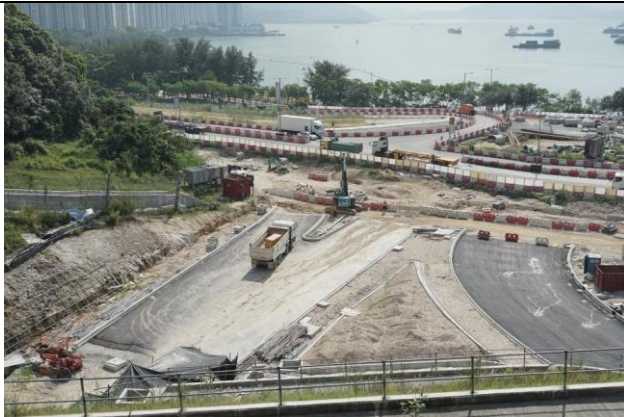
Photo 11 Road and drainage works at Portion H.

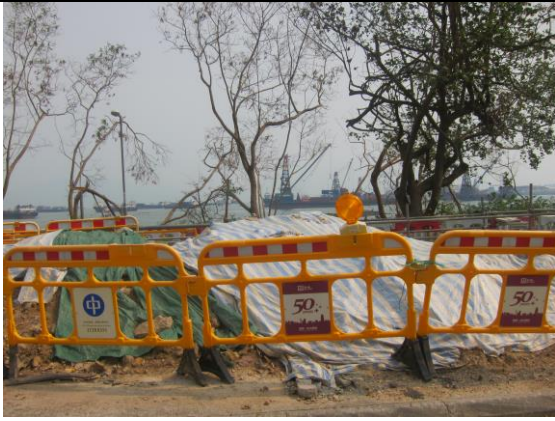
Photo 13 Stockpile at Portion H was covered with tarpaulin.

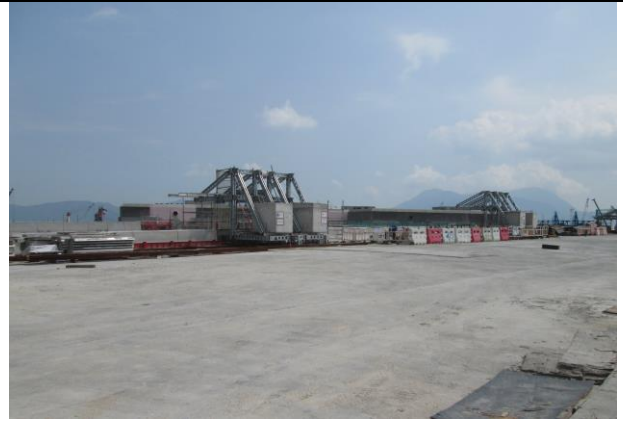
Photo 14 Housekeeping works at TD2 and most of the works area was hard paved.

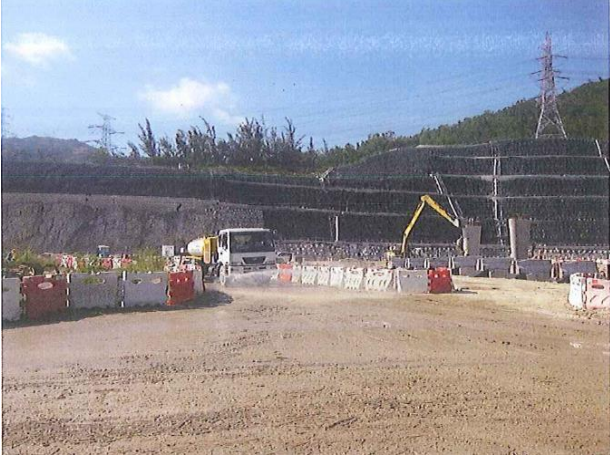
Photo 1 Watering of haul road by water truck to keep road surface wet

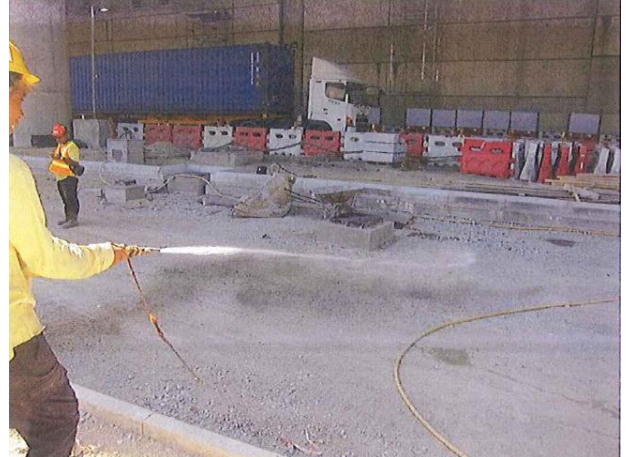
Photo 2 Water spraying by worker for un-accessible area.

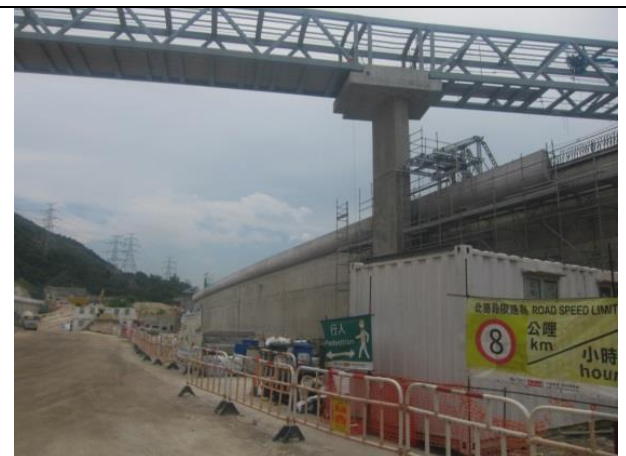
Photo 6 Set speed control at ~8km/hr for all vehicles using the haul road

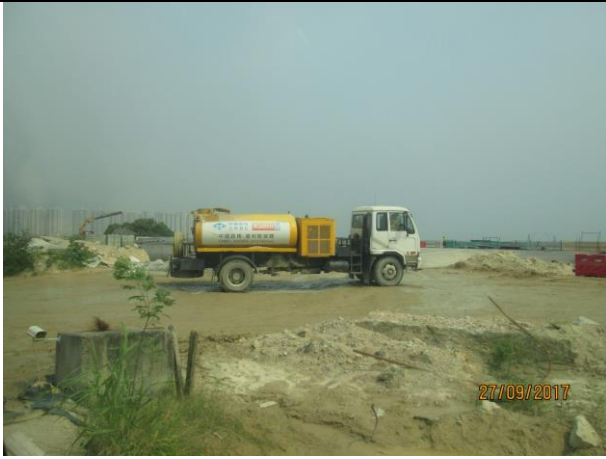
Photo 7 Watering of haul road by water truck to keep road surface wet was observed during the site inspection on 27 September 2017

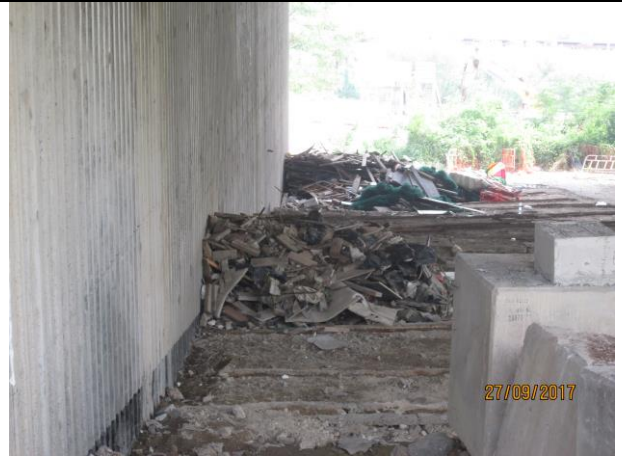
Photo 8 Housekeeping works at TD2 on 27 September 2017

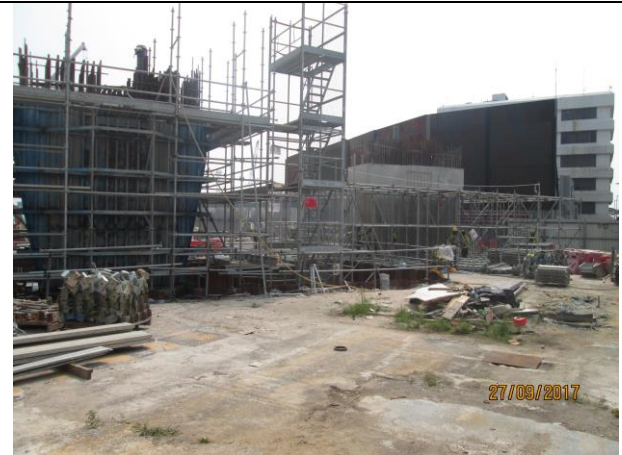
Photo 10 Consecution of column at Portion F on 27 September 2017.

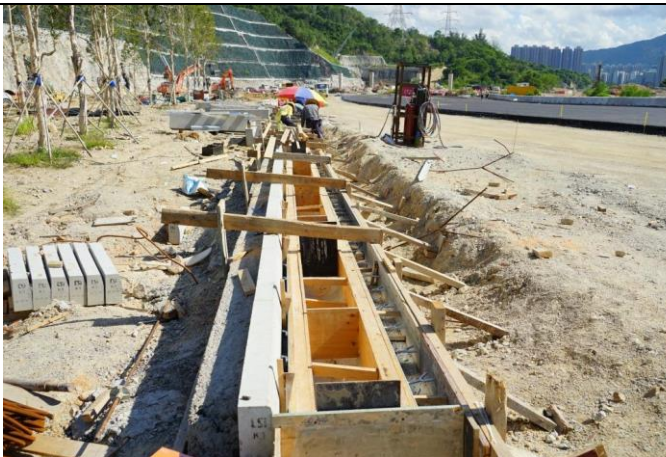
Photo 11 Drainage works at Platform 19.

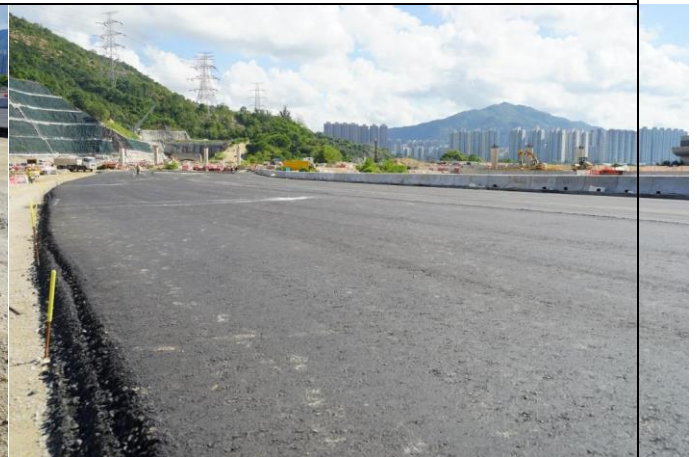
Photo 12 Road pavements works at Platform 19.

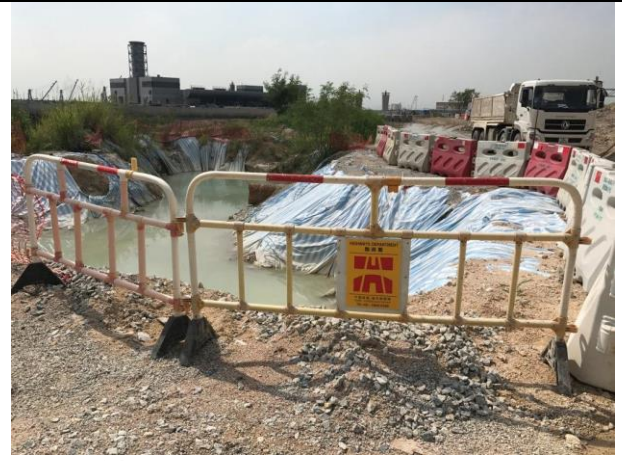
Photo 14 Exposed slope was covered with tarpaulin near TD2.

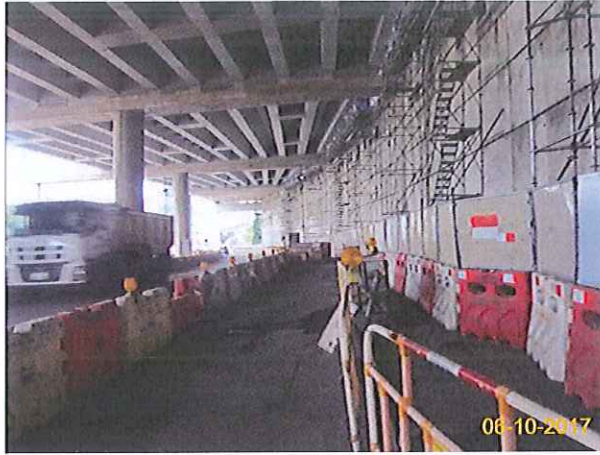
Item 5. Hoarding with panel around works area & Item 6. Temporary traffic management lighting.

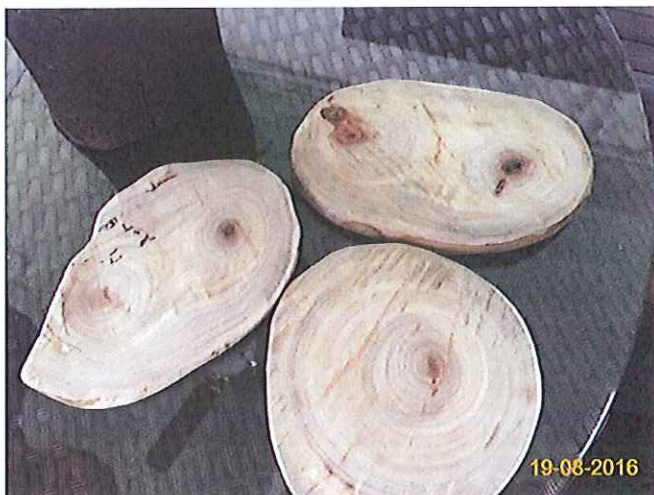
Item 9. Recycle of felled trees as facilities to reuse.

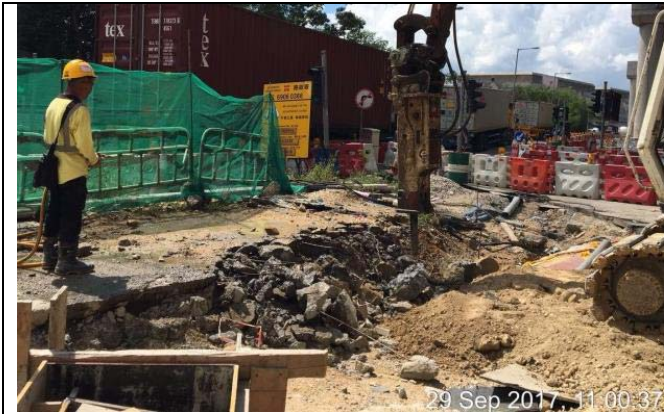
Photo 1
Water spraying for trim formation works on 29 September 2017.

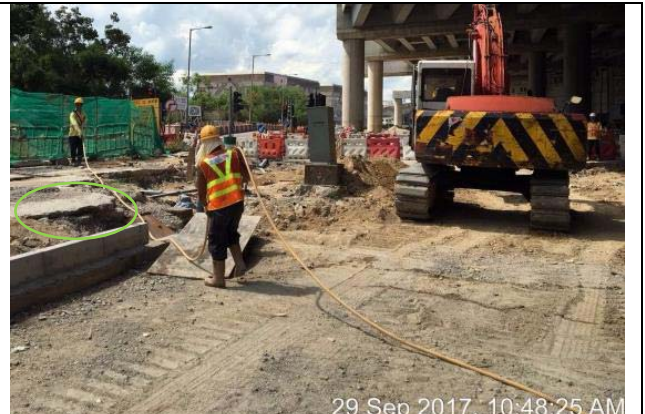
Photo 2
Water spraying for trim formation works on 29 September 2017.

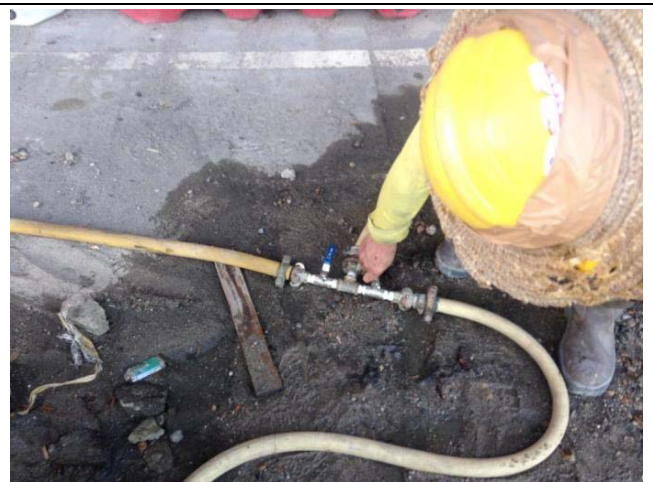
Photo 4
Installation of additional water jet at Lung Mun Road Central Divider.

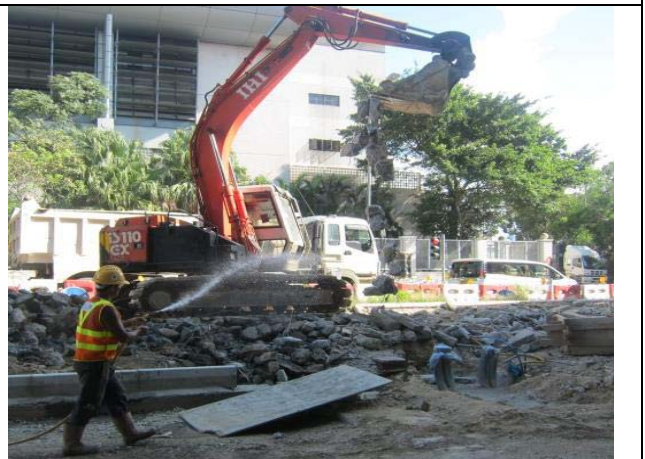
Photo 6
Provide additional water jet for trim formation works.

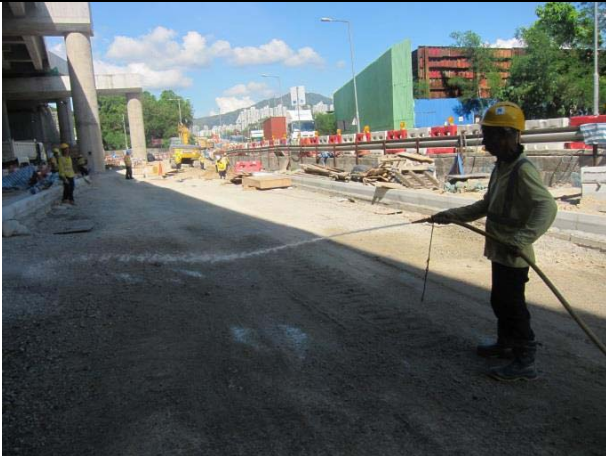
Photo 7
Water spraying at nearby exposed area to reduce dust suppression.

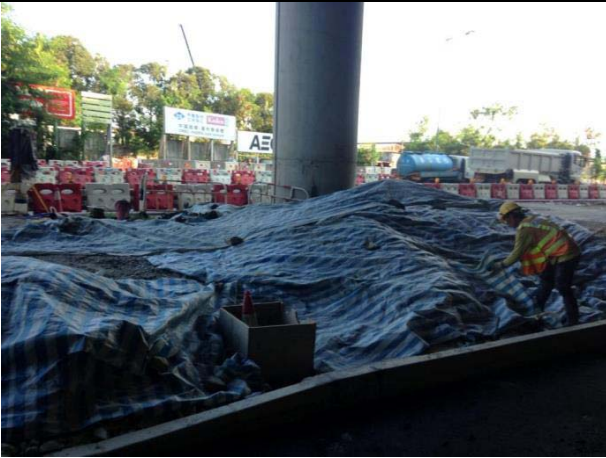
Photo 9
Stockpile was covered with tarpaulin to reduce dust suppression.

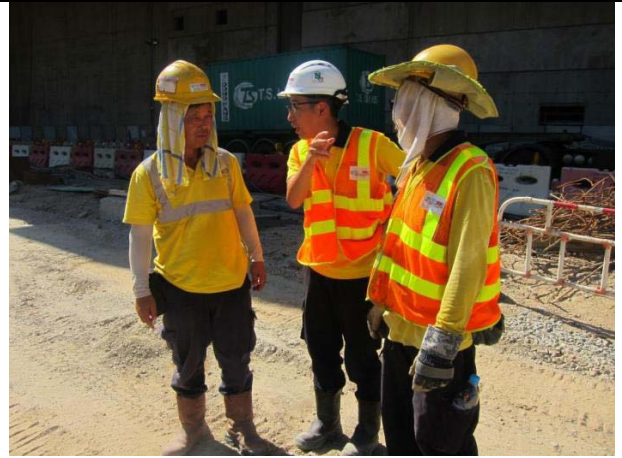
Photo 10
Additional training for dust control was provided to the workers.

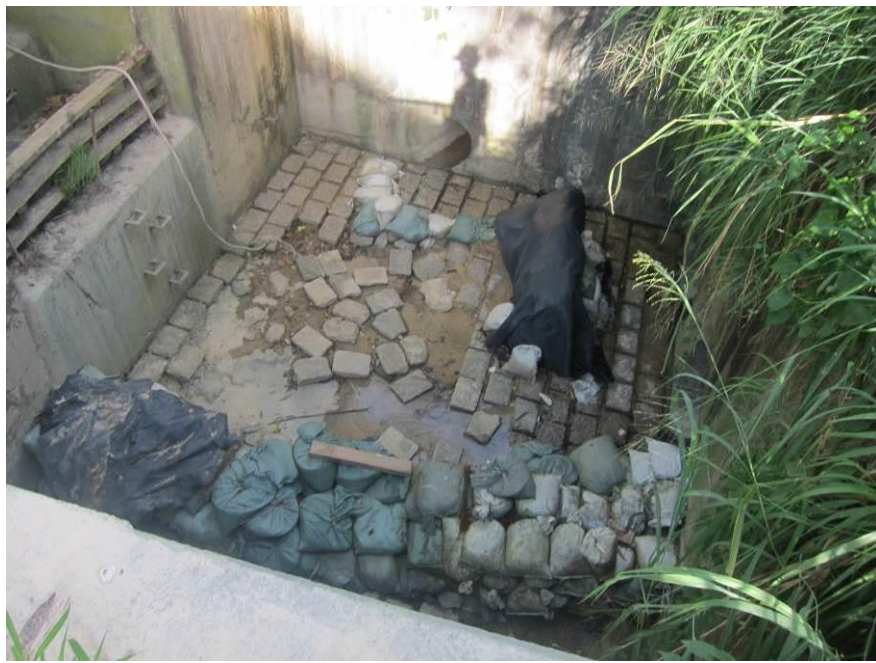
Stream B Outfall: No water is discharging.

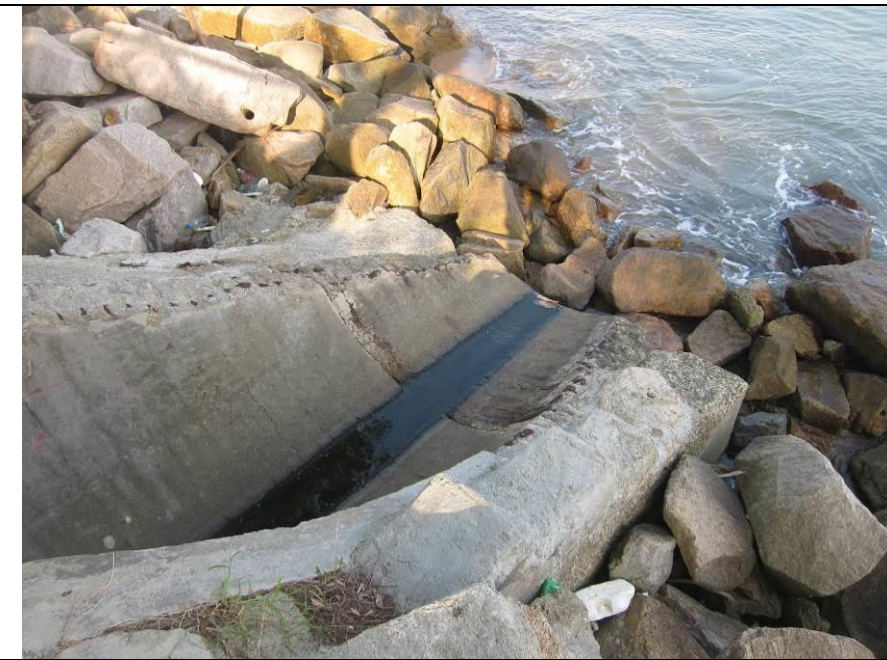
Outfall 1: Clean water is discharging.

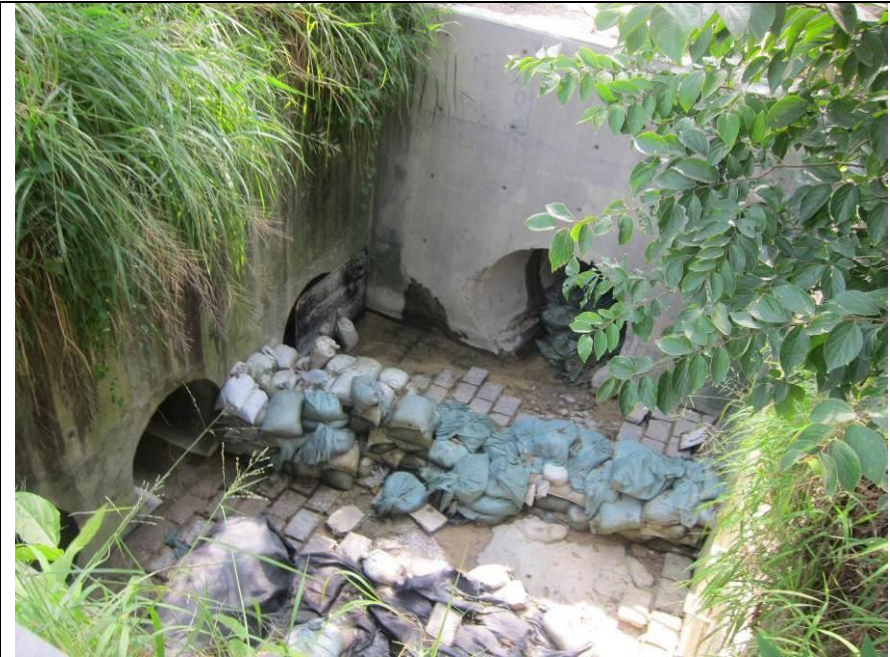
Stream B Outfall: No water is discharging.

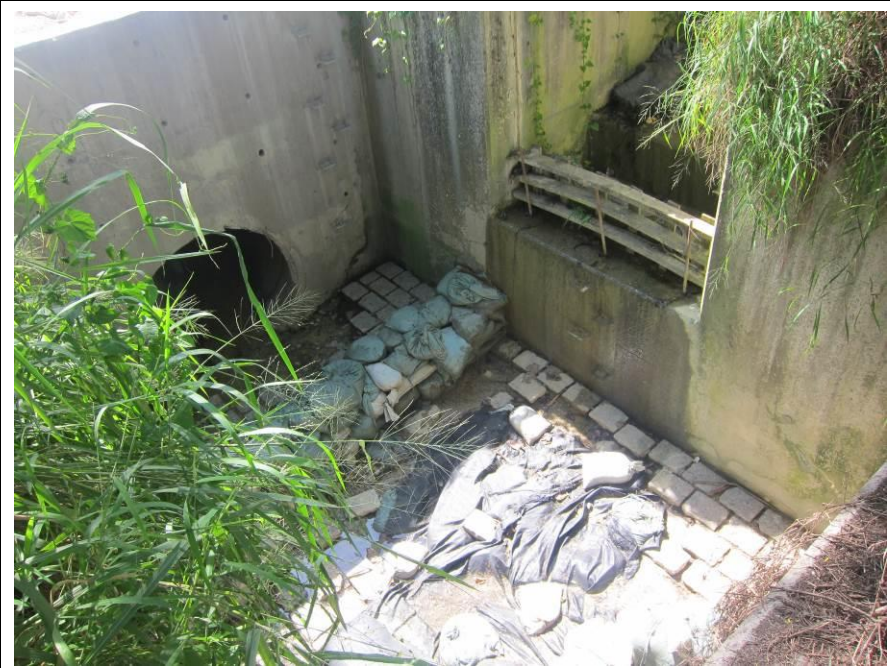
Stream B Outfall: No water is discharging.

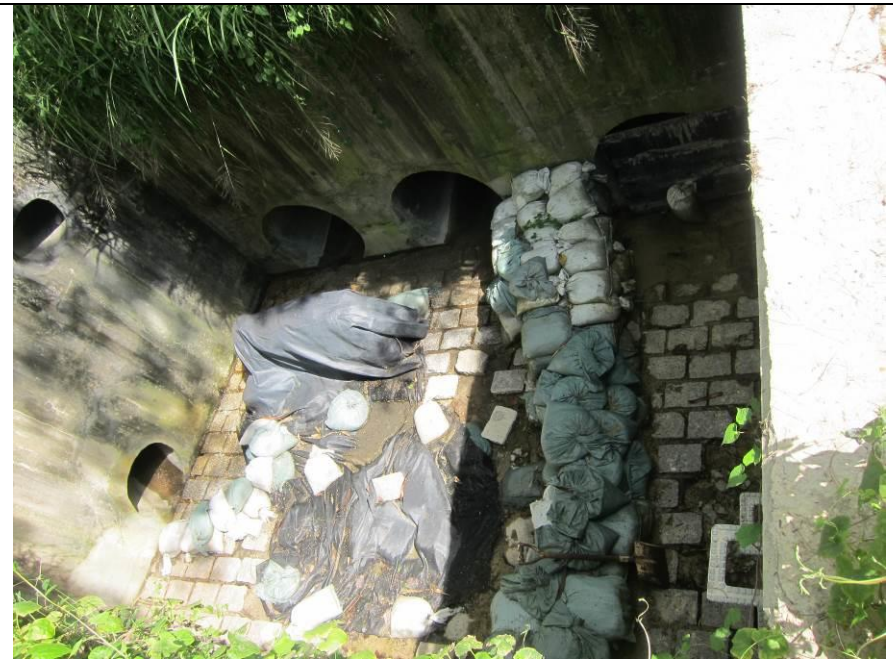
Stream B Outfall: No water is discharging.

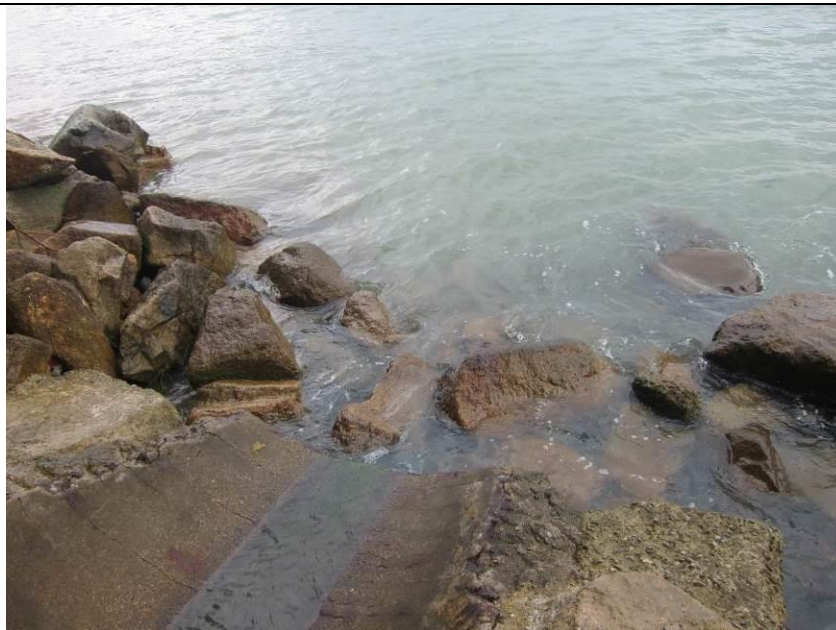
Outfall 1: Clean water is discharging.

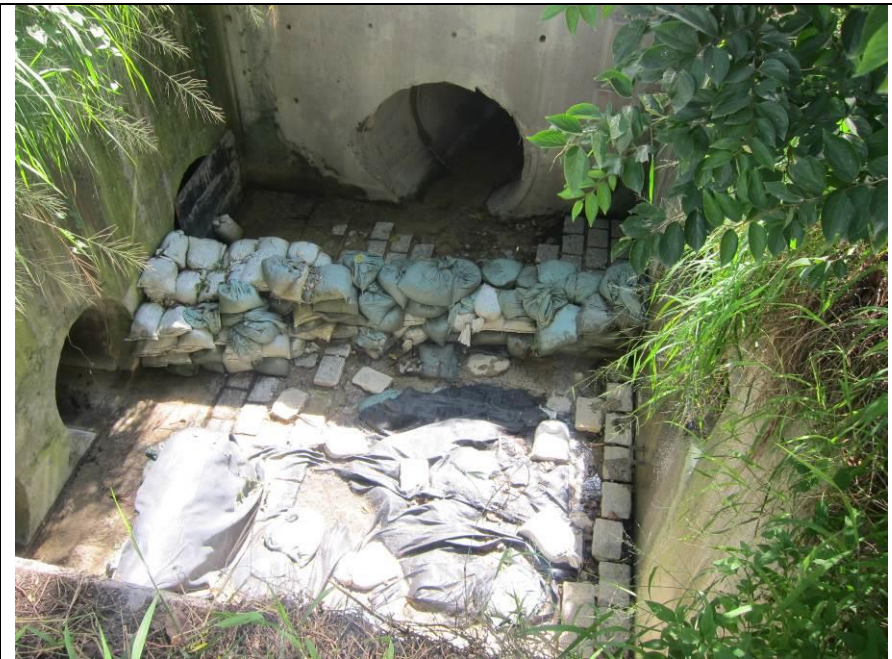
Stream B Outfall: No water is discharging.

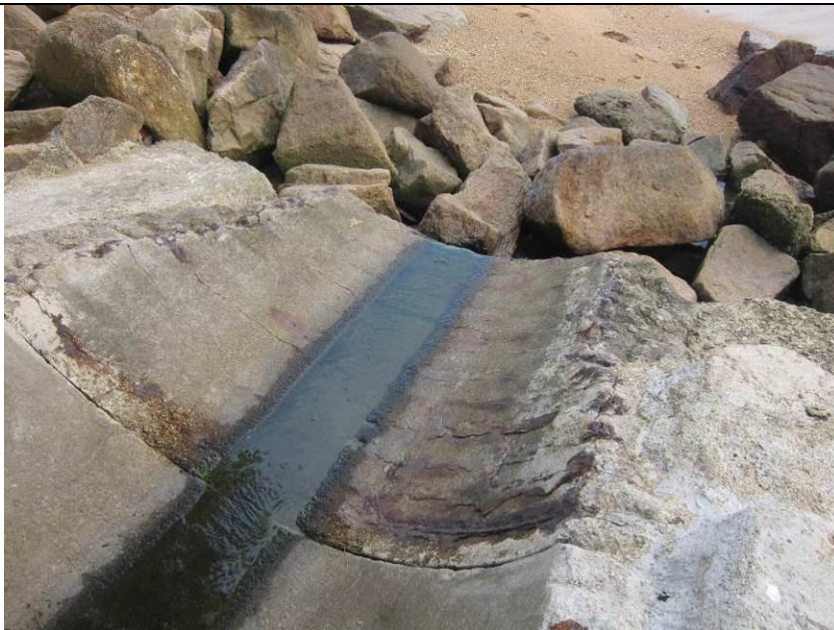
Outfall 1: Clean water is discharging.

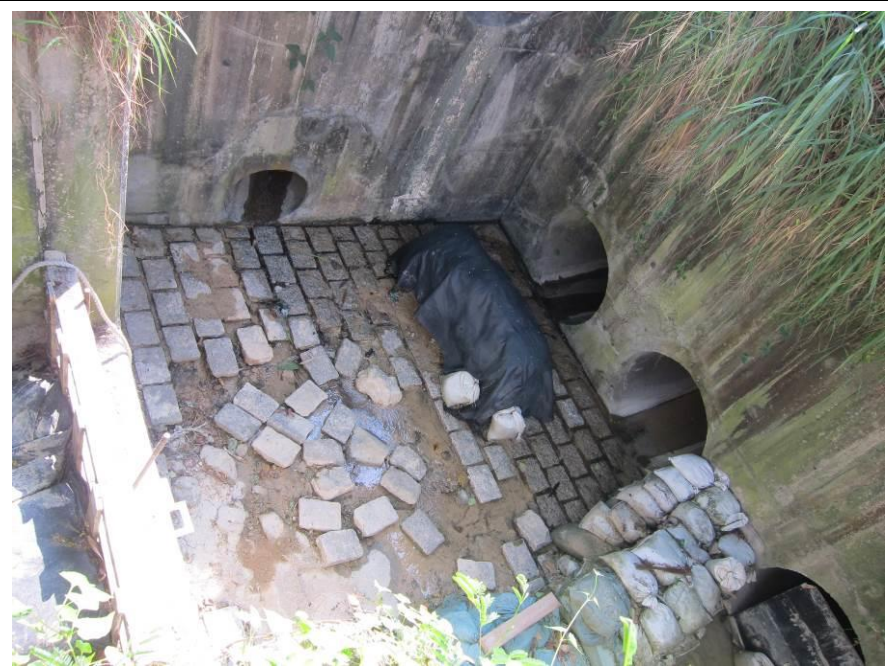
Stream B Outfall: No water is discharging.

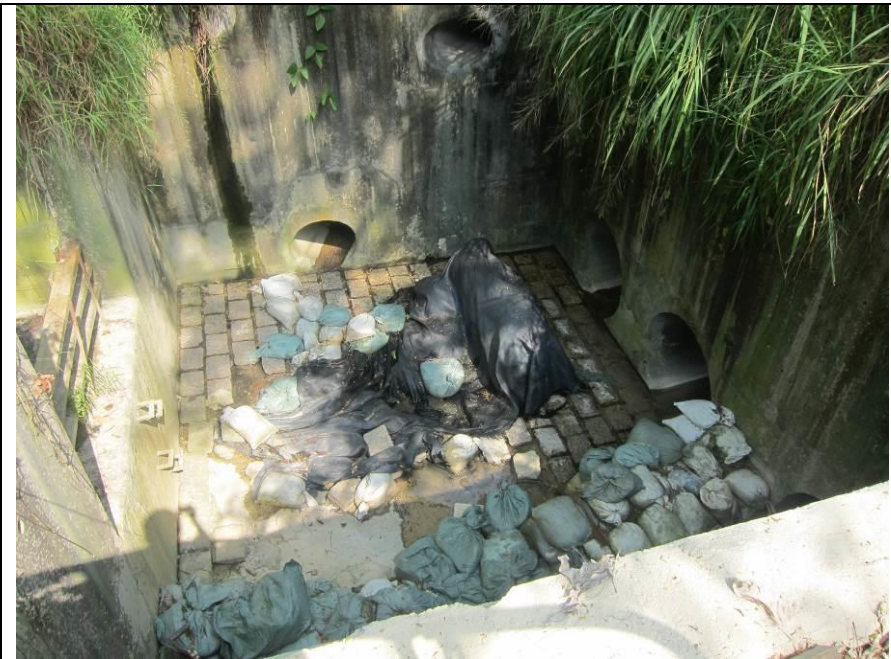
Stream B Outfall: No water is discharging.

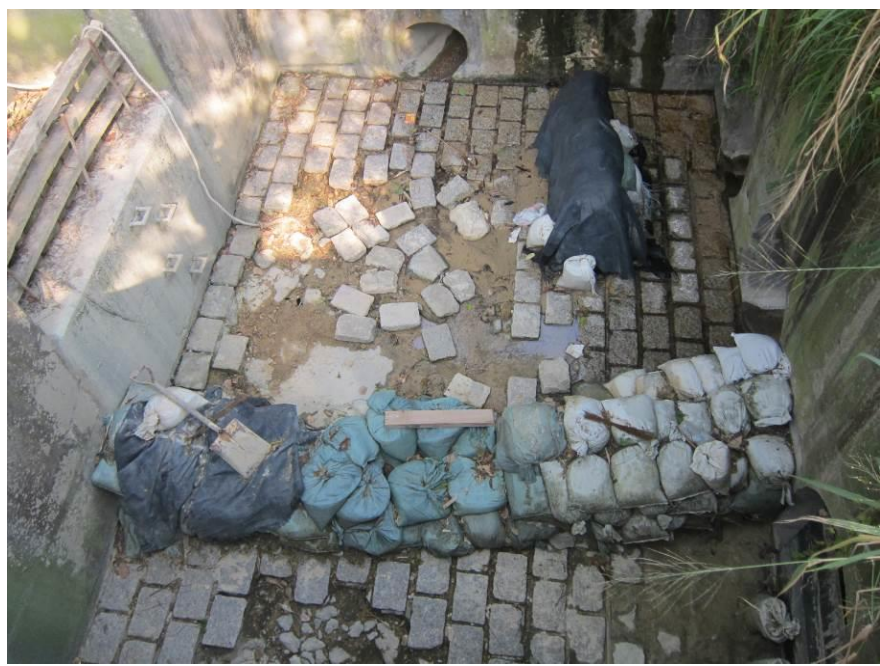
Stream B Outfall: No water is discharging.
