Annex M1 – Summary of Key Findings and Recommendations during the Monthly Site Audits

Site Memorandum No. 986

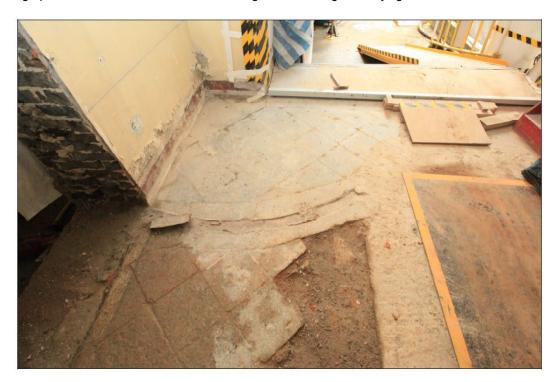
The granite flagstone in Block 10 Passageway was instructed to be labelled, carefully removed and reinstated following the installation of underground services. We have observed that the granite flagstones laid have not been installed to follow the original pattern. For example; The track on the granite flagstone near the east entrance for a former gate has not been reinstated. The solid border at the west archway has not been reinstated. The joint size is incorrect.

Photograph taken on 8th November 2016, showing the incorrect granite laying

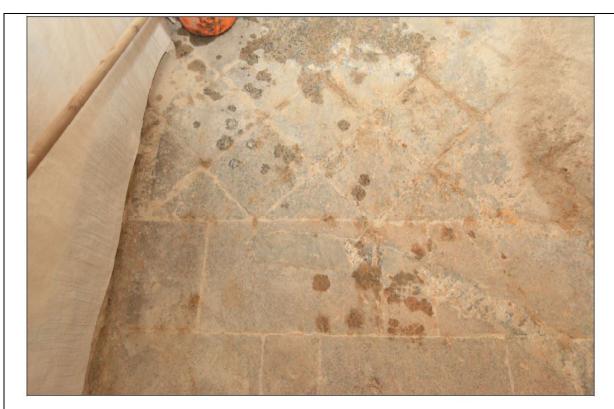
Photograph taken on 22^{nd} August 2013 by the Management Contractor, showing the track on the granite flagstone at the East entrance.

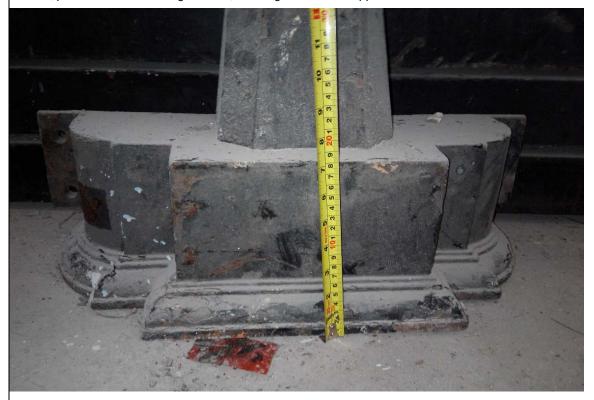
Above, photo taken on 22nd January 2015, showing the hopper being salaved from the building.
