## **Appendix F**

### **Details of Cultural Heritage Impact Assessment**

#### **(Built Heritage Catalogue)**

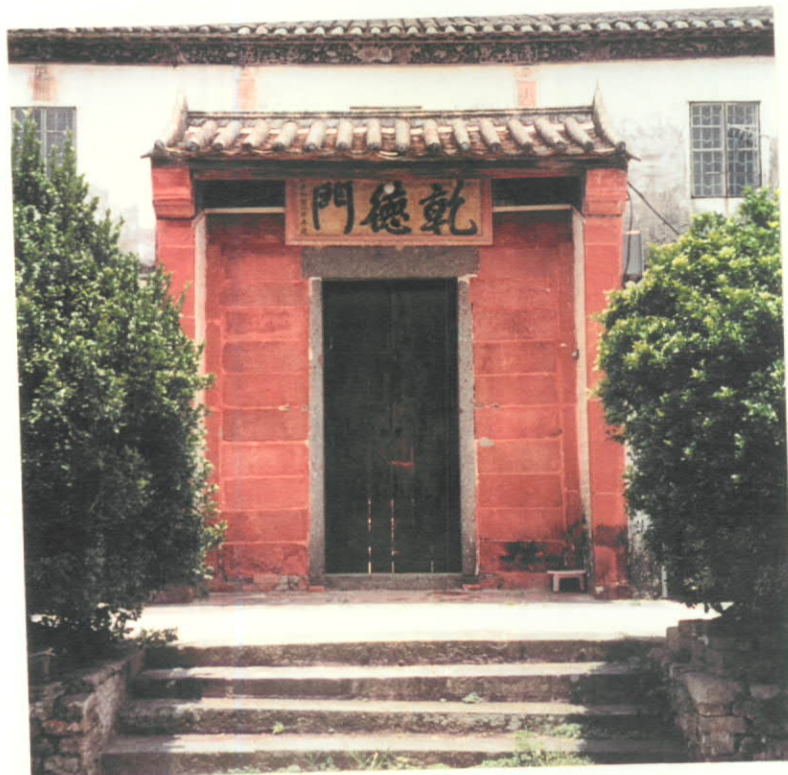
A damaged area near to one of the façade doors was said to have been caused by Japanese bullets during the Second World War.

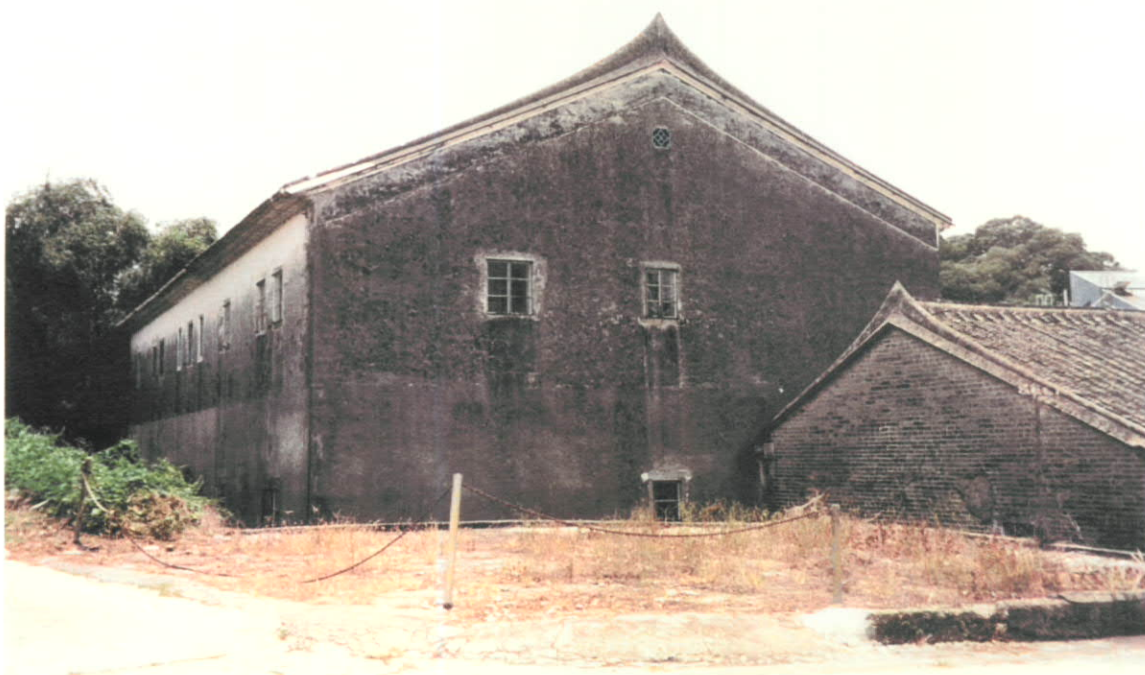
Rear and northeast elevation of AAHB-830

The land behind the compound is on a hill slope, the hill has been cut and there is a retaining wall (about 1 metre in height at the rear).

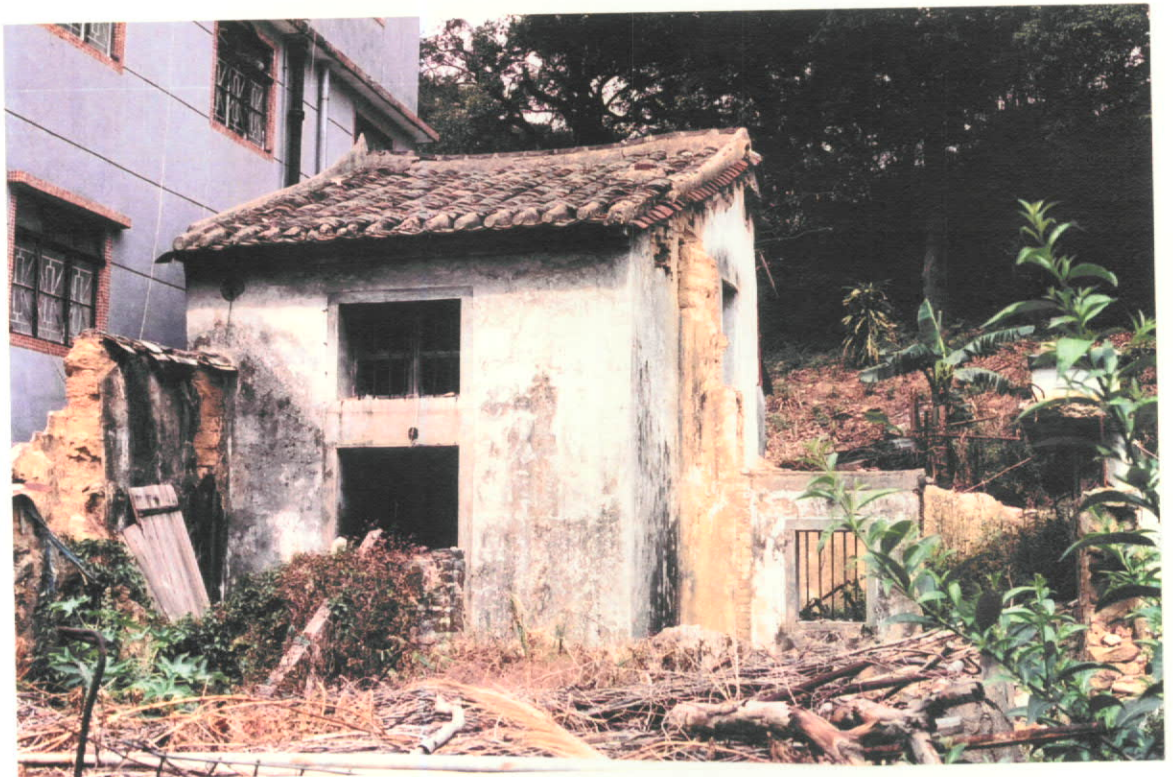
Front elevation of AAHB-851

<b>Building Type:</b> Row	<b>Architectural Style:</b> Traditional Chinese
<b>Layout:</b> single hall/ no courtyard	<b>Modifications:</b> Unmodified
<b>Original # of Stories:</b> Single extended hall with cockloft, no courtyards	<b>Current # of Stories:</b> Single extended hall with cockloft, no courtyards
<b>Original # of Units:</b> Indeterminate	<b>Current # of Units:</b> Only one is intact
<b>Roof:</b> Sloped towards the front (rear section very small). Hakka style tile with plain ridge, loose tiles, ridge is cracked and slumping. Tiles project slightly over the façade and there is a support beam under the tiles. No other roof remains present.	
<b>Façade:</b> Standing structure: render covered, Rectangular opening, no door. Large square window above the door.	
<b>Side Walls:</b> Both side walls are render covered. The buildings that were attached to the standing structure have collapsed or been demolished and only sections of pounded earth and mud brick sections remain.

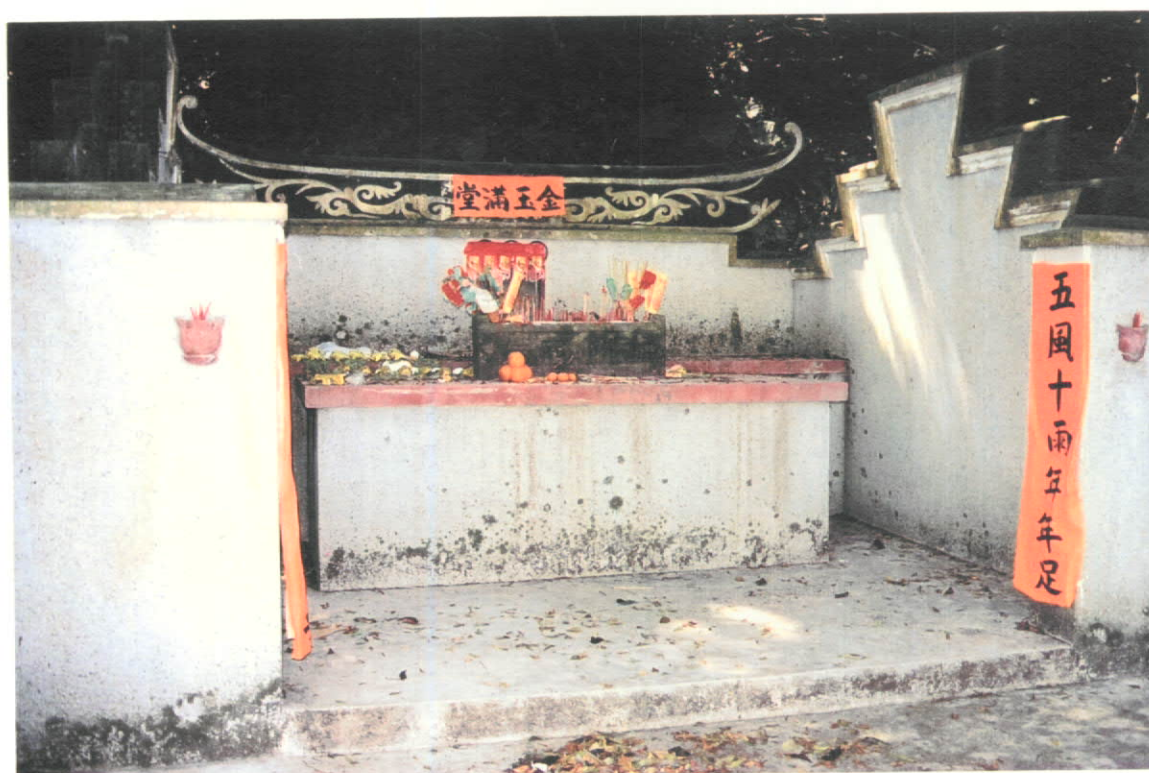
<b>Inscriptions:</b> 護鄉感應社稷XX大王神位 本村土地福德神之神位		
<b>Additional Notes:</b> All of the structural features are reconstructions.

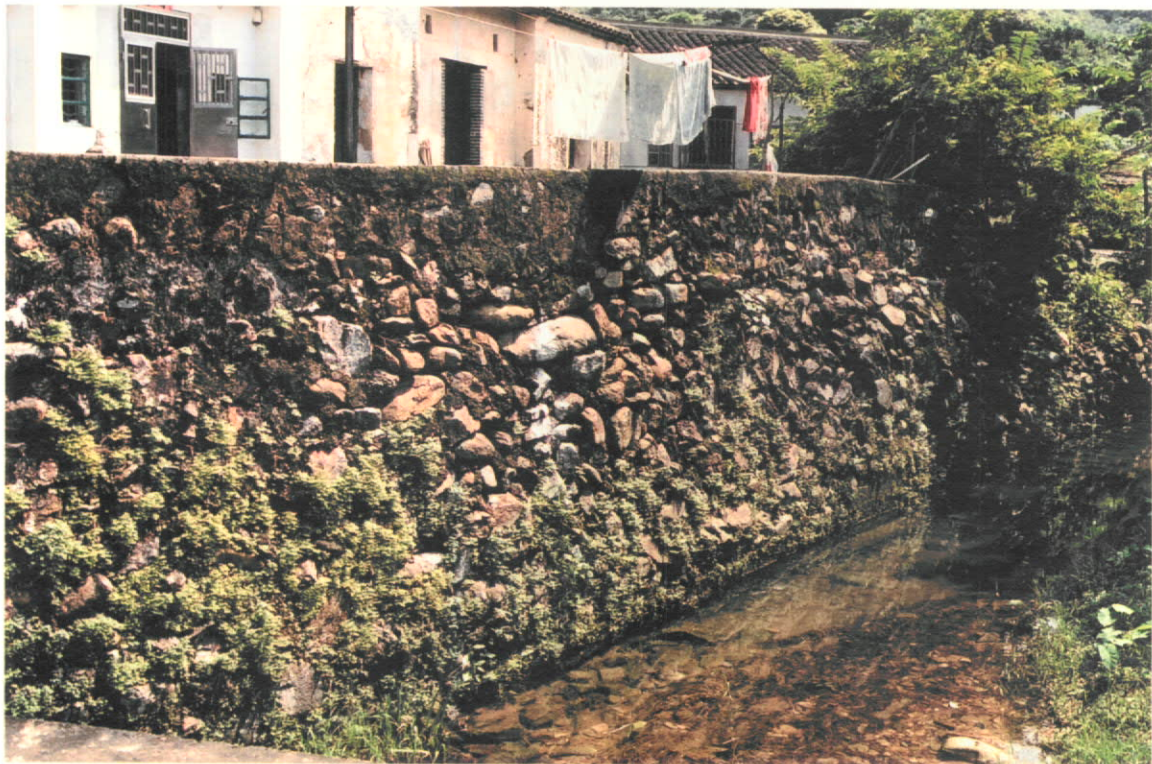
View of the stone wall in front of AAHB-855

There is a flat open area in front of the units. This courtyard is fronted by a rubble stone wall that continues down to the bank of the stream. The wall has been topped in concrete.

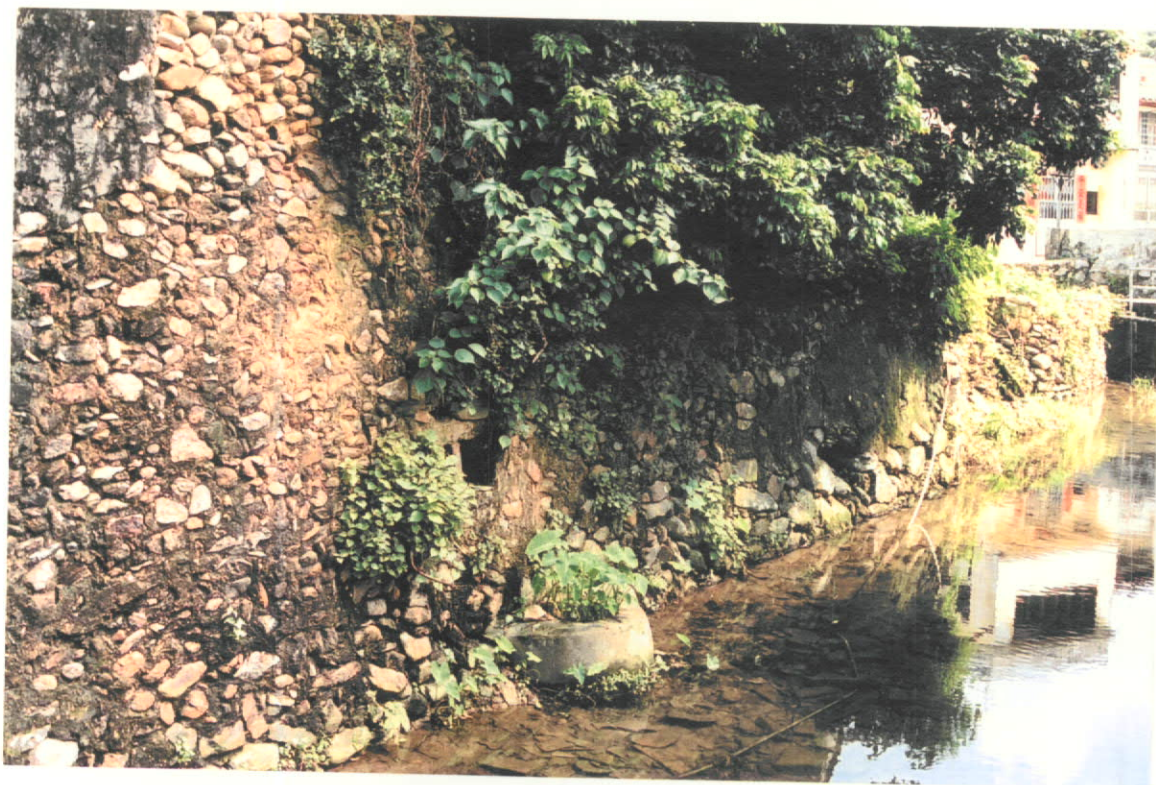
<b>Project:</b> NNT-C	<b>Location:</b> Lin Ma Hang	<b>Ref #</b> AAHB - 856 (Feature)
<b>Originally Recorded:</b> 06.09.04	<b>Updated On:</b> N/A	
<b>Original Usage:</b> Residential	<b>Current Usage:</b> Abandoned	
<b>Orientation:</b> South	<b>Map Reference:</b> N/A	
<b>Construction Date:</b> Unknown	<b>Ownership:</b> Private	
<b>Setting:</b> Along the edge of the river.	<b>Historical Associations:</b> None	
<b>Condition:</b> Ruin	<b>Degree of Modification:</b> Unmodified	
<b>Architectural Significance:</b> Medium	<b>Cultural Significance:</b> Low	
<b>Description:</b> The plot of land is located directly at the side of a stream. The bank of the stream has been built up with a rubble stone wall. There is an opening in the wall about 1 metre above the streambed. The rest of the structure has collapsed or been demolished. The ruin is overgrown with vegetation and there is a large tree growing near the stream side wall.

<b>Inscriptions:</b> None		
<b>Additional Notes:</b> the construction of the wall directly on the stream bank is not common in Hong Kong.

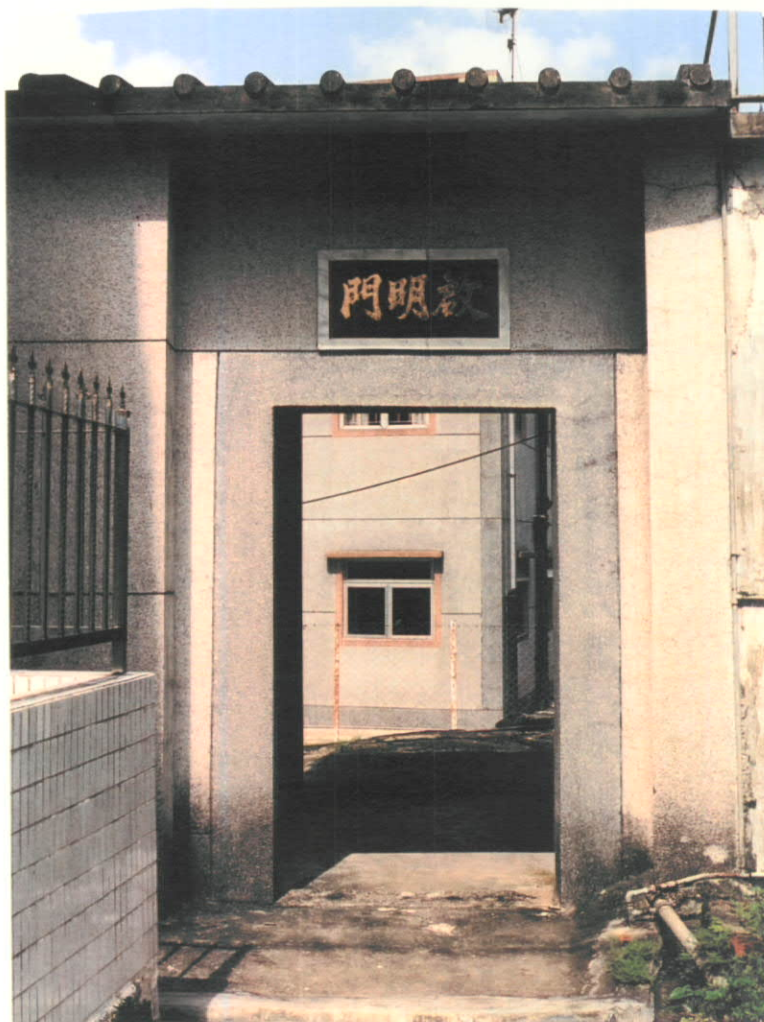
<b>Additional Notes:</b> Date of historical plaque which has been set into wall of modern gate structure: 光緒二十年

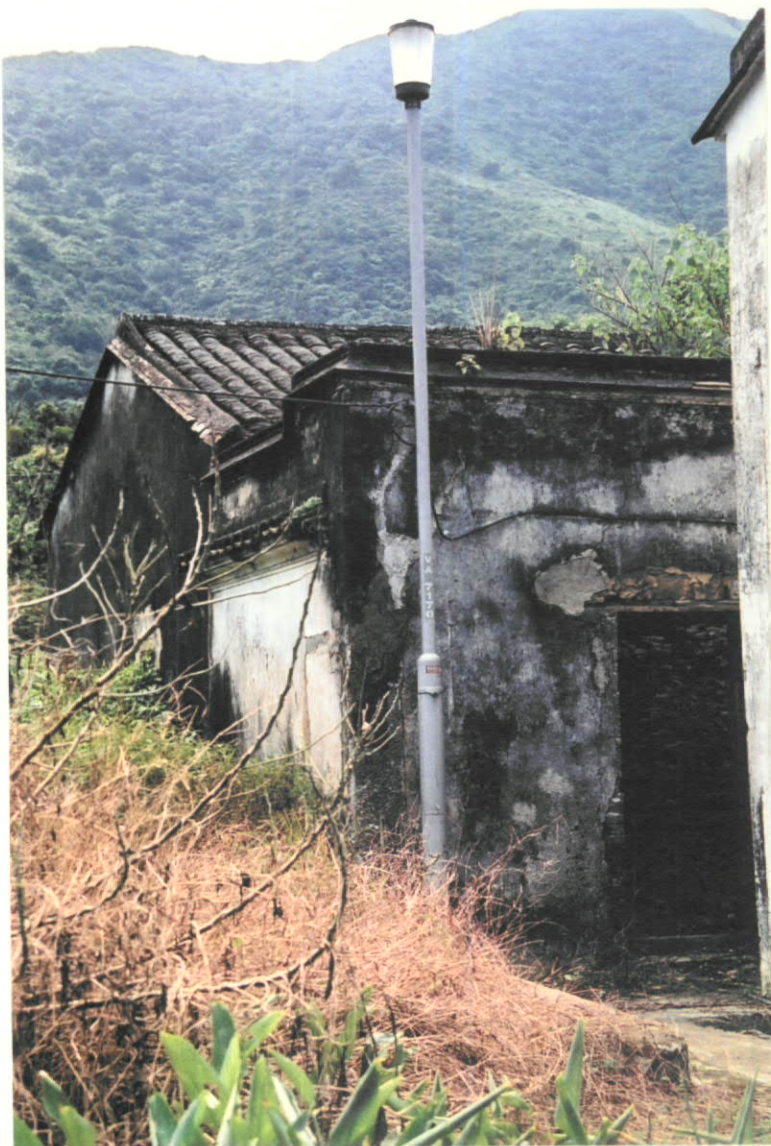
View of structures at northwestern end of the row (AAHB-875)

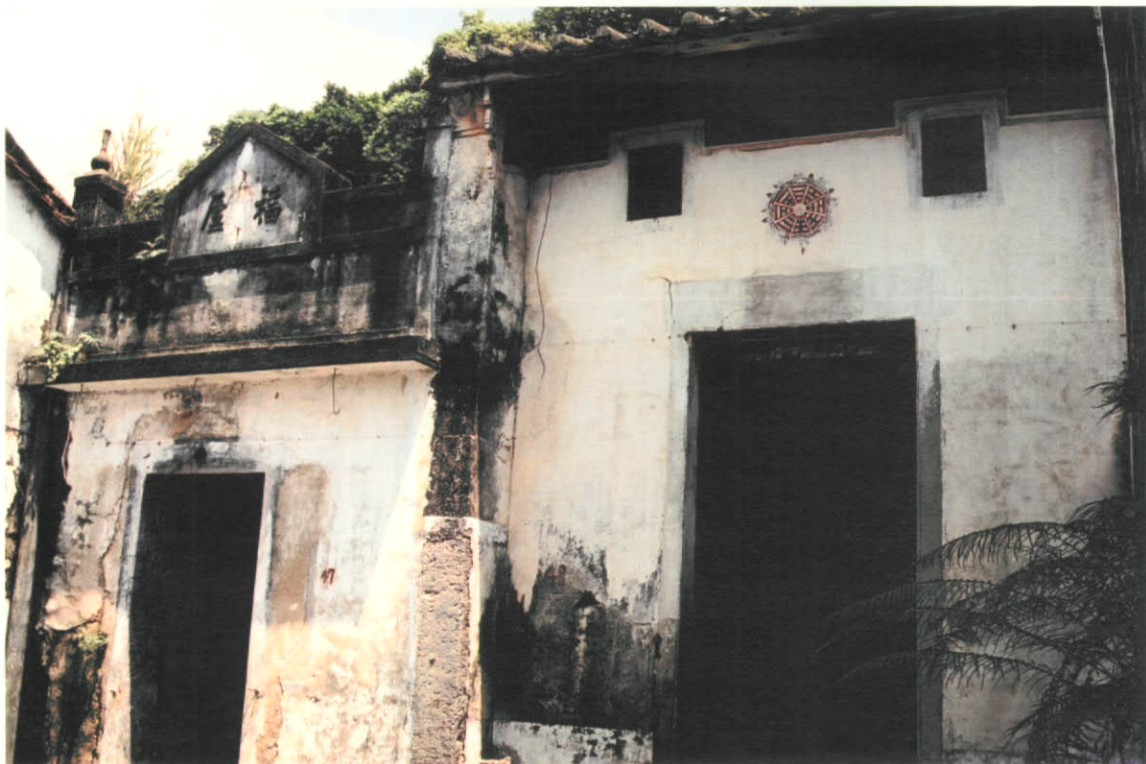
Front elevation of structures in central section of the row (AAHB-877)

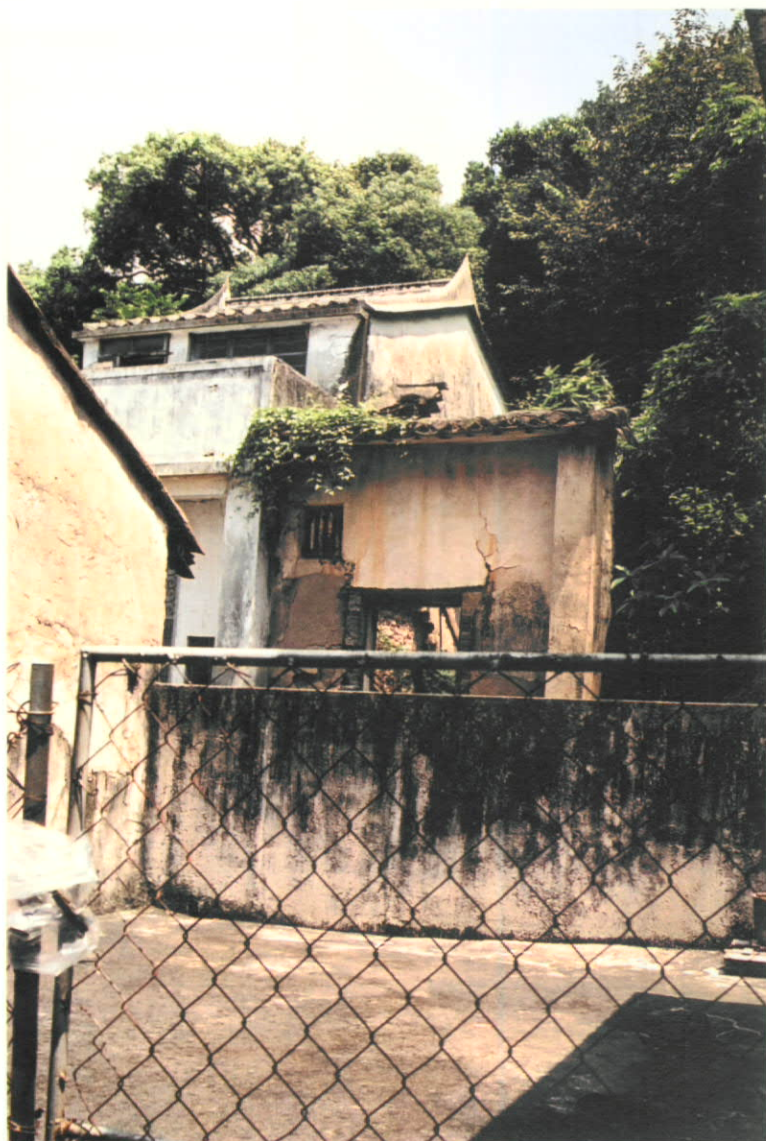
View of structures at eastern end of row (AAHB-877)

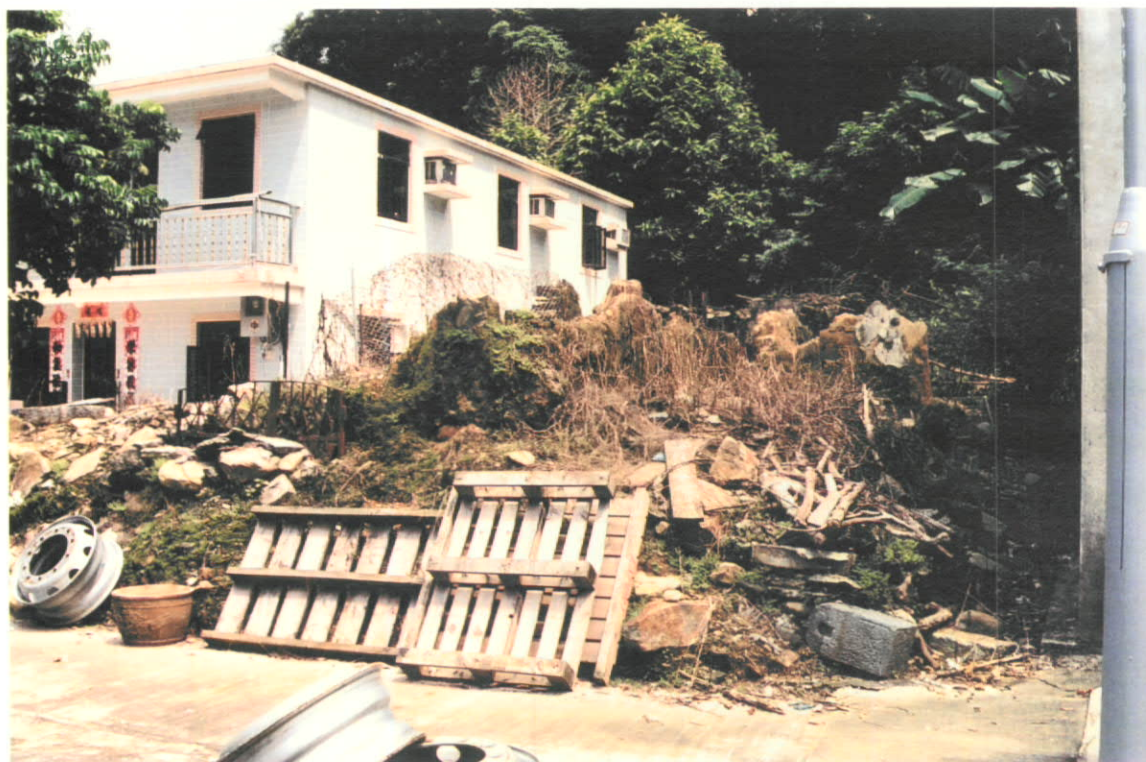
<b>Project:</b> NNT-C	<b>Location:</b> Lin Ma Hang	<b>Ref #</b> AAHB - 878 (Feature)
<b>Originally Recorded:</b> 06.09.04	<b>Updated On:</b> N/A	
<b>Original Usage:</b> Residential	<b>Current Usage:</b> Abandoned	
<b>Orientation:</b> N/A	<b>Map Reference:</b> N/A	
<b>Construction Date:</b> Unknown	<b>Ownership:</b> Private	
<b>Setting:</b> At the rear of the village at the base of the hill slope	<b>Historical Associations:</b> None	
<b>Condition:</b> Ruin	<b>Degree of Modification:</b> Unmodified	
<b>Architectural Significance:</b> Low	<b>Cultural Significance:</b> Low	
<b>Description:</b> Some sections of pounded earth walls, heavily overgrown, some render covering in places. The site has rubbish dumped on it and is overgrown with vegetation.		
<b>Inscriptions:</b> None		
<b>Additional Notes:</b> None

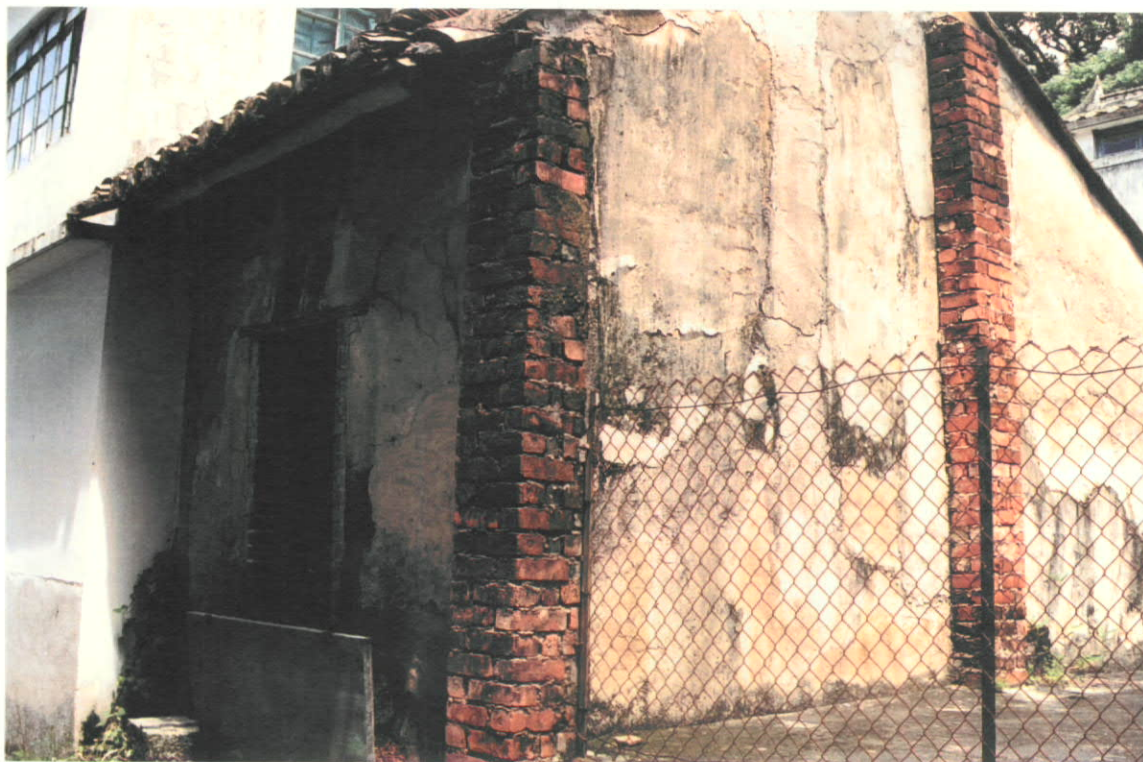
<b>Building Type:</b> Row	<b>Architectural Style:</b> Traditional Chinese
<b>Layout:</b> Single hall	<b>Modifications:</b> Concrete patching, red brick buttresses.
<b>Original # of Stories:</b> One	<b>Current # of Stories:</b> One
<b>Original # of Units:</b> One	<b>Current # of Units:</b> One
<b>Roof(s):</b> Pitched roof with the rear half being longer than the front. Hakka style tile, projects over the façade and rear walls (shaped chunam stops) and is supported by round wooden beams.	
<b>Façade:</b> Render covered with green brick door frame. There is a red brick pier at the eastern end.	
<b>Side Walls:</b> Render with concrete patching and a red brick buttress.	
<b>Rear Wall:</b> Render covered.	
<b>Inscriptions:</b> None	
<b>Additional Notes</b>	
None

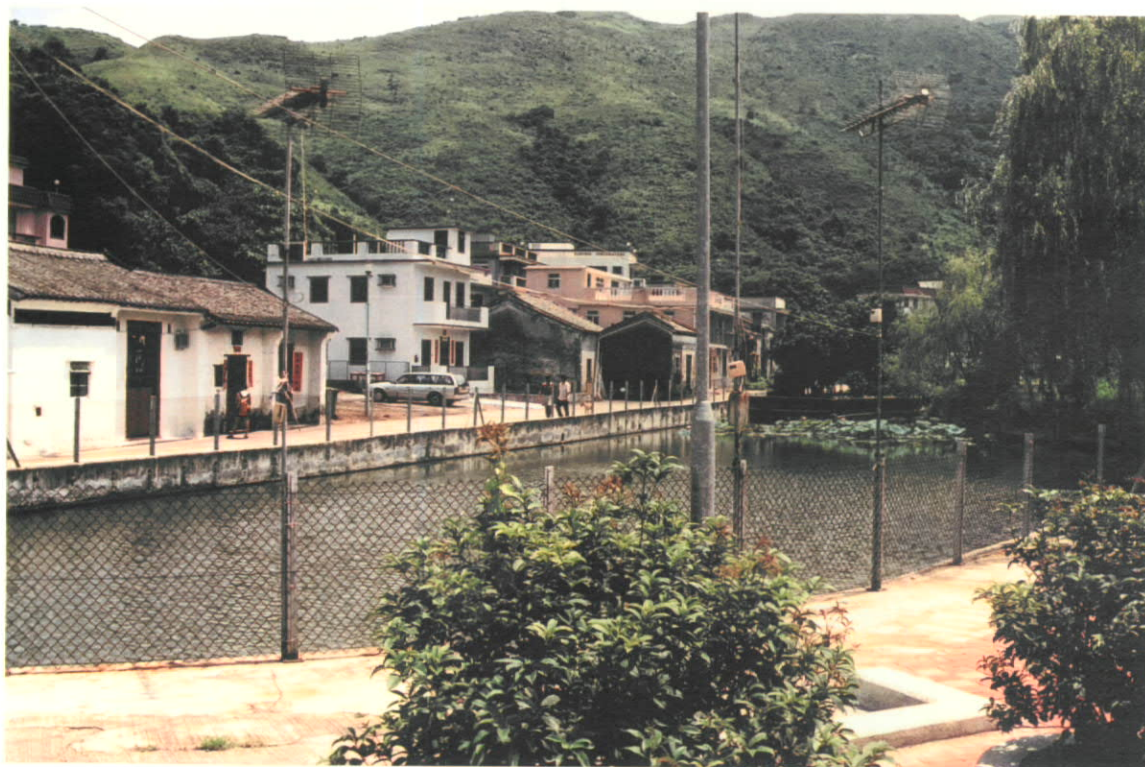
<b>Project:</b> NNT-C	<b>Location:</b> Lin Ma Hang	<b>Ref #</b> AAHB - 880 (Feature)
<b>Originally Recorded:</b> 06.09.04	<b>Updated On:</b> N/A	
<b>Original Usage:</b> Pond	<b>Current Usage:</b> Pond	
<b>Orientation:</b> N/A	<b>Map Reference:</b> N/A	
<b>Construction Date:</b> N/A	<b>Ownership:</b> Private	
<b>Setting:</b> At the front of the village.	<b>Historical Associations:</b> Associated with the village.	
<b>Condition:</b> Excellent.	<b>Degree of Modification:</b> Moderate.	
<b>Architectural Significance:</b> Low	<b>Cultural Significance:</b> High	
<b>Description:</b> A semi-circular shaped pond, concrete lined with wire fence around it. There are some lotus plants in the pond and several geese and ducks.		
<b>Inscriptions:</b> None		
<b>Additional Notes:</b> There is a plain granite stone (rectangular, set into the pond), near the southeastern end.
