Table 1 Response to EPD's Request for Supplementary Information (Ref: EPD's letter dated 9th March 2011)

ANNEX A

Update to EIA Report Section 4.6.4 Trees within the Project Site (Figures 1 and 3)

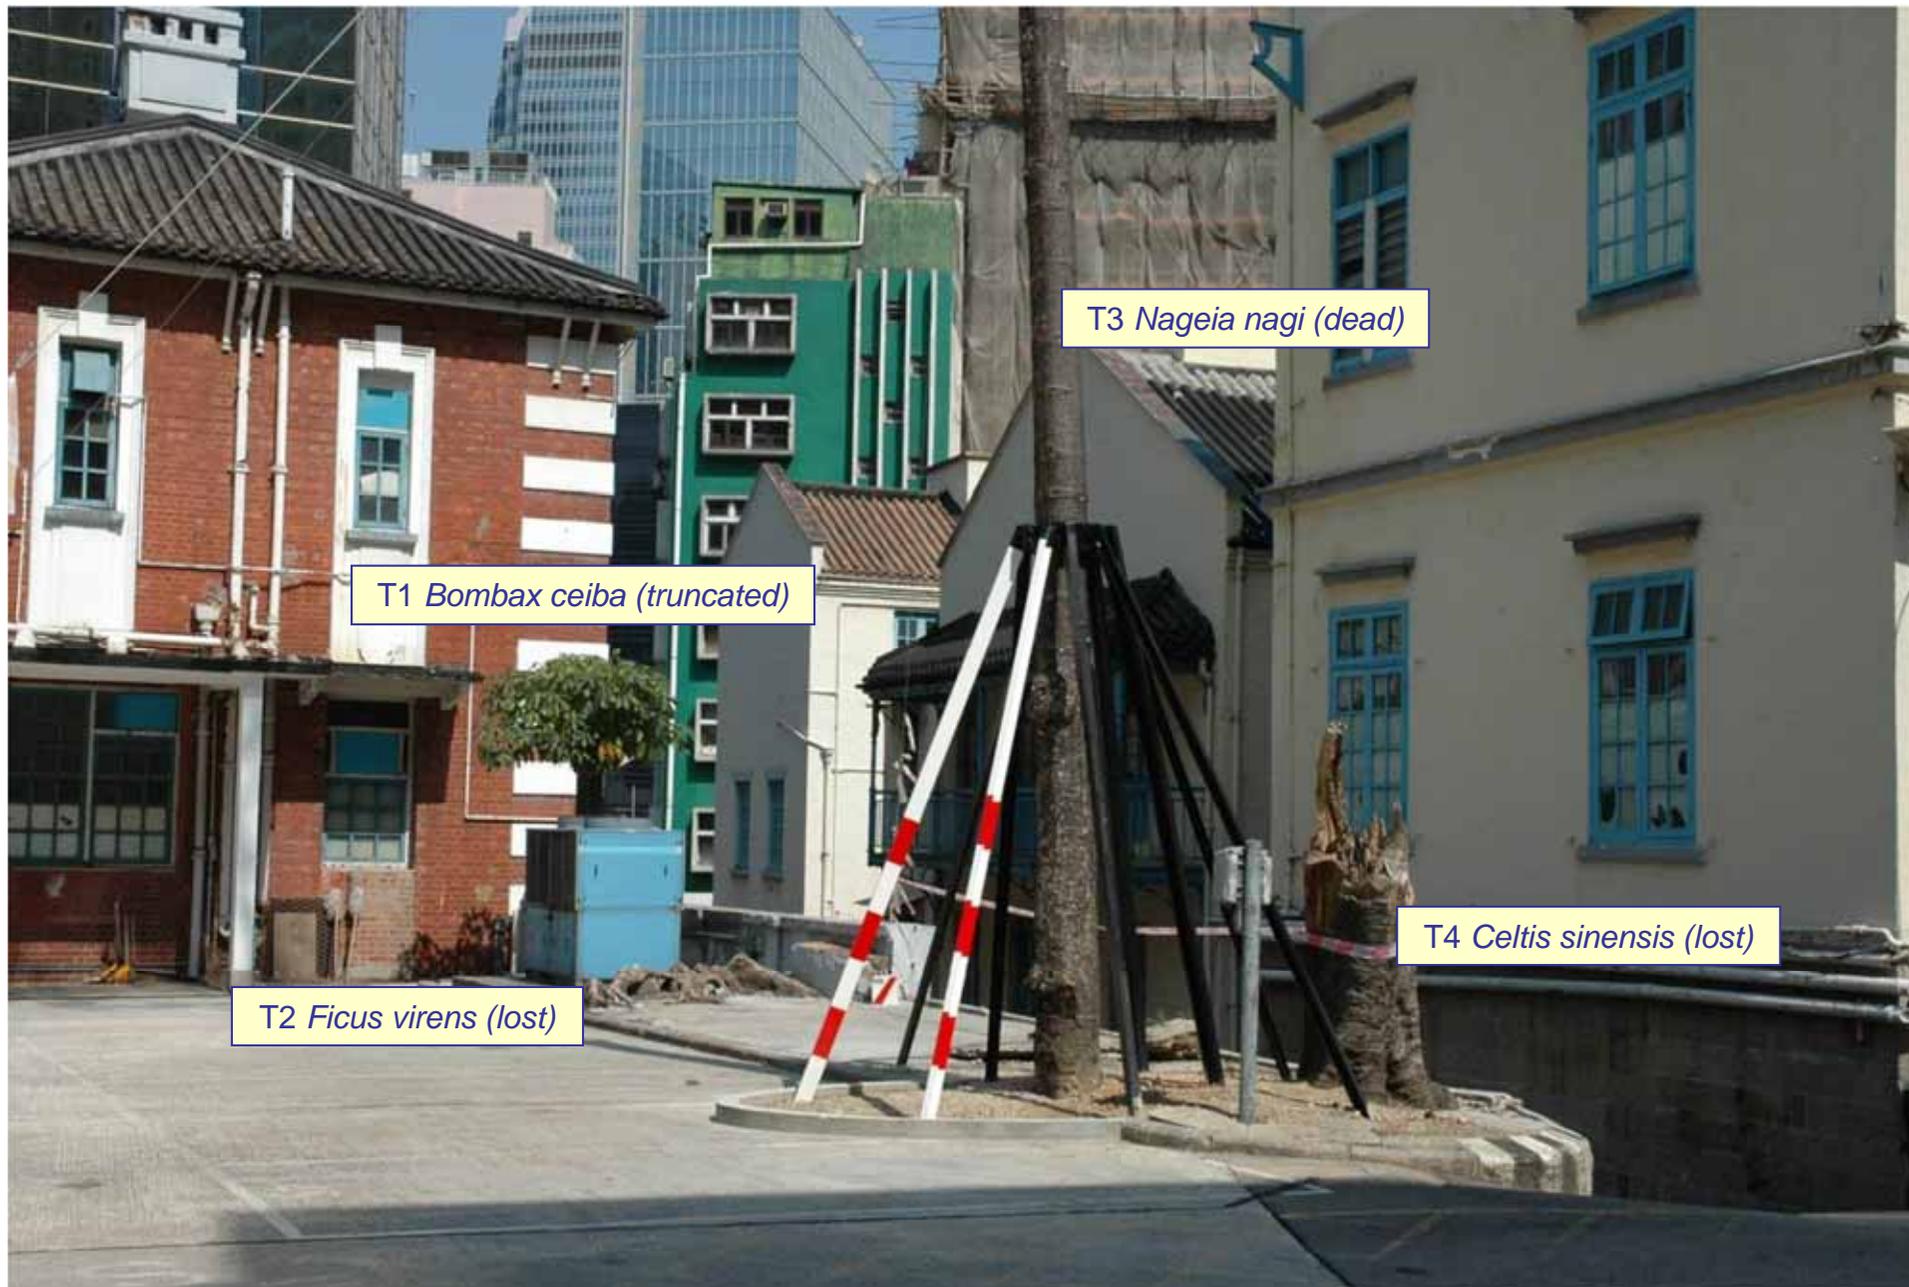
Figure 2. The site condition of the four trees situated on the east edge of the open space of the ex-Central Police Station.

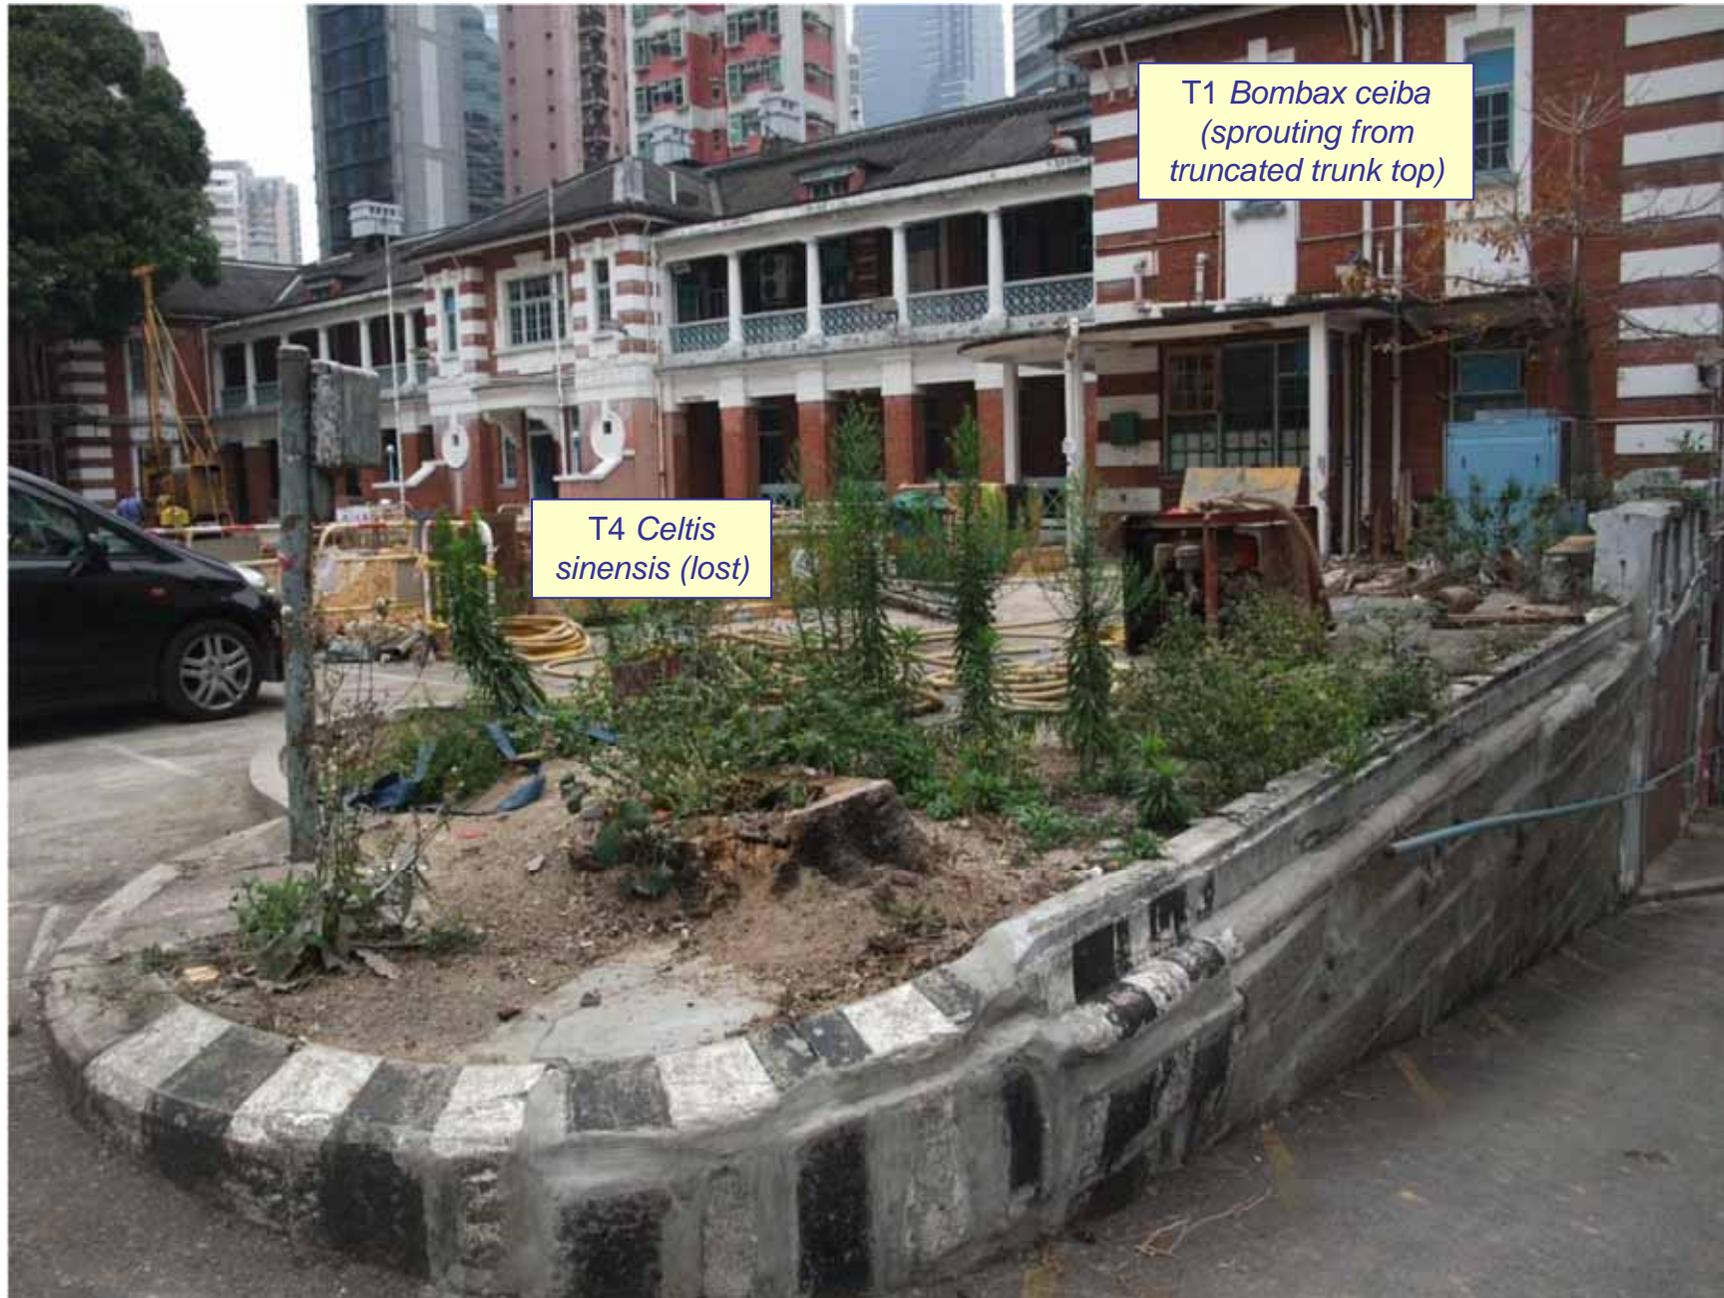
Figure 3. The site condition on 17 March 2011, showing that dead T3 and stump of dead T4 have been removed.

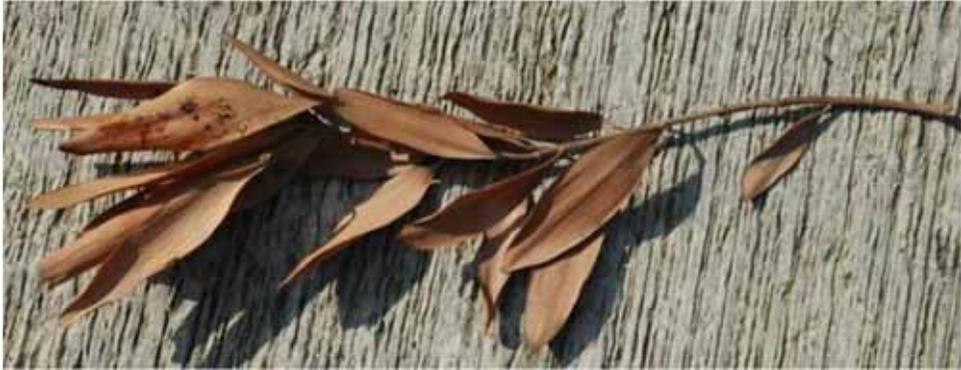
T3 is now considered to be dead as a result of toppling by Typhoon Fengshen which brought massive root breakage and injuries and should be removed. Despite no compensatory planting being required, it is suggested that the entire strip of land that previously accommodated T1 to T4 should be revamped to provide a planting site with improved soil conditions for future tree growth and six trees be planted here, as detailed in CM6 of Table 4.5.

Salvaged tree with green but few branches and foliage

Figure 17. T3 (*Nageia nagi*) was toppled by Typhoon Fengshen. It was subsequently lifted to an upright posture, and supported by props and guy cables. The evergreen tree has lost most of its branches and leaves, and all the remnant foliage have wilted.
