Appendix 1
Photographic Record

Project Title
 DESALINATION PLANT AT
 TSEUNG KWAN O
 - FEASIBILITY STUDY

Photo Records for Vegetation Survey

Photographic Record of Collared Scops Owl Survey

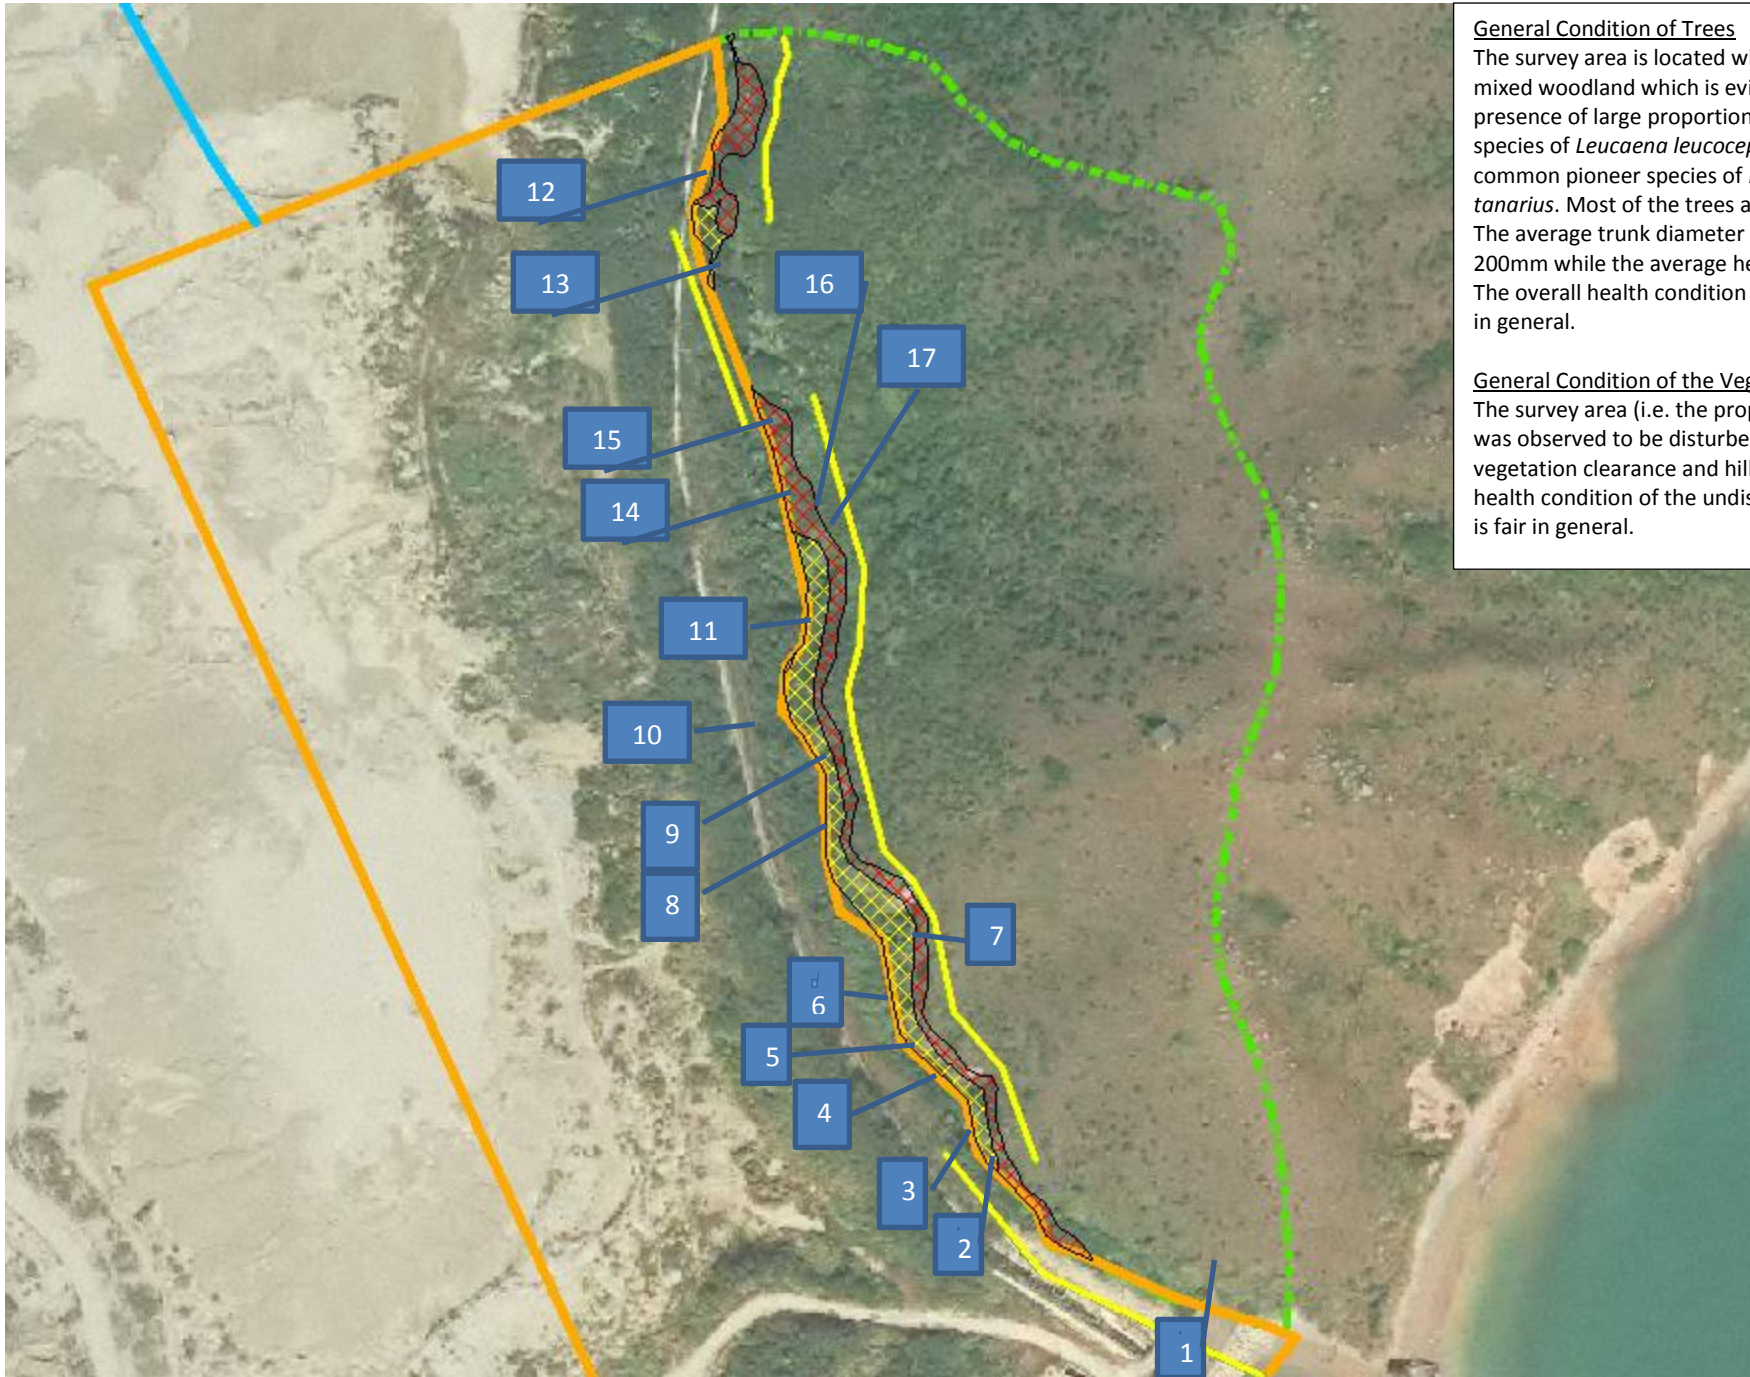
The survey area is located within a degraded mixed woodland which is evidenced by the presence of large proportion of invasive species of *Leucaena leucocephala* and common pioneer species of *Macaranga tanarius*. Most of the trees are young in age. The average trunk diameter ranges 100mm-200mm while the average height ranges 6-9m. The overall health condition of the trees is fair in general.

The survey area (i.e. the proposed works area) was observed to be disturbed recently by vegetation clearance and hill fires. The overall health condition of the undisturbed vegetation is fair in general.

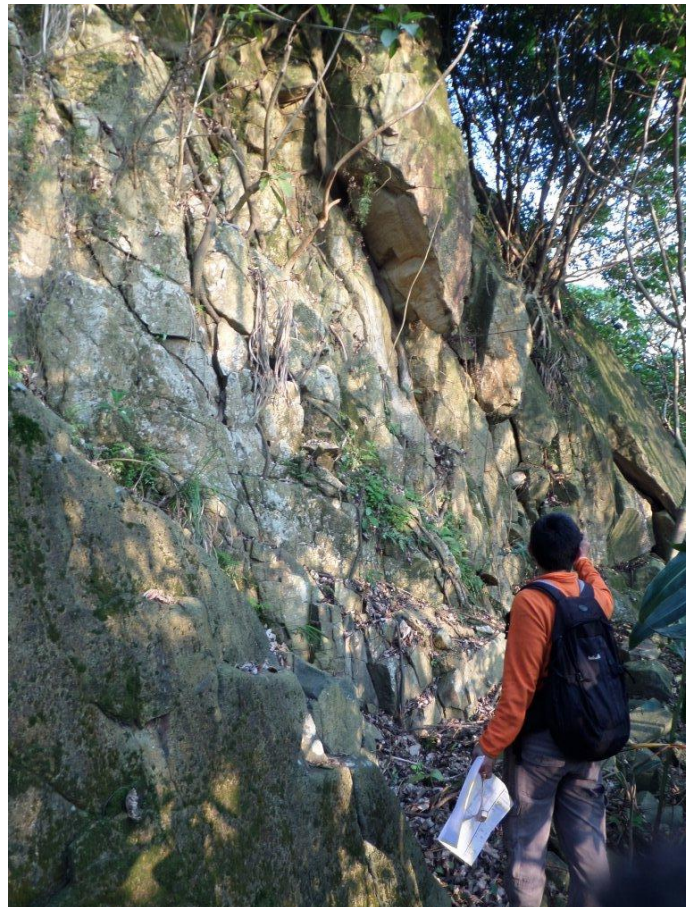
Plate 3

The survey area (i.e. the proposed works area) was observed to be disturbed recently by vegetation clearance and hill fires. The overall health condition of the undisturbed vegetation is fair in general.

The survey area is located within a degraded mixed woodland which is evidenced by the presence of large proportion of invasive species of *Leucaena leucocephala* and common pioneer species of *Macaranga tanarius*. Most of the trees are young in age. The average trunk diameter ranges 100mm-200mm while the average height ranges 6-9m. The overall health condition of the trees is fair in general.

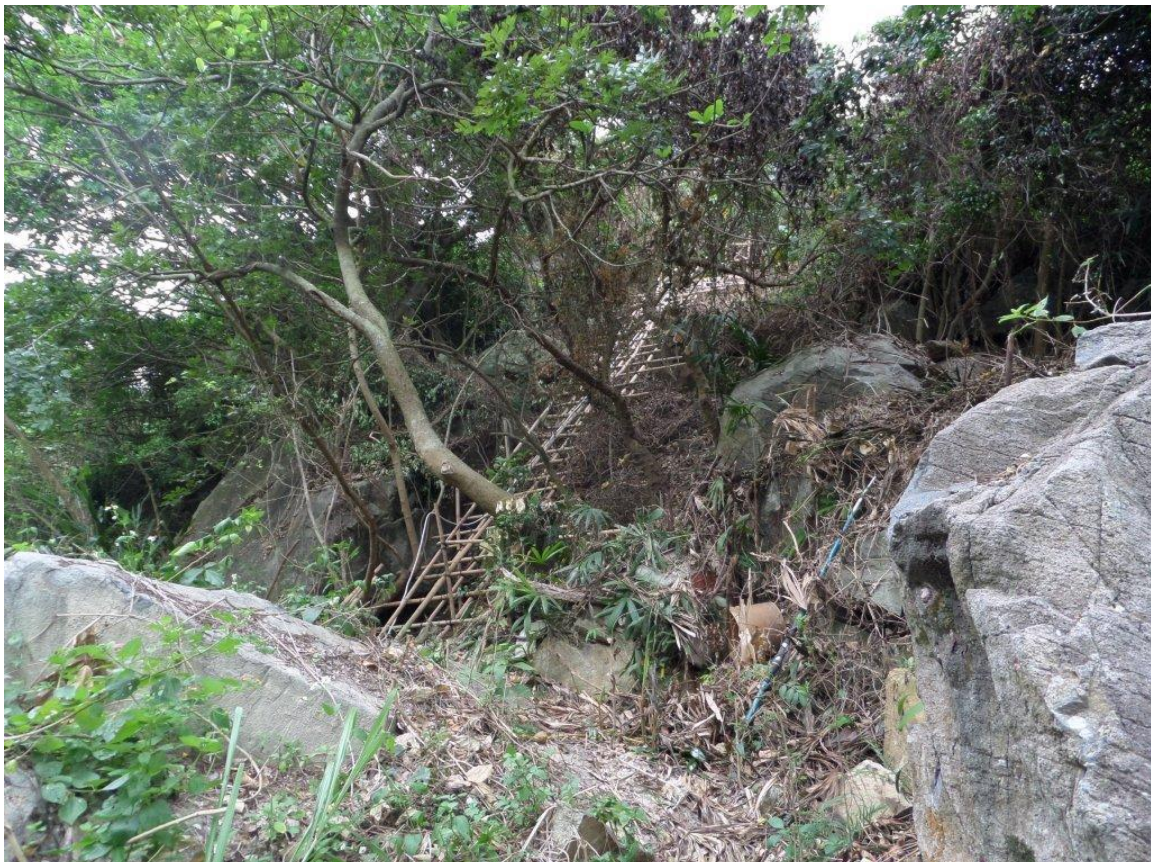
Plate 11

The survey area (i.e. the proposed works area) was observed to be disturbed recently by vegetation clearance and hill fires. The overall health condition of the undisturbed vegetation is fair in general.

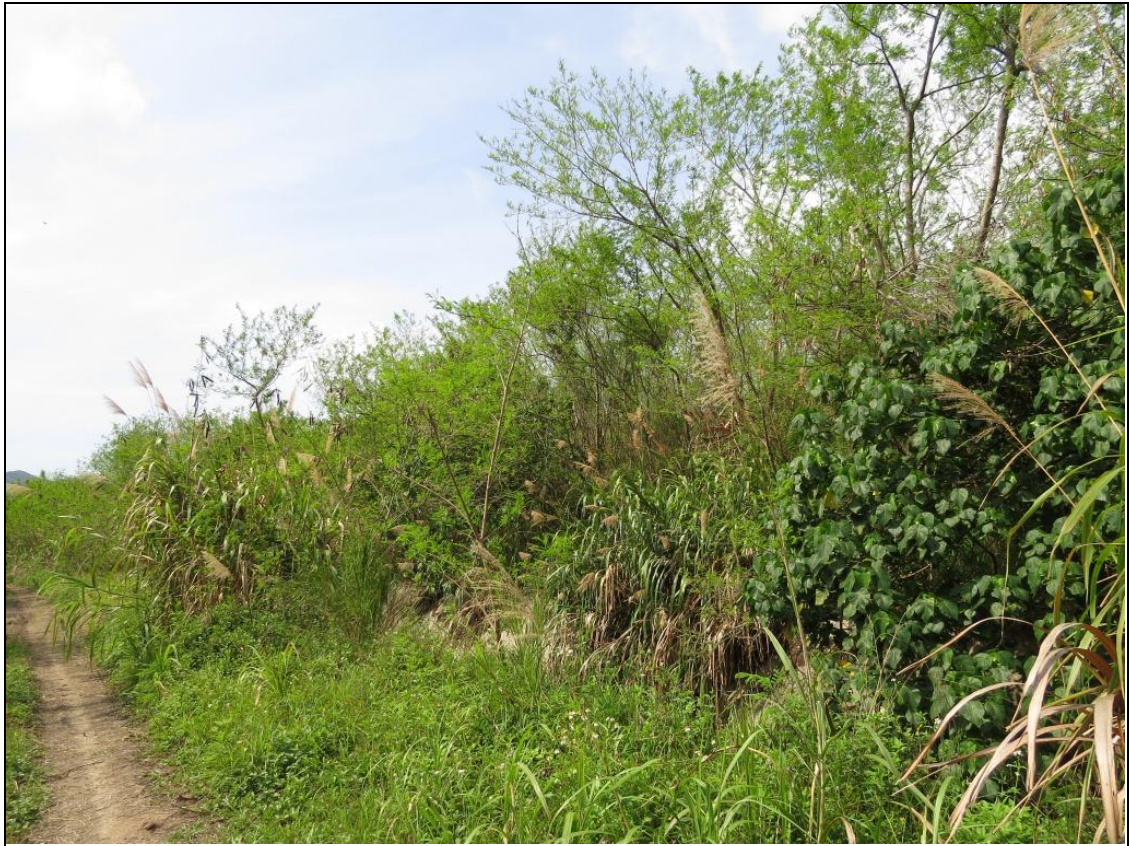
Plate 1: General view of study area for slope mitigation works

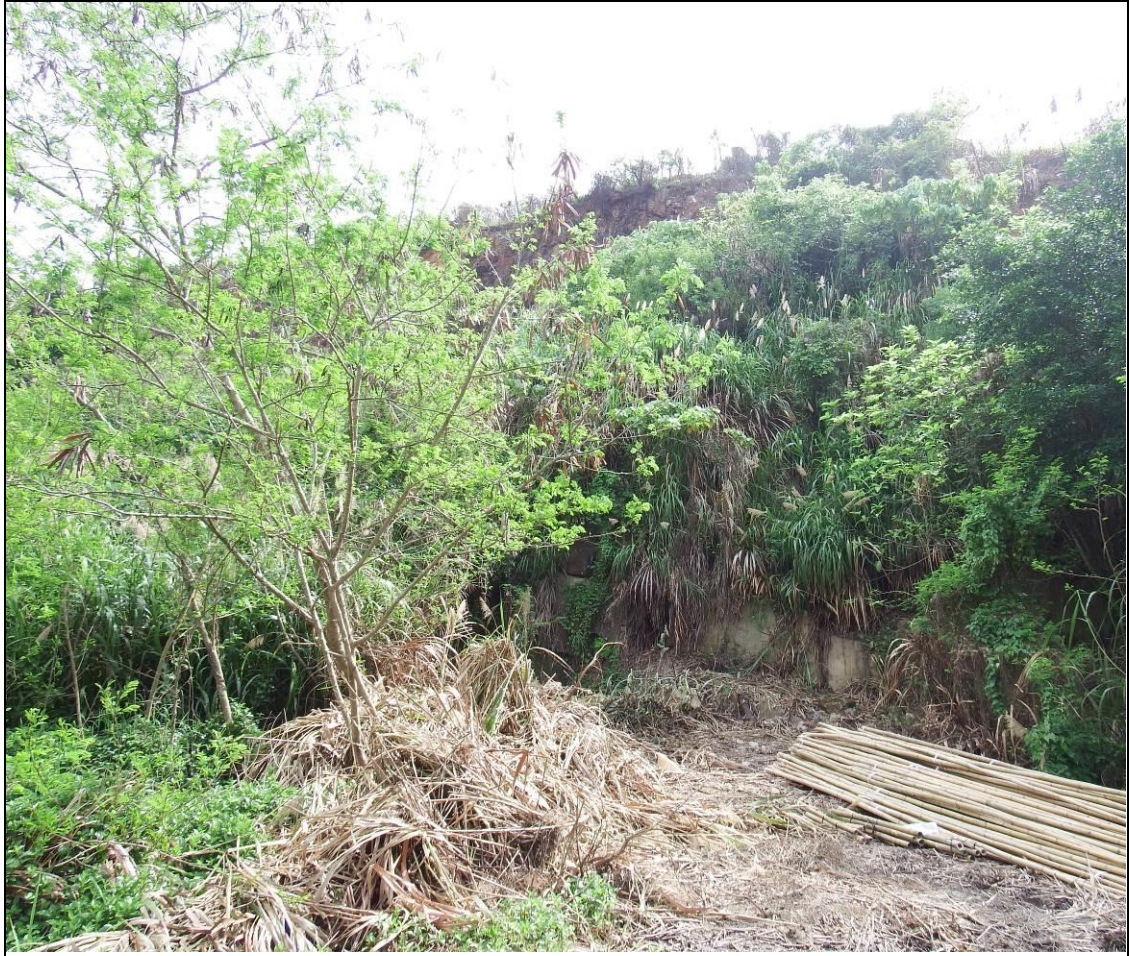
Plate 2: General view of study area for slope mitigation works
