Reprovisioning of Diamond Hill Crematorium: Contamination Assessment Plan

Hong Kong Productivity Council /
Architectural Services Department

5 February 2003
Final Report

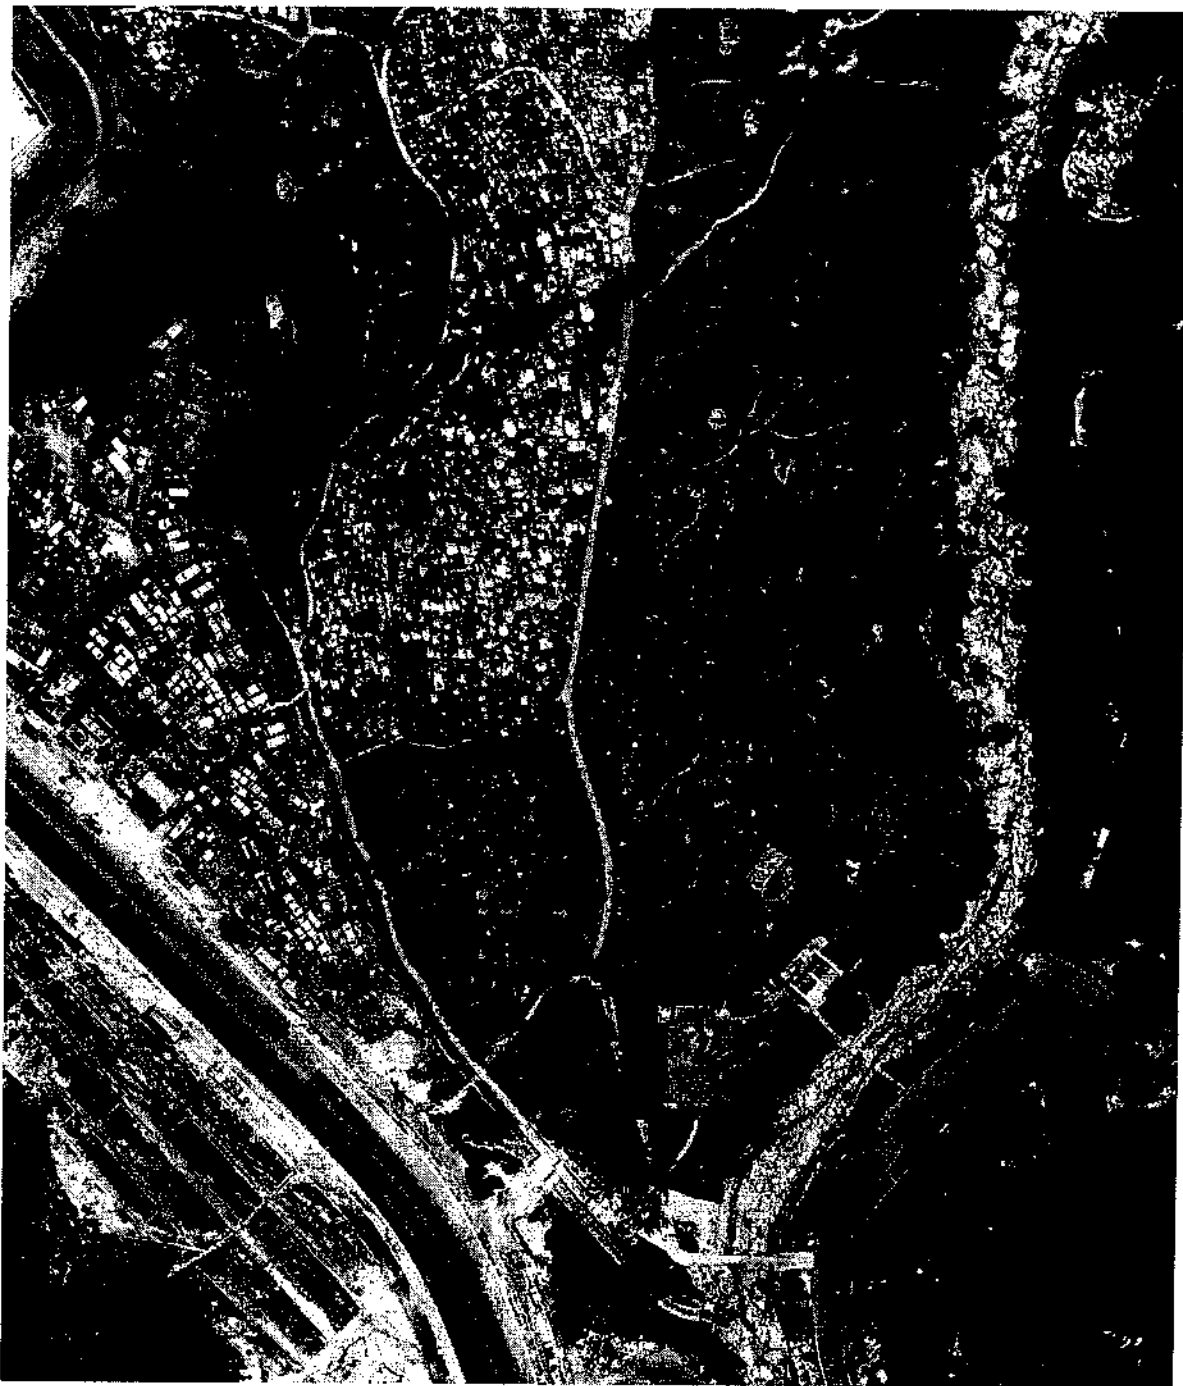
Aerial Photograph 2; Dated 1972

- 1.8.4 By the time of the 1972 photo, the area of graves had spread southwards, over part of the current crematorium site. The area to the south-west of the site (outside the current site boundary) appears to have been used as a car dismantling and repair facility. There are a number of buildings in the south-eastern corner of the site, comprising of the original Diamond Hill Crematorium and the associated staff accommodation. The 1976 photo shows the vehicles to the south-west to have been removed, and construction work appears to be underway. There is an area in the south-west of the current site which consists of irregular-shaped plots of land, and may represent a squatter area or small agricultural plots.
