West Island Line Project

Audit Report – Part 4
(On-site and Off-site Compensatory Trees of Sai Ying Pun & HKU Stations)

Audit Report for the On-site and Off-site Compensatory Trees of Sai Ying Pun & HKU Stations

This report is Part 4 of the Audit Report; it is the last part of the Audit Report for the West Island Line. This report presents the findings of the audit inspection for the compensatory trees planted in Ki Ling Lane Playground (SYP Entrance B3) and the off-site planting of compensatory trees for SYP and HKU. The audit inspection was conducted on 13 February 2017.

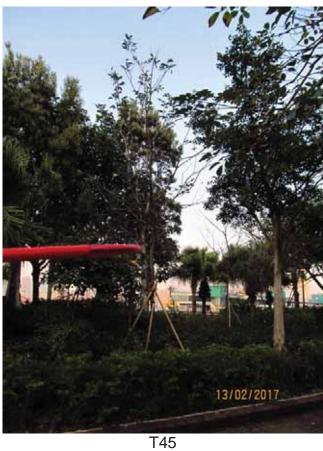
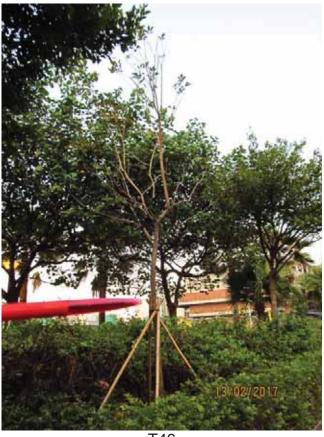
45 T46

- 2 Tabebuia chrysotricha are not found.
- 9 trees (Tree ID: T35, T36, T37, T43, T44, T45, T46, T47 and T48 in Appendix B) differ from the compensatory planting proposal in size.
- 1 tree (Tree ID: T38 in Appendix B) differ from the compensatory planting proposal in tree location.
- 6 trees (Tree ID: T39, T40, T41, T42, T50 and T51 in Appendix B) differ from the compensatory planting proposal in both size and location.
- Overall trees health and form are in fair condition.
