**Wan Chai Development Phase II –  
Central – Wan Chai Bypass at Wan Chai West  
Contract No. HK/2012/08**

**Final Landscape Plan  
for FEP-02/376/2009**

Revision 1

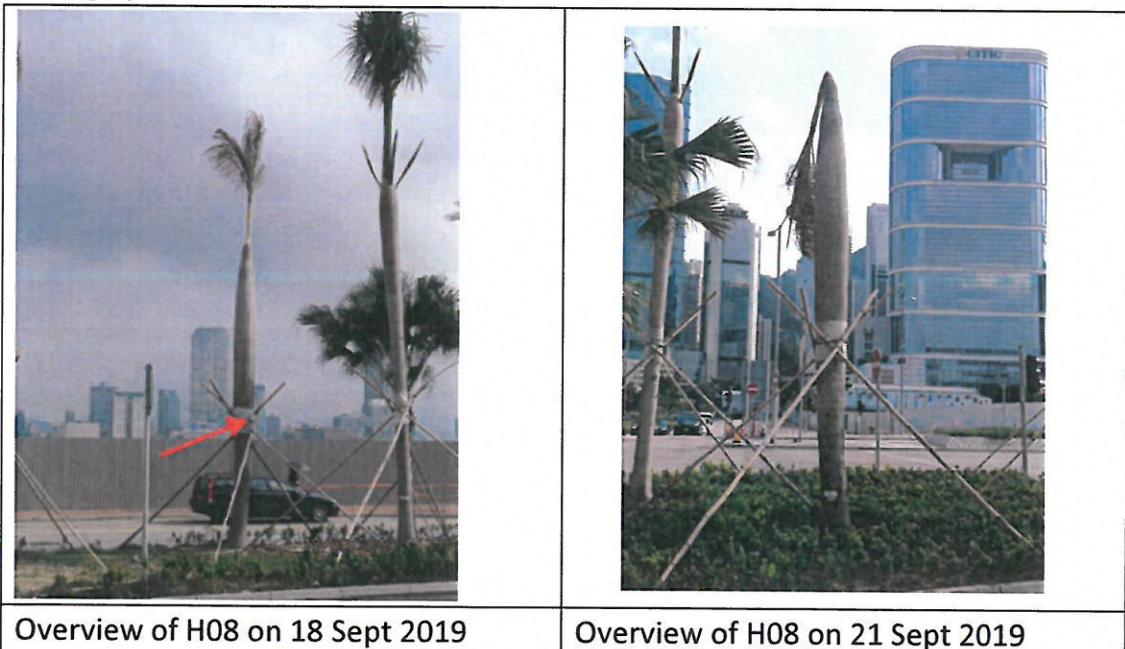
A transplanted trees, named H08 (C2) was observed dead during the site inspection on 21 September 2019. The general information of the tree is listed in the following table:

Tree ID	H08 (C2)
Tree Species	<i>Roystonea regia</i> 大王椰子
Diameter at Breast Height (DBH)	400mm
Overall Height	8
Average Crown Spread	2
Health condition	Dead

Crown wilting was observed on 18 Sept 2019	Growing point of the tree was dead on 21 Sept 2019

During this inspection, this tree is obviously dead after transplanting within 1 month. Tree felling may require but it will subject to the condition of TPRP under this Contract. Compensatory planting may necessary considered. Detail assessment of this tree please refers to the Form 2 attached.

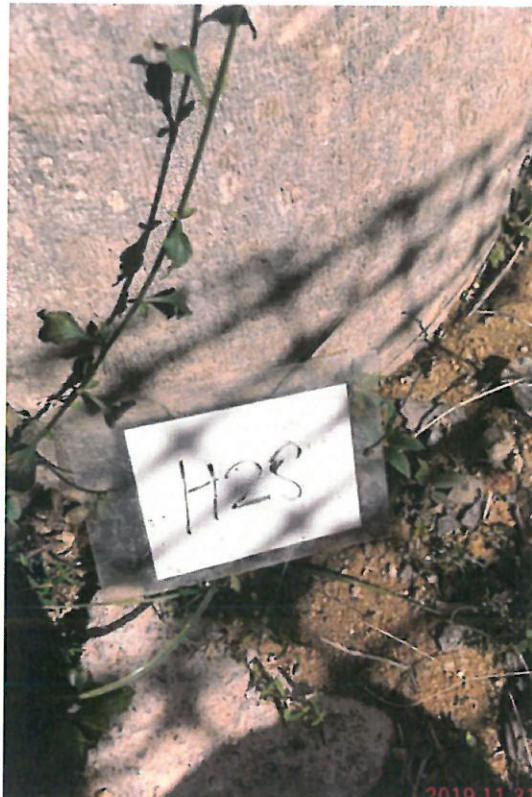
Tree tag

A transplanted tree, named H28 (C2) was observed dead during the site inspection on 21 November 2019. The general information of the tree is listed in the following table:

During this inspection, it is observed that the tree crown was fell on ground. As the growing point of palm tree (at the tip of the trunk) was damaged, the tree is unlikely to recover.

Tree felling is recommended and compensatory planting may necessary considered under the condition of TPRP of this Contract, detail assessment of this tree please refers to the Form 2 attached.
