DSD CONTRACT No.: DC/2009/08

CONSTRUCTION OF YUEN LONG SOUTH BRANCH SEWERS AND EXPANSION OF HA TSUEN SEWAGE PUMPING STATION

THE FORTH-SIXTH RESULTS OF LANDSCAPE AND VISUAL IMPACT MONITORING FOR NOVEMBER 2013 (NO.46)

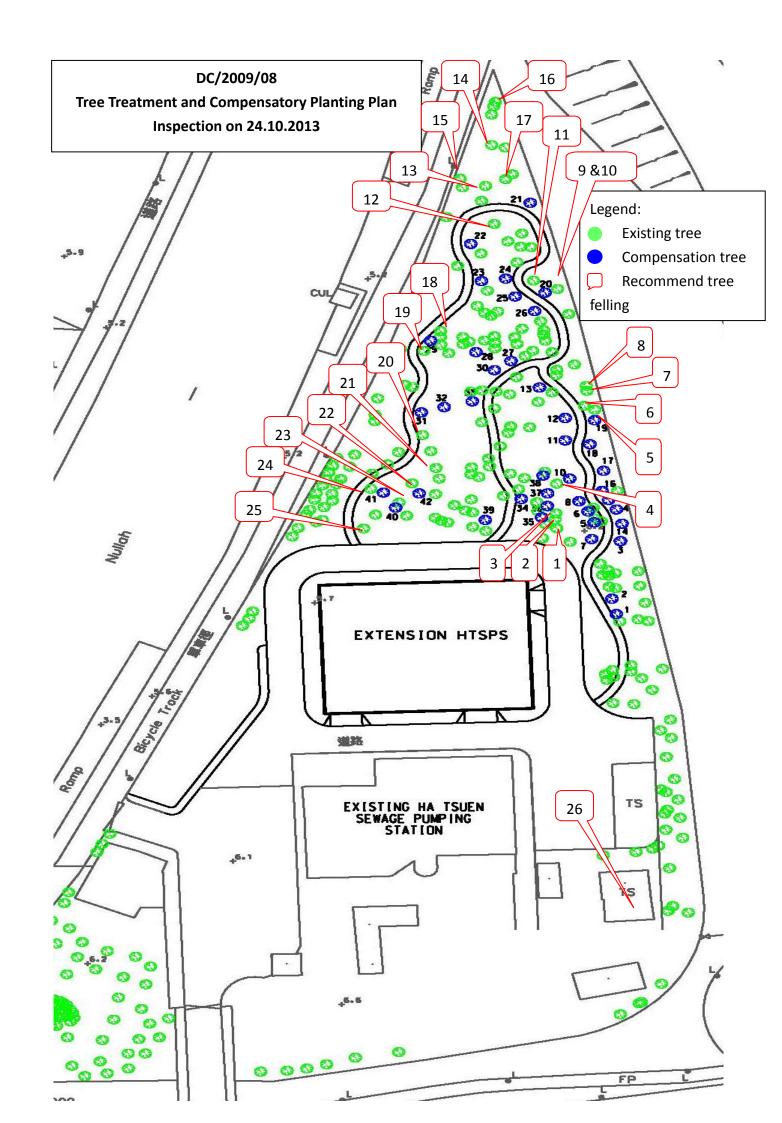
# Summary of Trees Felled on 18/11/2013 inside Ha Tsuen Sewage Pumping Station Area

1. All preserved trees are protected in accordance with the specification	ons 🗸				-
2. All preserved trees are fenced off properly	$\checkmark$				
<ol> <li>No construction activities are carried out in the protection zone of the preserved trees</li> </ol>	he 🗸				
Comments:					
All retained trees were fenced off and protected properly within the work	s area of the	site. DSD	is carry	ing out the pres	ervation
and protection.					
Conclusion					
Landscaping sub-contractor fell and removed total of 35 nos. damaged tr	rees on 12/10/	/2013. Dr	ainage Se	ervice Departme	ent confirmed to plant
42 nos. new trees with the following species:			Ü		· ·
10 nos. of Litsea glutlnosa (潺槁樹)					
10 nos. of Schlma superba (木荷)					
12 nos. of Bichofla polycarpa (重陽木)					
10 nos. of Cinnamomum burmanil (陰香)					
26 nos. of trees were felled and removed on 18 November 2013 under ins	struction of D	rainage S	ervice D	epartment.

Tree No.	Species	Chinese Name	Existing/Transplanted
HA188	Acacia auriculiformis	耳果相思	Existing
AB208	Acacia auriculiformis	耳果相思	Existing
AB220	Acacia auriculiformis	耳果相思	Existing
LM854	Acacia auriculiformis	耳果相思	Existing
HB3	Acacia auriculiformis	耳果相思	Existing
HB4	Acacia auriculiformis	耳果相思	Existing
HB6	Delonix Regia	鳳凰木	Existing
HB8	Delonix Regia	鳳凰木	Existing
HB70	Acacia Confusa	台灣相思	Existing
HB73	Acacia auriculiformis	耳果相思	Existing
HB16	Acacia Confusa	台灣相思	Transplanted
HB20	Acacia auriculiformis	耳果相思	Existing
HB21	Acacia auriculiformis	耳果相思	Existing
HB43	Acacia auriculiformis	耳果相思	Existing
HB39	Eucalyptus Robusta	大葉桉	Existing
HB38	Acacia auriculiformis	耳果相思	Existing
HB28	Acacia auriculiformis	耳果相思	Existing
HB43	Acacia auriculiformis	耳果相思	Existing
HB67	Acacia auriculiformis	耳果相思	Existing
HB71	Acacia auriculiformis	耳果相思	Existing
HB96	Acacia auriculiformis	耳果相思	Existing
HA214	Eucalyptus	毛葉桉	Transplanted
HB94	Acacia auriculiformis	耳果相思	Existing
