Improvements to San Tin Interchange
Environmental Monitoring and Audit

November 2005

**Contract No. HY 2004/09 Improvements to San Tin Interchange
Water Quality Visual Inspection Report**

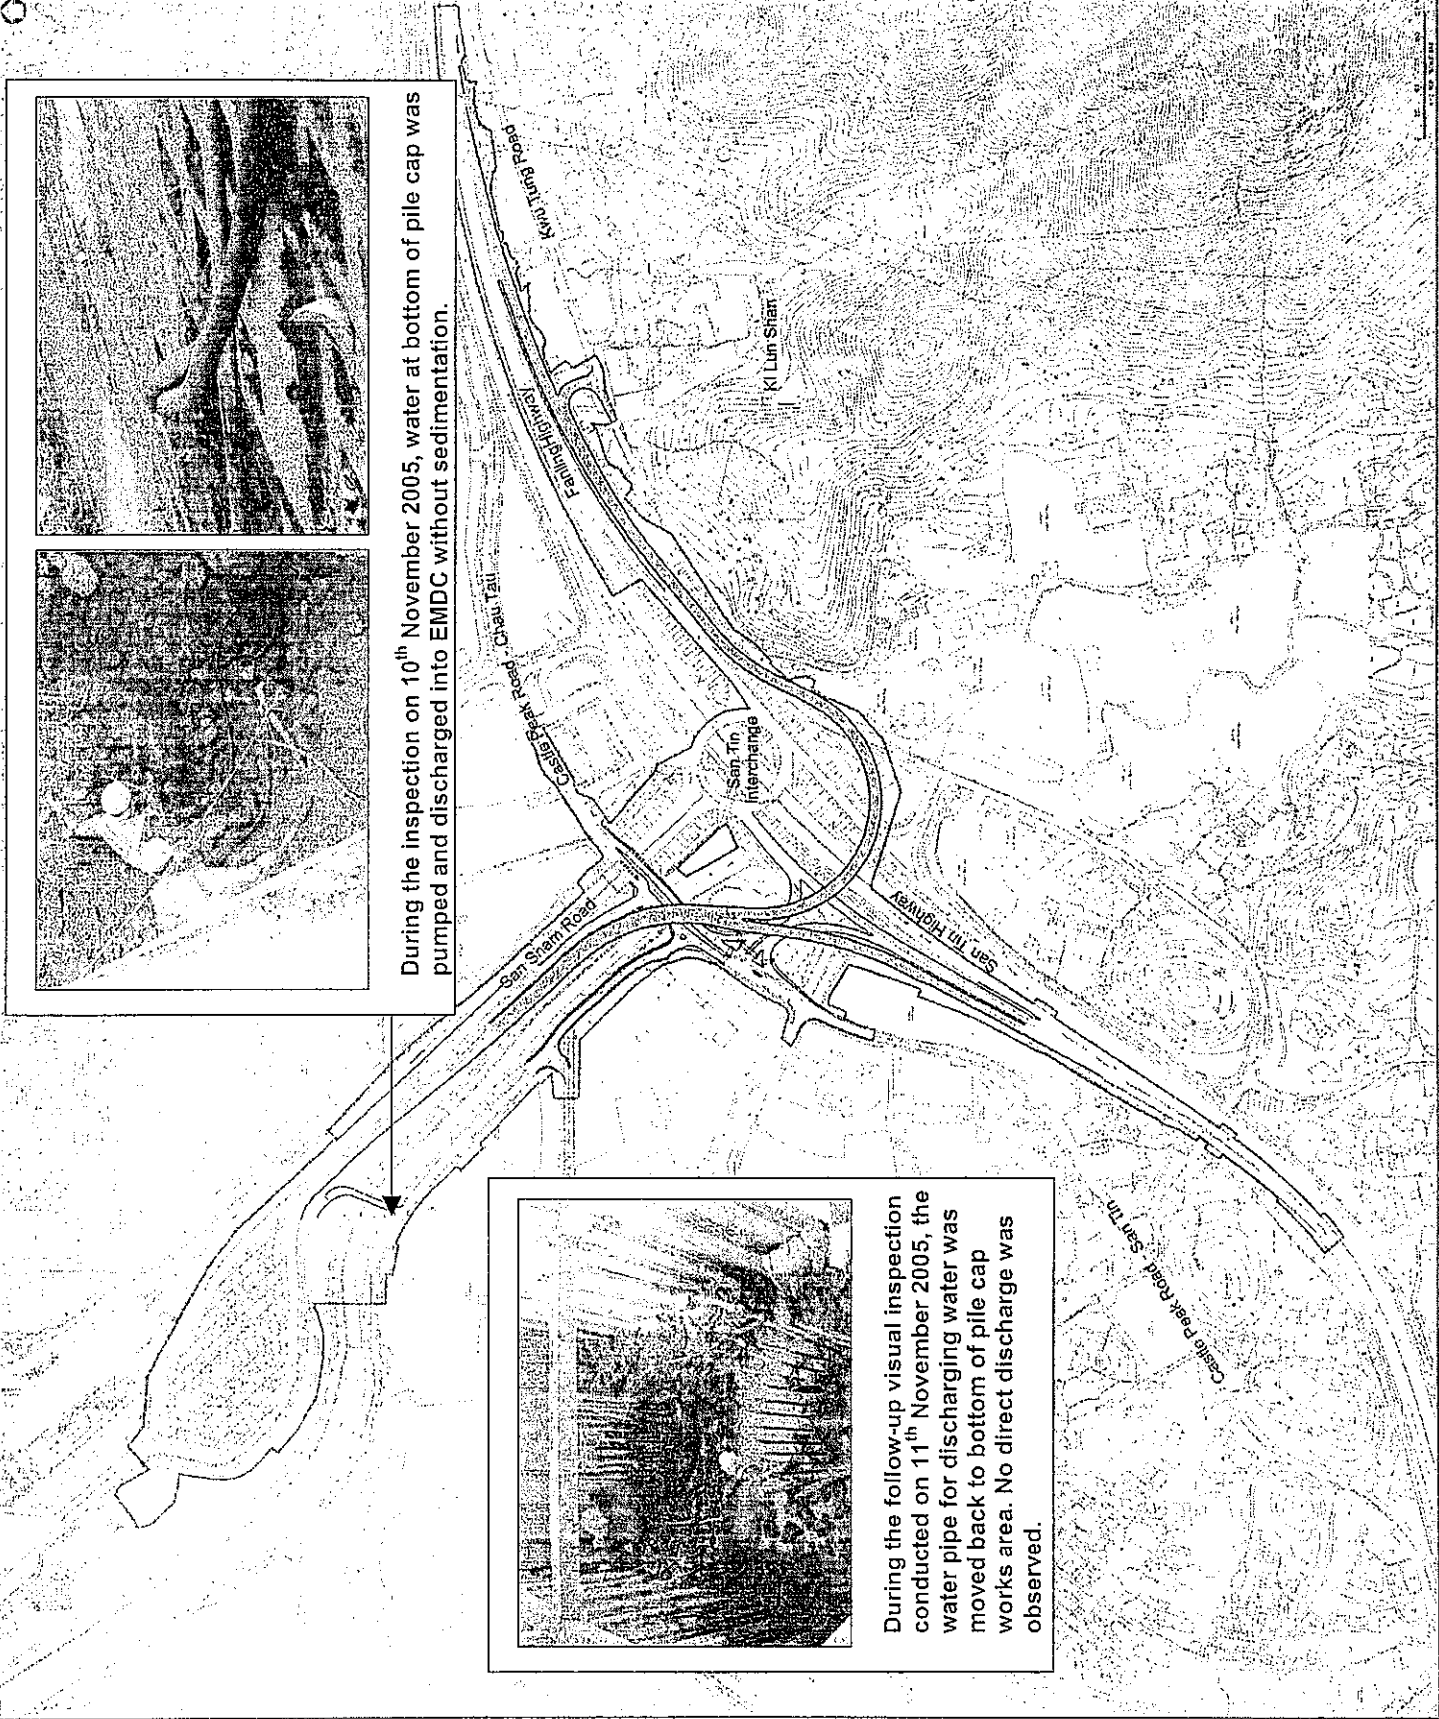
During the follow-up visual inspection conducted on 11th November 2005, the water pipe for discharging water was moved back to bottom of pile cap works area. No direct discharge was observed.

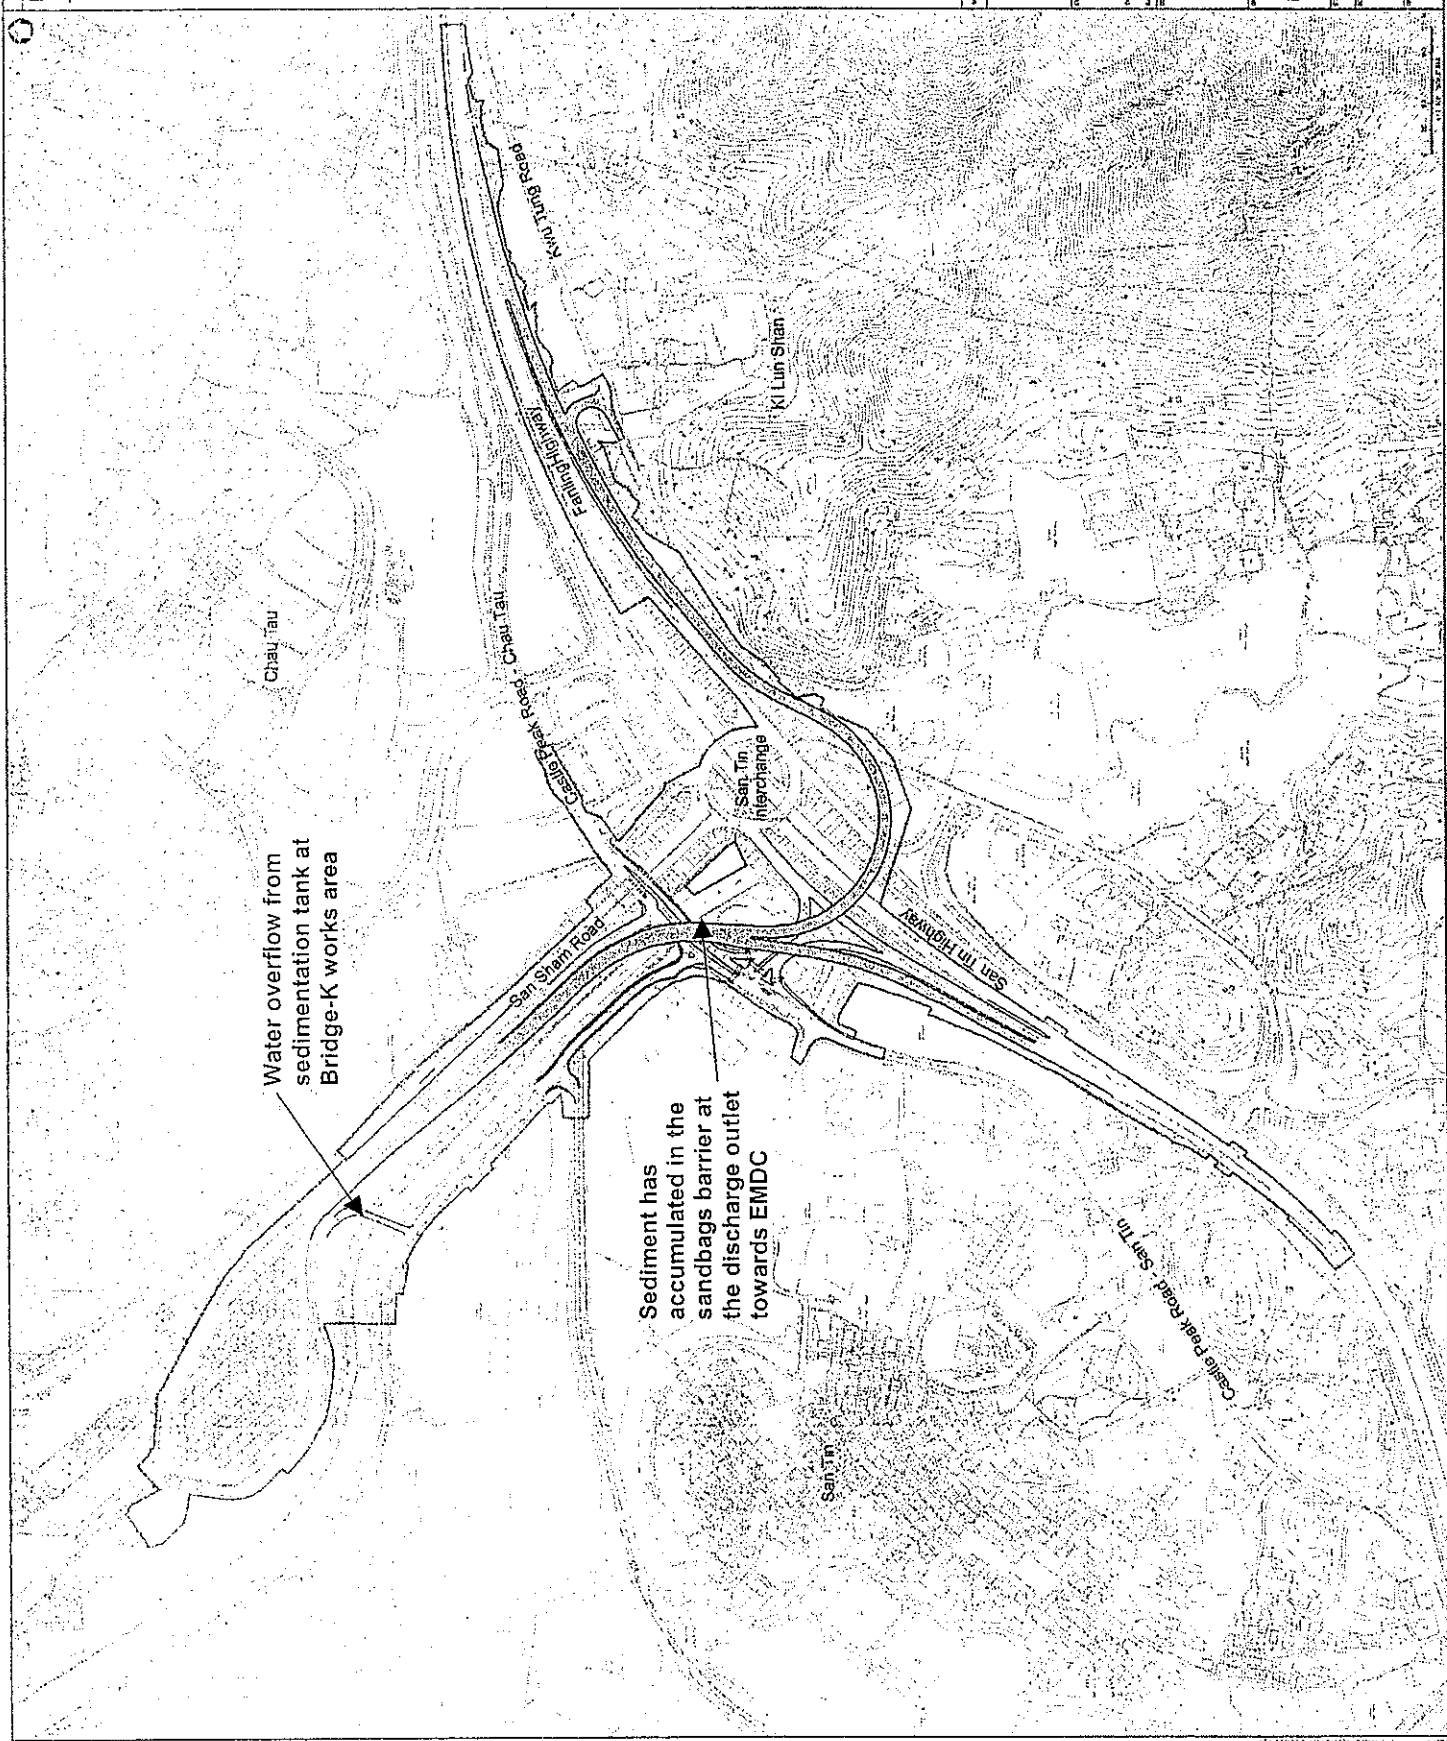
DATE	SCALE	PROJECT NO.	FIGURE NO.
11/11/09	1:1000	HY/2004/09	FIGURE 1

- During the inspection on 14th November 2005, silty water generated from the bored piling works at the Bridge-K works area was seen to have filled up the bored cavity. Overflow from the sedimentation tank provided was observed due to limited capacity. The Contractor had suspended the works and was seen pumping the water to a sedimentation tank with larger capacity. This control was seen to be effective. No overflow at this area was observed during the next inspection.
- During the inspection on 16th November 2005, sediment has accumulated in the sandbags barrier provided at the discharge outlet to the EMDC at N1 open lay-down area. The Contractor was reminded to remove the accumulated sediment and debris regularly.
- During the inspection on 17th November 2005, sediment accumulated at the discharge outlet to the EMDC at N1 open lay-down area was seen to have been cleaned up.
