SkyCity Nine Eagles Golf Course

Quarterly EM&A Compliance Report

August to October 2011

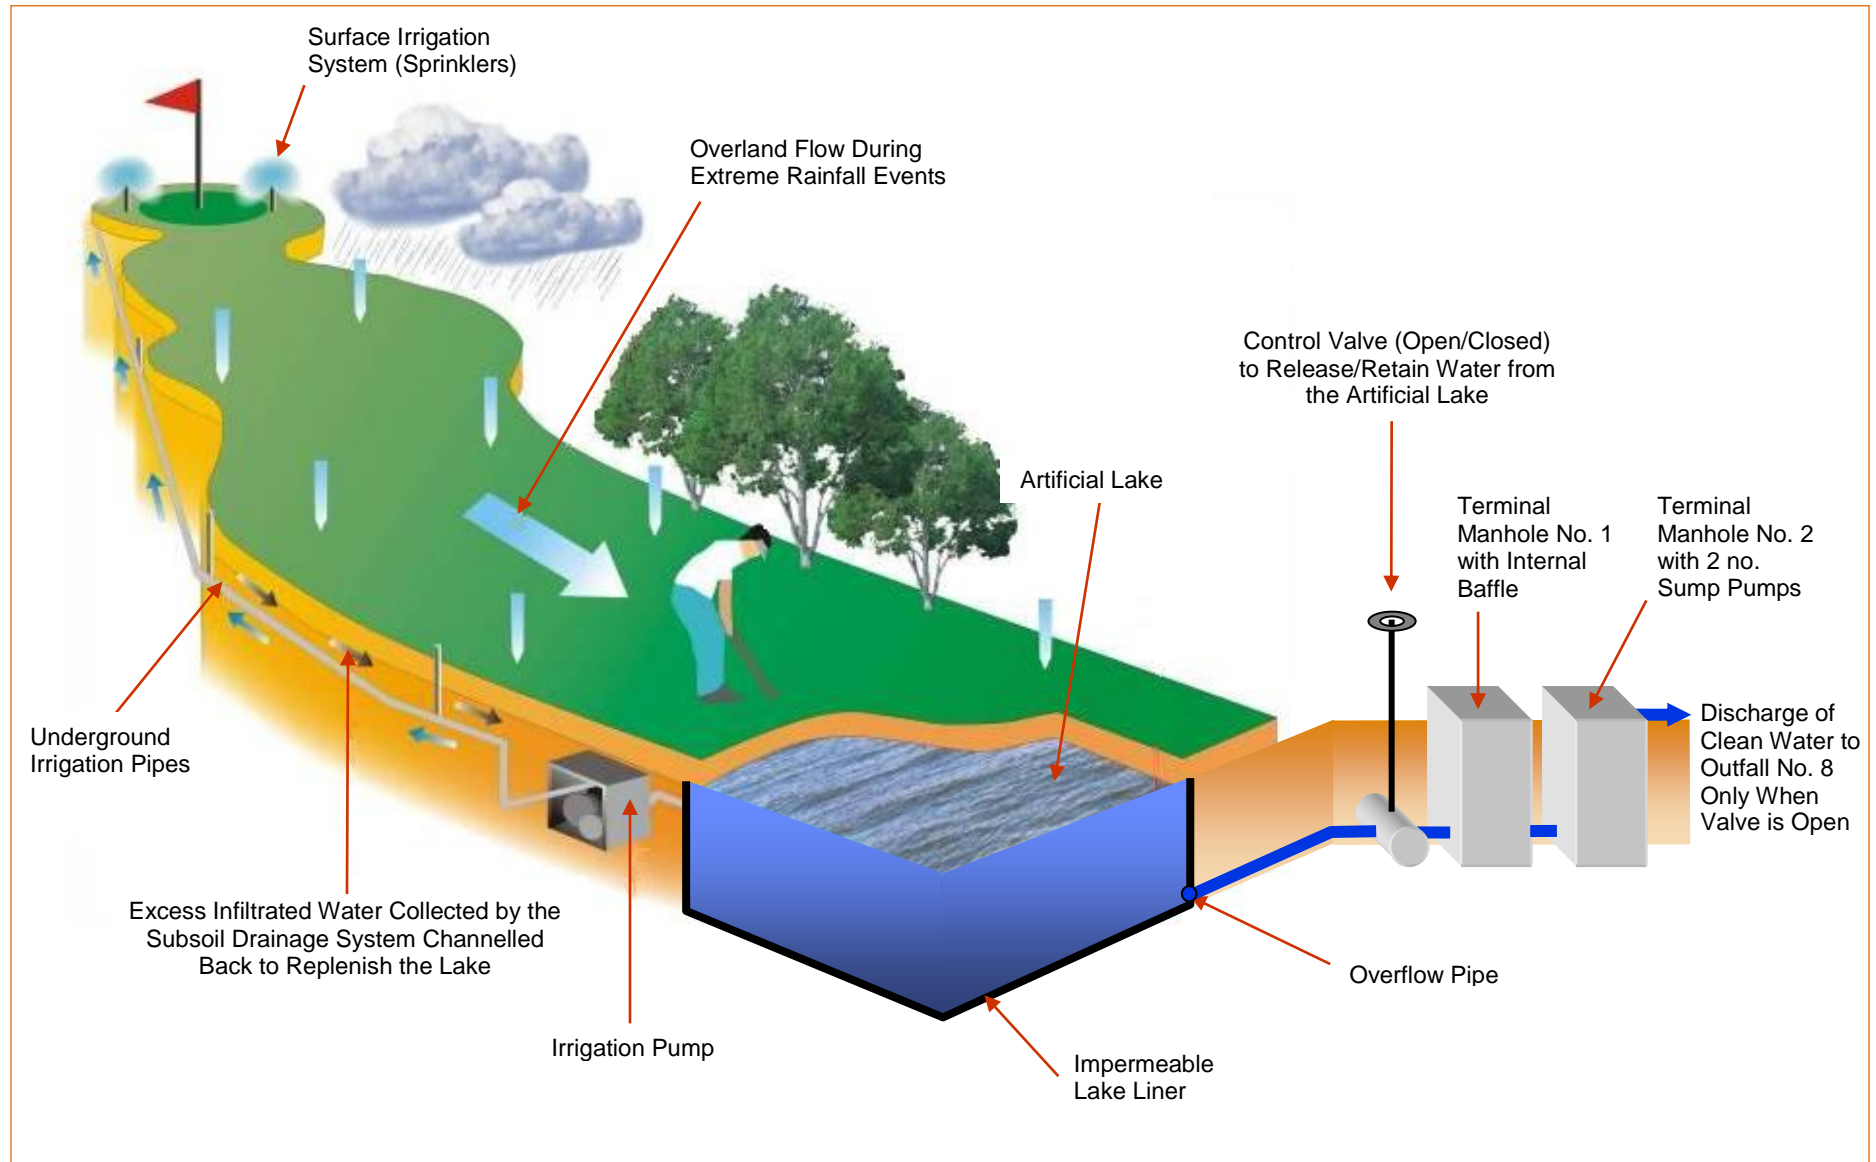
Figure 1-2 Schematic of Lake Water Control System

The system by which this water control is achieved is shown in *Figure 1-2*.
