# SkyCity Nine Eagles Golf Course

## Quarterly EM&A Compliance Report

November 2011 to January 2012

Project/Deliverable Number:	J481C   D04/05
Project Name:	SkyCity Nine Eagles Golf Course
Report Name:	Quarterly EM&A Compliance Report – November 2011 to January 2012
Report Date:	February 2012
Report for:	Sky City Nine Eagles Golf Course

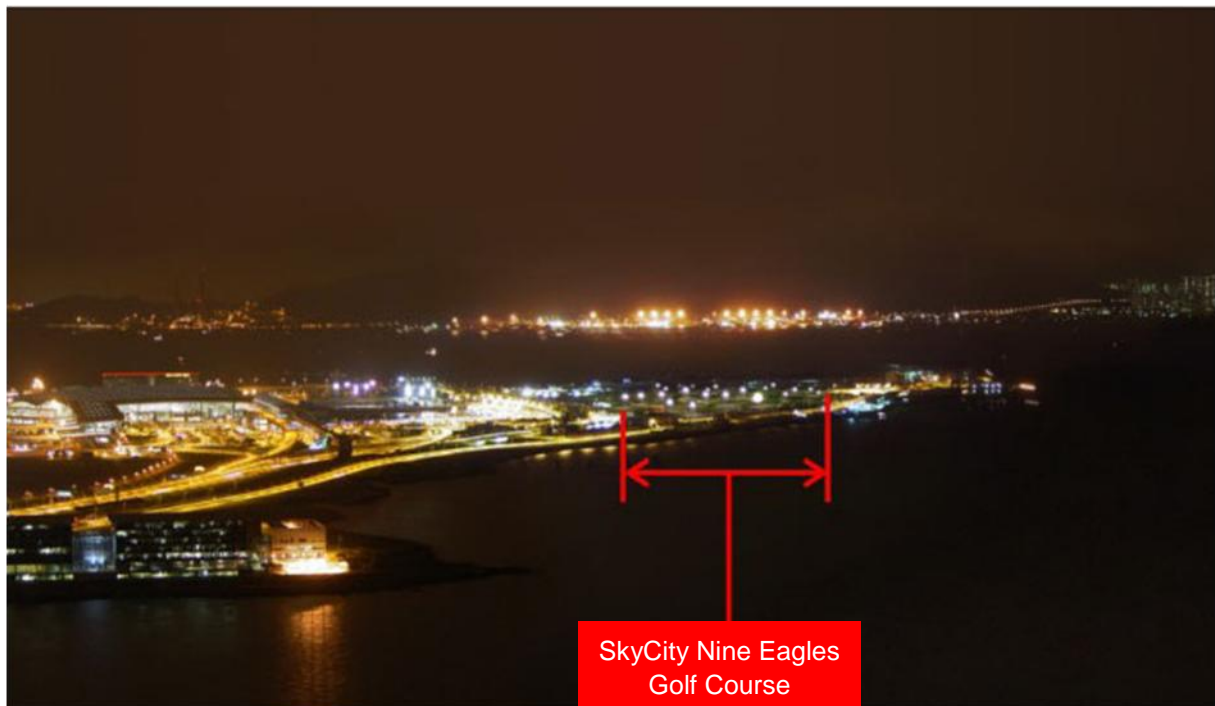
**Figure 3-1** Predicted Night-time View from Seaview Crescent, Tung Chung (Excerpt from Figure 3-3 of the Project Profile, July 2005)

**Figure 3-1**, below, is extracted from the Project Profile and is a photomontage showing the anticipated light pollution from Nine Eagles Golf Course when viewed from Tung Chung. **Figure 3-2**, is a photograph taken by the Project Proponent in October 2011 after the complaint was received.

**Figure 3-5**, is a photograph taken from Tung Chung towards Nine Eagles Golf Course by the Project Proponent on 13 November 2011, after the re-positioning of the floodlights. Compared to **Figure 3-2**, which was taken prior to the re-positioning, it can be seen that the glare from the floodlighting is less intense and more in line with that anticipated in the Project Profile, as shown in **Figure 3-1**.
