PROJECT No.: TCS/00408/08

DSD CONTRACT NO. DC/2007/17
DRAINAGE IMPROVEMENT WORKS IN
CHEUNG PO, MA ON KONG, YUEN KONG SAN TSUEN
AND TIN SAM TSUEN OF YUEN LONG DISTRICT AND
SEWERAGE AT TSENG TAU CHUNG TSUEN, TUEN MUN

MONTHLY EM&A REPORT FOR KT13
(NOVEMBER 2009)

PREPARED FOR
CHINA ROAD & BRIDGE CORPORATION

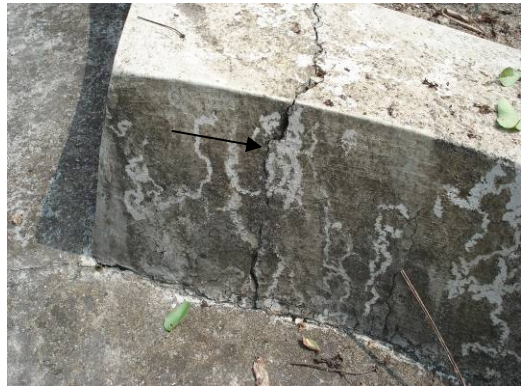
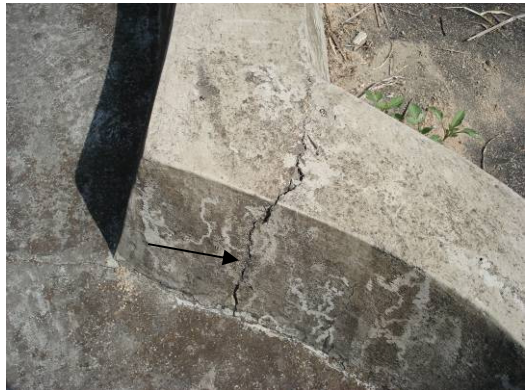
Crack No.	Crack Width (mm)	Photographic Record	
		Condition Survey Undertaken in August 2009	Condition Survey Undertaken in October 2009
8	1.2

During this survey, no new significant cracks were identified and no existing cracks were observed to have been widened. However, some micro-hairline cracks were identified on the grave. The cracks were tiny surface rendering cracks which were so insignificant that they could only be seen in close distance and would not induce structural damage to the grave. Although the construction work of the Contract had started within 100m area from the grave, in view of the surrounding dense vegetation and the grave being exposed (see *Figure 3.2b*), these cracks are likely to be caused by weathering (such as raining, intermittent heating and cooling) or root encroachment of overgrown vegetation (e.g. Crack No. 5).

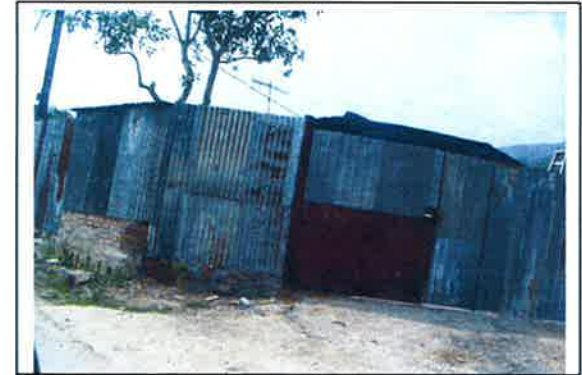
Photo No. B11—LCA 6 Industrial Landscape Character Area

10.7.17	LCA6 (Industrial Landscape Character Area)	B11 & B12	This comprise collection of slummy-built temporary structure and open storage uses land, which are characterized with metallic hoarding and used for poultry, recycling, vehicle repairing etc. The sensitivity to change of this area is low.	Reconstruction of hoarding was conducted by the land owner

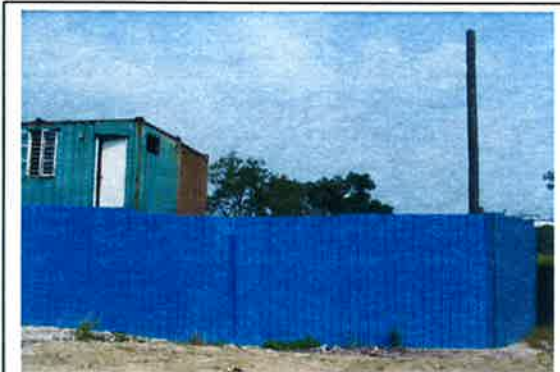
Photo No. C3-13 Plant Nursery at the east of Ma On Kong Channel

10.7.23	I3	C3	Plant Nursery at the west of Ma On Kong Channel The VSRs is workers of the plant nursery. The number of individual is very few and their sensitivity to visual impacts is low.	Temporary stockpiling was observed

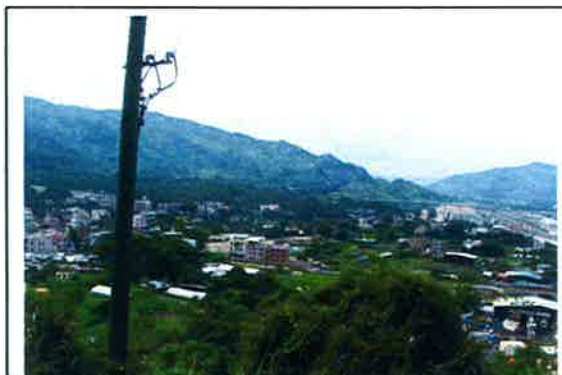
Photo No. A6 – LR2.1

10.7.4	LR2.1 (Fish Pond) within site boundary LR2.2 (Fish Pond) outside site boundary	A6 A7	There are 4 numbers of fallowed fish ponds at the upstream of the Ma On Kong Channel. A chain of fish ponds near downstream but distant from the Channel is noted. The fish ponds cover area of in total 23,000 m2. Most of them are heavily colonized by aquatic plants, which attribute to their low visual quality as a water landscape element. They have low landscape value and sensitive to change.	Minor change due to construction of structures within site boundary. A soil platform was

Fish Pond within site boundary

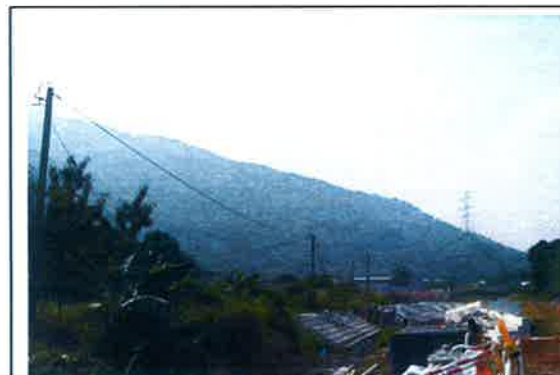
Photo No. A7 – LR2.2

created outside site boundary due to other project was noted.
Marsh				
10.7.5	LR3 (Marsh)	A8	It comprises 2 marshes at the upstream channel of the Channel. They are inundated lowland heavily colonized with wetland aquatic plants. They have low landscape value and sensitive to change.	Remain the same as the baseline
Vegetation

River/Stream
