PROJECT No.: TCS/00408/08

DSD CONTRACT NO. DC/2007/17
DRAINAGE IMPROVEMENT WORKS IN
CHEUNG PO, MA ON KONG, YUEN KONG SAN TSUEN
AND TIN SAM TSUEN OF YUEN LONG DISTRICT AND
SEWERAGE AT TSENG TAU CHUNG TSUEN, TUEN MUN

MONTHLY EM&A REPORT FOR KT13
(FEBRUARY 2010)

PREPARED FOR
CHINA ROAD & BRIDGE CORPORATION

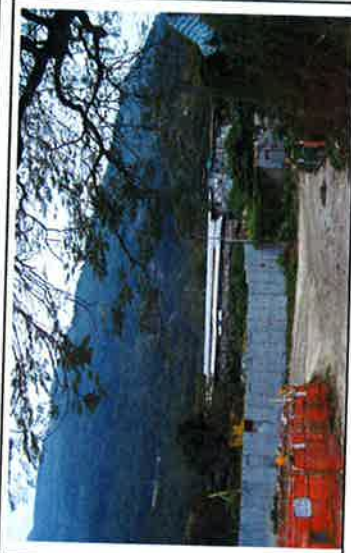
Photo No. C3-13 Plant Nursery at the east of Ma On Kong Channel

| Section in EIA Report | Identify number – VSR | Photo No. | Baseline Study, Environmental Impact Assessment Final Report [382047/E/EIA/Issue 9] | Current Situation |
|---|---|---|---|---|
| 10.7.23 | I3 | C3 | Plant Nursery at the west of Ma On Kong Channel The VSRs is workers of the plant nursery. The number of individual is very few and their sensitivity to visual impacts is low. | Temporary stockpiling was observed |
