PROJECT No.: TCS/00408/08

DSD CONTRACT NO. DC/2007/17
DRAINAGE IMPROVEMENT WORKS IN
CHEUNG PO, MA ON KONG, YUEN KONG SAN TSUEN
AND TIN SAM TSUEN OF YUEN LONG DISTRICT AND
SEWERAGE AT TSENG TAU CHUNG TSUEN, TUEN MUN

MONTHLY EM&A REPORT FOR KT13
(MARCH 2010)

Condition Survey of the Grave during Construction Phase

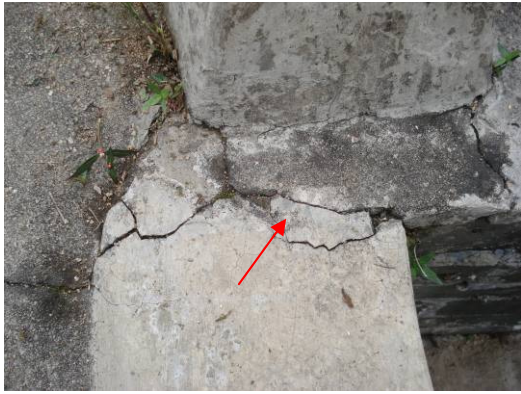
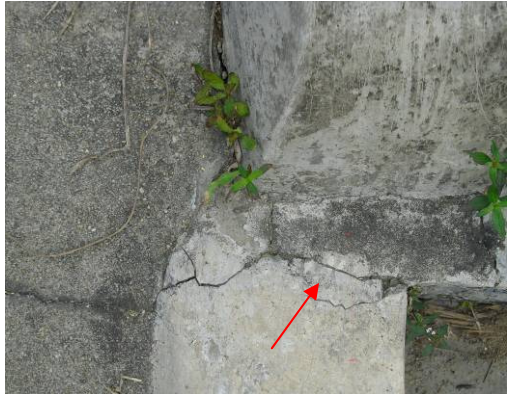
Crack No.	Current Crack Width (mm)	Photographic Record	
		Condition Survey Undertaken on 9 January 2010	Condition Survey Undertaken on 27 February 2010
1	1

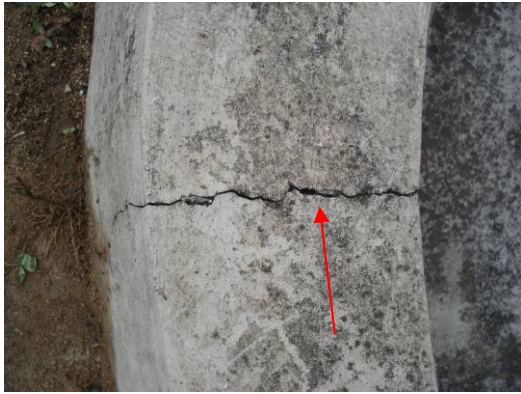
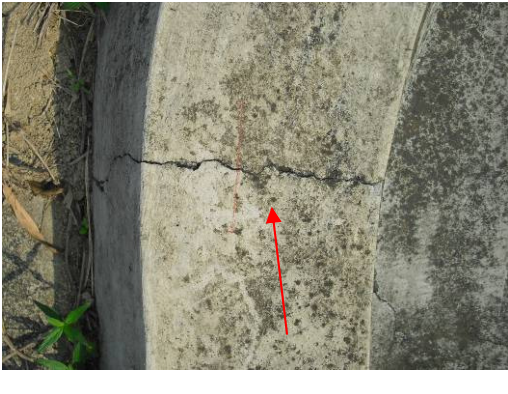
2	2

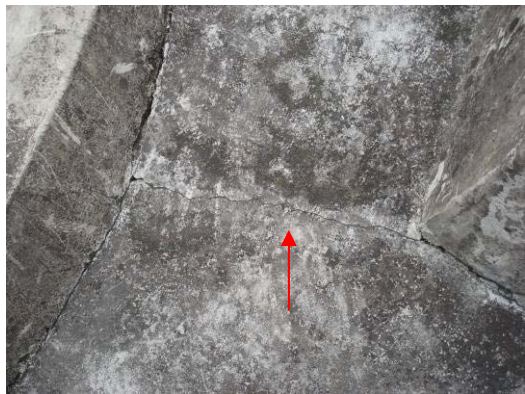
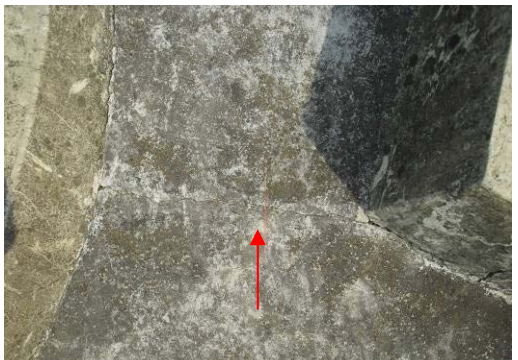
Crack No.	Current Crack Width (mm)	Photographic Record	
		Condition Survey Undertaken on 9 January 2010	Condition Survey Undertaken on 27 February 2010
9	0.4

Crack No.	Width of Crack Recorded on 9 January 2010 (mm)	Width of Crack Recorded on 27 February 2010 (mm)	Difference (mm)
5	5.5	5.6	0.1
7	1.6	1.7	0.1
9	Hair-line	0.4	0.4
10	0.2	1	0.8
14	1.3	1.6	0.3
19	0.1	0.4	0.3
20	0.1	0.9	0.8
25	Hair-line	0.4	0.4
26	1	2.5	1.5

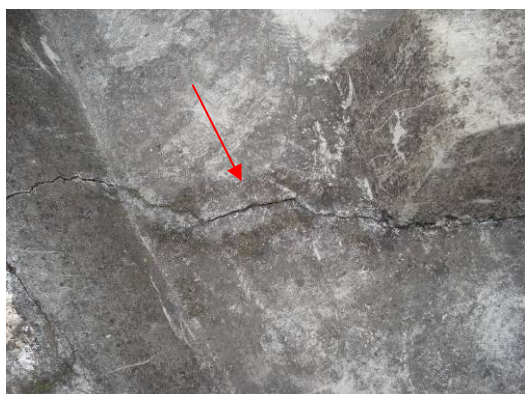
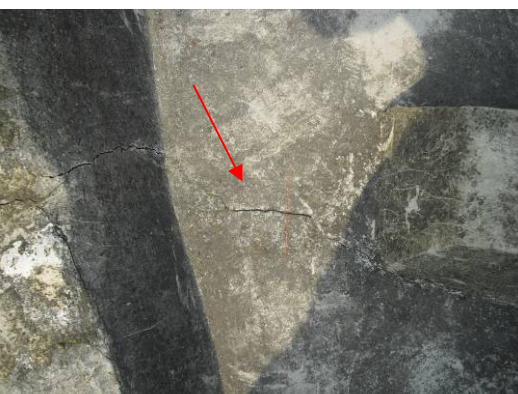
A photograph showing the same horizontal crack in the concrete surface. A red arrow points upwards to the crack.
10	1

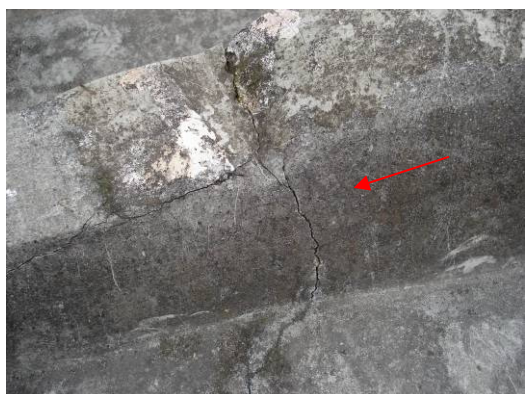
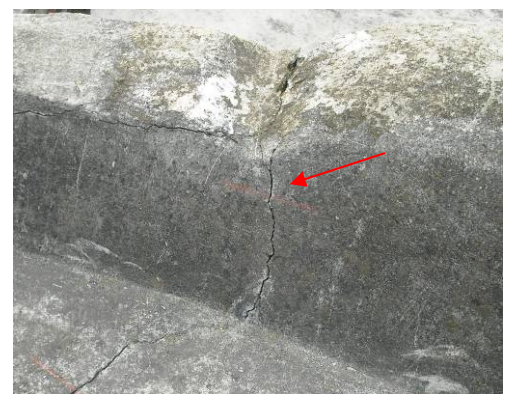
A photograph showing the same horizontal crack in the concrete surface. A red arrow points downwards to the crack.
11	1.5

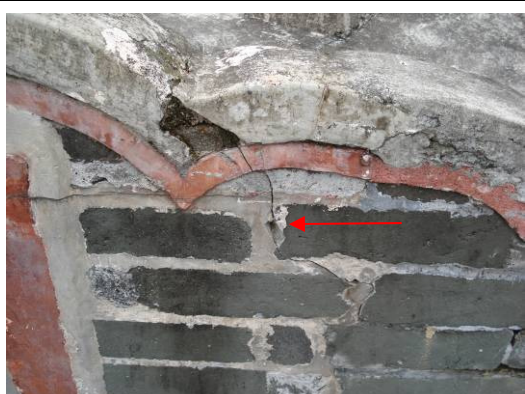
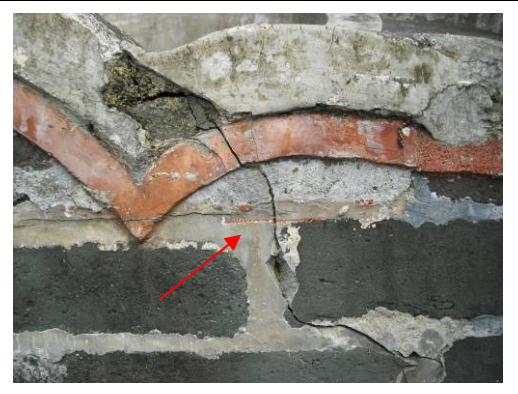
A photograph showing the same vertical crack in the concrete surface. A red arrow points to the right towards the crack.
12	1.6

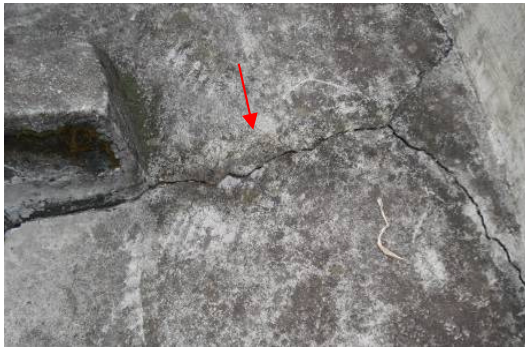
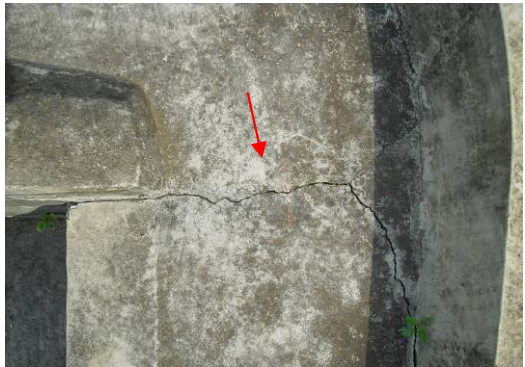
Crack No.	Current Crack Width (mm)	Photographic Record	
		Condition Survey Undertaken on 9 January 2010	Condition Survey Undertaken on 27 February 2010
13	2.9

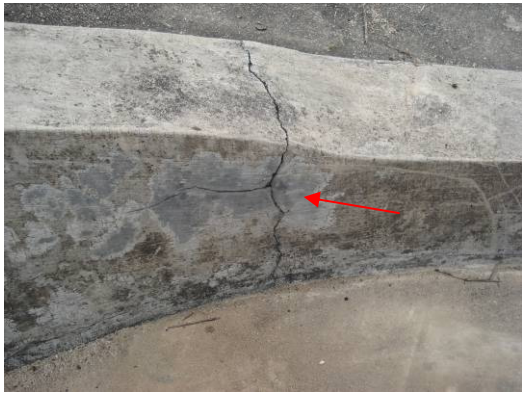
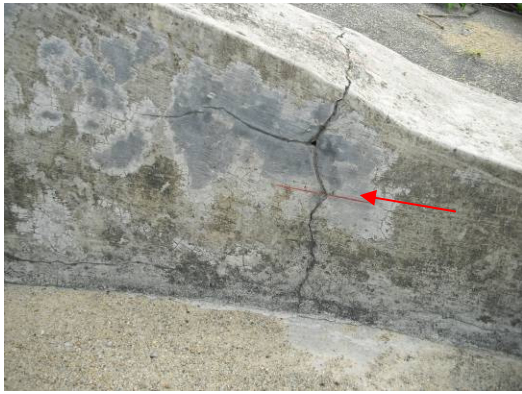
Crack No.	Current Crack Width (mm)	Photographic Record	
		Condition Survey Undertaken on 9 January 2010	Condition Survey Undertaken on 27 February 2010
17	1.6

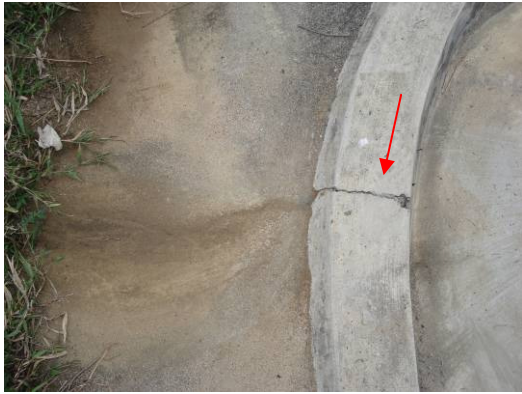
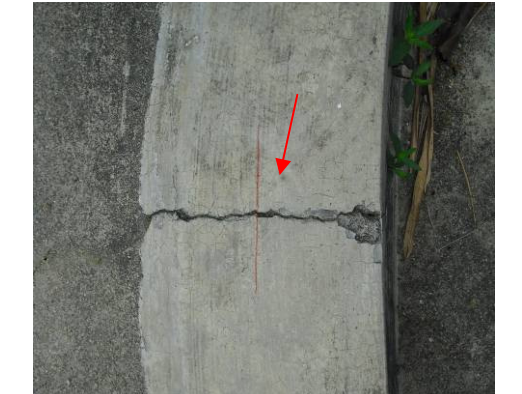
A photograph showing the same vertical crack in the concrete curb. A red arrow points to the crack.
18	2

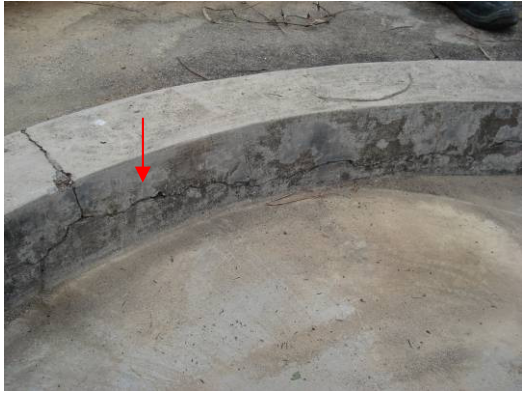
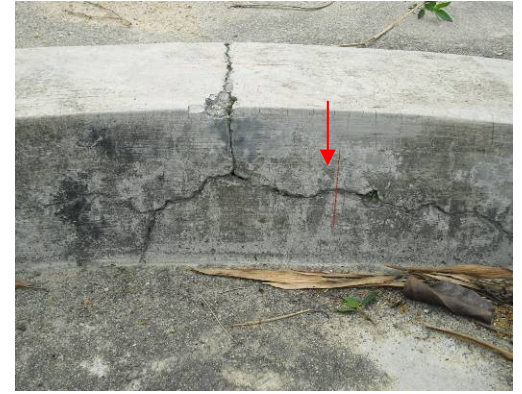
A photograph showing the same horizontal crack in the concrete curb. A red arrow points to the crack.
19	0.4

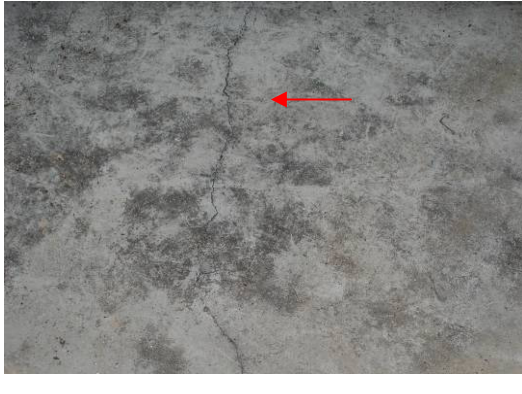
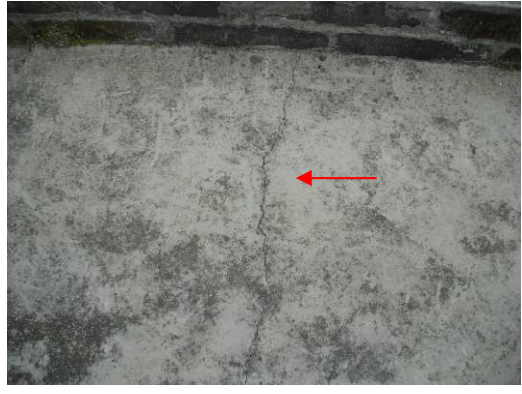
A photograph showing the same horizontal crack in the concrete curb. A red arrow points to the crack.
20	0.9

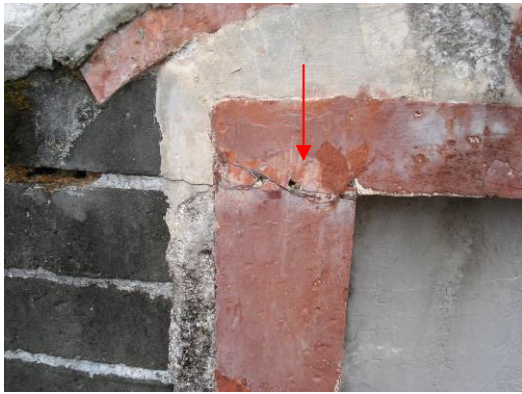
Crack No.	Current Crack Width (mm)	Photographic Record	
		Condition Survey Undertaken on 9 January 2010	Condition Survey Undertaken on 27 February 2010
21	0.5

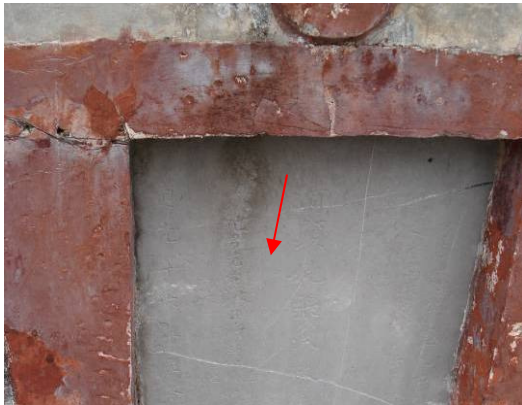
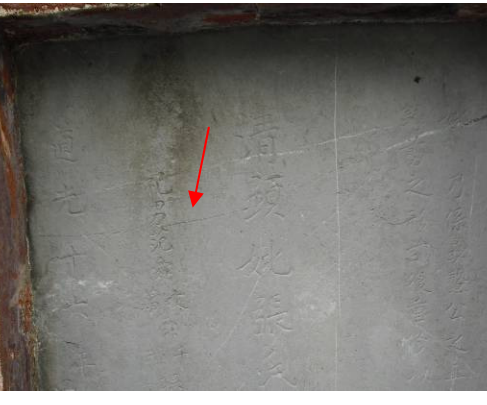
A close-up photograph of a masonry joint. A horizontal crack is visible in the mortar between a red brick and a grey concrete block. A red arrow points to the crack.	  A close-up photograph of the same masonry joint as in the previous image. The crack is still present, and a red arrow points to it.
22	Hair-line

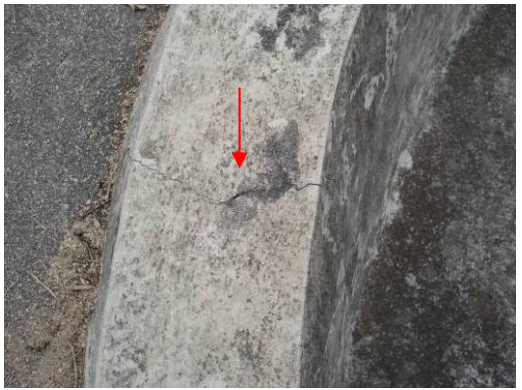
A photograph of a grey concrete surface with faint Chinese characters. A hair-line crack is visible, and a red arrow points to it.
23	Hair-line

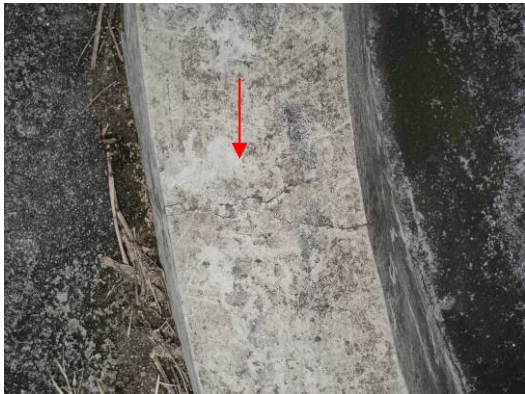
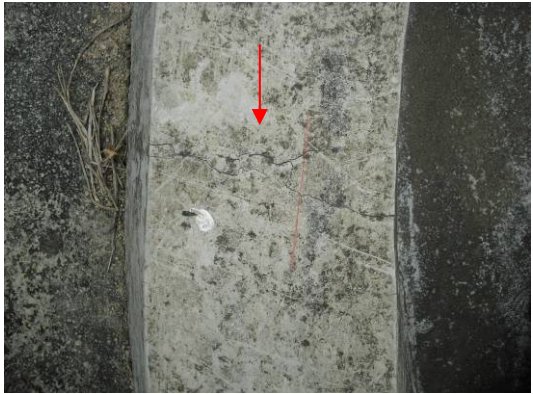
Crack No.	Current Crack Width (mm)	Photographic Record	
		Condition Survey Undertaken on 9 January 2010	Condition Survey Undertaken on 27 February 2010
24	Hair-line

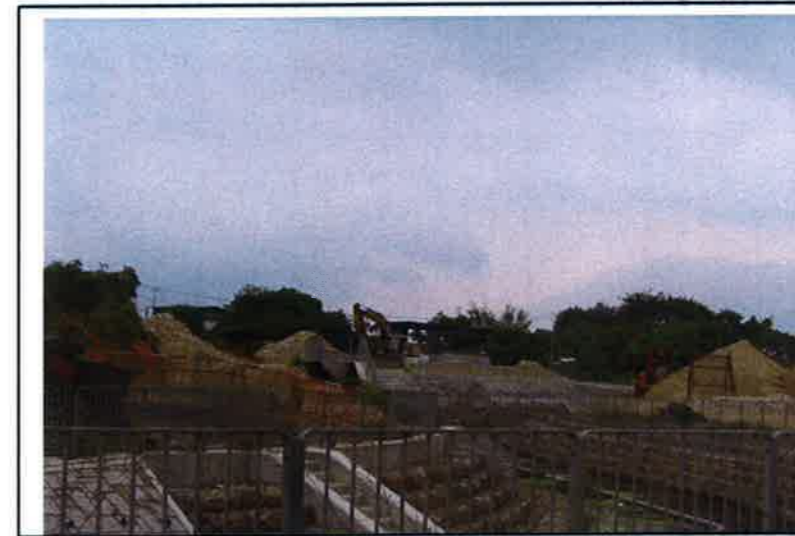
Photo No. A6 – LR2.1

10.7.4	LR2.1 (Fish Pond) within site boundary LR2.2 (Fish Pond) outside site boundary	A6 A7	There are 4 numbers of fallowed fish ponds at the upstream of the Ma On Kong Channel. A chain of fish ponds near downstream but distant from the Channel is noted. The fish ponds cover area of in total 23,000 m2. Most of them are heavily colonized by aquatic plants, which attribute to their low visual quality as a water landscape element. They have low landscape value and sensitive to change.	Minor change due to construction of structures within site boundary. A soil platform was

Fish Pond within site boundary

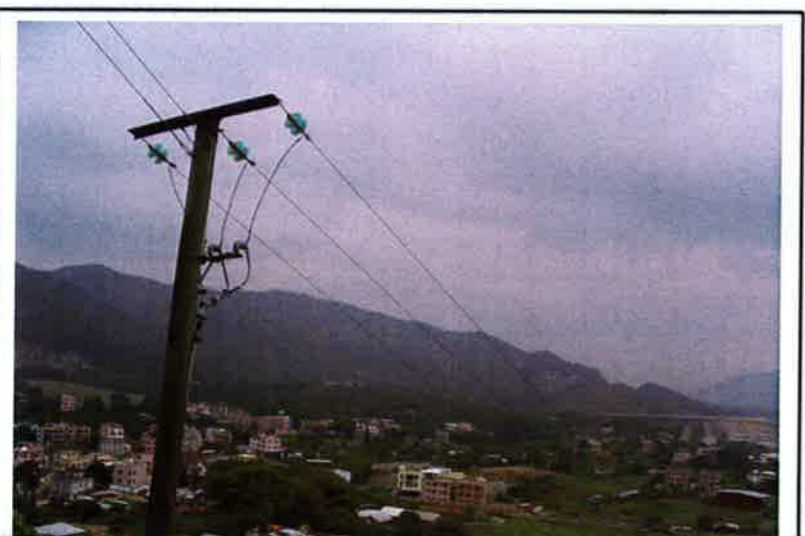
Photo No. A7 – LR2.2

created outside site boundary due to other project was noted.
Marsh				
10.7.5	LR3 (Marsh)	A8	It comprises 2 marshes at the upstream channel of the Channel. They are inundated lowland heavily colonized with wetland aquatic plants. They have low landscape value and sensitive to change.	Remain the same as the baseline
Vegetation

River/Stream

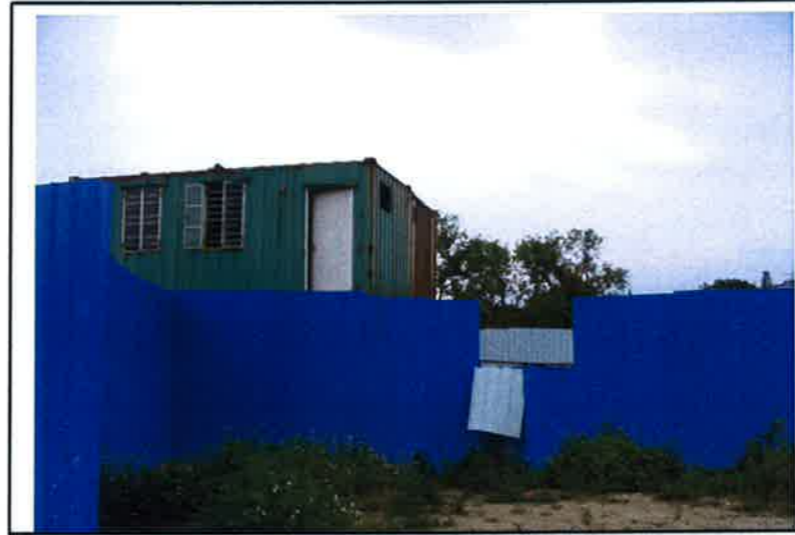
Photo No. B11—LCA 6 Industrial Landscape Character Area

10.7.17	LCA6 (Industrial Landscape Character Area)	B11 & B12	This comprise collection of slummy-built temporary structure and open storage uses land, which are characterized with metallic hoarding and used for poultry, recycling, vehicle repairing etc. The sensitivity to change of this area is low.	Reconstruction of hoarding was conducted by the land owner

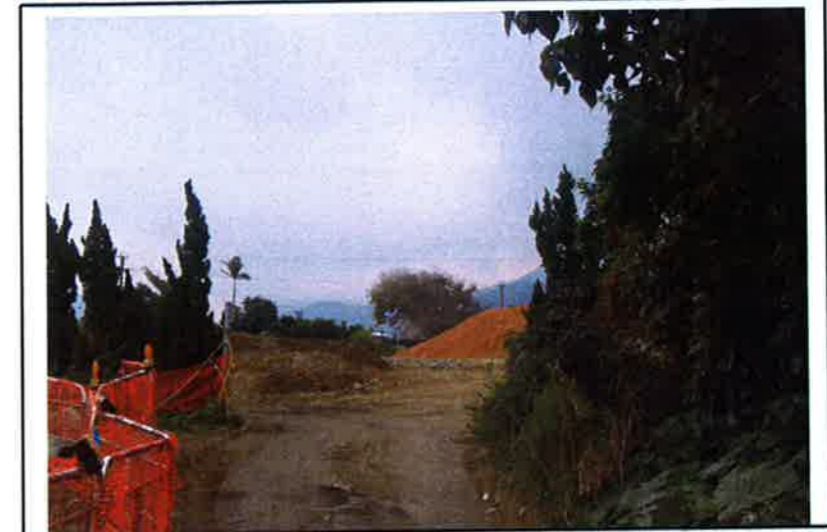
Photo No. C3—I3 Plant Nursery at the east of Ma On Kong Channel

10.7.23	I3	C3	Plant Nursery at the west of Ma On Kong Channel The VSRs is workers of the plant nursery. The number of individual is very few and their sensitivity to visual impacts is low.	Temporary stockpiling was observed

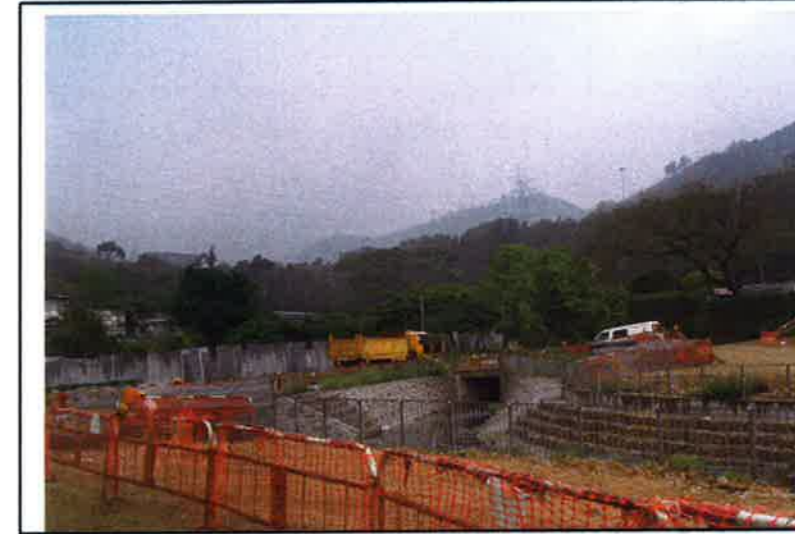
Photo No. A6 – LR2.1

Fish Pond within site boundary
