PROJECT No.: TCS/00408/08

DSD CONTRACT NO. DC/2007/17
DRAINAGE IMPROVEMENT WORKS IN
CHEUNG PO, MA ON KONG, YUEN KONG SAN TSUEN
AND TIN SAM TSUEN OF YUEN LONG DISTRICT AND
SEWERAGE AT TSENG TAU CHUNG TSUEN, TUEN MUN

MONTHLY EM&A REPORT FOR KT13
(JUNE 2010)

Scope: Condition survey and settlement monitoring of a Qing Dynasty Grave.

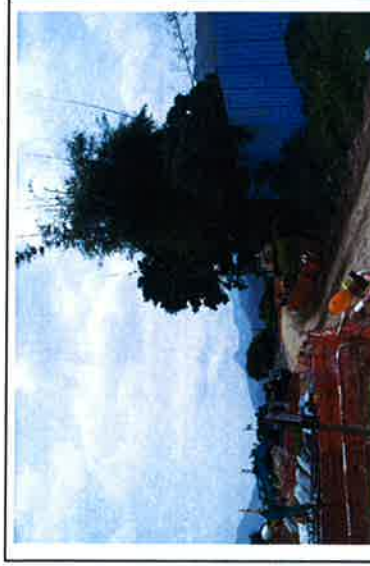
Photo No. C3-13 Plant Nursery at the east of Ma On Kong Channel

10.7.23	I3	C3	Plant Nursery at the west of Ma On Kong Channel The VSRs is workers of the plant nursery. The number of individual is very few and their sensitivity to visual impacts is low.	Temporary stockpiling was observed
