PROJECT No.: TCS/00408/08

DSD CONTRACT NO. DC/2007/17  
DRAINAGE IMPROVEMENT WORKS IN  
CHEUNG PO, MA ON KONG, YUEN KONG SAN TSUEN  
AND TIN SAM TSUEN OF YUEN LONG DISTRICT AND  
SEWERAGE AT TSENG TAU CHUNG TSUEN, TUEN MUN

MONTHLY EM&A REPORT FOR KT13  
(NOVEMBER 2010)

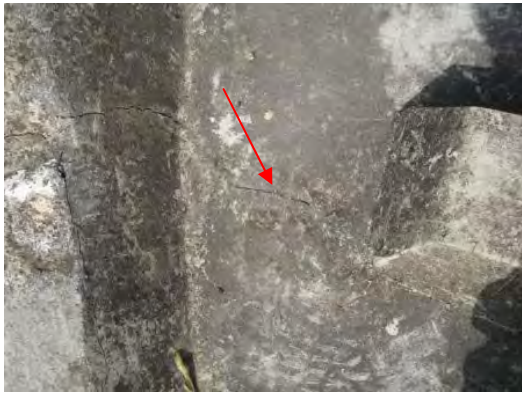
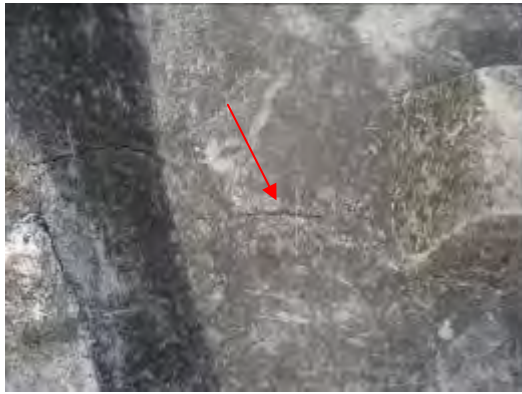
A close-up photograph of the same crack in the concrete surface. A red arrow points to the crack, which appears slightly wider than in the August photograph.
10	1

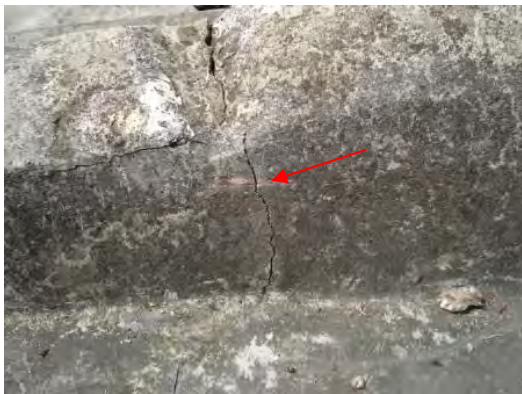
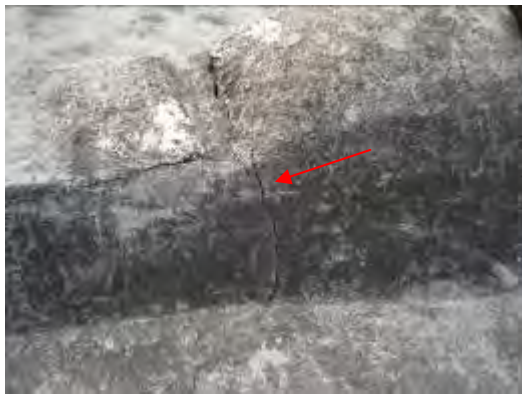
A close-up photograph of the same crack in the concrete surface. A red arrow points to the crack, which appears slightly wider than in the August photograph.
11	1.5

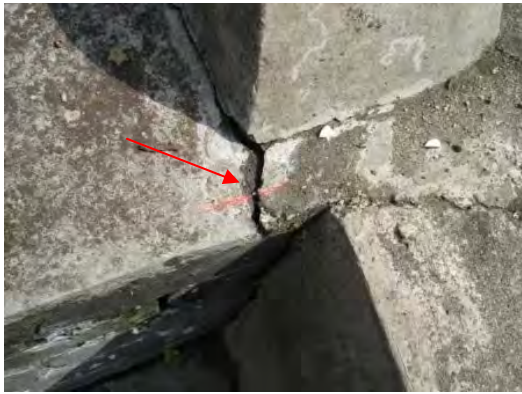
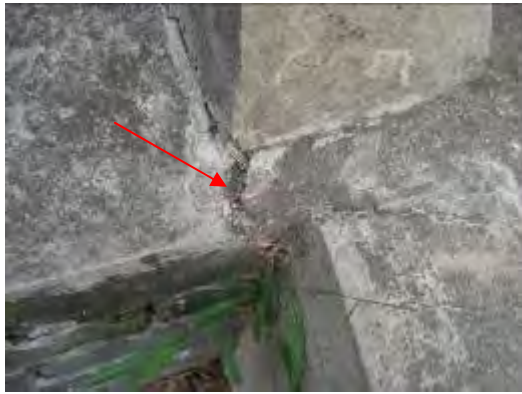
A close-up photograph of the same crack in crack 13, showing its width and texture on 23 October 2010. A red arrow points to the crack.
14	2.1

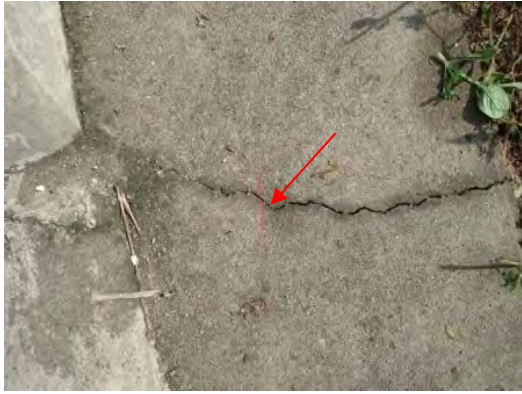
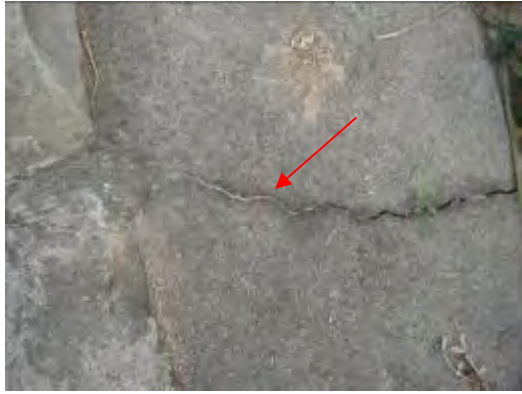
A close-up photograph of the same crack in crack 14, showing its width and texture on 23 October 2010. A red arrow points to the crack.
15	2.7

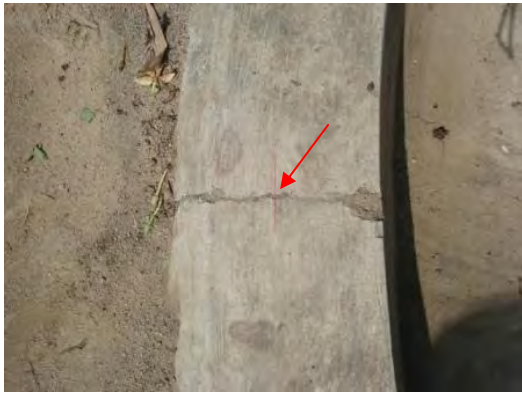
A photograph showing a horizontal crack in a concrete surface. A red arrow points to the crack. The crack is located on a vertical concrete wall.

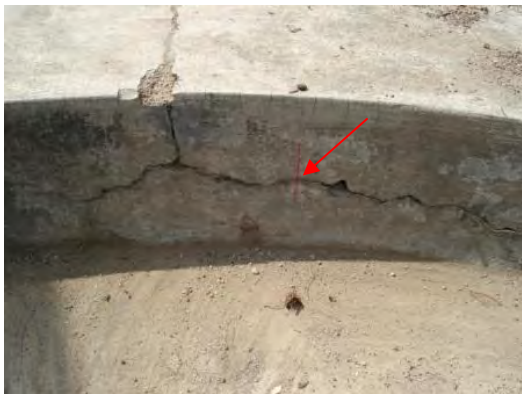
A photograph showing a horizontal crack in a concrete structure. A red arrow points to the crack. The crack is located at the junction of a horizontal concrete ledge and a vertical wall.

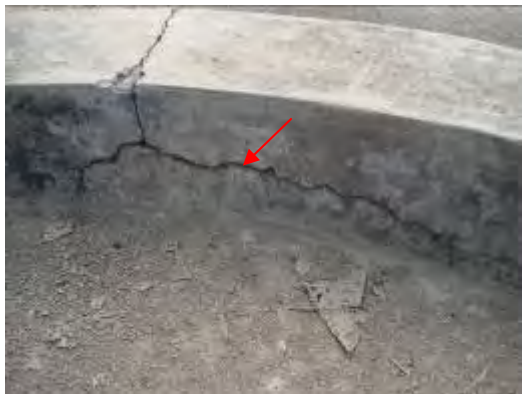
A photograph showing the same crack in the same location. A red arrow points to the crack. The crack appears slightly wider and more irregular than in the August photo.

Crack No.	Width of Crack Recorded on 21 August 2010 (mm)	Width of Crack Recorded on 23 October 2010 (mm)	Difference (mm)
8	1.5	1.6	+0.1
14	2	2.1	+0.1
15	2.5	2.7	+0.2
20	1	1.1	+0.1

In view of the surrounding dense vegetation and the grave being exposed, existing cracks are likely to be slightly widened by weathering (such as raining, intermittent heating and cooling) or root encroachment of overgrown vegetation.

The settlement monitoring suggested that there is no settlement or differential settlement at the grave and therefore the slight increase of crack widths is unlikely due to the construction works. The slight increase of the crack widths will not affect the structural integrity of the grave. However, they

need to be monitored closely in the next condition survey to determine if these cracks will be widened.

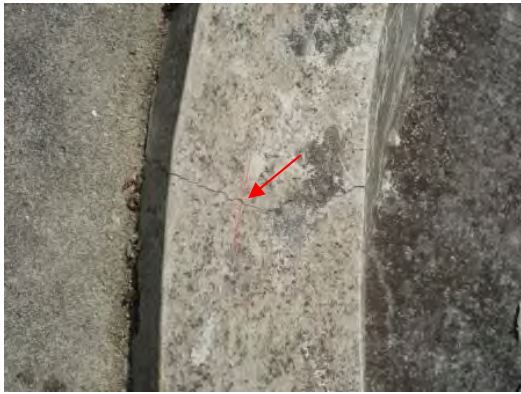
A photograph showing a hair-line crack in a concrete surface. A red arrow points to the crack, which is very thin and barely visible against the grey concrete background.

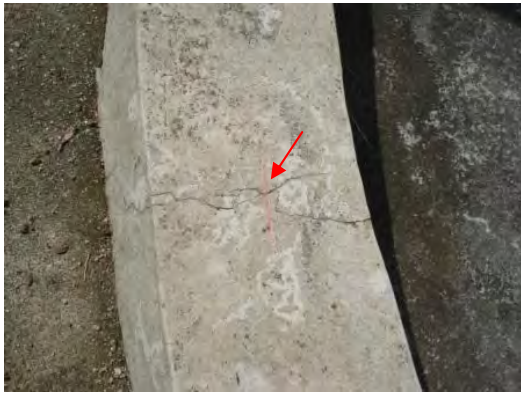
A photograph showing a crack in a concrete surface with a width of 0.5 mm. A red arrow points to the crack, which is clearly visible and has a consistent width.

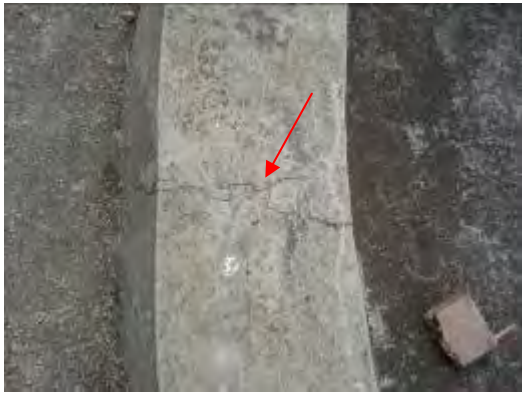
A photograph showing the same crack in the concrete surface. A red arrow points to the crack, which appears to have slightly increased in width compared to the August survey.
25	0.5

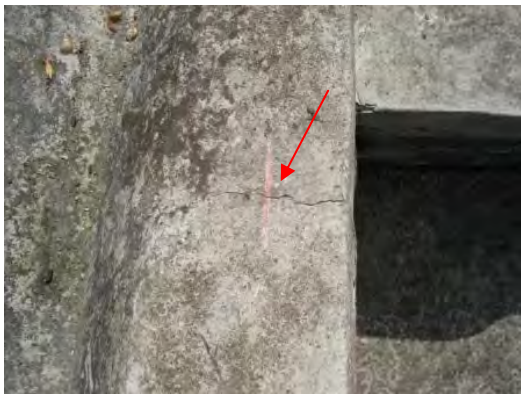
A photograph showing a crack in a concrete surface with a width of 0.5 mm. A red arrow points to the crack, which is clearly visible and has a consistent width.

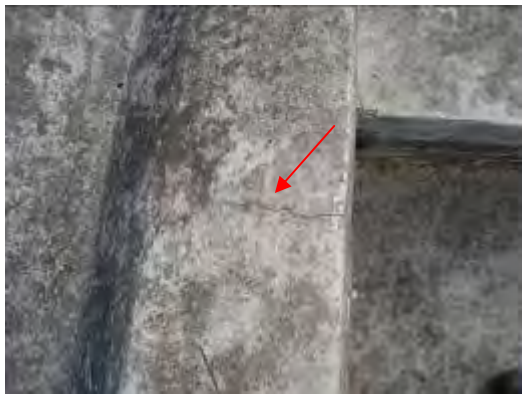
A photograph showing the same crack in the concrete surface. A red arrow points to the crack, which appears to have slightly increased in width compared to the August survey.

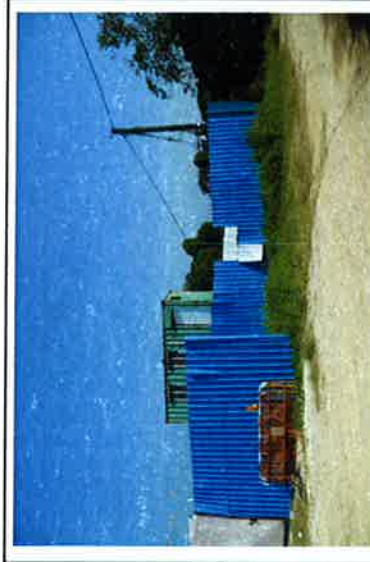
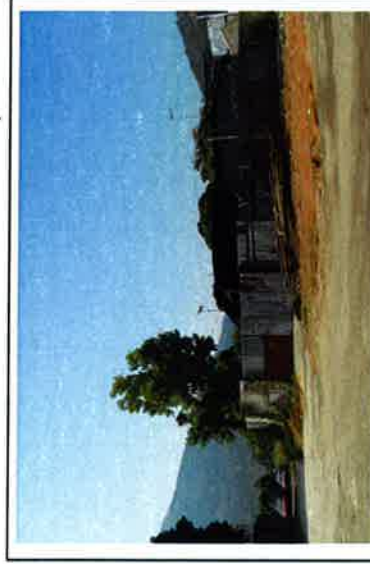
10.7.17	LCA6 (Industrial Landscape Character Area)	B11 & B12	This comprise collection of slummy-built temporary structure and open storage uses land, which are characterized with metallic hoarding and used for poultry, recycling, vehicle repairing etc. The sensitivity to change of this area is low.	Reconstruction of hoarding was conducted by the land owner

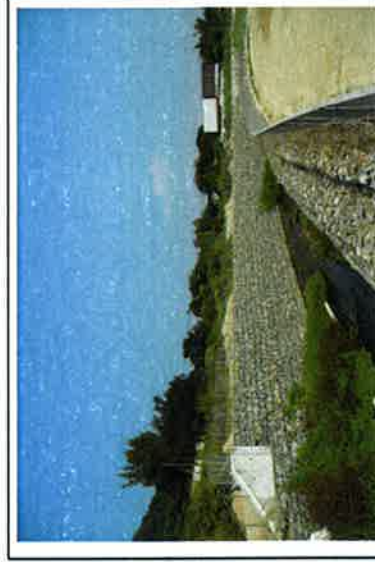
Photo No. A8 – LR3

created outside site boundary due to other project was noted.
<b>Marsh</b>				
10.7.5	LR3 (Marsh)	A8	It comprises 2 marshes at the upstream channel of the Channel. They are inundated lowland heavily colonized with wetland aquatic plants. They have low landscape value and sensitive to change.	Remain the same as the baseline
<b>Vegetation</b>

River/Stream
