PROJECT No.: TCS/00408/08

DSD CONTRACT NO. DC/2007/17  
DRAINAGE IMPROVEMENT WORKS IN  
CHEUNG PO, MA ON KONG, YUEN KONG SAN TSUEN  
AND TIN SAM TSUEN OF YUEN LONG DISTRICT AND  
SEWERAGE AT TSENG TAU CHUNG TSUEN, TUEN MUN

MONTHLY EM&A REPORT FOR KT13  
(DECEMBER 2010)

Date	Reference No.	Prepared By	Certified by
13 January 2011	TCS00408/08/600/R1549v2

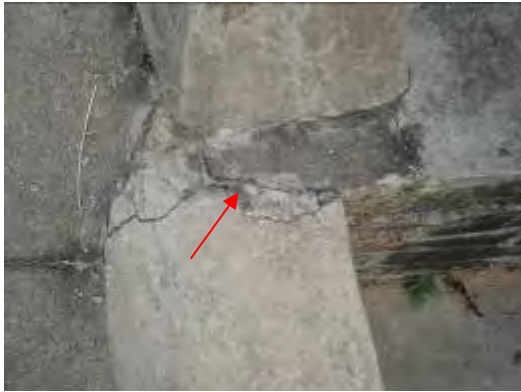
Crack No.	Current Crack Width (mm)	Photographic Record	
		Condition Survey Undertaken on 23 October 2010	Condition Survey Undertaken on 18 December 2010
1	1

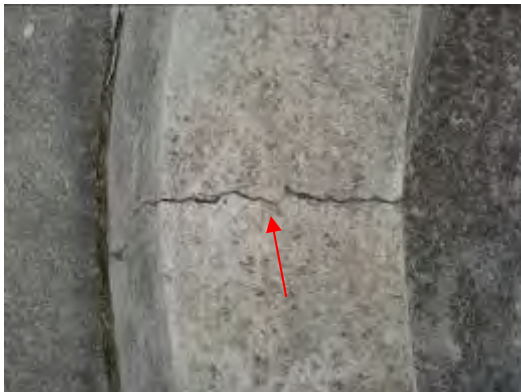
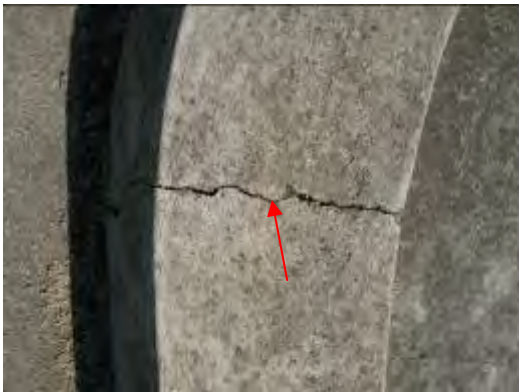
2	2

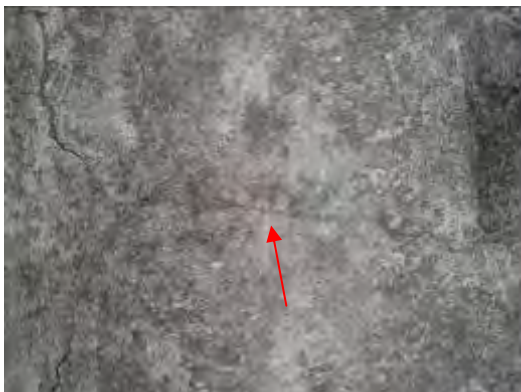
3	1.5

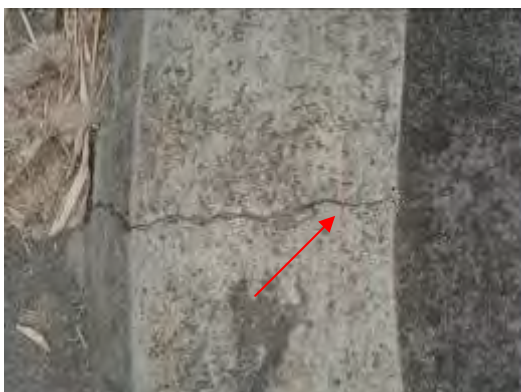
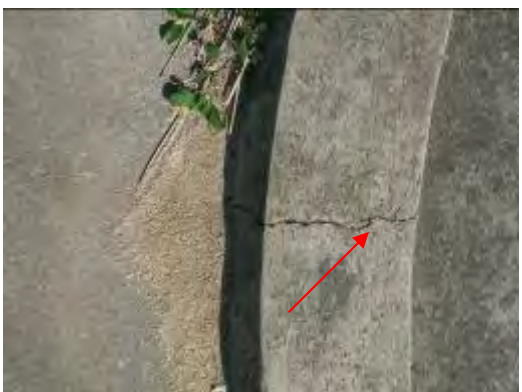
4	1.5

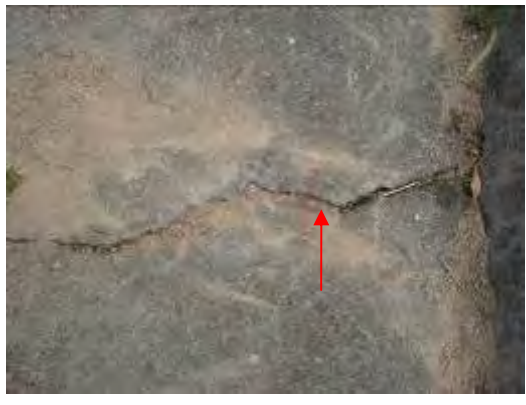
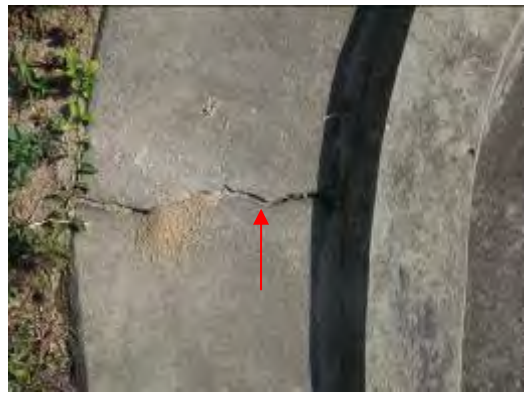
Crack No.	Current Crack Width (mm)	Photographic Record	
		Condition Survey Undertaken on 23 October 2010	Condition Survey Undertaken on 18 December 2010
5	5.6

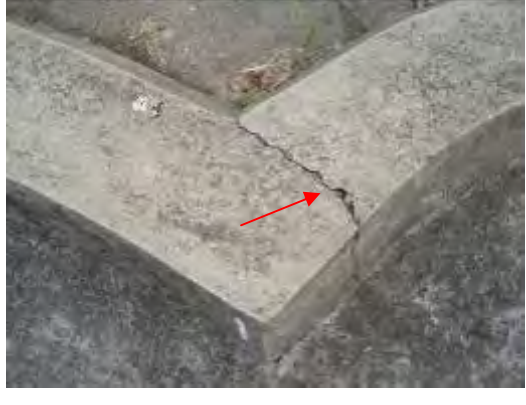
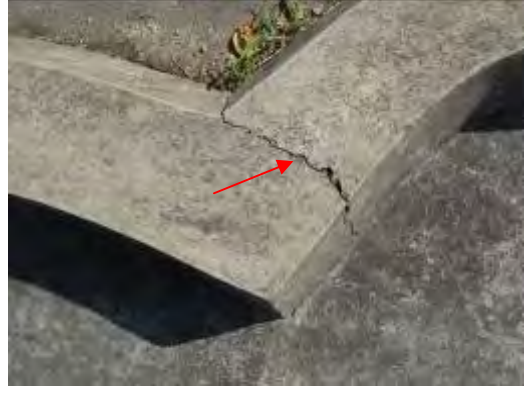
6	1.6

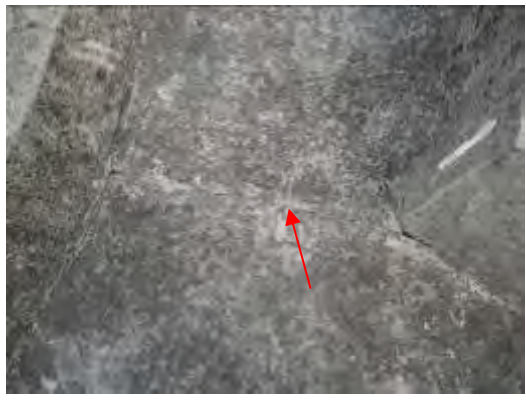
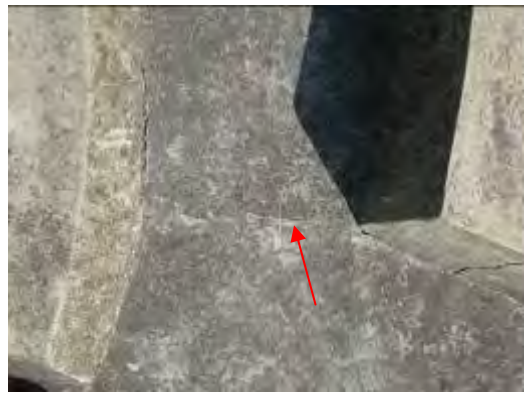
Crack No.	Current Crack Width (mm)	Photographic Record	
		Condition Survey Undertaken on 23 October 2010	Condition Survey Undertaken on 18 December 2010
9	0.5

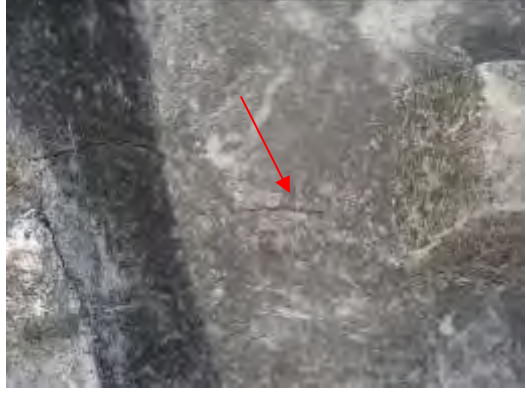
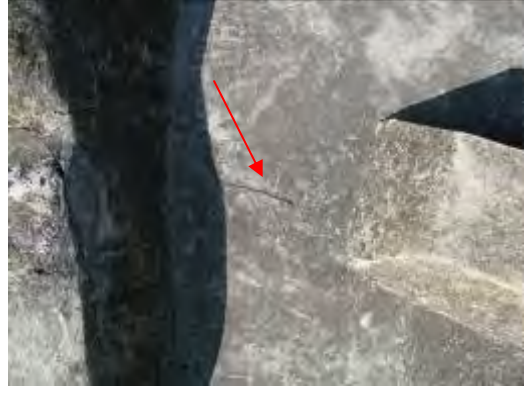
A photograph showing the same crack in the concrete surface as in the October 2010 survey. A red arrow points to the crack. The crack appears slightly wider or more defined.
10	1

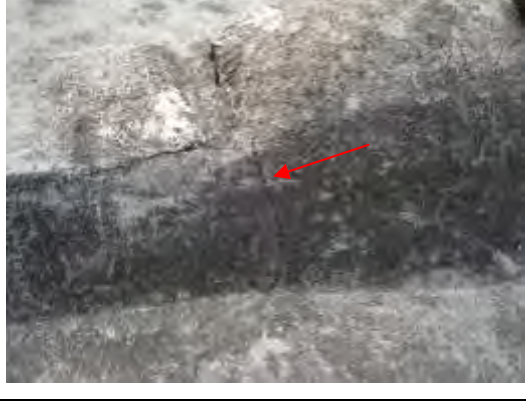
A photograph showing the same crack in the concrete surface as in the October 2010 survey. A red arrow points to the crack. The crack appears slightly wider or more defined.
11	1.5

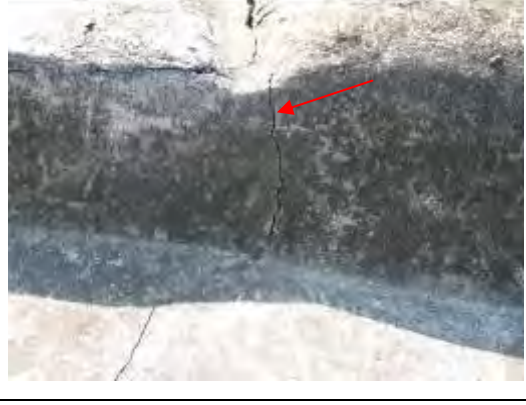
12	1.6

A photograph showing the same crack in the concrete surface as in the October 2010 survey. A red arrow points to the crack. The crack appears slightly wider or more defined.

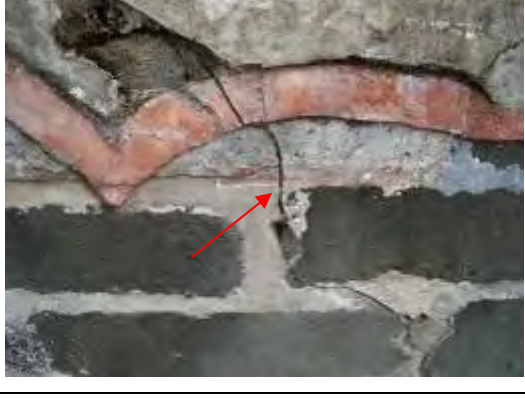
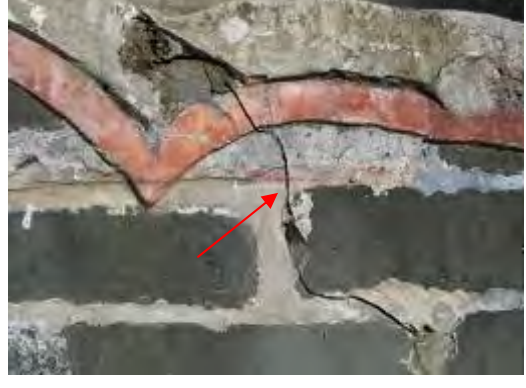
A photograph showing a crack in a concrete surface. A red arrow points to the crack. The surface is dark and appears to be part of a larger structure.

A photograph showing the same crack in the concrete surface as in the October 2010 survey. A red arrow points to the crack. The crack appears slightly wider or more defined.

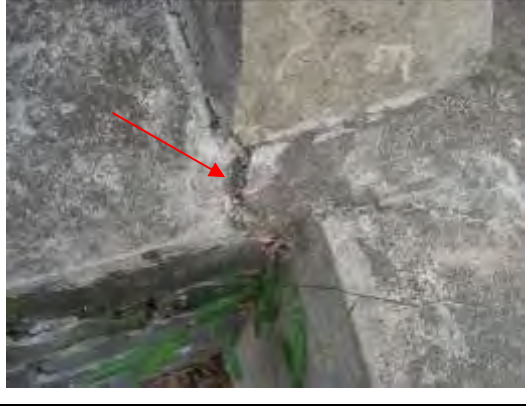
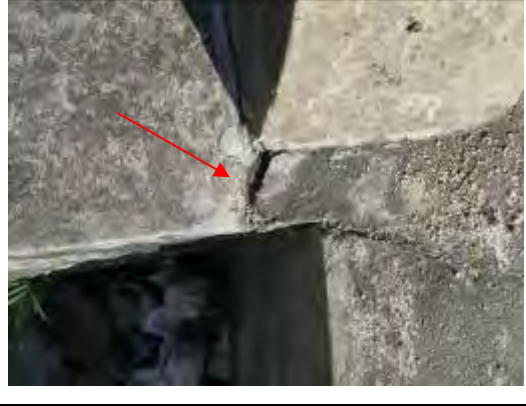
A photograph showing a vertical crack at a joint in a concrete structure. A red arrow points to the crack.

A photograph showing the same vertical crack at the joint. A red arrow points to the crack.
15	2.7

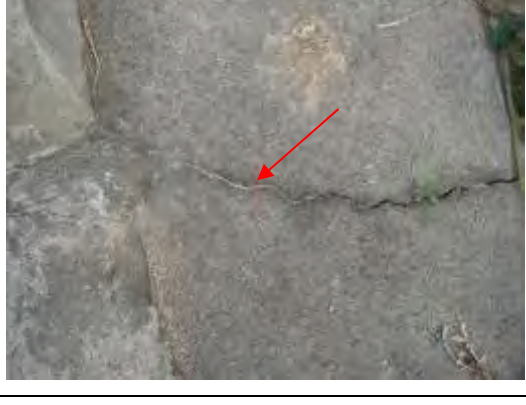
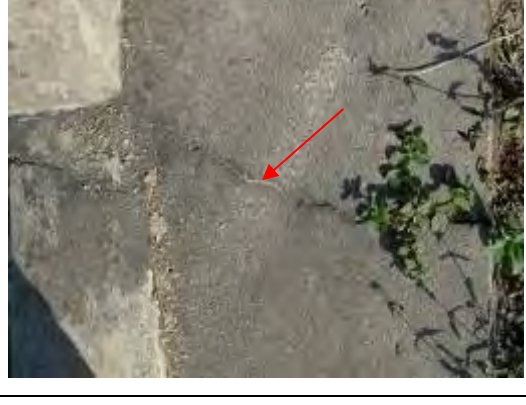
A photograph showing a horizontal crack in a concrete surface. A red arrow points to the crack.

A photograph showing the same horizontal crack in the concrete surface. A red arrow points to the crack.
16	1.7

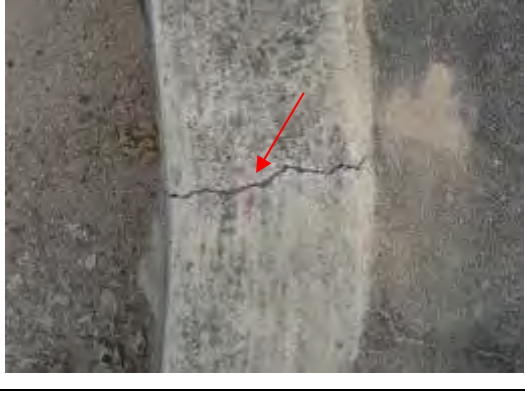
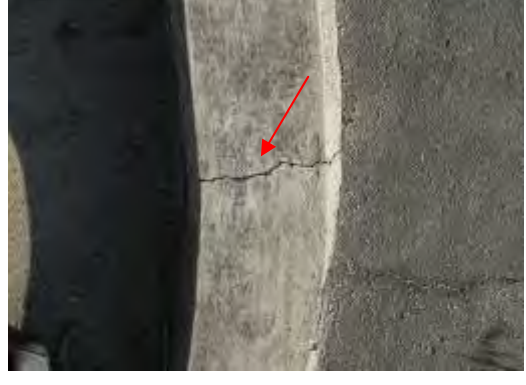
A photograph showing a horizontal crack in a concrete surface. A red arrow points to the crack.

A photograph showing the same horizontal crack in the concrete surface. A red arrow points to the crack.

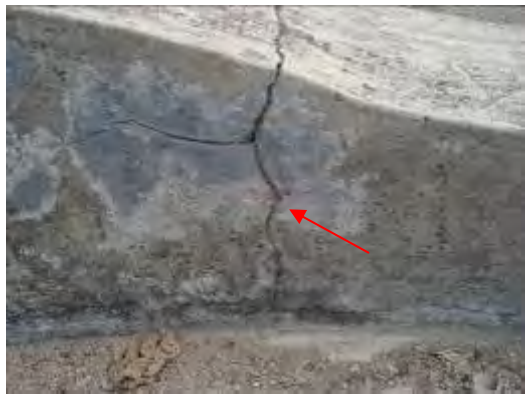
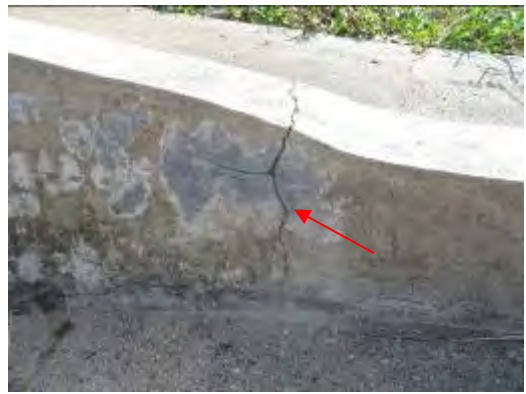
A photograph showing a vertical crack in a concrete surface. A red arrow points to the crack. The crack is located at the base of a concrete curb or edge.

A photograph showing the same vertical crack in the concrete surface as in the October 2010 image. A red arrow points to the crack. The crack appears slightly wider and more irregular.
18	2.2

Crack No.	Width of Crack Recorded on 23 October 2010 (mm)	Width of Crack Recorded on 18 December 2010 (mm)	Difference (mm)
18	2.1	2.2	+0.1

In view of the surrounding dense vegetation and the grave being exposed, existing cracks are likely to be slightly widened by weathering (such as raining, intermittent heating and cooling), root encroachment of overgrown vegetation and the platform built by an unknown third party adjacent to the grave used as a car park since November 2009. *Figures 3.3* and *3.4* show the general views of the platform on the day of monitoring on 18 December 2010.

The settlement monitoring suggested that there is no settlement or differential settlement at the grave and therefore the slight increase of crack width is unlikely due to the construction works. The slight increase of the crack width will not affect the structural integrity of the grave. However, they need to be monitored closely in the next condition survey to determine if these cracks will be widened.

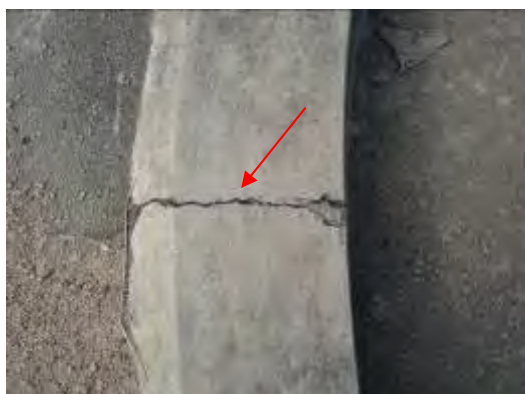
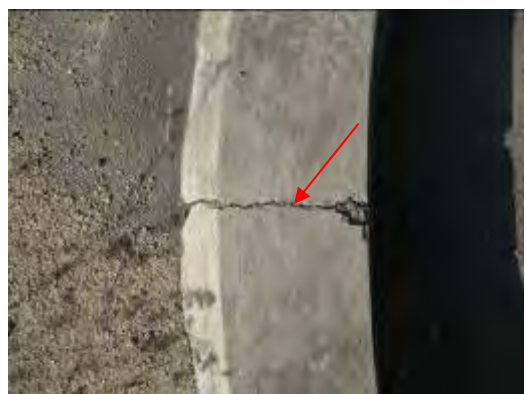
A close-up photograph of a horizontal crack in a concrete surface. A red arrow points to the crack. The crack is located on a vertical concrete pillar or wall.

A close-up photograph of the same horizontal crack in the concrete surface. A red arrow points to the crack. The crack appears slightly wider and more irregular.
19	0.5

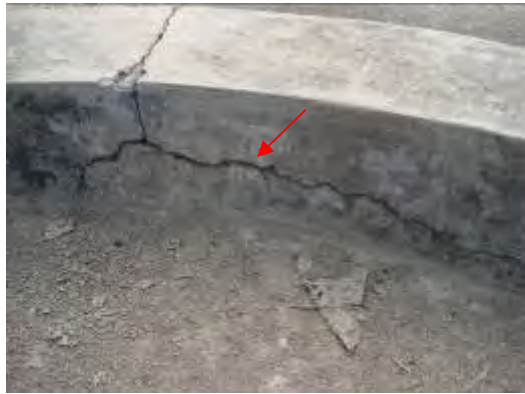
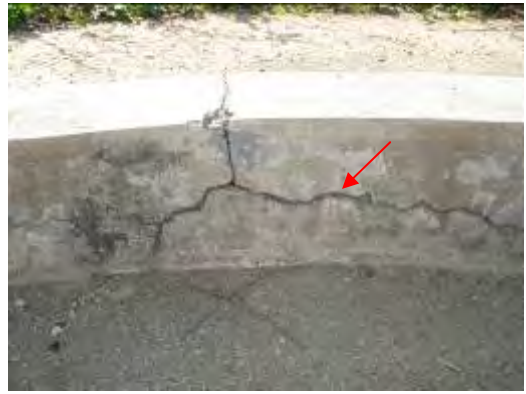
A photograph showing a horizontal crack in a concrete surface. A red arrow points to the crack. The crack is located at the base of a concrete curb or edge.

A photograph showing the same horizontal crack in the concrete surface as in the October 2010 image. A red arrow points to the crack. The crack appears slightly wider and more irregular.

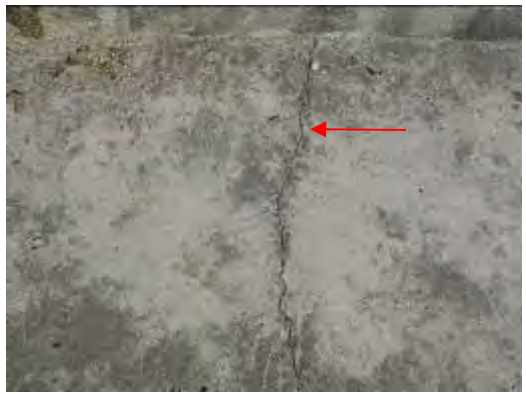
Crack No.	Current Crack Width (mm)	Photographic Record	
		Condition Survey Undertaken on 23 October 2010	Condition Survey Undertaken on 18 December 2010
20	1.1	  A photograph showing a vertical crack in a concrete surface. A red arrow points to the crack.

A photograph showing the same vertical crack in the concrete surface. A red arrow points to the crack.
21	0.5

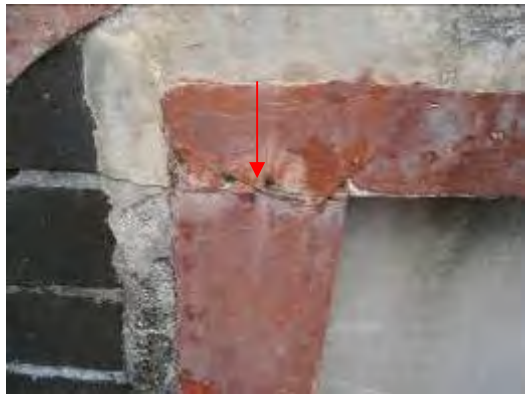
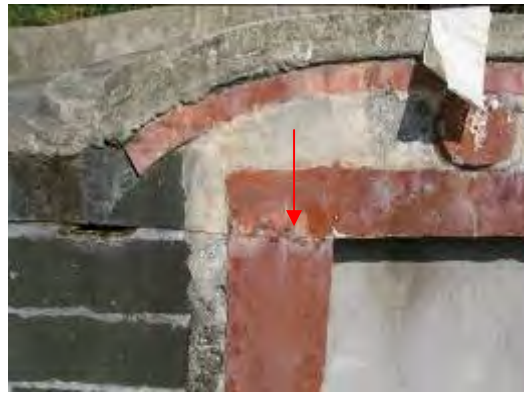
A close-up photograph of a crack in a concrete structure. A red arrow points to the crack.

A close-up photograph of the same crack in the concrete structure. A red arrow points to the crack.
22	Hair-line

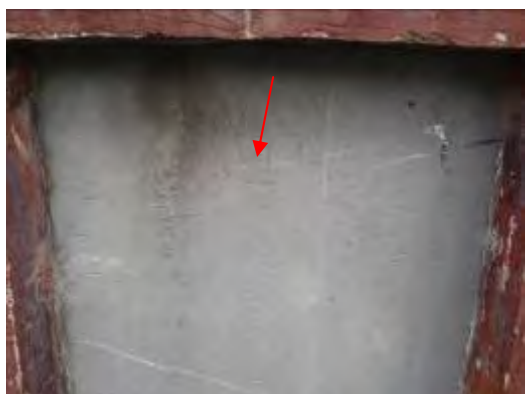
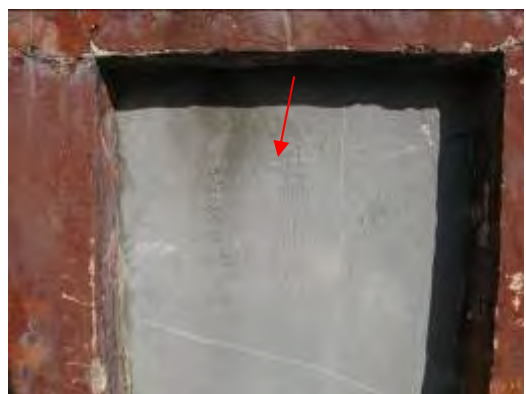
A close-up photograph of a hair-line crack in a concrete surface. A red arrow points to the crack.

A close-up photograph of the same hair-line crack in the concrete surface. A red arrow points to the crack.

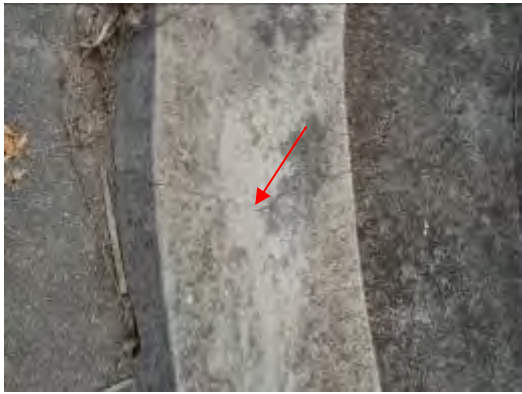
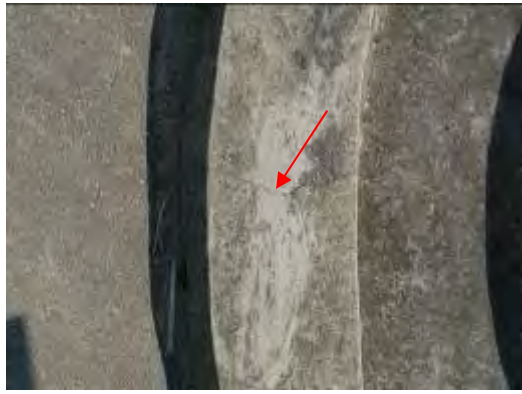
A photograph showing a hair-line crack in a concrete surface. A red arrow points to the crack.

A photograph showing the same hair-line crack in a concrete surface. A red arrow points to the crack.
24	0.5

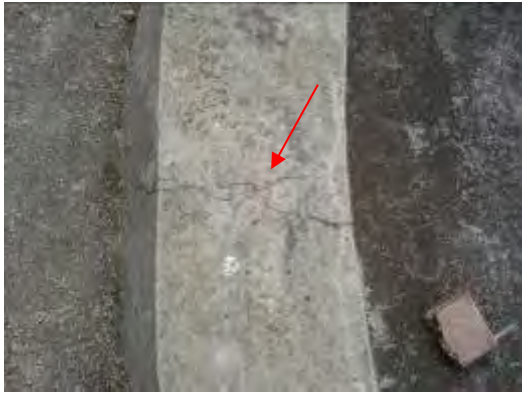
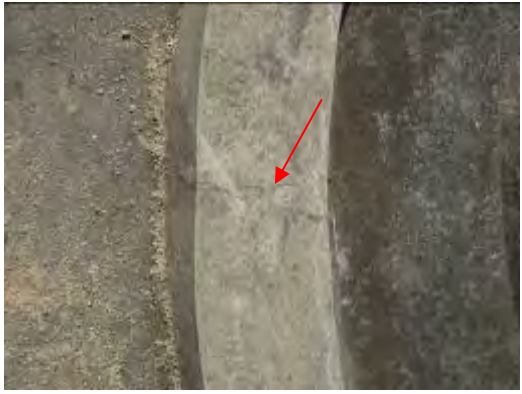
A photograph showing a 0.5 mm wide crack in a concrete surface. A red arrow points to the crack.

A photograph showing the same 0.5 mm wide crack in a concrete surface. A red arrow points to the crack.
25	0.5

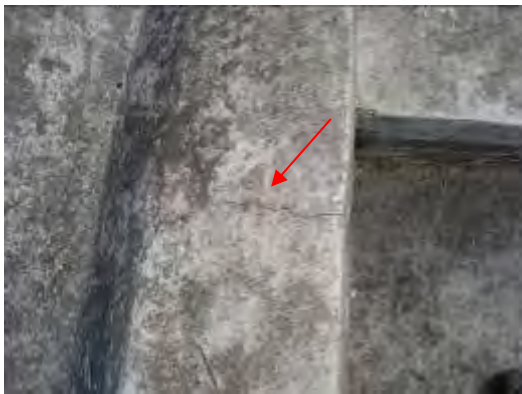
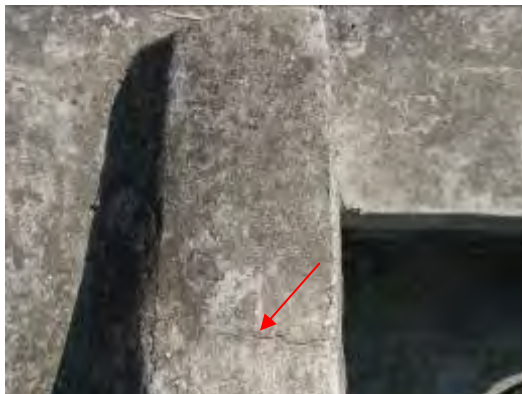
A photograph showing a 0.5 mm wide crack in a concrete surface. A red arrow points to the crack.

A photograph showing the same 0.5 mm wide crack in a concrete surface. A red arrow points to the crack.

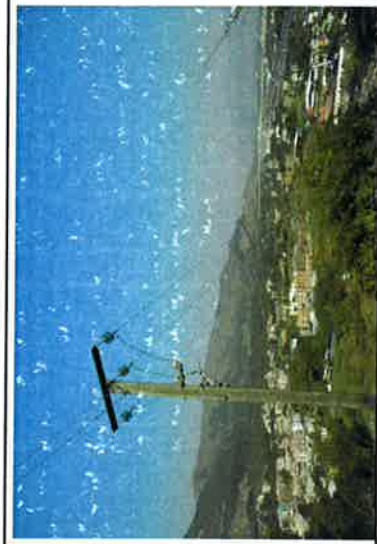
Photo No. A7 – LR2.2  
 River/Stream

10.7.4	LR2.1 (Fish Pond) within site boundary LR2.2 (Fish Pond) outside site boundary	A6 A7	There are 4 numbers of fallowed fish ponds at the upstream of the Ma On Kong Channel. A chain of fish ponds near downstream but distant from the Channel is noted. The fish ponds cover area of in total 23,000 m2. Most of them are heavily colonized by aquatic plants, which attribute to their low visual quality as a water landscape element. They have low landscape value and sensitive to change.	Minor change due to construction of structures within site boundary. A soil platform was

created outside site boundary due to other project was noted.
<b>Marsh</b>				
10.7.5	LR3 (Marsh)	A8	It comprises 2 marshes at the upstream channel of the Channel. They are inundated lowland heavily colonized with wetland aquatic plants. They have low landscape value and sensitive to change.	Remain the same as the baseline
<b>Vegetation</b>

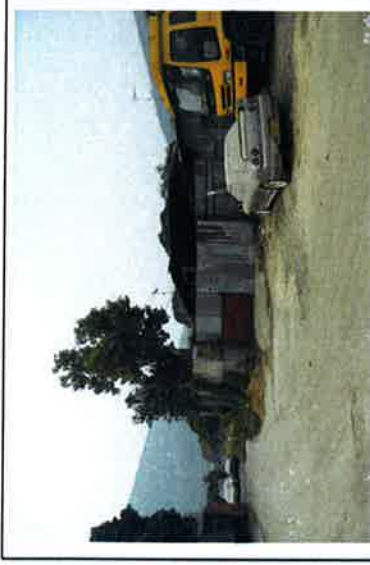
Photo No. B11—LCA 6 Industrial Landscape Character Area

10.7.17	LCA6 (Industrial Landscape Character Area)	B11 & B12	This comprise collection of slummy-built temporary structure and open storage uses land, which are characterized with metallic hoarding and used for poultry, recycling, vehicle repairing etc. The sensitivity to change of this area is low.	Reconstruction of hoarding was conducted by the land owner

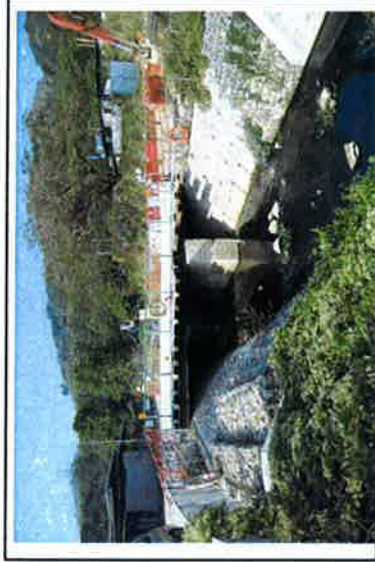
Photo No. A6 – LR2.1

Fish Pond within site boundary

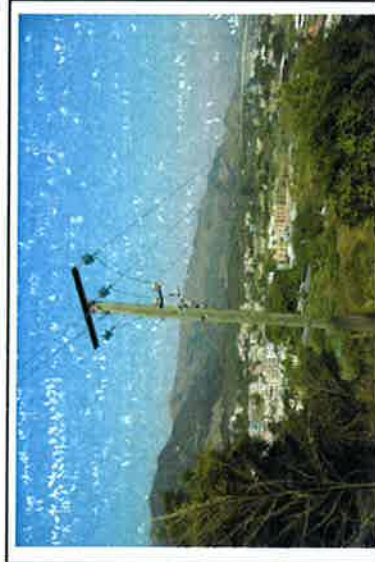
Photo No. A7 – LR2.2

River/Stream

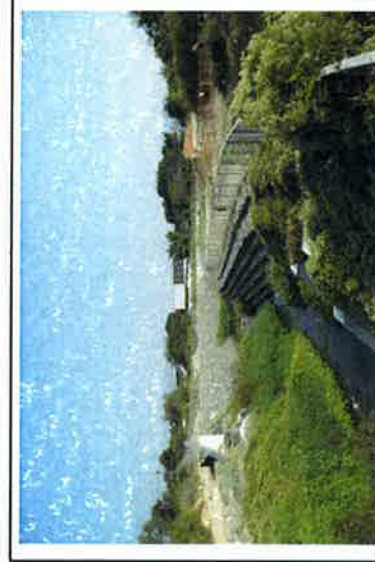
Photo No. A8 – LR3

River/Stream
