DSD CONTRACT NO. DC/2007/17
DRAINAGE IMPROVEMENT WORKS IN
CHEUNG PO, MA ON KONG, YUEN KONG SAN TSUEN
AND TIN SAM TSUEN OF YUEN LONG DISTRICT AND
SEWERAGE AT TSENG TAU CHUNG TSUEN, TUEN MUN

MONTHLY EM&A REPORT FOR KT13
(MARCH 2011)

Condition Survey of the Grave during Construction Phase

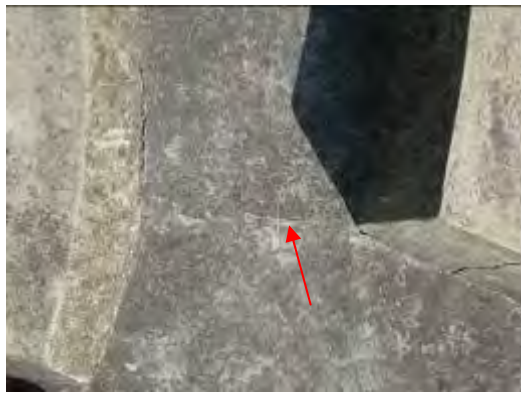
Crack No.	Current Crack Width (mm)	Photographic Record	
		Condition Survey Undertaken on 18 December 2010	Condition Survey Undertaken on 26 February 2011
9	0.5

A close-up photograph of a concrete surface showing a vertical crack. A red arrow points to the crack. The crack is relatively narrow and appears to be in a corner or joint area.

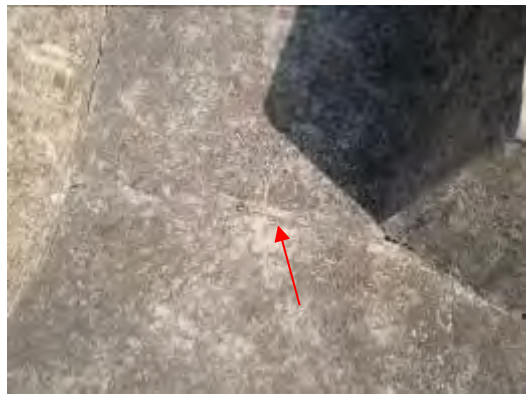
A close-up photograph of the same crack as in the previous image. A red arrow points to the crack. The crack appears slightly wider and more irregular in shape compared to the 2010 survey.
10	1.1

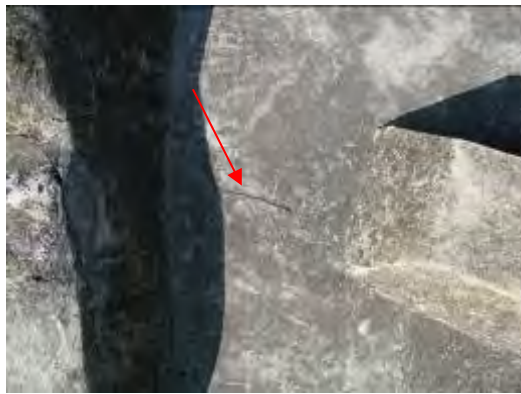
A close-up photograph of a concrete surface showing a vertical crack. A red arrow points to the crack. The crack is wider than crack No. 9 and shows some surface texture.

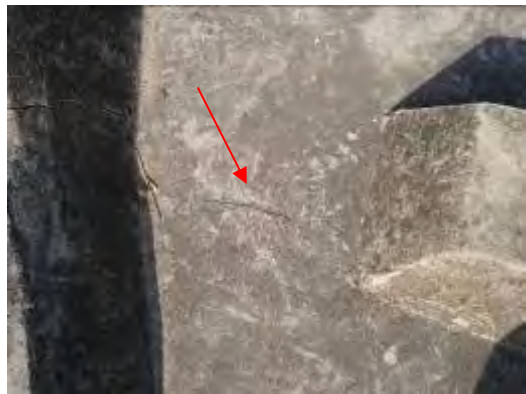
A close-up photograph of the same crack as in the previous image. A red arrow points to the crack. The crack appears wider and more irregular in shape compared to the 2010 survey.

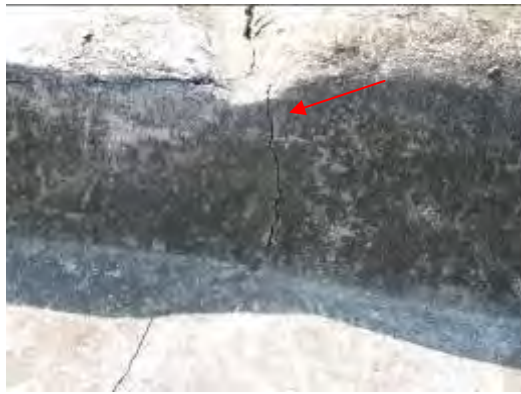
11	1.5

A close-up photograph of a concrete surface showing a vertical crack. A red arrow points to the crack. The crack is wider than crack No. 10 and shows some surface texture.

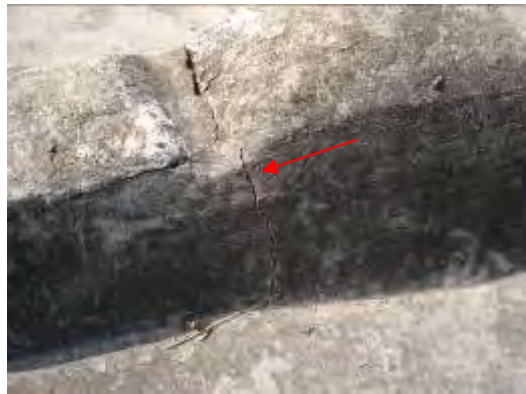
A close-up photograph of the same crack as in the previous image. A red arrow points to the crack. The crack appears wider and more irregular in shape compared to the 2010 survey.
12	1.6

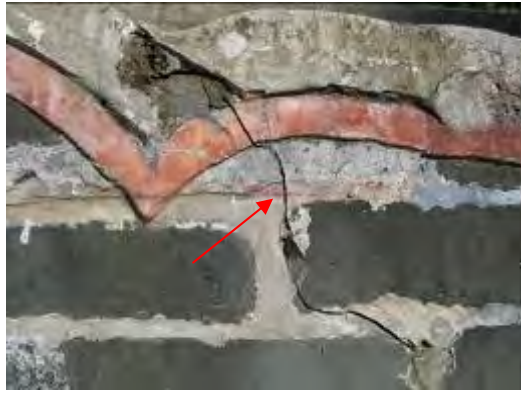
A close-up photograph of a concrete surface showing a vertical crack. A red arrow points to the crack. The crack is wider than crack No. 11 and shows some surface texture.

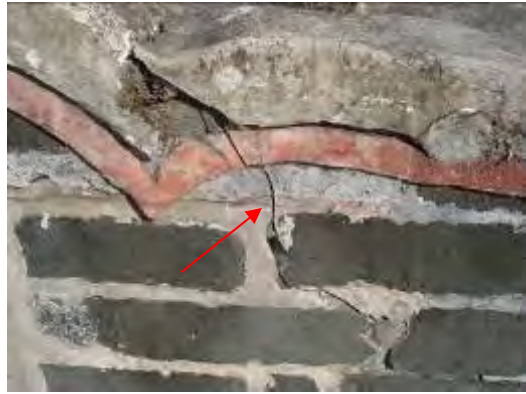
A close-up photograph of the same crack as in the previous image. A red arrow points to the crack. The crack appears wider and more irregular in shape compared to the 2010 survey.

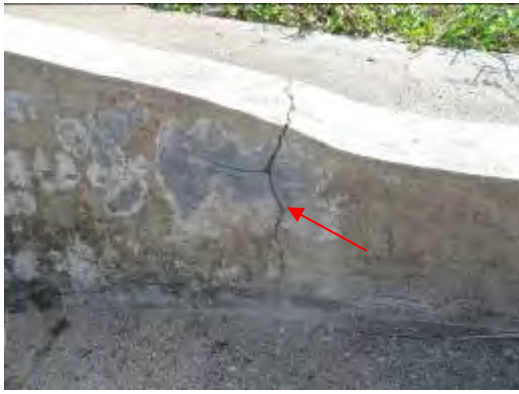
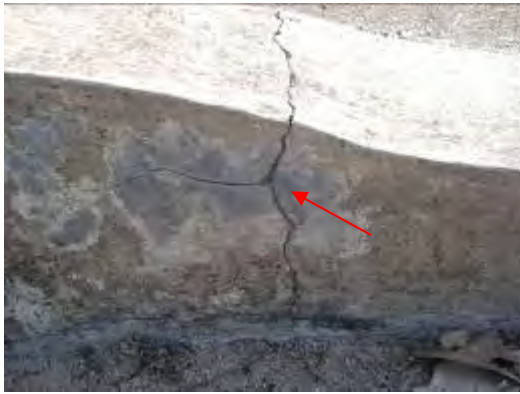
Crack No.	Current Crack Width (mm)	Photographic Record	
		Condition Survey Undertaken on 18 December 2010	Condition Survey Undertaken on 26 February 2011
17	1.7

A photograph showing a vertical crack in a concrete structure. A red arrow points to the crack. The crack is approximately 1.7 mm wide.

A photograph showing the same crack in the concrete structure. A red arrow points to the crack. The crack appears slightly wider than in the 2010 photo.
18	2.2

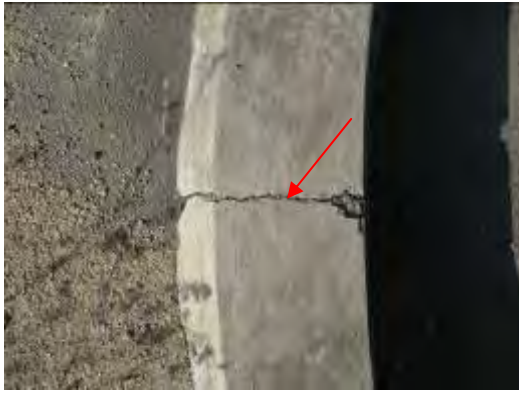
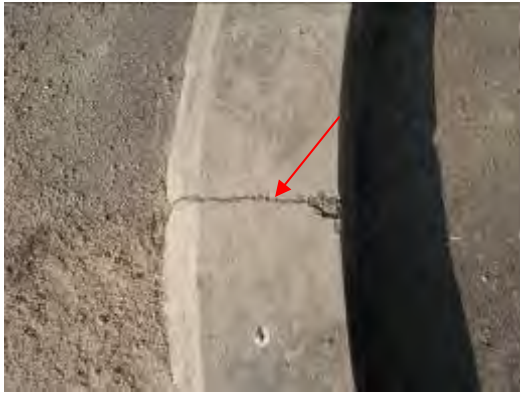
A close-up photograph of a horizontal crack in a concrete surface. A red arrow points to the crack. The crack is approximately 2.2 mm wide.

A close-up photograph of the same horizontal crack. A red arrow points to the crack. The crack appears slightly wider than in the 2010 photo.
19	0.6

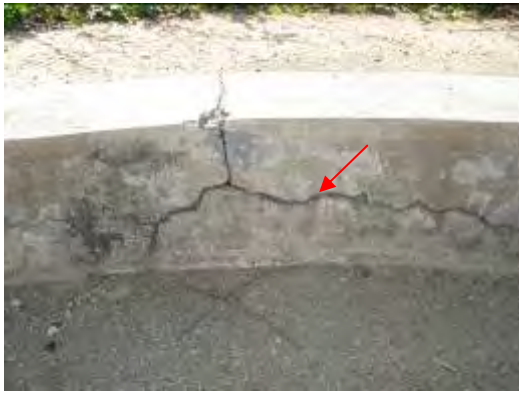
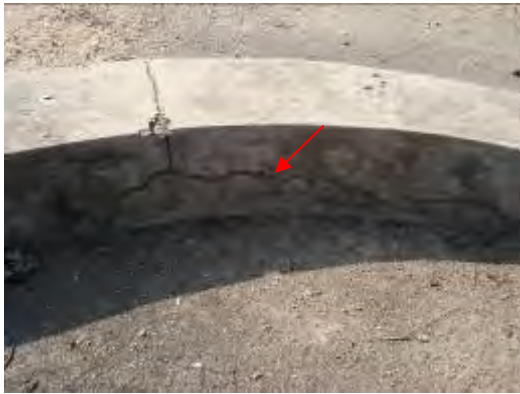
A photograph showing a horizontal crack in a concrete structure. A red arrow points to the crack. The crack is approximately 0.6 mm wide.

A photograph showing the same horizontal crack. A red arrow points to the crack. The crack appears slightly wider than in the 2010 photo.

Crack No.	Width of Crack Recorded on 18 December 2010 (mm)	Width of Crack Recorded on 26 February 2011 (mm)	Difference (mm)
8	1.6	1.8	+0.2
10	1.0	1.1	+0.1
14	2.1	2.2	+0.1
19	0.5	0.6	+0.1

The settlement monitoring suggested that there is no settlement or differential settlement at the grave and therefore the slight increase of crack width is unlikely due to the construction works. The slight increase of the crack width will not affect the structural integrity of the grave. However, they

need to be monitored closely in the next condition survey to determine if these cracks will be widened.

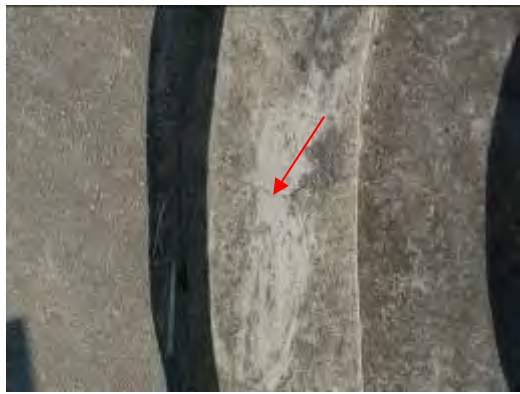
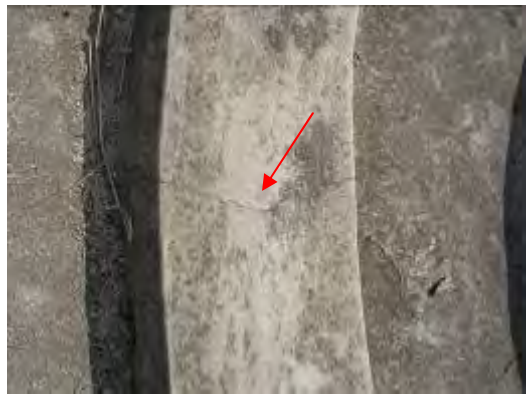
Crack No.	Current Crack Width (mm)	Photographic Record	
		Condition Survey Undertaken on 18 December 2010	Condition Survey Undertaken on 26 February 2011
23	Hair-line

A close-up photograph of a hair-line crack in a concrete surface. A red arrow points to the crack, which is barely visible against the grey concrete background.

A close-up photograph of the same hair-line crack in the concrete surface. A red arrow points to the crack, which remains very faint and narrow.
24	0.5

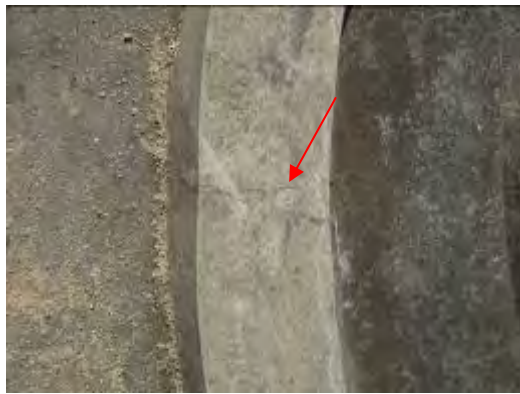
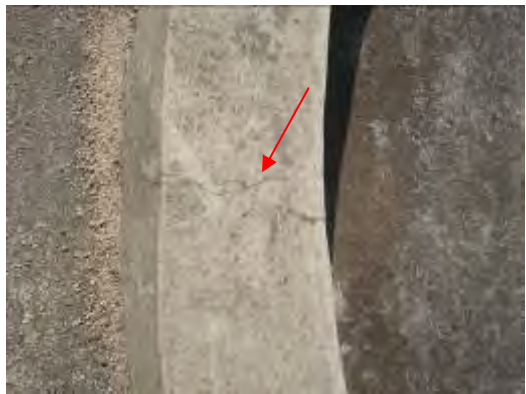
A close-up photograph of a crack in concrete with a width of 0.5 mm. A red arrow points to the crack, which is clearly visible and slightly wider than the hair-line crack.

A close-up photograph of the same crack in concrete. A red arrow points to the crack, which appears to have slightly increased in width or depth compared to the 2010 survey.
25	0.5

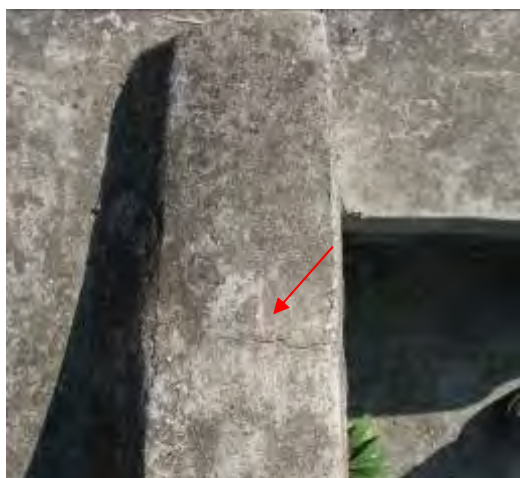
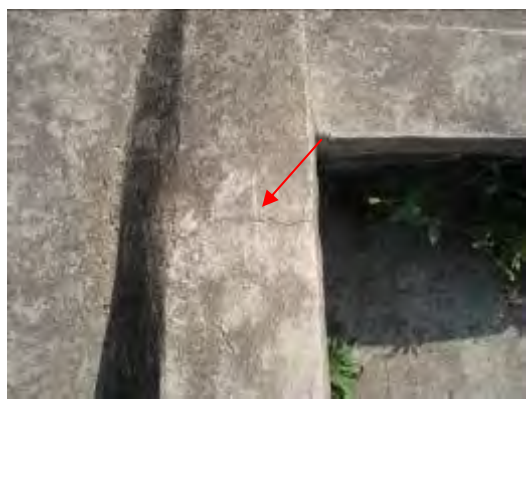
A close-up photograph of a crack in concrete with a width of 0.5 mm. A red arrow points to the crack, which is clearly visible and slightly wider than the hair-line crack.

A close-up photograph of the same crack in concrete. A red arrow points to the crack, which appears to have slightly increased in width or depth compared to the 2010 survey.

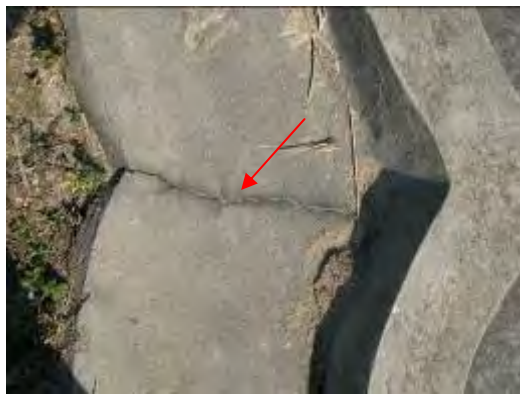
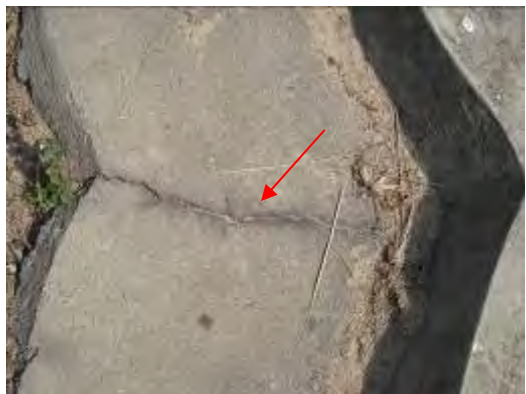
26	2.5

A close-up photograph of a wide crack in concrete with a width of 2.5 mm. A red arrow points to the crack, which is very prominent and shows some surface irregularities.

A close-up photograph of the same wide crack in concrete. A red arrow points to the crack, which appears to have slightly increased in width or depth compared to the 2010 survey.

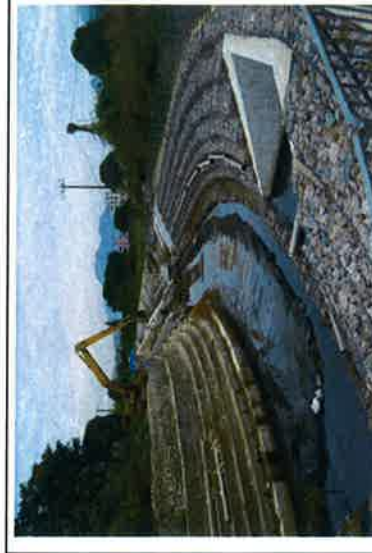
Photo No. A6 – LR2.1

10.7.4	LR2.1 (Fish Pond) within site boundary LR2.2 (Fish Pond) outside site boundary	A6 A7	There are 4 numbers of followed fish ponds at the upstream of the Ma On Kong Channel. A chain of fish ponds near downstream but distant from the Channel is noted. The fish ponds cover area of in total 23,000 m ² . Most of them are heavily colonized by aquatic plants, which attribute to their low visual quality as a water landscape element. They have low landscape value and sensitive to change.	Minor change due to construction of structures within site boundary. A soil platform was

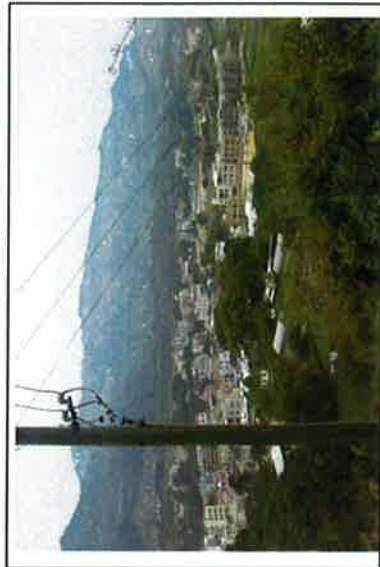
Photo No. A7 – LR2.2

created outside site boundary due to other project was noted.
Marsh				
10.7.5	LR3 (Marsh)	A8	It comprises 2 marshes at the upstream channel of the Channel. They are inundated lowland heavily colonized with wetland aquatic plants. They have low landscape value and sensitive to change.	Remain the same as the baseline
Vegetation

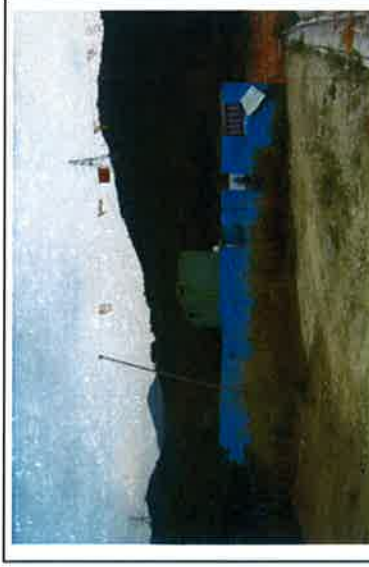
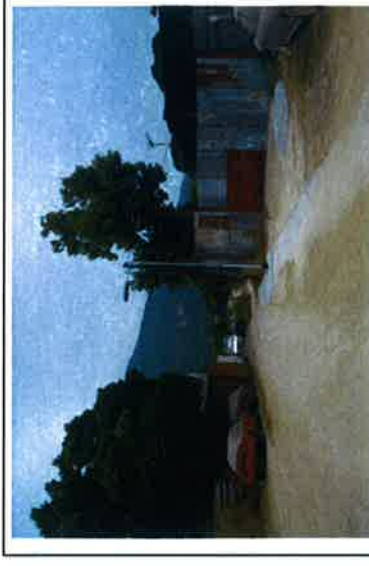
10.7.17	LCA6 (Industrial Landscape Character Area)	B11 & B12	This comprise collection of slummy-built temporary structure and open storage uses land, which are characterized with metallic hoarding and used for poultry, recycling, vehicle repairing etc. The sensitivity to change of this area is low.	Reconstruction of hoarding was conducted by the land owner

Photo No. B11—LCA 6 Industrial Landscape Character Area

Photo No. B12—LCA 6 Industrial Landscape Character Area

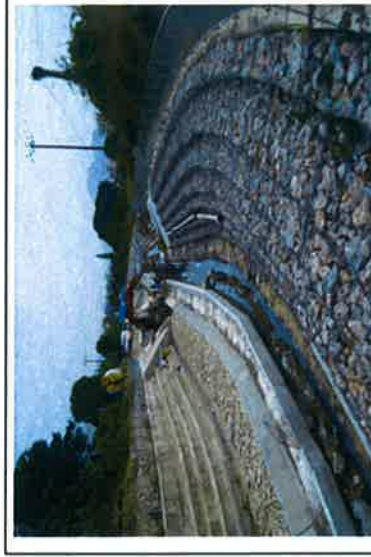
Photo No. A6 – LR2.1

Fish Pond within site boundary

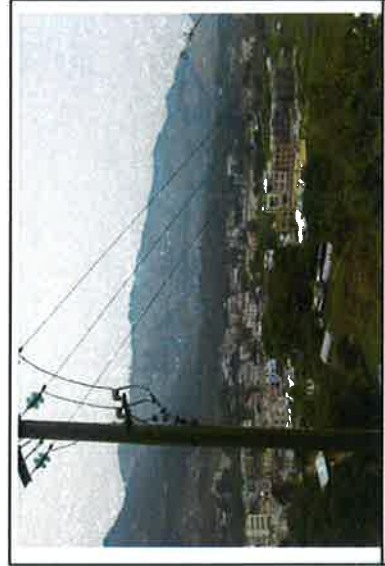
Photo No. A7 – LR2.2

River/Stream

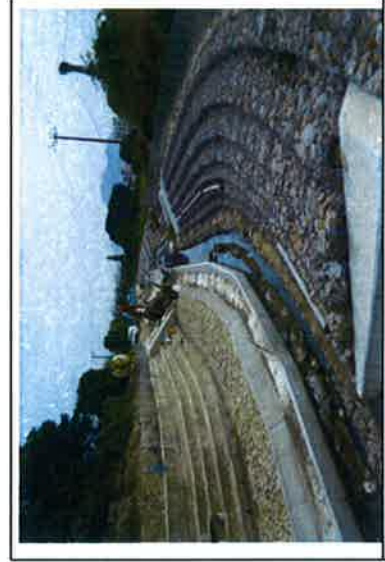
Photo No. A8 – LR3

River/Stream
