PROJECT No.: TCS/00408/08

DSD CONTRACT NO. DC/2007/17
DRAINAGE IMPROVEMENT WORKS IN
CHEUNG PO, MA ON KONG, YUEN KONG SAN TSUEN
AND TIN SAM TSUEN OF YUEN LONG DISTRICT AND
SEWERAGE AT TSENG TAU CHUNG TSUEN, TUEN MUN

MONTHLY EM&A REPORT FOR KT13
(JUNE 2011)

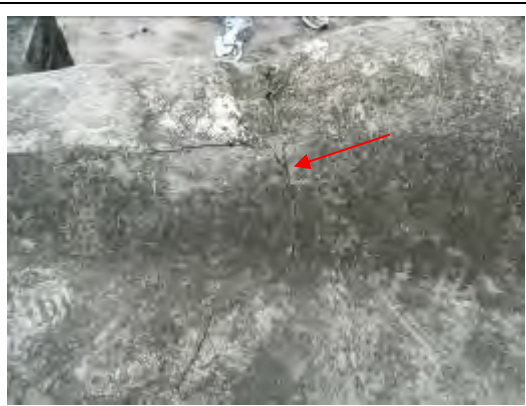
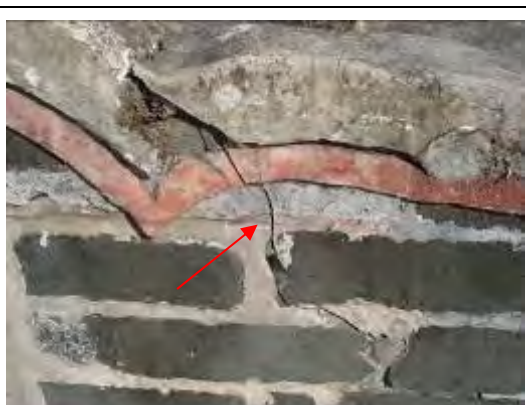
12	1.6

A close-up photograph of the same crack as in the February 2011 image. A red arrow points to the crack. The crack appears very wide and deep, with some debris visible.

A photograph showing a crack in a concrete structure. A red arrow points to the crack. The crack is very wide and appears to be a deep, structural crack. The structure has a reddish-brown coating.

Crack No.	Width of Crack Recorded on 26 February 2011 (mm)	Width of Crack Recorded on 25 June 2011 (mm)	Difference (mm)
11	1.5	1.6	+0.1
19	0.6	0.7	+0.1
26	2.5	2.55	+0.05

In view of the surrounding dense vegetation and the grave being exposed, existing cracks are likely to be slightly widened by weathering (such as raining, intermittent heating and cooling), root encroachment of overgrown vegetation and the platform built by an unknown third party adjacent to the grave used as a car park since November 2009. *Figures 3.3* and *3.4* show the general views of the platform.

The settlement monitoring suggested that there is no settlement or differential settlement at the grave and therefore the slight increase of crack width is unlikely due to the construction works. The slight increase of the crack width will not affect the structural integrity of the grave.

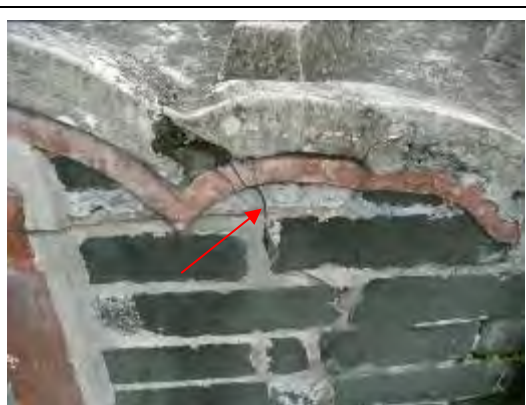
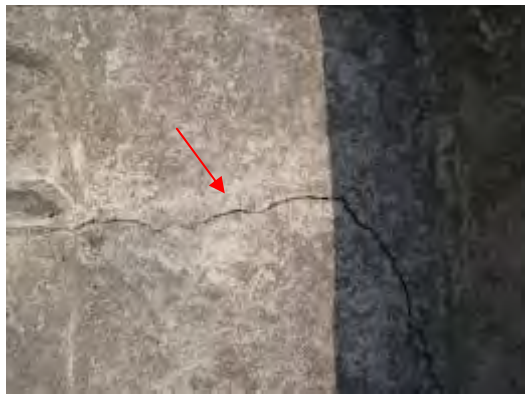
Crack No.	Current Crack Width (mm)	Photographic Record	
		Condition Survey Undertaken on 26 February 2011	Condition Survey Undertaken on 25 June 2011
13	2.9

A photograph showing the same crack as in the February 2011 image. A red arrow points to the crack. The crack appears very wide and deep, with some debris visible. The structure has a reddish-brown coating.

A photograph showing a horizontal crack in a concrete surface. A red arrow points to the crack. The crack is wider in the center and tapers towards the edges.

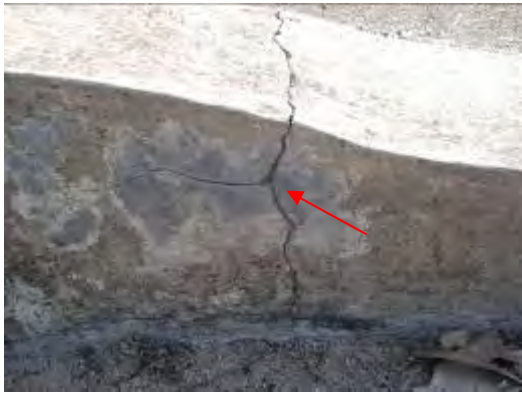
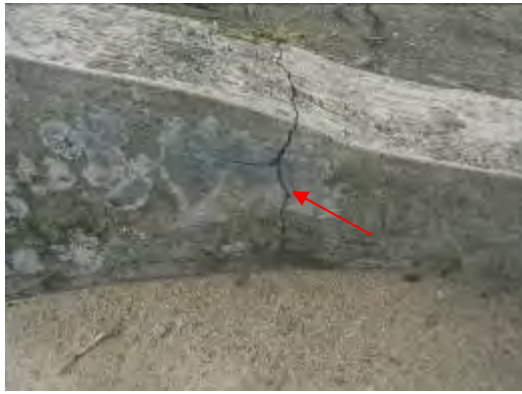
A photograph showing a vertical crack in a concrete surface. A red arrow points to the crack. The crack is located in a curved concrete structure, possibly a bridge pier or abutment.

A photograph showing the same crack in the same location as the previous image. A red arrow points to the crack. The crack appears slightly wider and more irregular in shape compared to the February 2011 image.
18	2.2

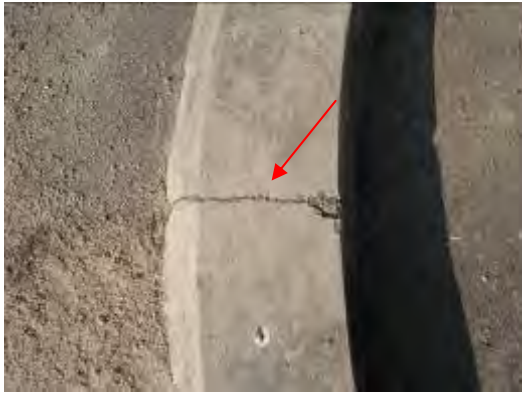
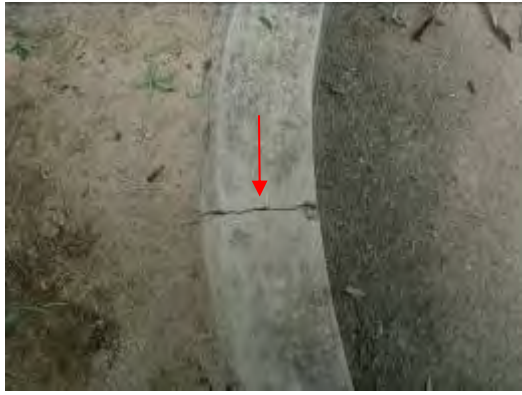
A photograph showing a horizontal crack in a concrete surface. A red arrow points to the crack. The crack is located in a curved concrete structure, possibly a bridge pier or abutment.

A photograph showing the same crack in the same location as the previous image. A red arrow points to the crack. The crack appears slightly wider and more irregular in shape compared to the February 2011 image.

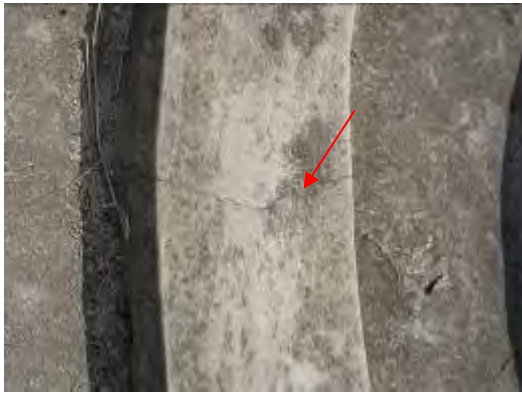
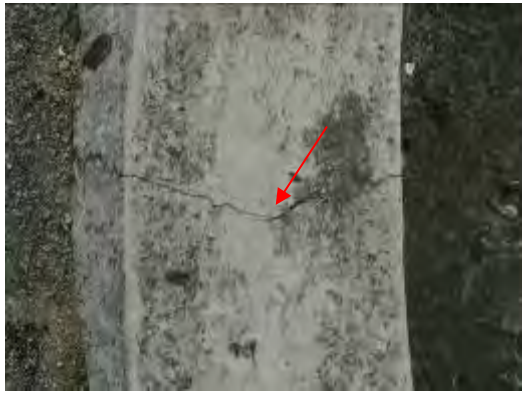
A close-up photograph of a concrete surface showing a very fine, hair-line crack. A red arrow points to the crack.

A close-up photograph of the same crack as in the previous image, showing its progression over time. A red arrow points to the crack.
24	0.5

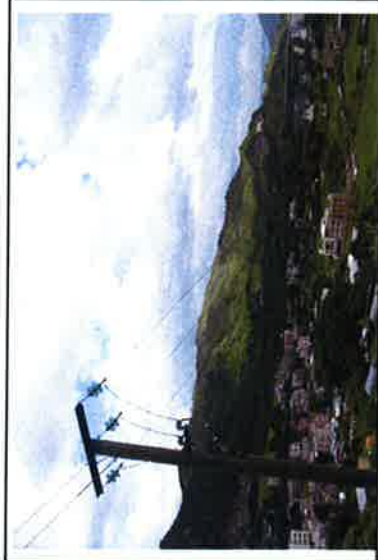
Photo No. A7 – LR2.2

10.7.4	LR2.1 (Fish Pond) within site boundary LR2.2 (Fish Pond) outside site boundary	A6 A7	There are 4 numbers of fallowed fish ponds at the upstream of the Ma On Kong Channel. A chain of fish ponds near downstream but distant from the Channel is noted. The fish ponds cover area of in total 23,000 m2. Most of them are heavily colonized by aquatic plants, which attribute to their low visual quality as a water landscape element. They have low landscape value and sensitive to change.	Minor change due to construction of structures within site boundary. A soil platform was

created outside site boundary due to other project was noted.
Marsh				
10.7.5	LR3 (Marsh)	A8	It comprises 2 marshes at the upstream channel of the Channel. They are inundated lowland heavily colonized with wetland aquatic plants. They have low landscape value and sensitive to change.	Remain the same as the baseline
Vegetation

River/Stream

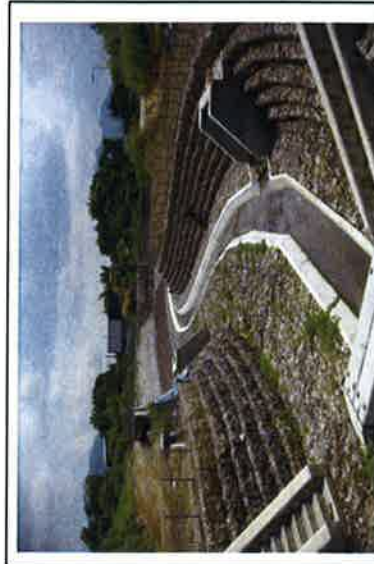
Photo No. A8 – LR3

River/Stream

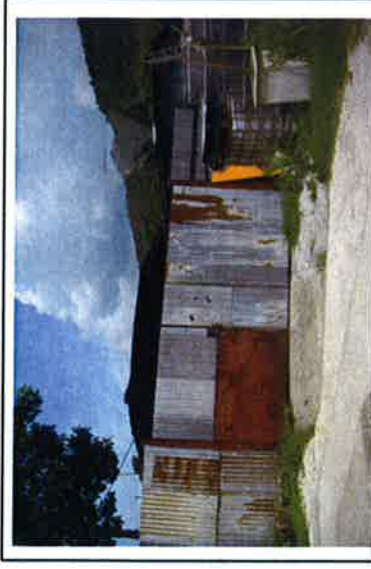
Photo No. B11—LCA 6 Industrial Landscape Character Area

10.7.17	LCA6 (Industrial Landscape Character Area)	B11 & B12	This comprise collection of slummy-built temporary structure and open storage uses land, which are characterized with metallic hoarding and used for poultry, recycling, vehicle repairing etc. The sensitivity to change of this area is low.	Reconstruction of hoarding was conducted by the land owner

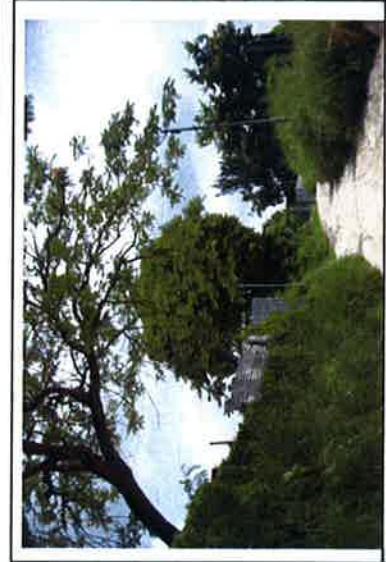
Photo No. A6 – LR2.1

Fish Pond within site boundary

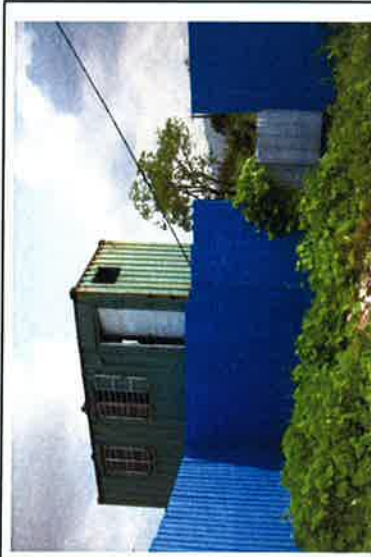
Photo No. C3 - 13
 Plant Nursery at the east of Ma On Kong Channel

10.7.23	I3	C3	Plant Nursery at the west of Ma On Kong Channel The VSRs is workers of the plant nursery. The number of individual is very few and their sensitivity to visual impacts is low.	Temporary stockpiling was observed
