13th Post-transplantation Monitoring and Audit Report (11th August 2023)

Northeast New Territories Landfill Extension (NENTX) | Contract No. EP/SP/77/15

0092/22/ED/0423 02 | 14 August 2023

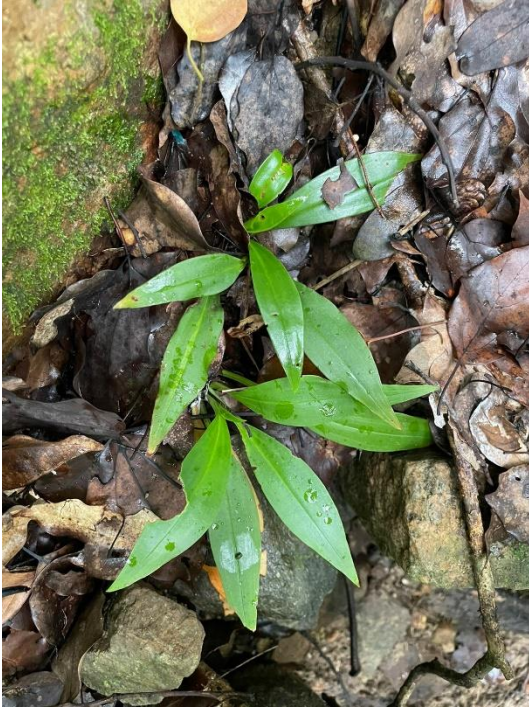
Photo B.3.13: Individual GP-13.

Date of Monitoring and Maintenance	Receptor Site	No.	Species	Plant Size Measurements			Amenity Value (High/ Medium/ Low)	Form (Good/ Fair/ Poor)	Health Condition (Good/ Fair/ Poor)	Structural Condition (Good/ Fair/ Poor)	Recommendation on Post-Transplantation Maintenance	Key Maintenance Activities Conducted	Remark
				DBH (mm)	Crown Spread (m)	Height (to cm)							
11/8/2023	A	AS02	A. sinensis			115			Poor				remove weeds
"	A	AS03	"			175			Poor				remove weeds
"	B	CB01	C. barometz			84			Good				
"	B	GP01	G. procerum			14			Good				
"	B	GP02	"			15			Good				
"	B	GP03	"			7			Fair				partially wilted leaves
"	B	GP04	"			—			—				missing
"	B	GP05	"			—			—				missing
"	B	GP06	"			10			Fair				Chlorotic leaves
"	B	GP07	"			11			Fair				"
"	B	GP08	"			10			Fair				"
"	B	GP09	"			18			Good				
"	B	GP10	"			15			Fair				Chlorotic leaves
"	B	GP11	"			14			Good				
"	B	GP12	"			14			Good				
"	B	GP13	"			8			Fair				partially wilted leaves

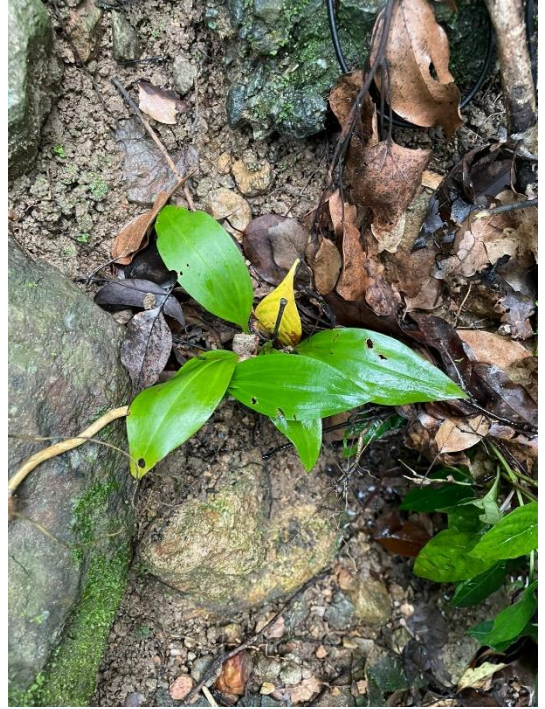
Photo B.3.14: Individual GP-14.

"	B	GP14	"			11			Fair				holes in leaves
"	B	GP15	"			12			Poor				Chlorotic wilted leaves
"	B	GP16	"			13			Fair				holes on leaves
"	B	GP17	"			9			Fair				Chlorotic leaves
"	B	GP18	"			—			—				missing
"	B	GP19	"			16			Good
