The Jockey Club CPS Limited

Central Police Station Conservation  
and Revitalisation Project:  
*First Monthly EM&A Report*  
*(From 24 October 2011 to 30*  
*November 2011)*

Issue Date: December 2011

**Environmental Resources Management**

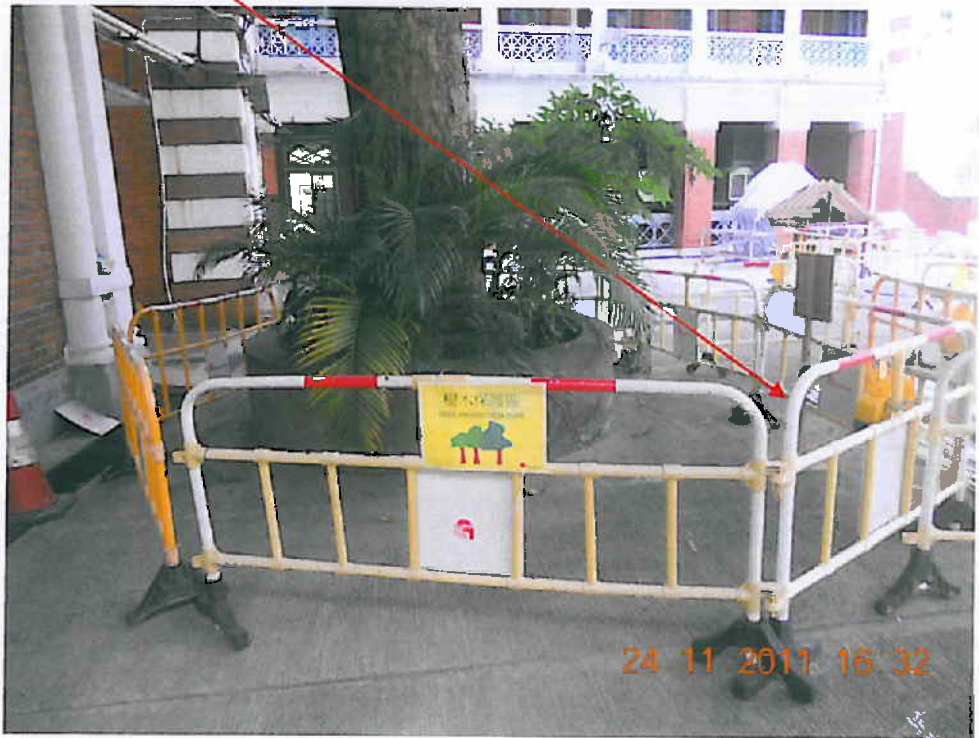
Fig. 4 The rails have been linked up as a temperate protection zone.

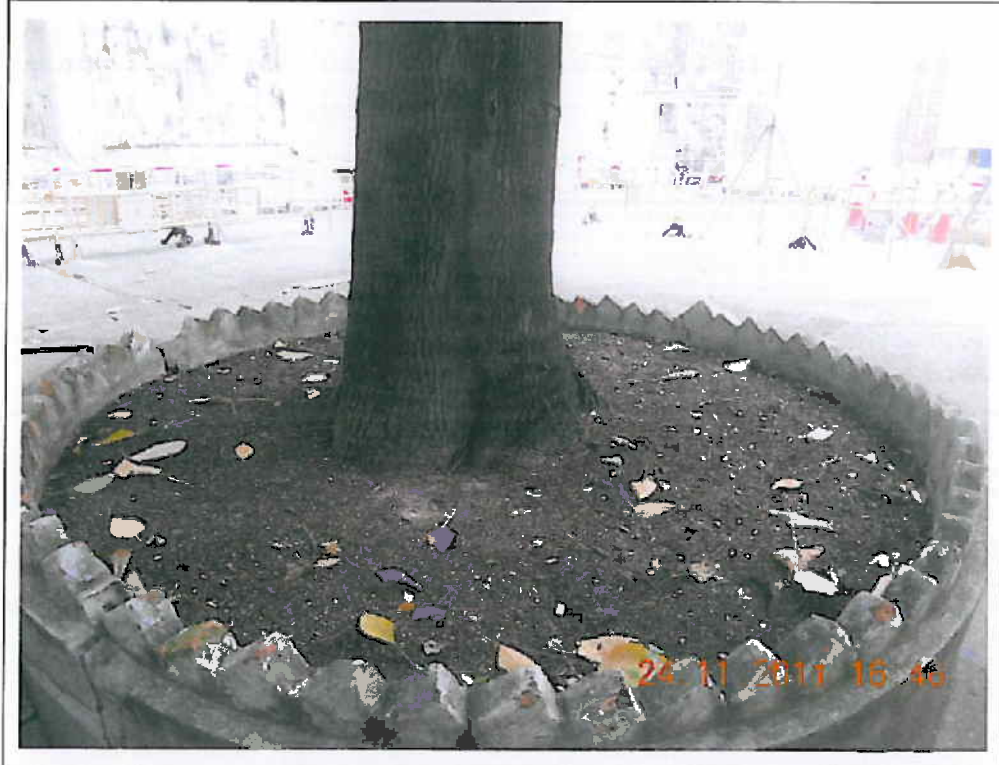
Fig. 3 The planter keeps clean and tidy at the time of inspection.

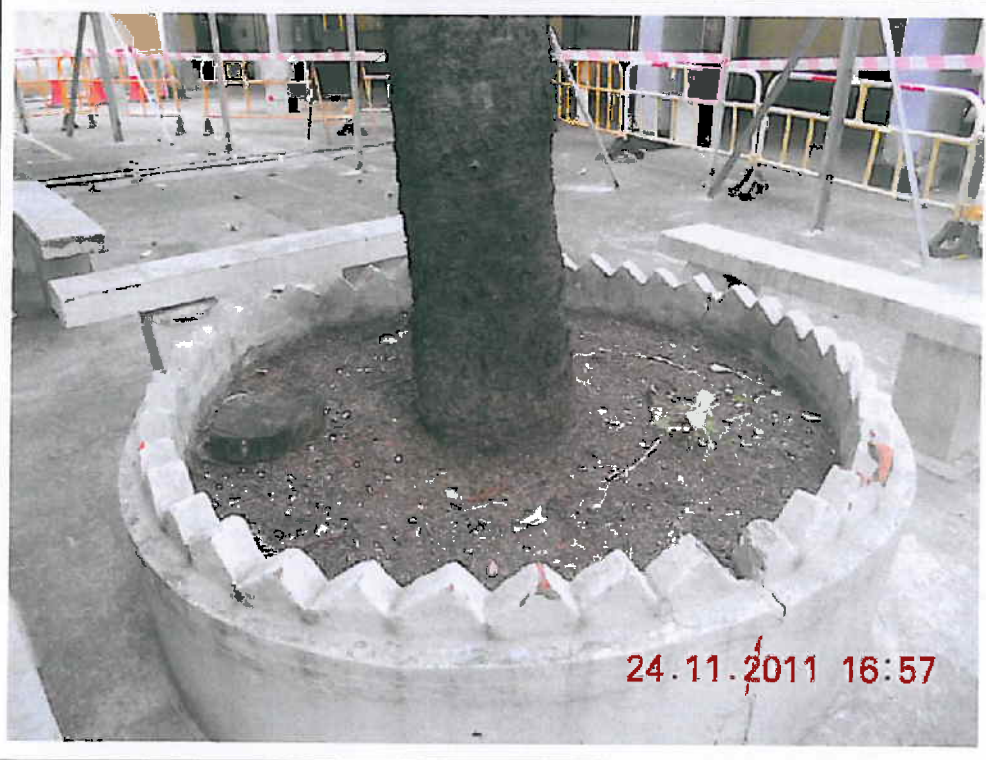
Fig. 3 Under-growth and rubbish have been cleared prior to inspection,  
The planter keeps clean and tidy.

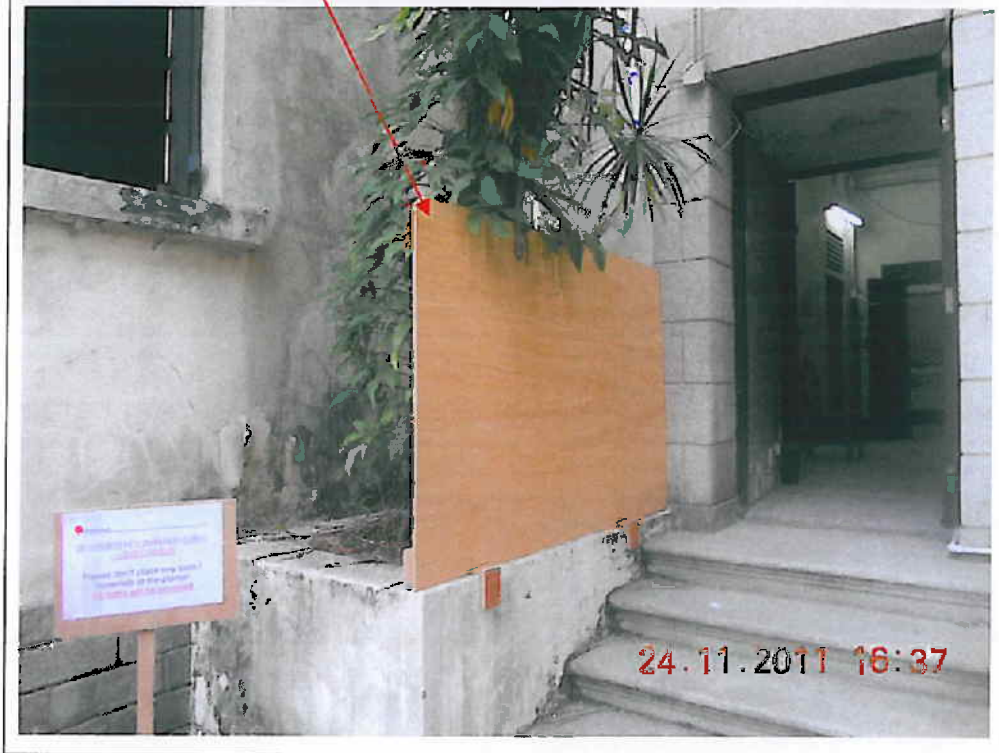
Fig. 4 Temperate fence has been erected at the planter.
