**Landslip Prevention and Mitigation
Programme, 2008, Package J**

**Above Leung Fai Tin along Clear Water
Bay Road, Sai Kung**

**Independent Environmental Checker
(IEC)**

Monthly Audit Report No. 15

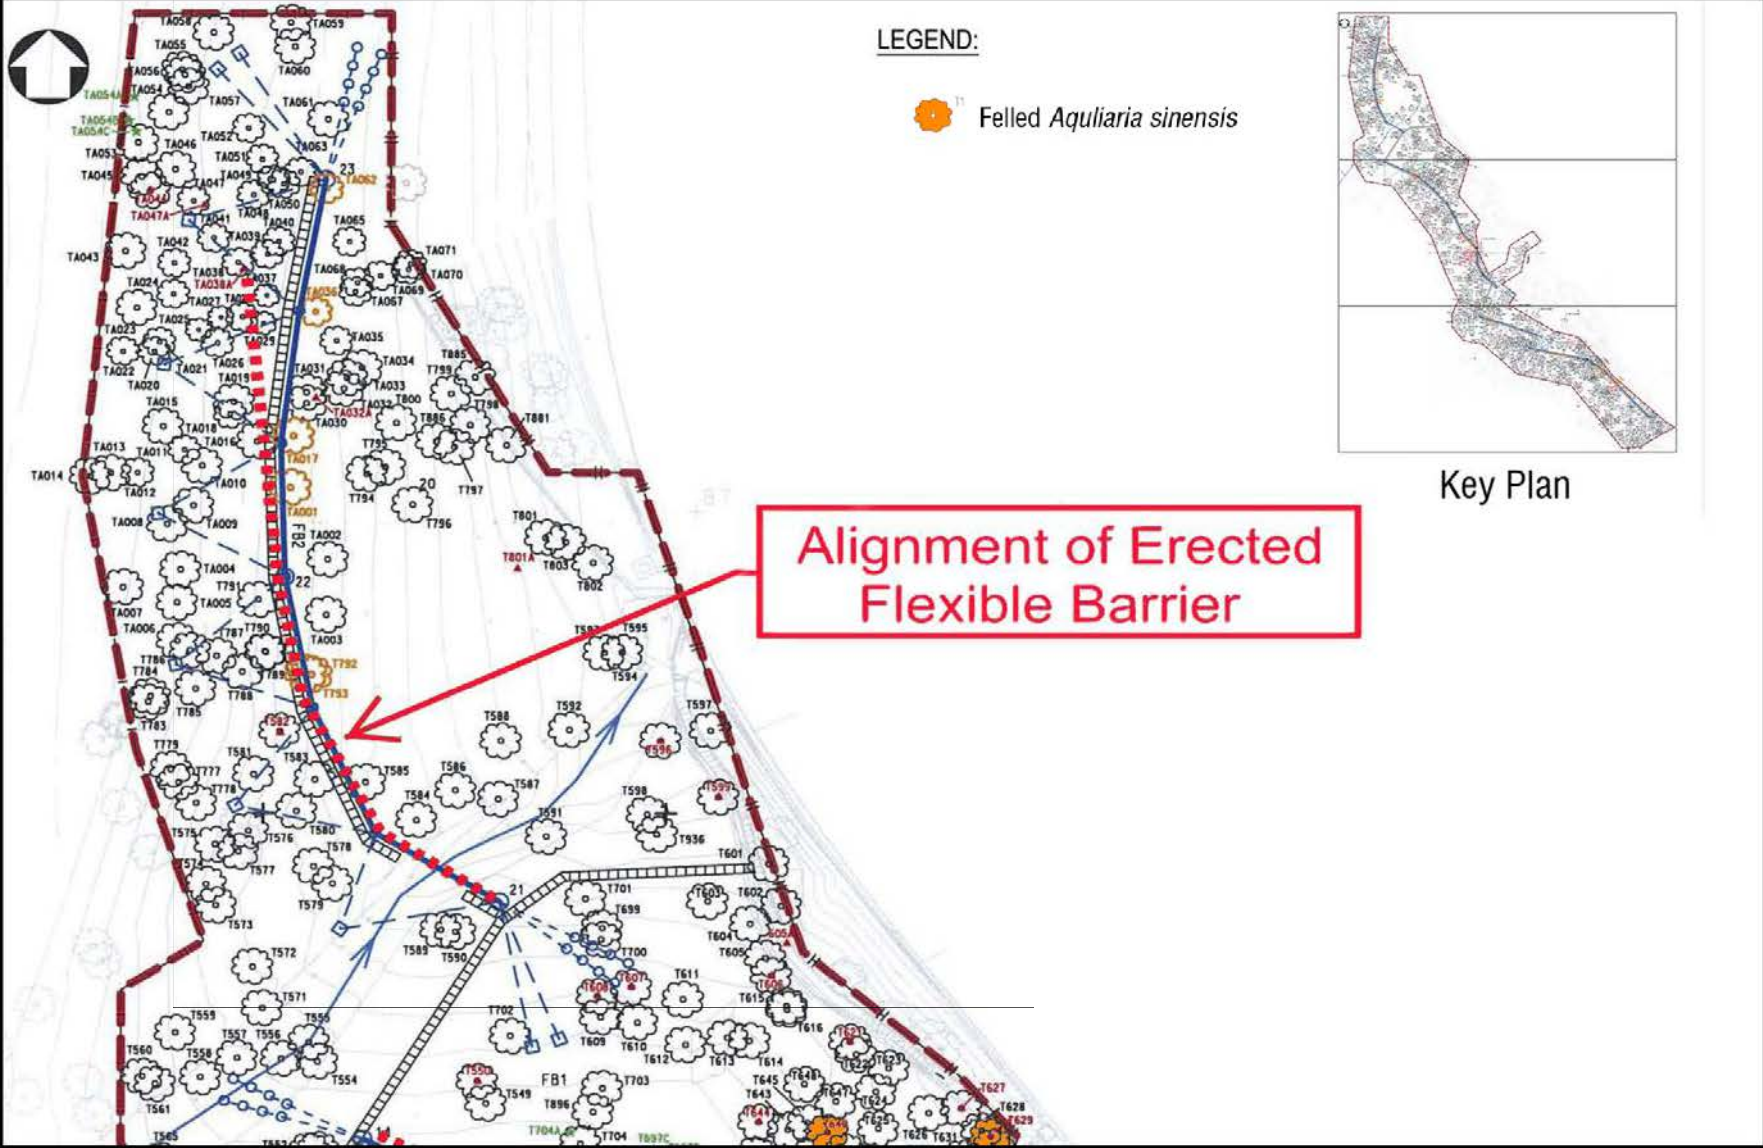
Figure 2 IEC Audit Route along the Erected Flexible Barrier on 27 April 2015 (Sheet 1 of 3)

2.2.1 The Project has been commenced on 15 January 2014. During the reporting period, construction of flexible barrier and maintenance access were carried out. Site audit was carried out along the works areas as shown in **Figure 2**.

2.3.2 Joint site audit was carried out with CHMHC and KOCCL on 27 April 2015. Construction of flexible barrier and maintenance access were observed within the works area. **Photos 1 to 3** show the construction work progress within permitted works areas. The temporary access was extended beyond to the stream course.
