**Landslip Prevention and Mitigation
Programme, 2008, Package J**

**Above Leung Fai Tin along Clear Water
Bay Road, Sai Kung**

**Independent Environmental Checker
(IEC)**

Monthly Audit Report No. 16

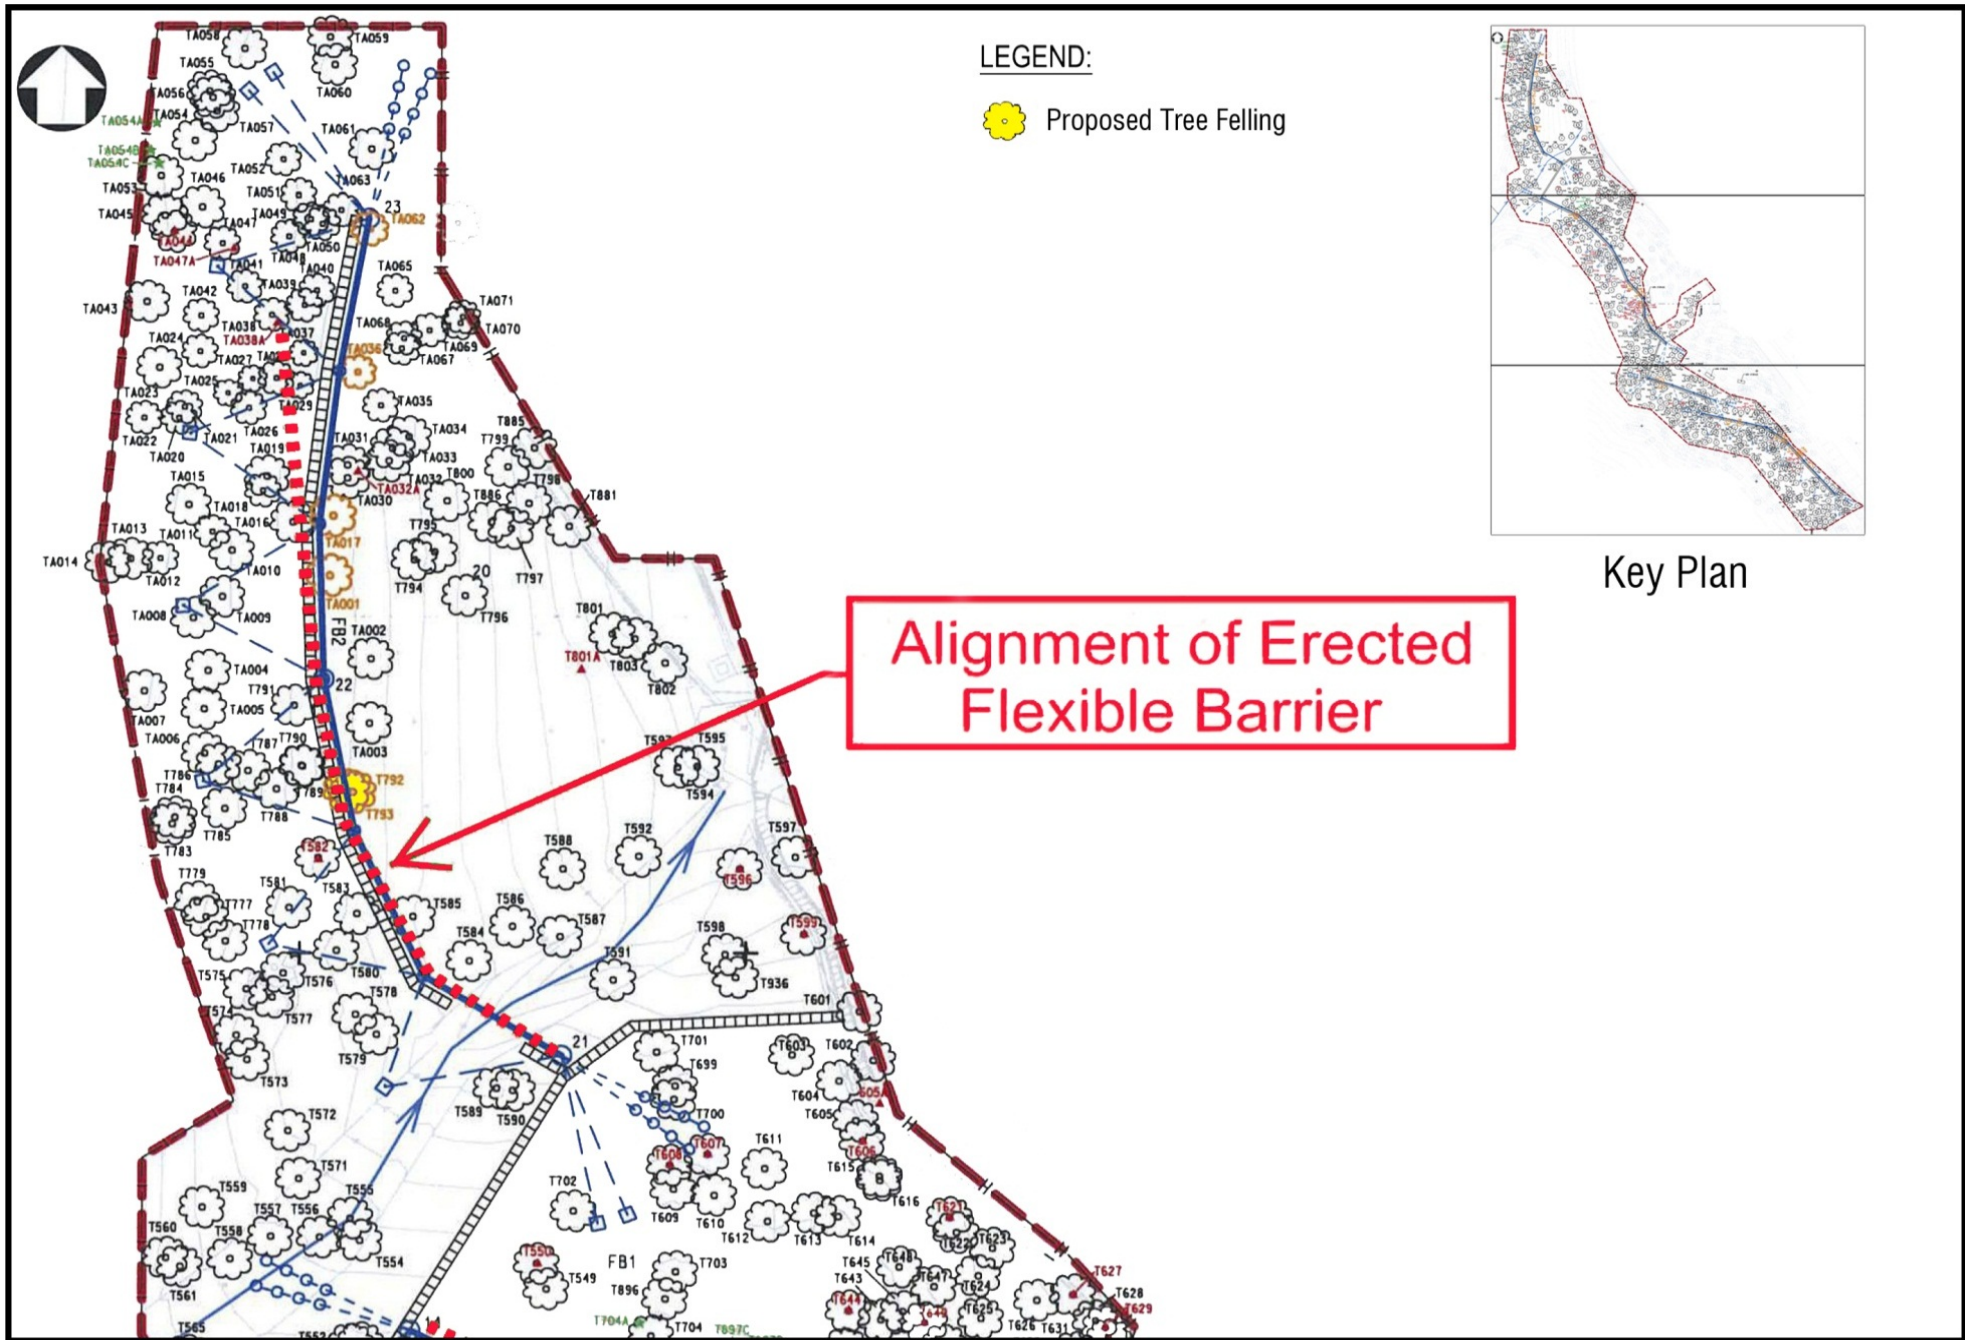
Figure 2 IEC Audit Route along the Erected Flexible Barrier on 26 May 2015 (Sheet 1 of 3)

2.2.1 The Project has been commenced on 15 January 2014. During the reporting period, construction of flexible barrier and maintenance access were carried out. Site audit was carried out along the works areas as shown in **Figure 2**.
