**Landslip Prevention and Mitigation
Programme, 2008, Package J**

**Landslip Prevention and Mitigation
Works in New Territories**

**Above Leung Fai Tin along Clear Water
Bay Road, Sai Kung**

Monthly Audit Report No. 17

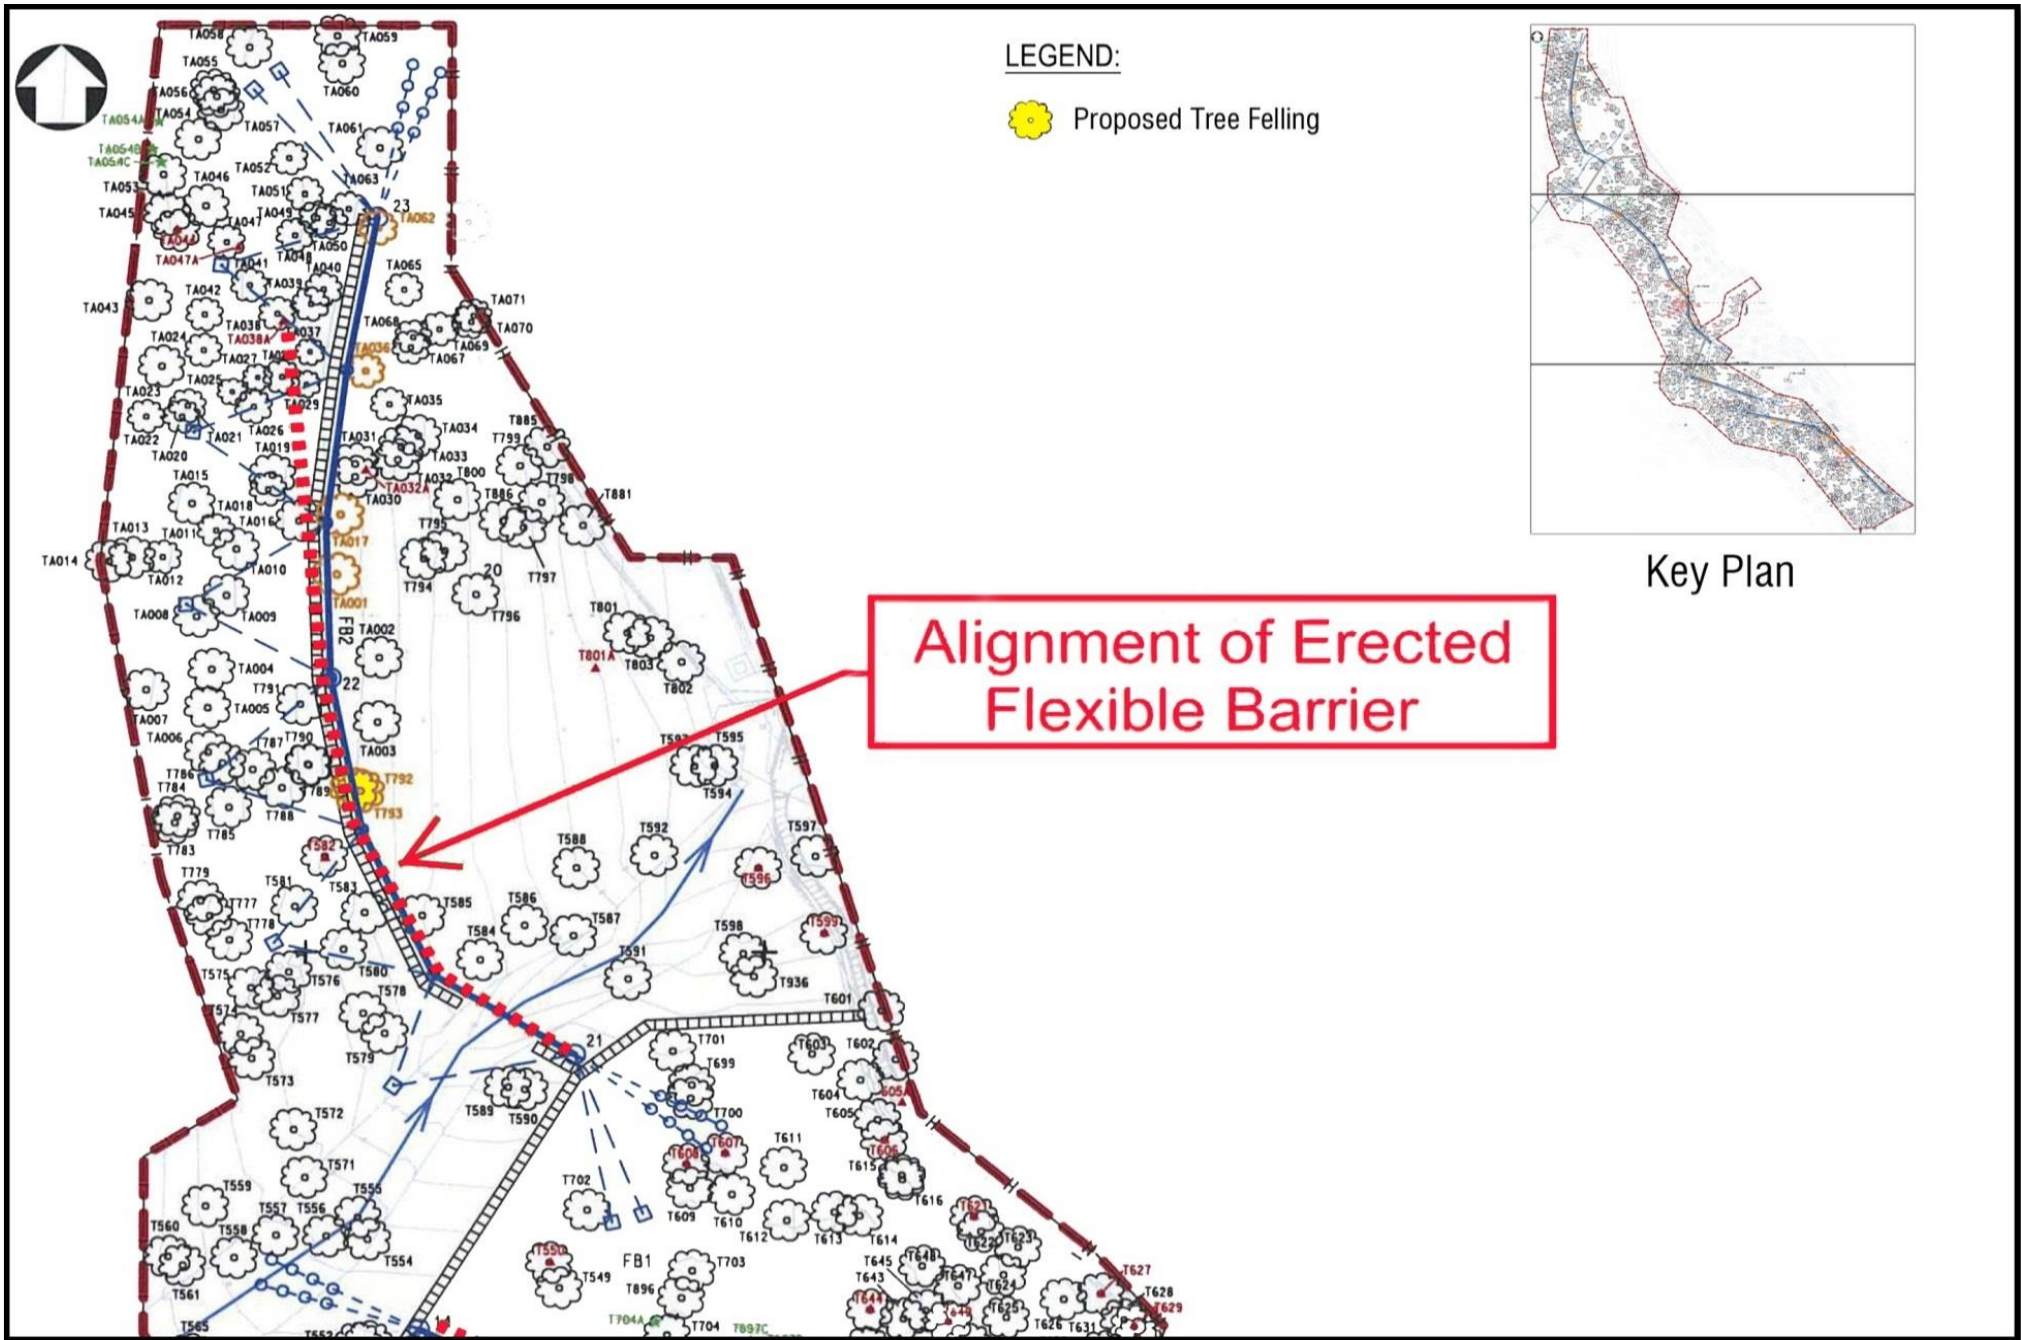
Figure 2 IEC Audit Route along the Erected Flexible Barrier on 29 June 2015 (Sheet 1 of 3)

2.2.1 The Project has been commenced on 15 January 2014. During the reporting period, landscaping works and dismantling works were carried out. Site audit was carried out along the works areas as shown in **Figure 2**.
