**Expansion of Research and Residential Facilities for
The Swire Institute of Marine Science, Faculty of Science,
The University of Hong Kong at Cape d' Aguilar, Shek O, Hong Kong
Submission of Monthly Environmental Monitoring and Audit Report No.44**

**MONTHLY ENVIRONMENTAL MONITORING AND AUDIT
(EM&A) REPORT (NO. 44)**

**Expansion of Research and Residential Facilities for the Swire Institute of
Marine Science, The University of Hong Kong at Cape D'Aguiar, Shek O**

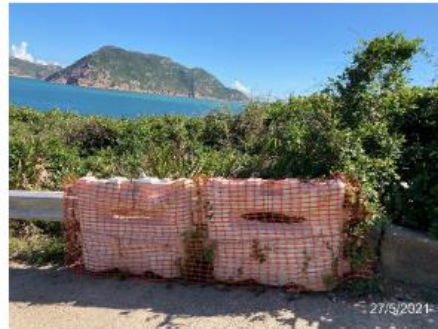
Plate 2: Photographic updates of the three retained trees that close to construction activities .

significant impact to the tree. Corresponding photographic records of T5, T6 and TA are illustrated in Plate 2.

<p>No change in condition of T5 from previous monitoring.</p>	<p>No change in condition of T6 from previous monitoring.</p>

- 4.1.9. Construction works should be optimized to avoid encroaching into the protection zones as far as possible. Any works inevitably conducted in the protection zone of the three retained trees (e.g. removing man made concrete surface of a path) shall be minimized its impact to the root system and avoid any damage to the anchor roots. Alignment of pipes passing through among aerial roots of TA has been adjusted with minimum pruning of small, non-supportive aerial roots. Soil excavation at the core root zone has been avoided. Since TA (*Ficus elastica*) is a species with extensive aerial root system, such minimum pruning without tearing wounds would be acceptable and unlikely results in significant impact to the tree.
