**Expansion of Research and Residential Facilities for
The Swire Institute of Marine Science, Faculty of Science,
The University of Hong Kong at Cape d' Aguilar, Shek O, Hong Kong
Submission of Monthly Environmental Monitoring and Audit Report No.45**

**MONTHLY ENVIRONMENTAL MONITORING AND AUDIT
(EM&A) REPORT (NO. 45)**

**Expansion of Research and Residential Facilities for the Swire Institute of
Marine Science, The University of Hong Kong at Cape D'Aguiar, Shek O**

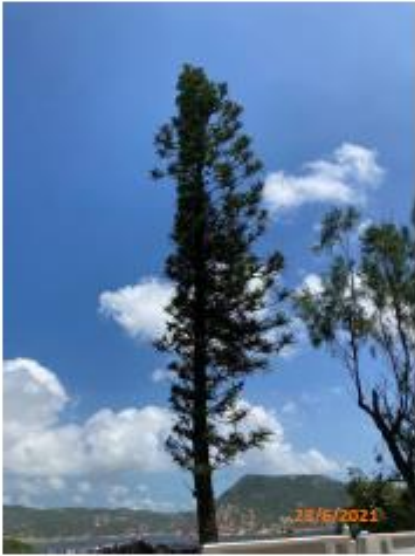
<p>No change in condition of T5 from previous monitoring.</p>	<p>No change in overall condition of T6 from previous monitoring.</p>

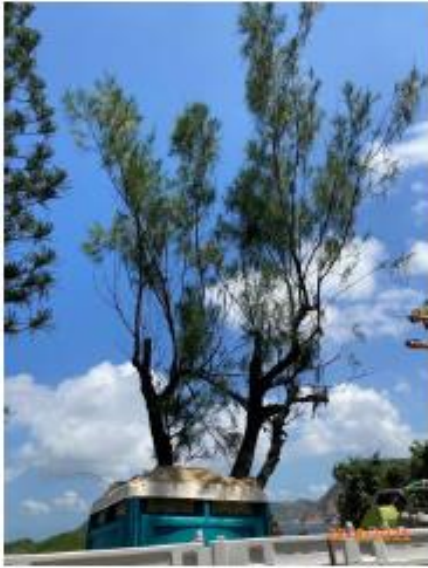
- 2.4.8. Young leaves of the deciduous *Vitis bryoniifolia* (蔓蘘) has emerged.
- 2.4.9. For the three retained trees, there is no change in overall condition of T5, T6 and TA, despite a small branch of T6 was blown down under adverse weather on 7th July 2021, as reported by the Contractor (Plate 2). Broken branches in TA due to the typhoon damage should receive appropriate assessment and treatment. Alignment of pipes passing though among aerial roots of TA has been adjusted with minimum pruning of small, non supportive aerial roots. Soil excavation at the core root zone has been avoided. Since TA (*Ficus elastica*) is a species with extensive aerial root system, such minimum pruning without tearing wounds would be acceptable and unlikely results in significant impact to the tree. Corresponding photographic records T5, T6 and TA are illustrated in Plate 2.
