**Expansion of Research and Residential Facilities for  
The Swire Institute of Marine Science, Faculty of Science,  
The University of Hong Kong at Cape d' Aguilar, Shek O, Hong Kong  
Submission of Monthly Environmental Monitoring and Audit Report No.46**

## **MONTHLY ENVIRONMENTAL MONITORING AND AUDIT (EM&A) REPORT (NO. 46)**

**Expansion of Research and Residential Facilities for the Swire Institute of  
Marine Science, The University of Hong Kong at Cape D'Aguiar, Shek O**

**(Rev. 0)**

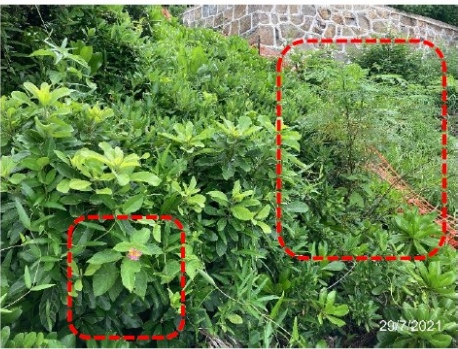
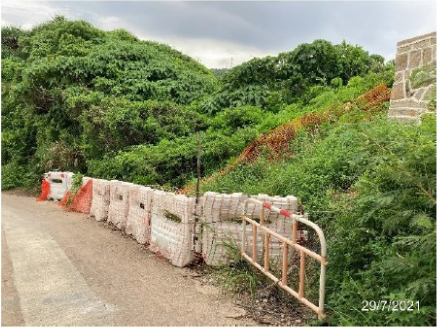
<p><i>Pittosporum tobira</i> 海桐: sprouts of previously cleared invasive species emerged again (red dottedline)</p>	<p>Collapsed fencing to be rectified</p>

- 4.1.7. Protection zone has been provided in accordance with Condition 2.6 of the Environmental Permit. Any damage of the protection zone (e.g. due to coastal weather condition or disturbance of hikers and visitors) should be repaired promptly. Warning sign should be maintained at prominent positions within the works area to encourage hikers and visitors keeping away from any no-entry area or protection zone.

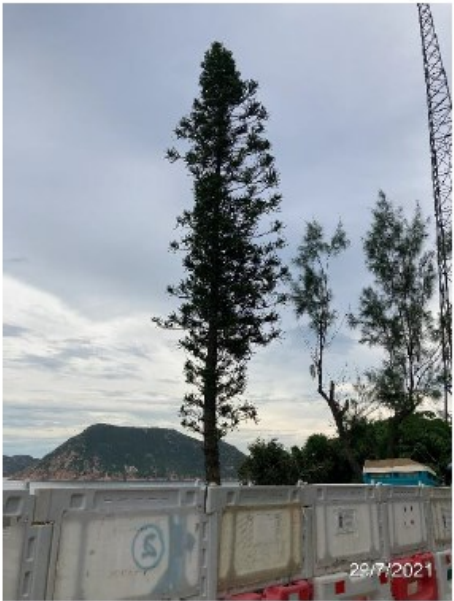
- 2.4.8. Young leaves of the deciduous *Vitis bryoniifolia* (蔓蘗) has emerged.
- 2.4.9. For the three retained trees, there is no change in overall condition of T5, T6 and TA, despite a small branch of T6 was blown down under adverse weather on 7th July 2021, as reported by the Contractor (Plate 2). Broken branches in TA due to the typhoon damage should receive appropriate assessment and treatment. Alignment of pipes passing through among aerial roots of TA has been adjusted with minimum pruning of small, non-supportive aerial roots. Soil excavation at the core root zone has been avoided. Since TA (*Ficus elastica*) is a species with extensive aerial root system, such minimum pruning without tearing wounds would be acceptable and unlikely results in significant impact to the tree. Corresponding photographic records T5, T6 and TA are illustrated in Plate 2.

A tree with a more irregular, spreading canopy of dark green needles, situated behind a concrete construction barrier. A crane is visible in the background. The date '29/7/2021' is printed in the bottom right corner of the image.
<p>No change in condition of T5 from previous monitoring.</p>	<p>No change in overall condition of T6 from previous monitoring.</p>
