Environmental Permit (No. EP-537/2017)

**Expansion of Research and Residential Facilities for
The Swire Institute of Marine Science, Faculty of Science,
The University of Hong Kong at Cape d' Aguilar, Shek O, Hong Kong
Submission of Monthly Environmental Monitoring and Audit Report No.47**

MONTHLY ENVIRONMENTAL MONITORING AND AUDIT (EM&A) REPORT (NO. 47)

**Expansion of Research and Residential Facilities for the Swire Institute of
Marine Science, The University of Hong Kong at Cape D'Aguiar, Shek O**

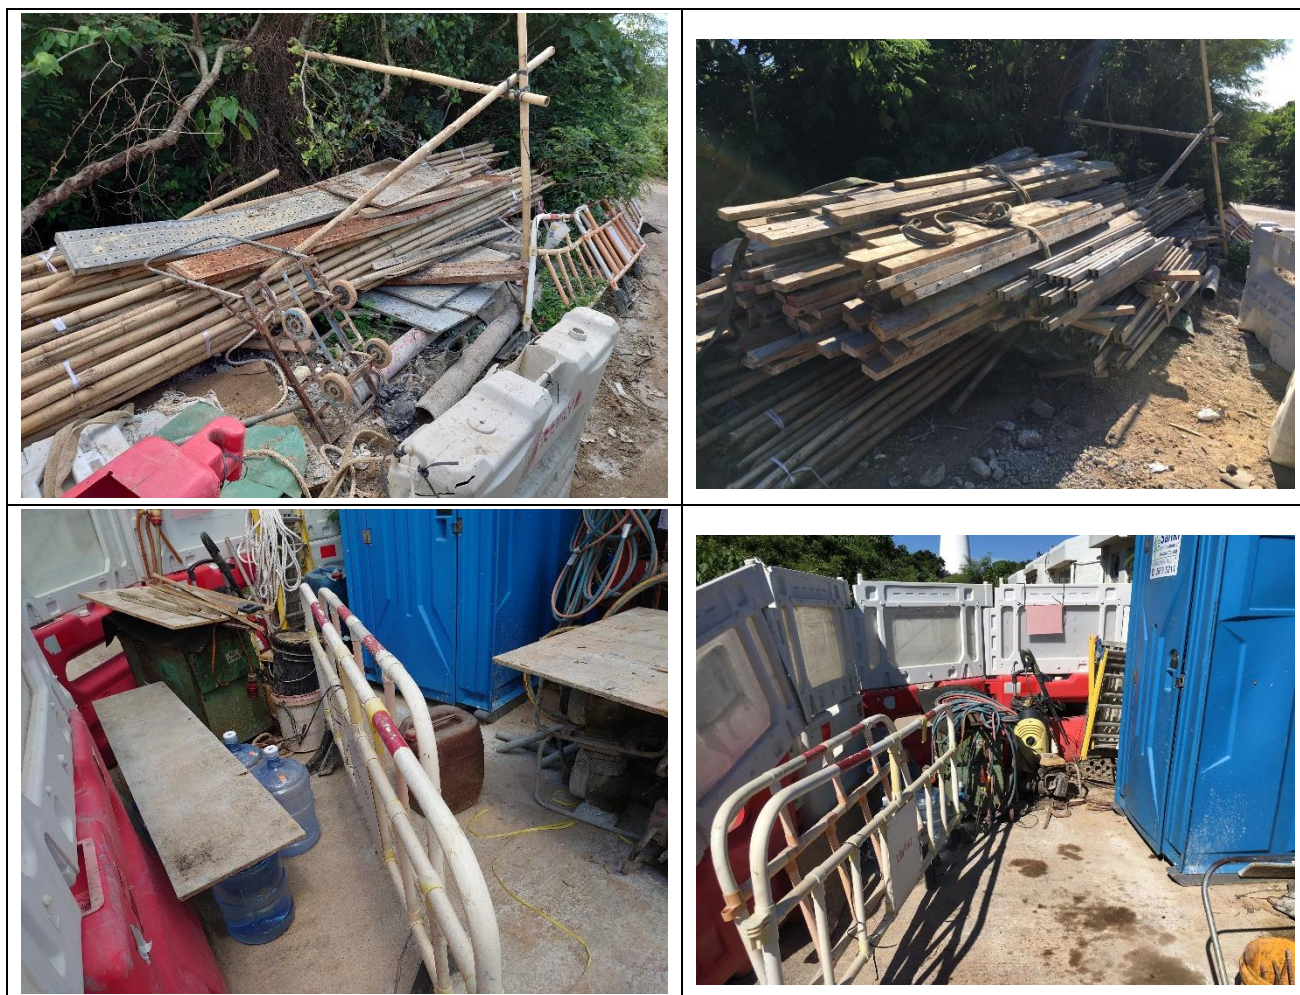
Observation - Item 2	
Observed 25 August 2021	Rectified by the Contractor on 03 Sep 2021
<p>At site F, drip trays should be provided for chemical containers and retaining trees should be free from construction materials.</p>	<p>Chemicals are removed from site. Construction materials are tidied up and moved away from nearby trees.</p>

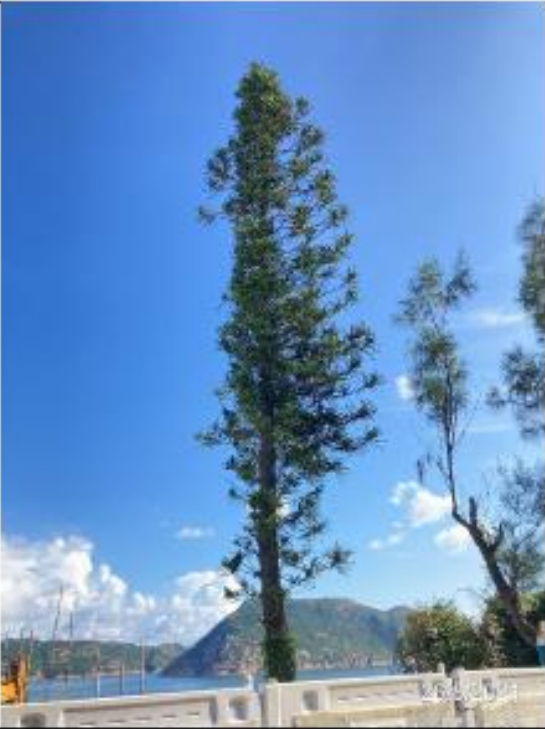
Plate 2: Photographic updates of the three retained trees that close to construction activities.

- 2.4.8. Young leaves of the deciduous *Vitis bryoniifolia* (蔓蘗) has emerged.
- 2.4.9. For the three retained trees, there is no change in overall condition of T5, T6 and TA, despite a small branch of T6 was blown down under adverse weather on 7th July 2021, as reported by the Contractor. Broken branches in TA due to the typhoon damage should receive appropriate assessment and treatment. Alignment of pipes passing through among aerial roots of TA has been adjusted with minimum pruning of small, non-supportive aerial roots. Soil excavation at the core root zone has been avoided. Since TA (*Ficus elastica*) is a species with extensive aerial root system, such minimum pruning without tearing wounds would be acceptable and unlikely results in significant impact to the tree.

- 4.1.8. A small branch of T6 was blown down under adverse weather on 7th July 2021, as reported by the Contractor, but overall condition of T6 is not affected.

- 4.1.10. Construction works should be optimized to avoid encroaching into the protection zones as far as possible. Any works inevitably conducted in the protection zone of the three retained trees (e.g. removing man made concrete surface of a path) shall be minimized its impact to the root system and avoid any damage to the anchor roots. Alignment of pipes passing through among aerial roots of TA has been adjusted with minimum pruning of small, non-supportive aerial roots. Soil excavation at the core root zone has been avoided. Since TA (*Ficus elastica*) is a species with extensive aerial root system, such minimum pruning without tearing wounds would be acceptable and unlikely results in significant impact to the tree.
