**Expansion of Research and Residential Facilities for
The Swire Institute of Marine Science, Faculty of Science,
The University of Hong Kong at Cape d' Aguilar, Shek O, Hong Kong
Submission of Monthly Environmental Monitoring and Audit Report No.51**

MONTHLY ENVIRONMENTAL MONITORING AND AUDIT (EM&A) REPORT (NO. 51)

**Expansion of Research and Residential Facilities for the Swire Institute of
Marine Science, The University of Hong Kong at Cape D'Aguiar, Shek O**

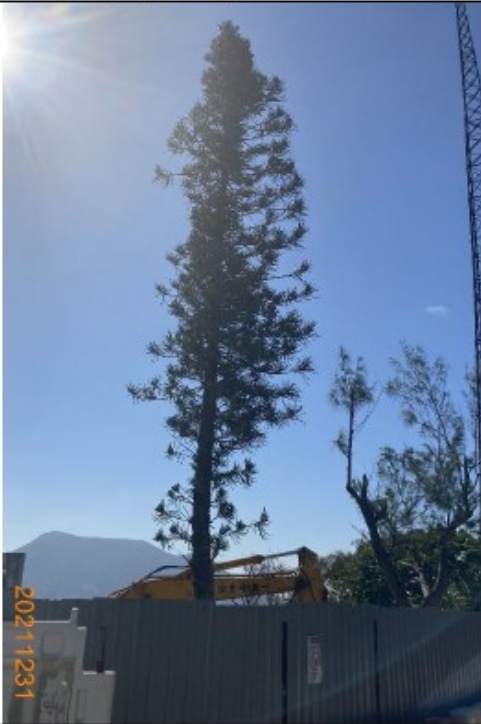
Plate 2: Photographic updates of the three retained trees that close to construction activities.

- 2.4.8. Leaves of the deciduous *Vitis bryoniifolia* (襲蔭) is no more observable.
- 2.4.9. For the three retained trees, there is no change in overall condition of T5, T6 and TA, despite a small branch of T6 was blown down under adverse weather on 7th July 2021, as reported by the Contractor. Another branch of T6 was broken, probably due to the 2 Typhoons Kompasu & Lionrock in October 2021. Several broken stubs on TA were also observed during last monitoring. These stubs due to the typhoon damage have been pruned (Plate 2). Alignment of pipes passing though among aerial roots of TA has been adjusted with minimum pruning of small, non supportive aerial roots. Soil excavation at the core root zone has been avoided. Since TA (*Ficus elastica*) is a species with extensive aerial root system, such minimum pruning without tearing wounds would be acceptable and unlikely results in significant impact to the tree. Corresponding photographic records T5, T6 and TA are illustrated in Plate 2.

- 4.1.8. A small branch of T6 was blown down under adverse weather on 7th July 2021, as reported by the Contractor. Another branch of T6 was broken, probably by the two recent typhoons in October 2021, but overall condition of T6 is not affected. These broken branches, together

with those stubs observed in the retained tree TA, have been pruned. Any further appropriate tree treatment on the retained trees is subjected to a Tree Risk Assessment appointment. Good written and photographic records should be made before, during and after any actions of treatment for the assessed tree.
