**Expansion of Research and Residential Facilities for  
The Swire Institute of Marine Science, Faculty of Science,  
The University of Hong Kong at Cape d' Aguilar, Shek O, Hong Kong  
Submission of Monthly Environmental Monitoring and Audit Report No.53**

## **MONTHLY ENVIRONMENTAL MONITORING AND AUDIT (EM&A) REPORT (NO. 53)**

**Expansion of Research and Residential Facilities for the Swire Institute of  
Marine Science, The University of Hong Kong at Cape D'Aguiar, Shek O**

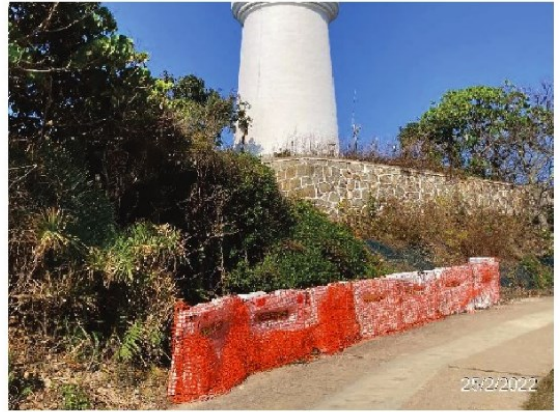
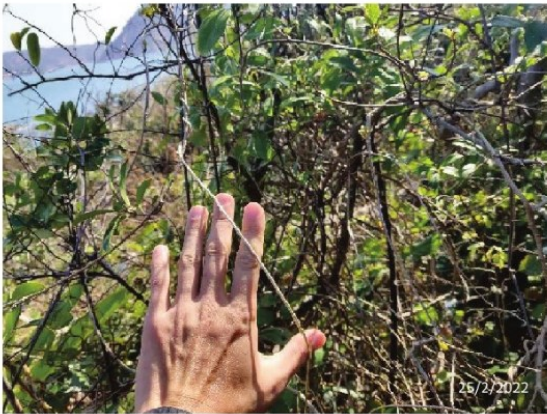
*Vitis bryoniifolia* 嬰菓 (deciduous)

- 2.4.8. Leaves of the deciduous *Vitis bryoniifolia* (蘗蘗) is not observable yet..
- 2.4.9. For the three retained trees, there is no change in overall condition of T5, T6 and TA, despite a small branch of T6 was blown down under adverse weather on 7th July 2021, as reported by the Contractor. Another branch of T6 was broken, probably due to the 2 Typhoons Kompas & Lionrock in October 2021. Several broken stubs on TA were also observed during last monitoring. These stubs due to the typhoon damage have been pruned. Alignment of pipes passing through among aerial roots of TA has been adjusted with minimum pruning of small, non supportive aerial roots. Soil excavation at the core root zone has been avoided. Since TA (*Ficus elastica*) is a species with extensive aerial root system, such minimum pruning without tearing wounds would be acceptable and unlikely results in significant impact to the tree. Corresponding photographic records T5, T6 and TA are illustrated in Plate 2.

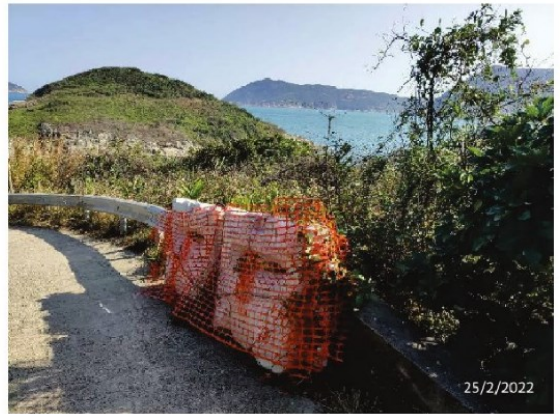
**Plate 2.** Photographic updates of the three retained trees that close to construction activities.

<p>A large, dense tree with thick branches and green leaves. In the background, a red and white construction barrier is visible. A date stamp '25/2/2022' is located in the bottom right corner of the image.</p>
<p>No change in condition of T5 from previous monitoring.</p>	<p>No change in condition of TA</p>

<p>A tree with a thick, gnarled trunk and green foliage. In the foreground, a grey corrugated metal fence is visible. A date stamp '25/2/2022' is located in the bottom right corner of the image.</p>	<p>BLANK</p>
<p>No change in condition of T6 from previous monitoring.</p>

- 4.1.7. A small branch of T6 was blown down under adverse weather on 7th July 2021, as reported by the Contractor. Another branch of T6 was broken, probably by the two recent typhoons in October 2021, but overall condition of T6 is not affected. These broken branches, together with those stubs observed in the retained tree TA, have been pruned. Any further appropriate tree treatment on the retained trees is subjected to a Tree Risk Assessment appointment.

- 4.1.8. Construction works should be optimized to avoid encroaching into the protection zones as far as possible. Any works inevitably conducted in the protection zone of the three retained trees (e.g., removing made concrete surface of a path) shall be minimized its impact to the root system and avoid any damage to the anchor roots. Alignment of pipes passing through among aerial roots of TA has been adjusted with minimum pruning of small, non supportive aerial roots. Soil excavation at the core root zone has been avoided. Since TA (*Ficus elastica*) is a species with extensive aerial root system, such minimum pruning without tearing wounds would be acceptable and unlikely results in significant impact to the tree.

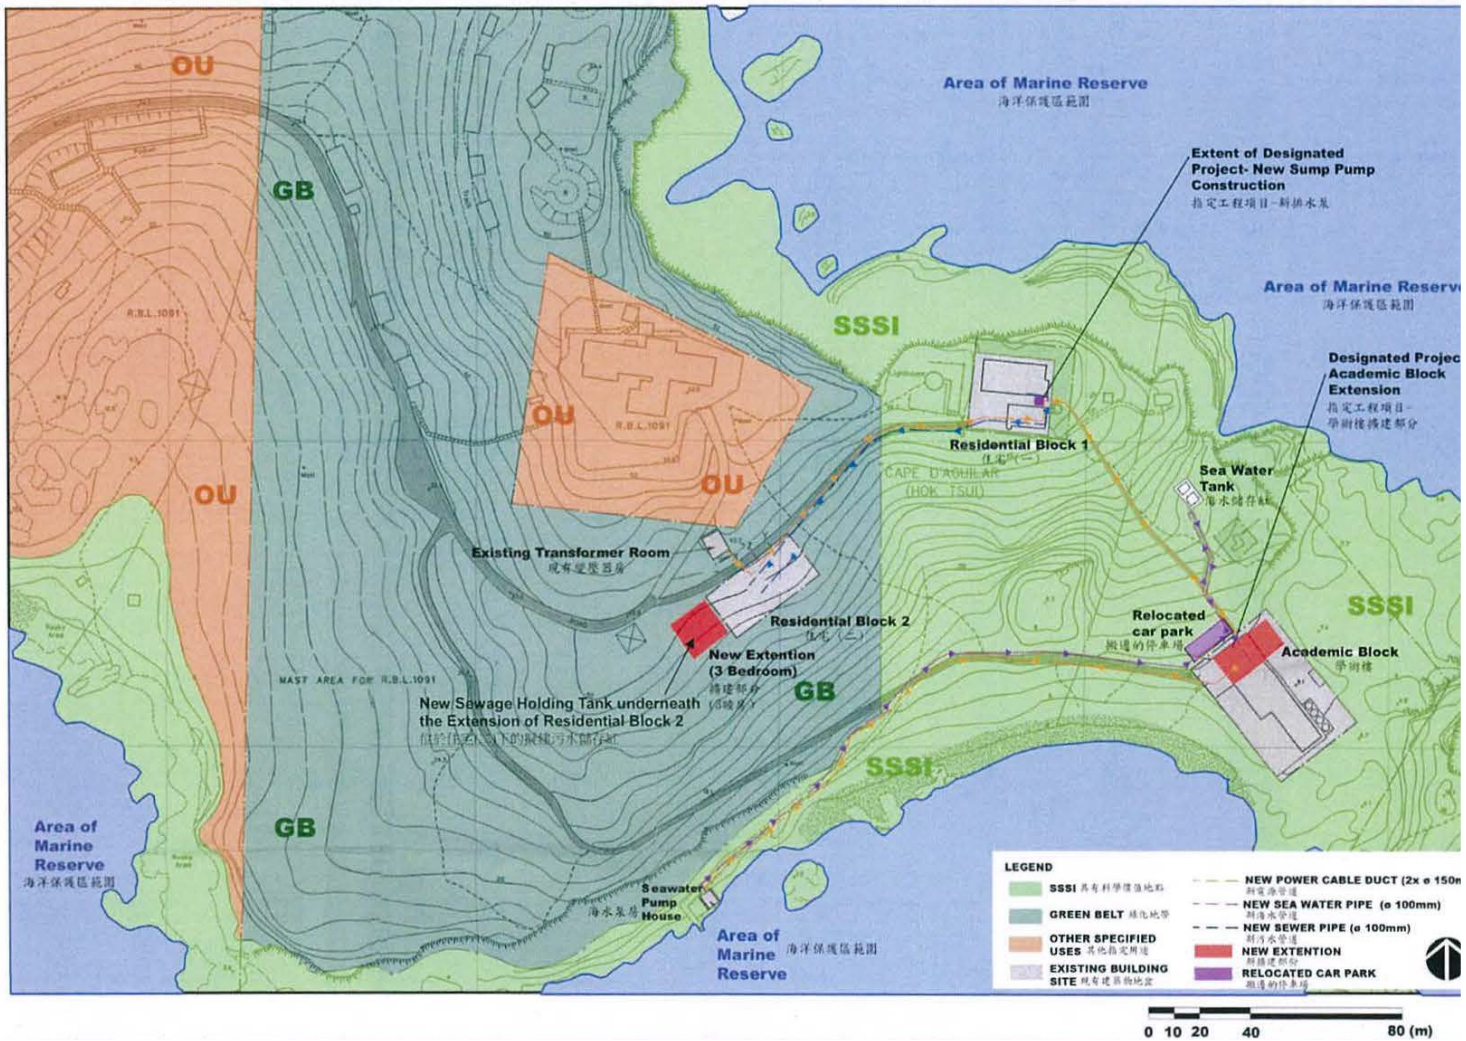
**Plate 3.** Five compensatory *Hibiscus tiliaceus* trees have been planted outside Academic Block.

- 2.4.10. Compensatory planting is in progress. Five *Hibiscus tiliaceus* (黃槿) trees have been planted at new tree pits outside the Academic Block (Plate 3).
