Contract No. DC/2018/02
Upgrading of Sewage Pumping
Stations and Sewerage Along
Ting Kok Road

Condition Survey Report on a
Grade 3 Historical Building
(Yu Cheung Tong)

P19076/CSR/002 (Issue 7)

June 2021

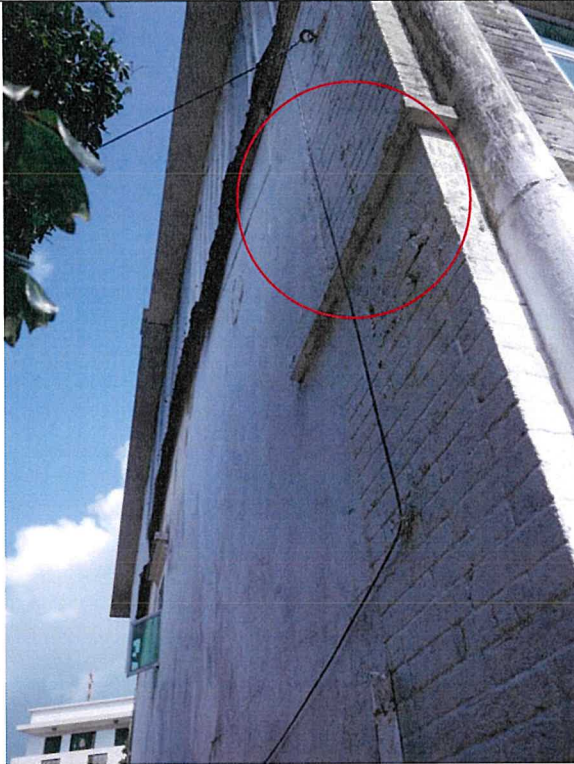
Photo No:
007

Photo description:
Spalling is identified on the
brick wall of the building
(indicated by red circle in the
photo)

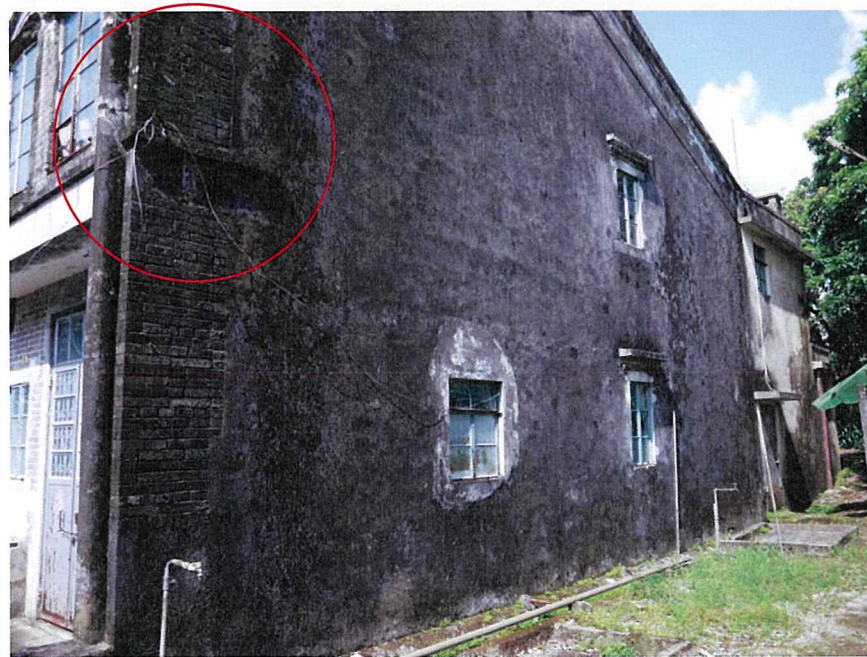
Photo No:
0012

Photo description:
Spalling is identified on the
north wall (brick wall)
of Yu Cheung Tong
(indicated by red circle in
the photo)

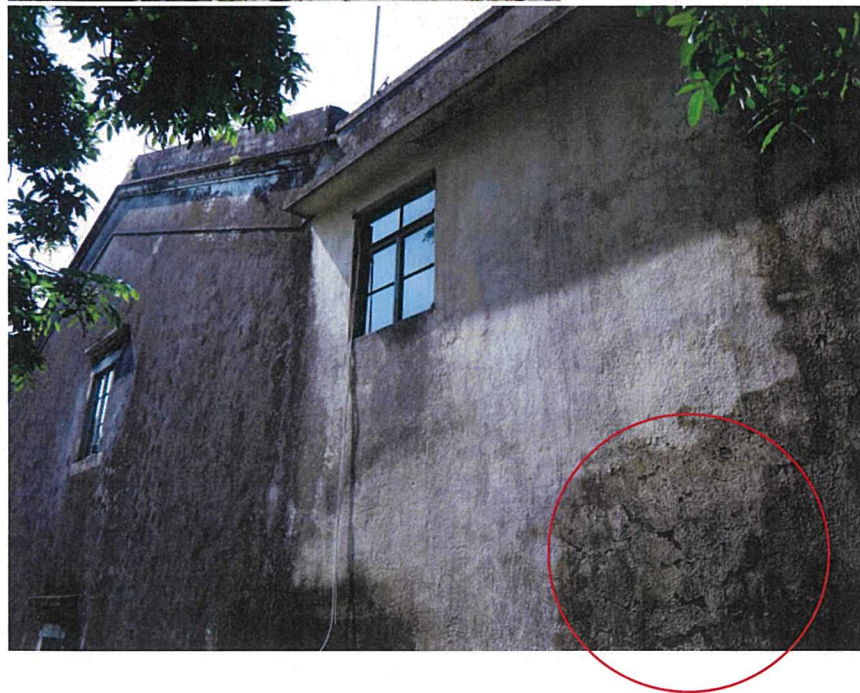
Photo No:
014

Photo description:
Spalling is identified on the
north wall (brick wall)
of Yu Cheung Tong
(indicated by red circle in
the photo)

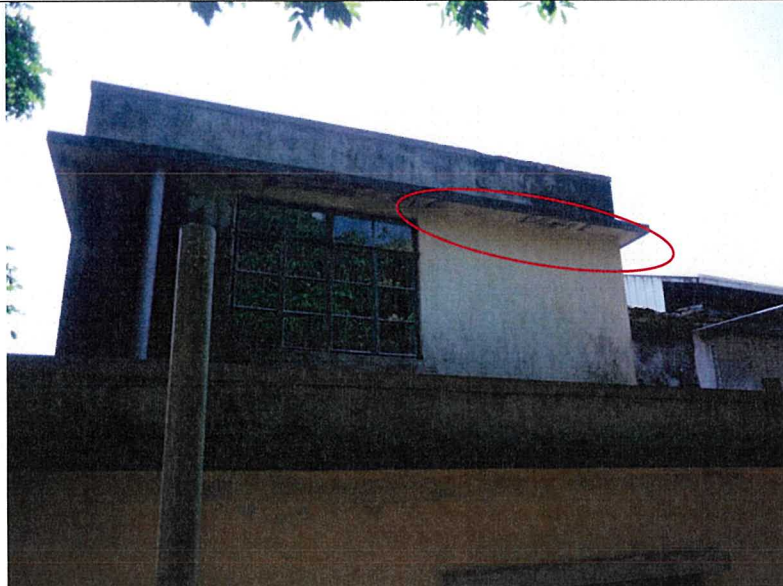
Photo No:
015

Photo description:
Spalling is identified on the north
wall of Yu Cheung Tong
(indicated by red circle in
the photo)

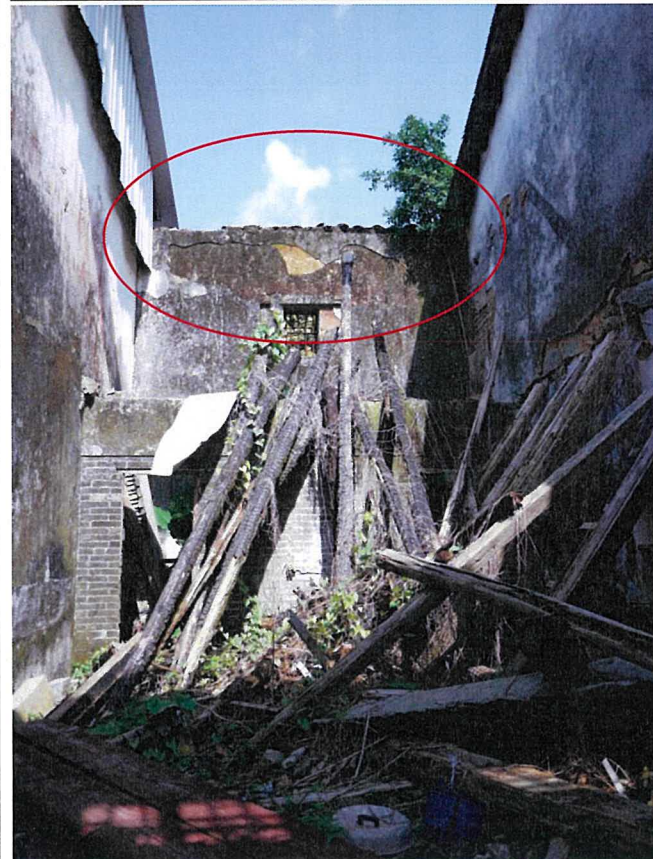
Photo No:
020

Photo description:
Spalling is identified on the wall
of the 2nd Block
of Yu Cheung Tong
(indicated by red circle in
the photo)

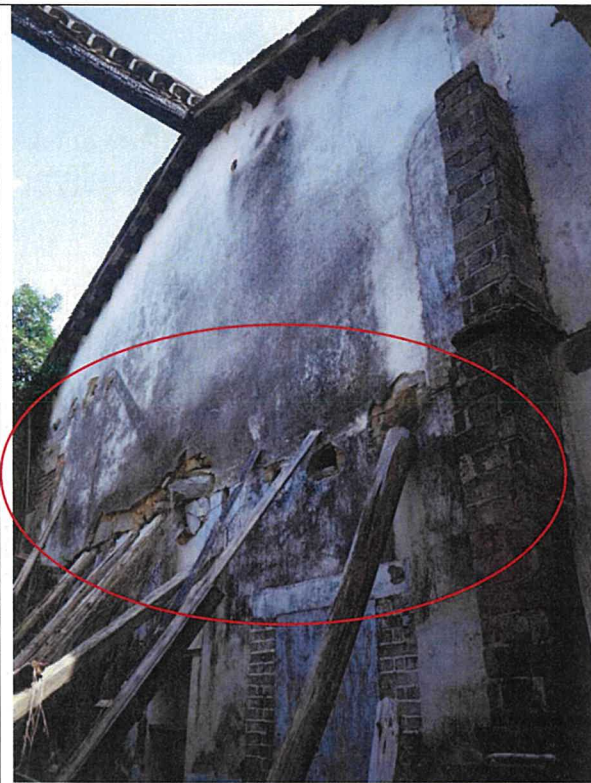
Photo No:
021

Photo description:
Spalling is found on the wall
of the 1st Block
of Yu Cheung Tong
(indicated by red circle in
the photo)

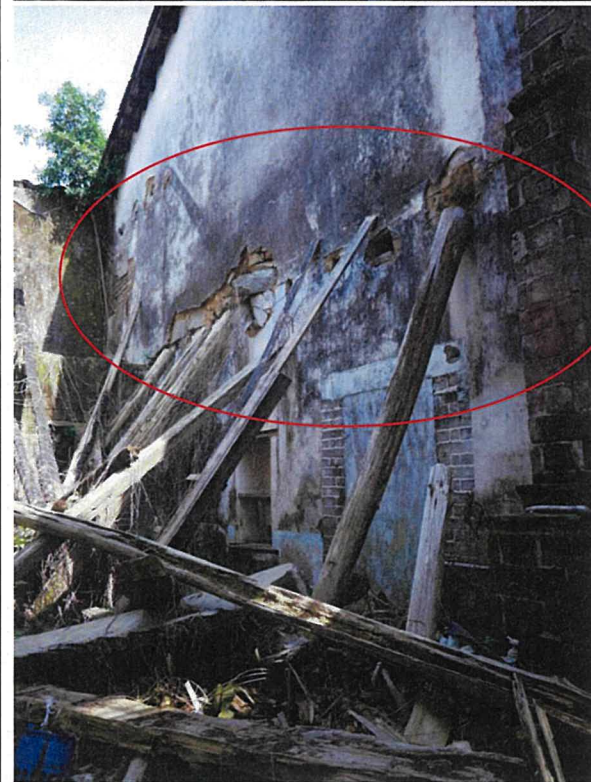
Photo No:
022

Photo description:
Spalling is found on the wall
of the 1st Block
of Yu Cheung Tong
(indicated by red circle in
the photo)

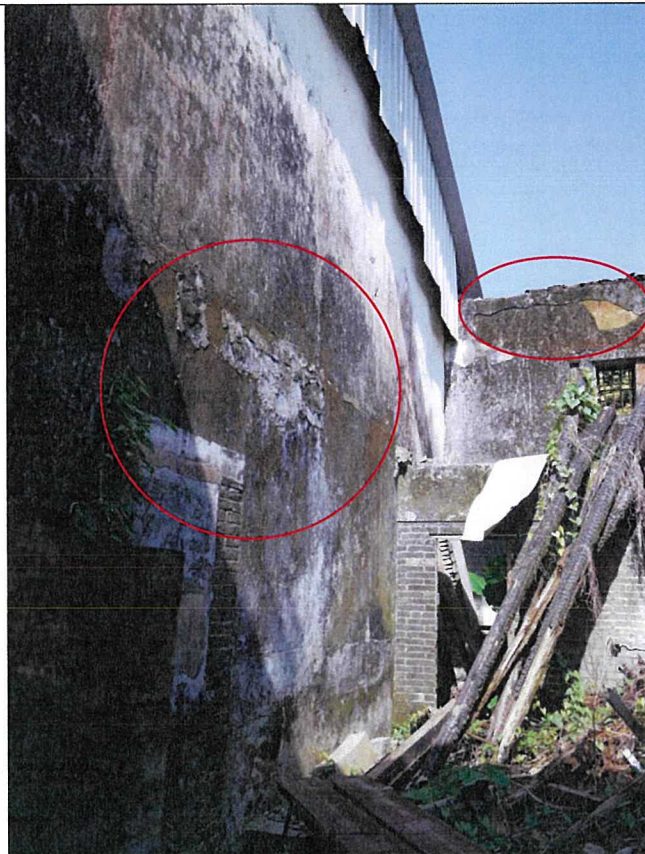
Photo No:
023

Photo description:
Spalling is found on the wall
of the 3rd Block
of Yu Cheung Tong
(indicated by red circle in
the photo)

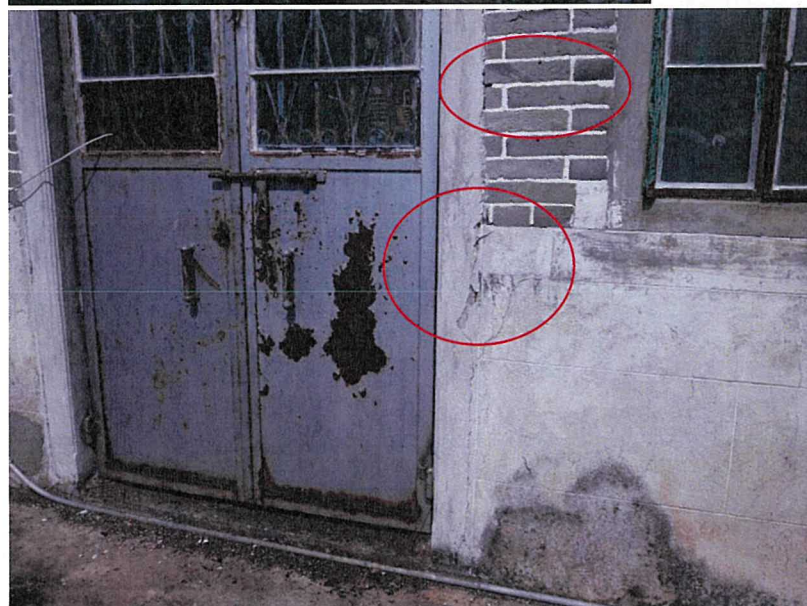
Photo No:
024

Photo description:
Wide cracks are found on the
wall adjacent to
the 1st Block
of Yu Cheung Tong
(indicated by red circle in
the photo)
(Point C1)

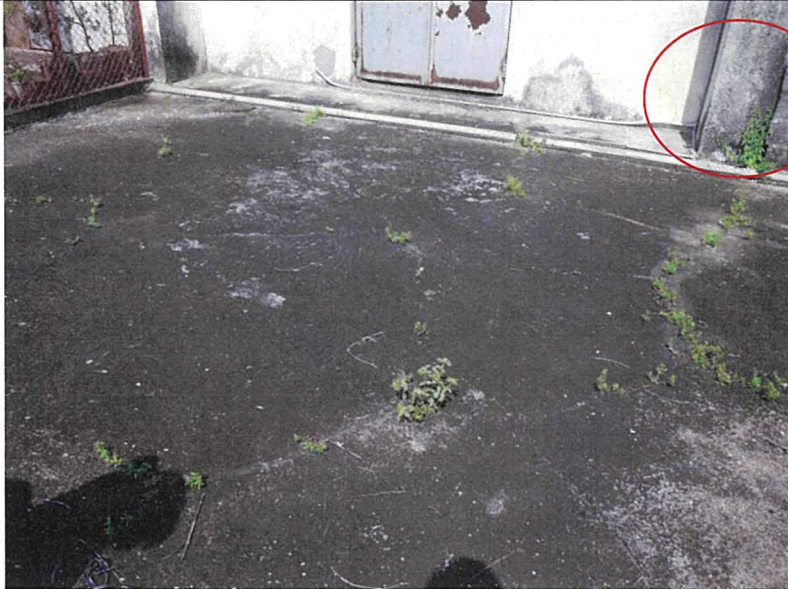
Photo No:
025

Photo description:
Wide cracks are found on
the wall adjacent to
the 1st Block
of Yu Cheung Tong
(indicated by red circle in
the photo)
(Point C2)

(Please refer to “Notice for Installation of Monitoring Instrument at Yu Cheung Tong Block 1 and 2” posted on 16 June 2021 – Appendix H)
025	In front of Yu Cheung Tong (East Side)	Wide cracks	Owner of Yu Cheung Tong Block No. 1 disagreed to installed the crack meter (Point C2) (Please refer to “Notice for Installation of Monitoring Instrument at Yu Cheung Tong Block 1 and 2” posted on 16 June 2021 – Appendix H)
026	In front of Yu Cheung Tong (East Side)	Wide cracks on Concrete Floor	Not Required to monitor cracks on concrete floor
027	In front of Yu Cheung Tong (East Side)	Wide cracks on Concrete Floor	Not Required to monitor cracks on concrete floor
028	Inside 3 rd Block of Yu Cheung Tong (G/F)	Wide cracks on Timber Beam	Crack monitoring on <u>monthly basis</u> is recommended (Point C3 & C3-1)
029	Inside 3 rd Block of Yu Cheung Tong (G/F)	Wide cracks on Timber Beam	Crack monitoring on <u>monthly basis</u> is recommended (Point C4)

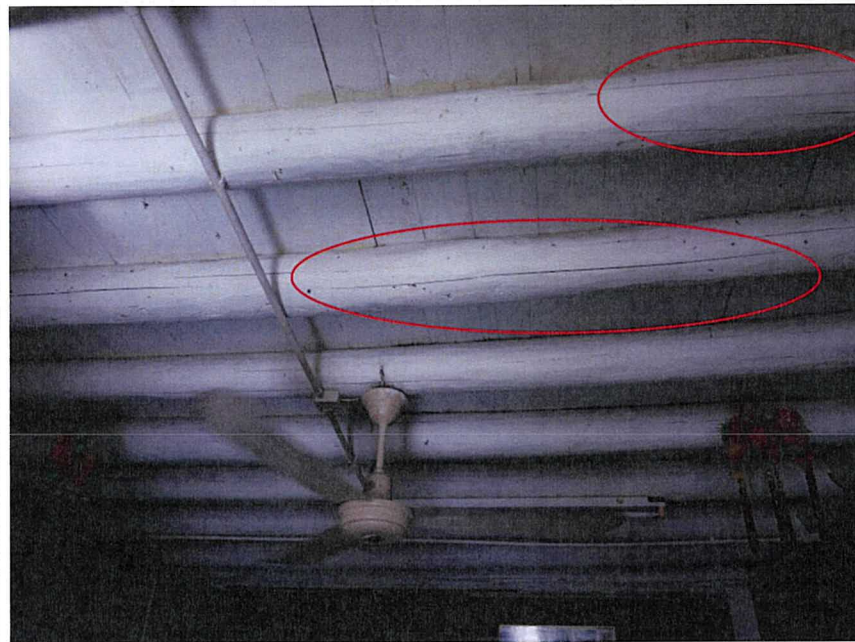
Photo No:
028

Photo description:
Wide cracks are found on
the timber beam and
ceiling of G/F
(indicated by red circle in
the photo)

***[Crack meter is
recommended for
monitoring]
(Point C3)***

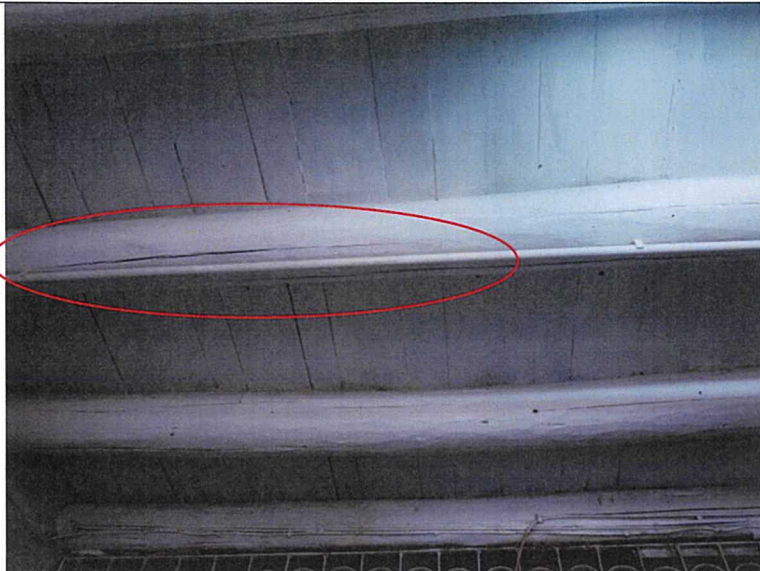
Photo No:
029

Photo description:
Wide cracks are found on the
timber beam and ceiling of G/F
(indicated by red circle in
the photo)

***[Crack meter is recommended
for monitoring]
(Point C4)***

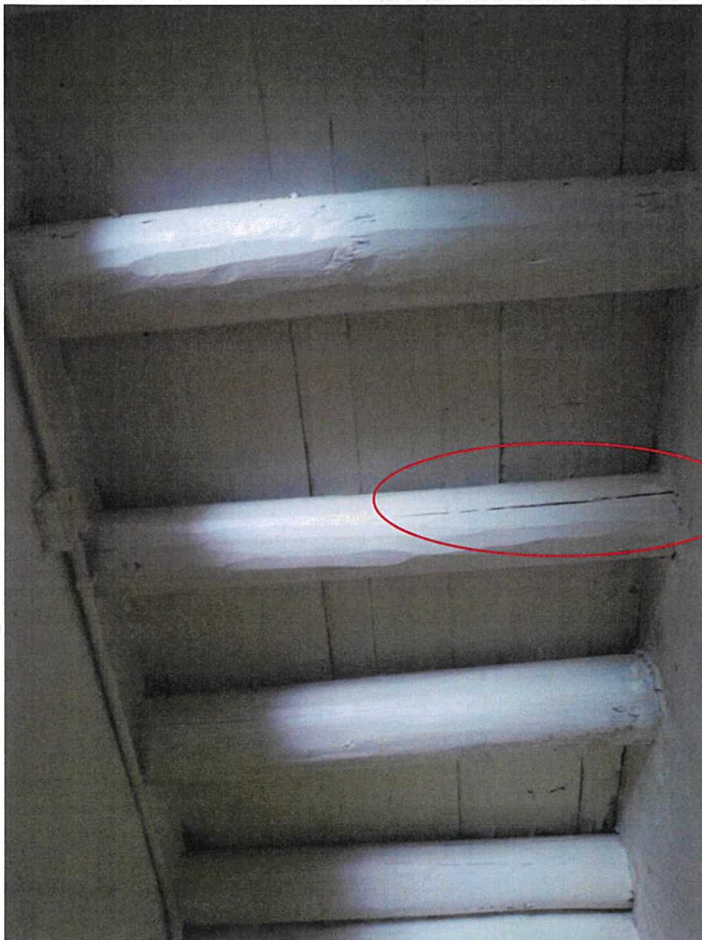
Photo No:
030

Photo description:
Wide cracks are found on the
timber beam and ceiling of G/F
(indicated by red circle in
the photo)

030	Inside 3 rd Block of Yu Cheung Tong (G/F)	Wide cracks on Timber Beam	Crack monitoring on <u>monthly basis</u> is

recommended (Point C5)
031	Inside 3rd Block of Yu Cheung Tong (G/F)	Wide cracks on Timber Beam	Owner of Yu Cheung Tong Block No. 3 disagreed to installed the crack meter (Point C6) (Please refer the minutes of liaison meeting held on 9 June 2021 – Appendix H)
033	Inside 3rd Block of Yu Cheung Tong (G/F)	Spalling	Defect found to be spalling instead of crack. Thus, crack monitoring is not required (Point C7) (Please refer the minutes of liaison meeting held on 9 June 2021 – Appendix H)
034	Inside 3rd Block of Yu Cheung Tong (G/F)	Spalling	not applicable for spalling
035	Inside 3rd Block of Yu Cheung Tong (G/F)	Spalling	Defect found to be spalling instead of crack. Thus, crack monitoring is not required (Point C8) (Please refer the minutes of liaison meeting held on 9 June 2021 – Appendix H)

***[Crack meter is recommended
for monitoring]
(Point C5)***

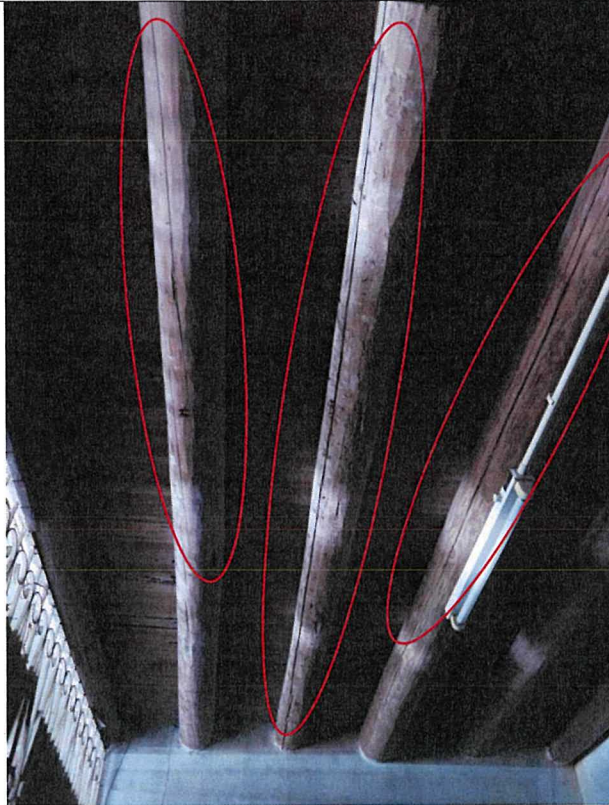
031

Wide cracks are found on the
timber beam and ceiling of G/F
(indicated by red circle in
the photo)

(Point C6)

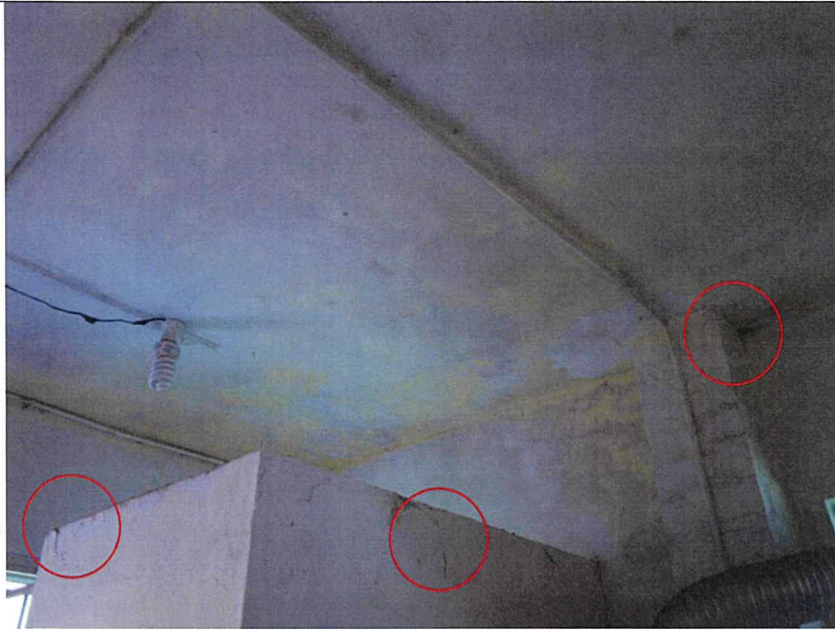
Photo No:
033

Photo description:
Spalling are found on the
wall and ceiling of G/F
(indicated by red circle in
the photo)
(Point C7)

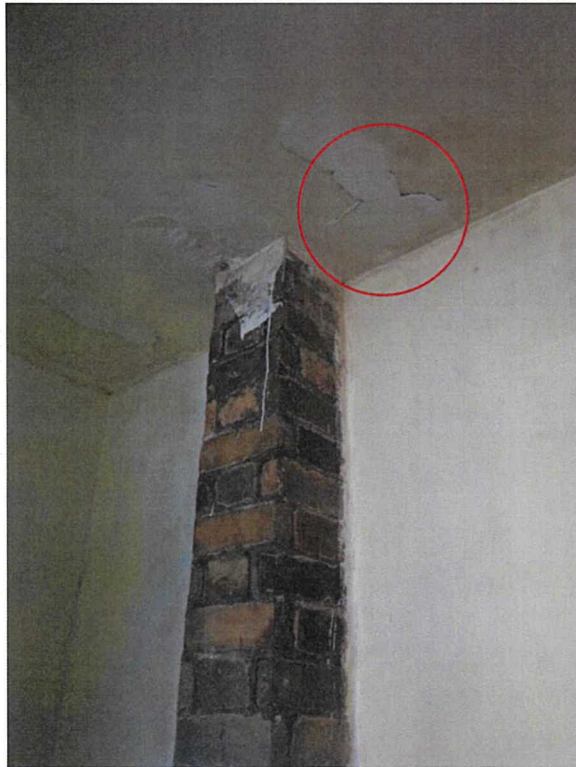
Photo No:
034

Photo description:
Spalling is found on the
wall and ceiling of G/F
(indicated by red circle in
the photo)

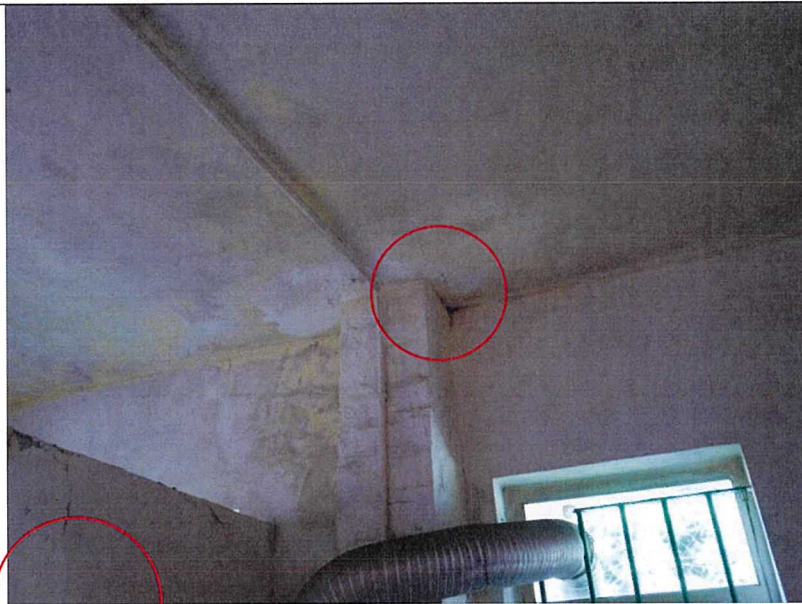
Photo No:
035

Photo description:
Spalling are found on the
wall and ceiling of G/F
(indicated by red circle in
the photo)
(Point C8)

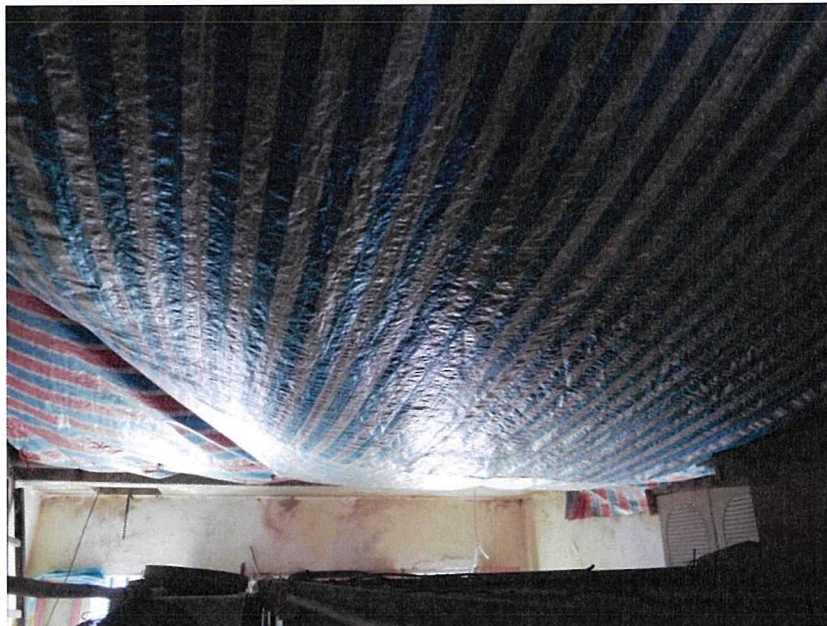
Photo No:
040

Photo description:
Timber structures with
no observable defects with
canvas cover blocking the
sight to upper possible
structures

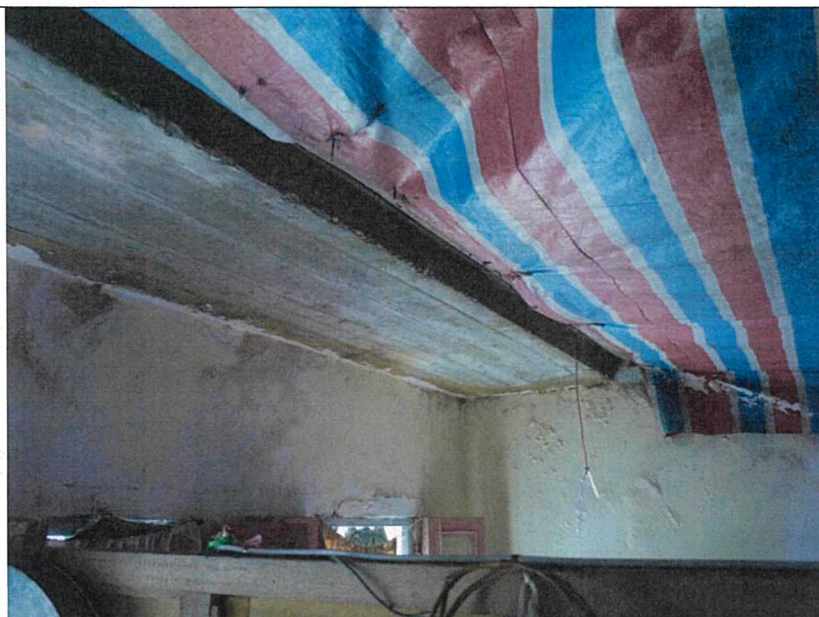
Photo No:
041

Photo description:
Timber structures and wall
with no observable defects

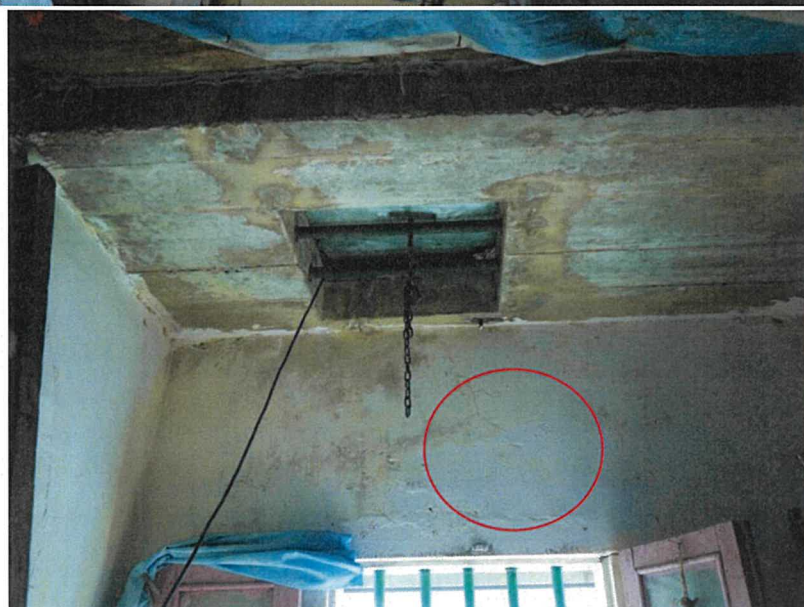
Photo No:
042

Photo description:
Fine cracks are found on
the wall of the building
(indicated by red circle in
the photo)
(Point C9)

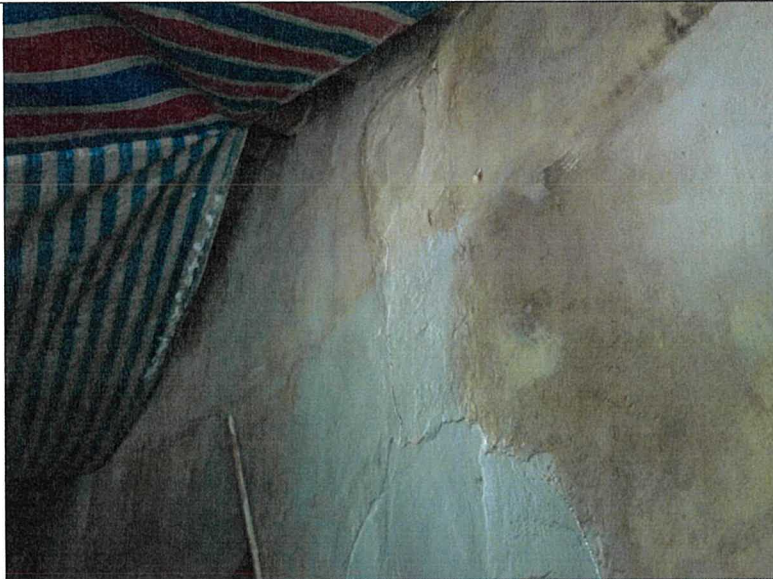
Photo No:
043

Photo description:
Wall with no observable
defects

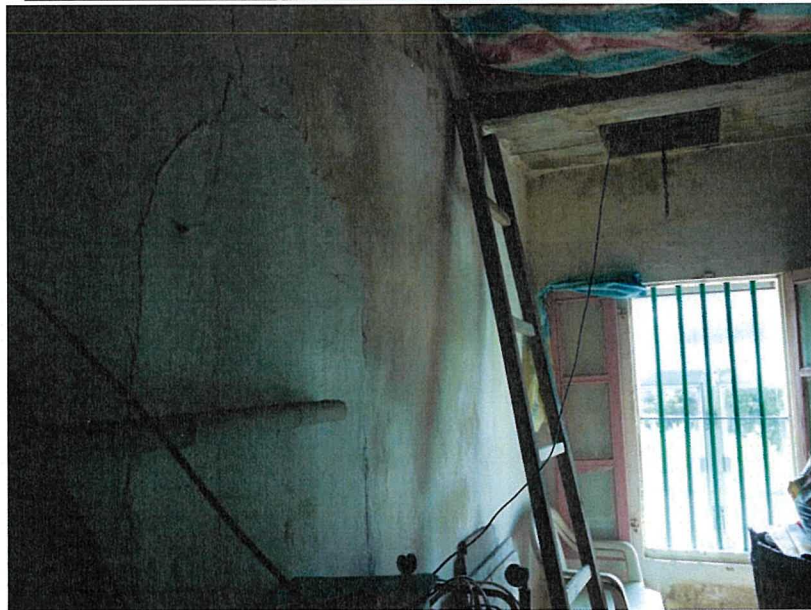
Photo No:
044

Photo description:
Wall with no observable
defects

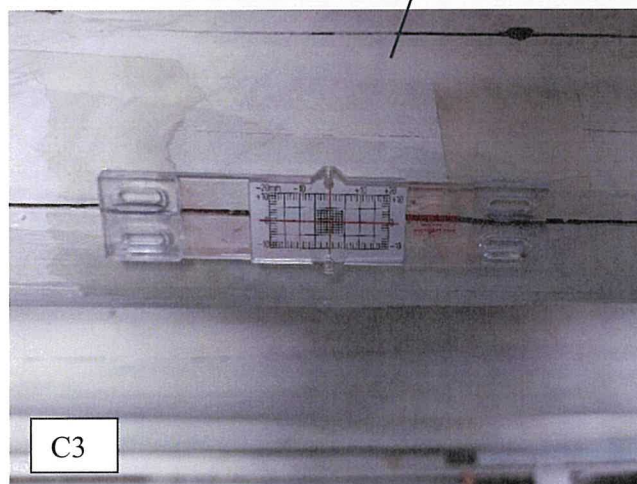
Crack Meter No.: C3

C3 Original Crack Widths – 3mm

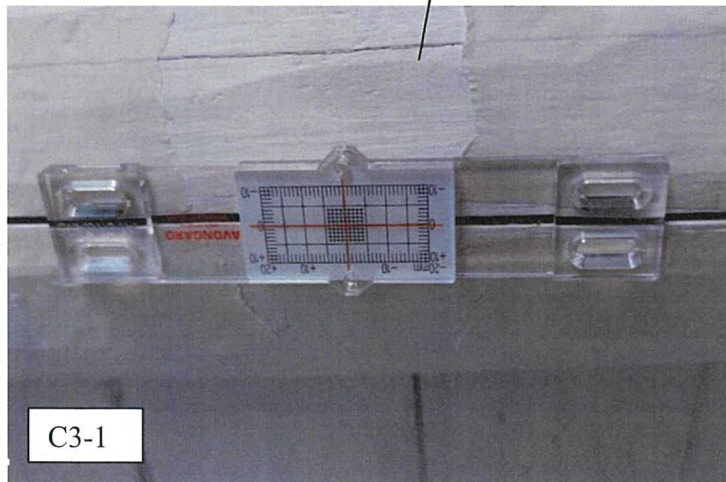
Location: Inside 3rd Block of Yu Cheung Tong G/F
Crack Meter No.: C3-1

C3-1 Original Crack Widths – 3mm

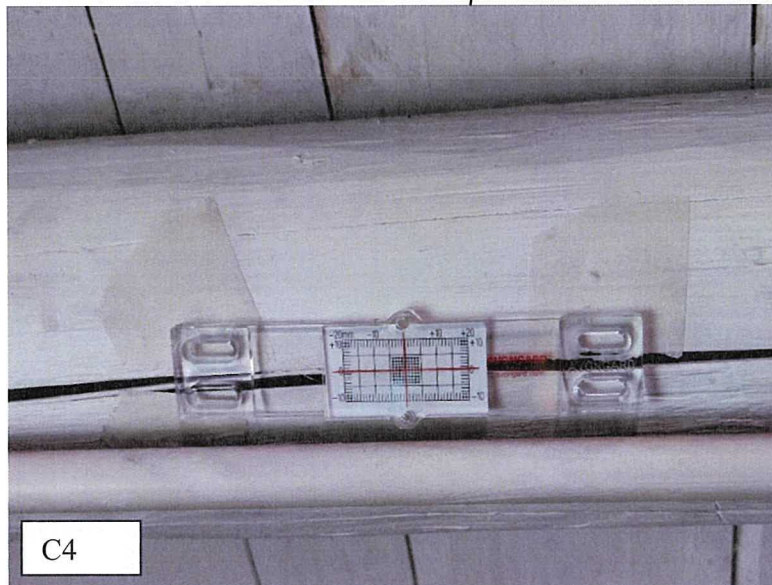
Location: Inside 3rd Block of Yu Cheung Tong G/F
Crack Meter No.: C4

C4 Original Crack Widths – 4mm

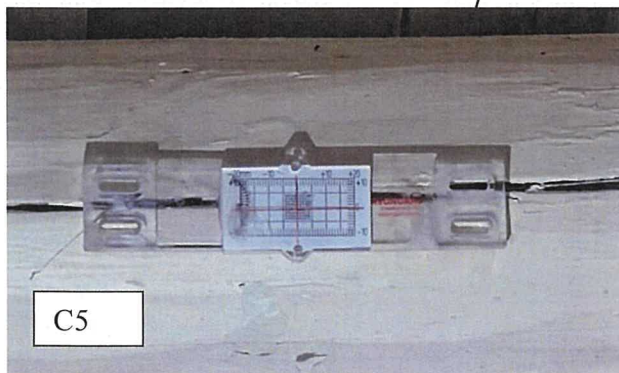
Location: Inside 3rd Block of Yu Cheung Tong G/F
Crack Meter No.: C5

C5 Original Crack Widths – 4mm

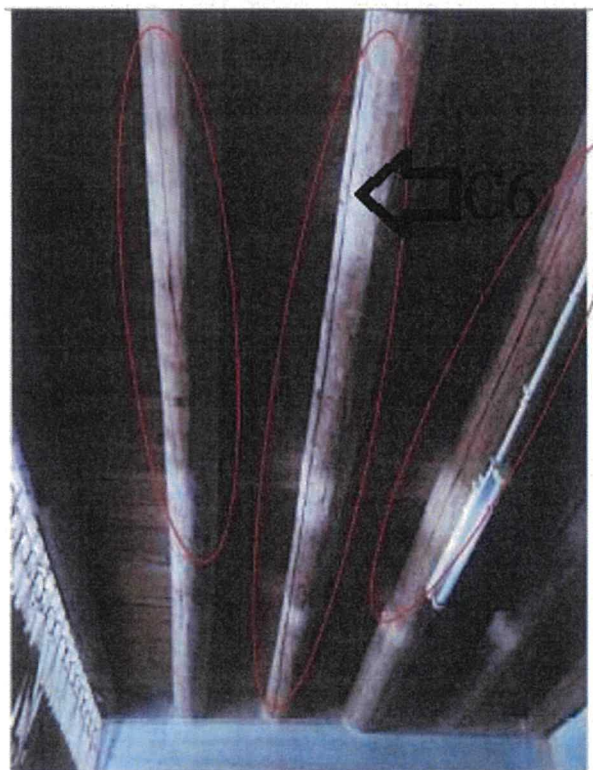
相片 C6 (豫章堂 1 號屋內)

1.5.2	羅先生擔心安裝裂紋監察儀(詳見附件相片 007)會對天花上的橫樑造成損害，因此不同意在豫章堂三號屋內安裝裂紋監察儀以監察附件相片 C3 至 C9 所示之裂紋。他希望工程團隊能使用其他方法進行監察。		
1.5.3	上海建工提出在工程開展前在各裂紋監察位置量度及記錄裂紋闊度和長度以代替安裝裂紋監察儀。

豫章堂

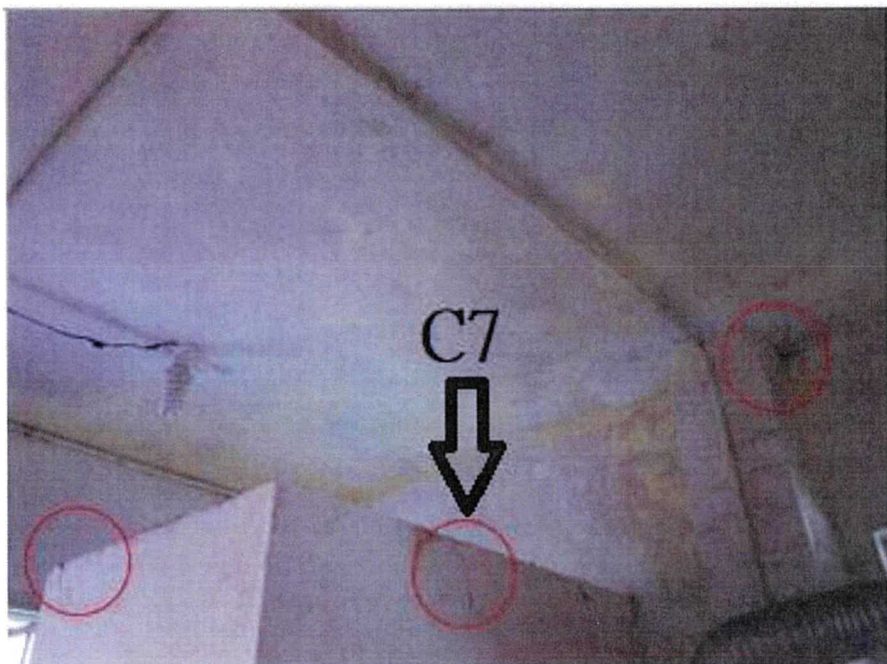
相片 C7 (豫章堂 1 號屋內)

於 2021 年 3 月 15 日下午 2 時在豫章堂進行安裝裂紋監察儀(C1 至 C9 所示位置)，羅先生表示跟據現場所見裂紋監察儀 C6 及 C9 位置分別在睡房內及 1 樓位置。這兩個位置羅先生都不同意工程團隊進入，在以上位置安裝裂紋監察儀。而裂紋監察儀 C7 及 C8 位置現場所見為牆壁油漆剝落未發現裂縫，因此羅先生同意取消 C7 及 C8 位置安裝裂紋監察儀。

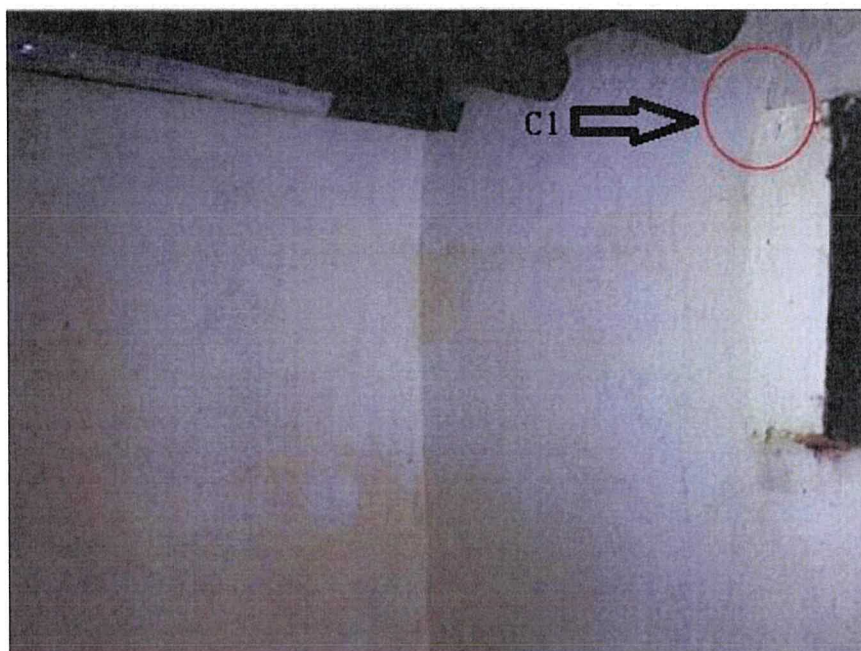
相片 LC1

2.4.3	羅先生同意上述方法。		
2.5	監察頻率		
2.5.1	上海建工指出在工程進行期間需要每日量度上述工程監察裝置的數據, 包括沉降, 裂紋及傾斜監察。		
2.5.2	羅先生對沉降監察及傾斜監察的監察頻率沒有意見。羅先生指出進入室內進行監察必須先與其聯絡安排, 為減少對其影響, 希望量度屋內裂紋(即附件相片 LC1 所示之裂紋)的監察頻率定為一個月兩次。其餘量度屋外裂紋的監察頻率則可以維持每天一次。

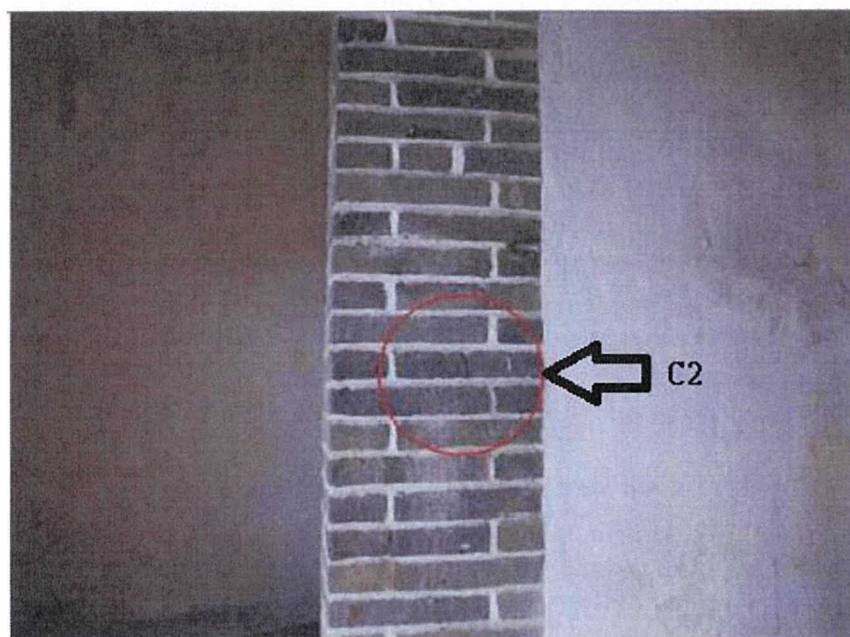
相片 LC2

2.2.2	羅先生同意。		
2.3	裂紋監察		
2.3.1	承上次會議所述，上海建工希望羅先生能考慮讓工程團隊在附件相片 LC1 至 LC3 所示屋內位置安裝裂紋監察儀，並現場展示裂紋監察儀樣板相片(詳見附件相片 007)。		
2.3.2	經了解後，羅先生認同安裝裂紋監察儀較為穩妥，並同意在附件相片 LC1 至 LC3 所示位置安裝裂紋監察儀進行裂紋監察。		
2.3.3	上海建工提出在工程開展前需在各裂紋監察位置安裝裂紋監察儀及量度及記錄裂紋闊度和長度。		
2.3.4	羅先生表示希望工程團隊安排與豫章堂同日安裝裂紋監察儀。		
2.3.5	上海建工同意。		
2.4	裂紋監察頻率		
2.4.1	因應古物古蹟辦事處的建議，上海建工詢問可否增加屋內裂紋 (即附件相片 LC1 至 LC3 所示)的監察頻率，一個月兩次增加為每日一次。羅先生提出因需要進入羅家祠內進行監察，其本人必須陪同工程人員入內，因此要求與豫章堂同日進行裂紋監察，頻率改為一個月一次。與豫章堂情況一樣，建議如工程團隊發現裂紋監察點出現明顯變化，再與其相討增加監察頻率。		
2.4.2	建議如工程團隊發現裂紋監察點出現明顯變化，再與其相討增加監察頻率。		
2.5	總結		
2.5.1	AECOM 及上海建工明白羅先生的要求並表示工程團隊會進一步提交以上建議予有關部門再作審批。		
	會議結束

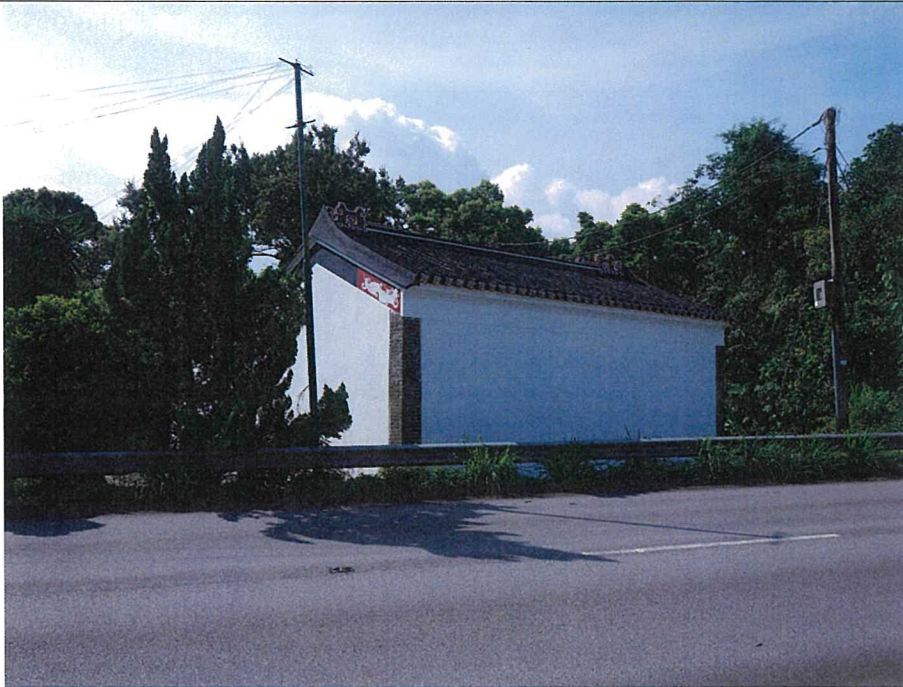
Photo No:
001

Photo description:
General View of
Law Ancestral Hall

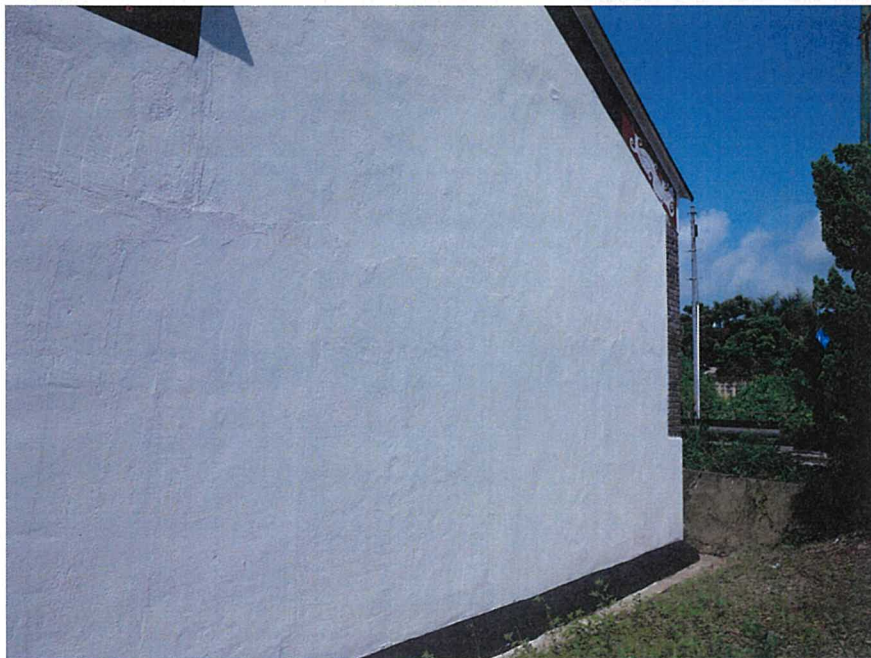
Photo No:
002

Photo description:
Fine condition of north-
faced wall of Law
Ancestral Hall with
no observable cracks

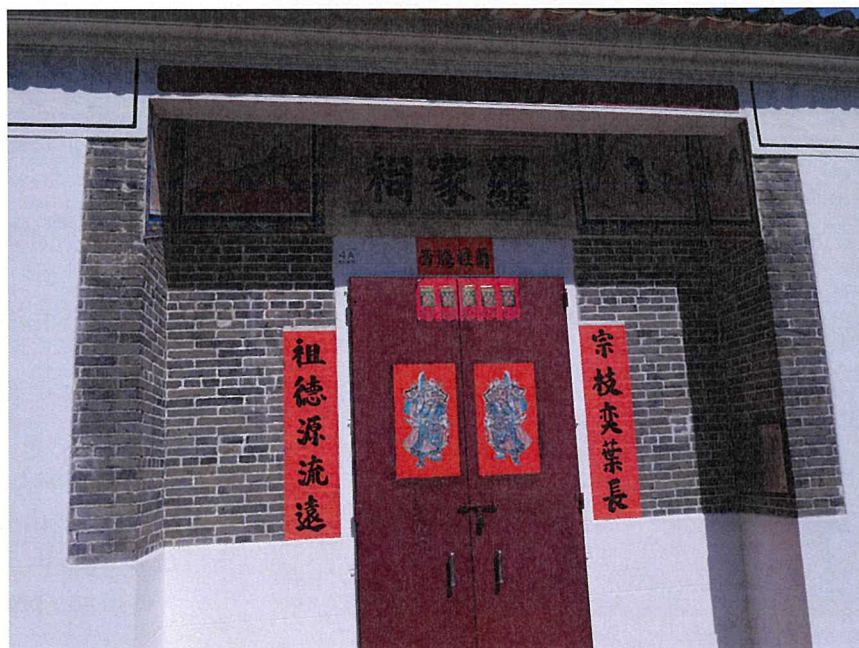
Photo No:
008

Photo description:
Front Door of
Law Ancestral Hall

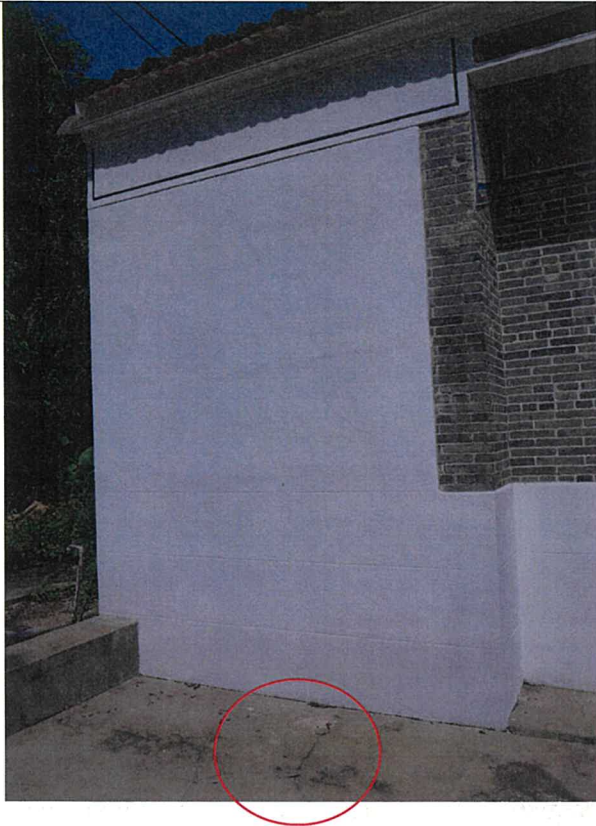
Photo No:
009

Photo description:
Fine condition on the wall of
the building with
no observable cracks.
Wide cracks are identified in the
front ground of the building
(indicated by red circle in
the photo)

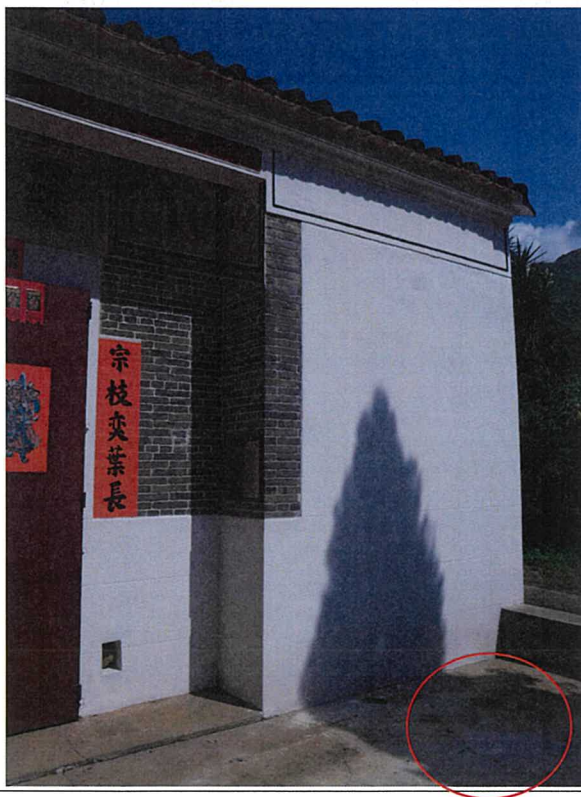
Photo No:
010

Photo description:
Fine condition on the wall of the
building with
no observable cracks.
Wide cracks are identified in the
front ground of the building
(indicated by red circle in
the photo)

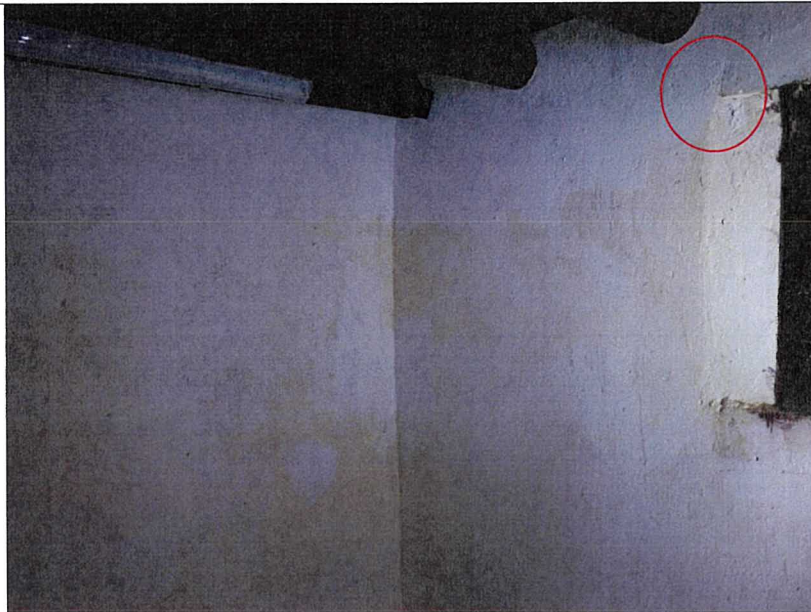
Photo No:
015

Photo No.	Location	Identified defects	Recommendations on Crack Monitoring
004	Front ground of Law Ancestral Hall	Wide cracks on Concrete Pavement	Not Required to monitor cracks on Concrete Pavement
005	Front ground of Law Ancestral Hall	Wide cracks on Concrete Pavement	Not Required to monitor cracks on Concrete Pavement
006	Front ground of Law Ancestral Hall	Wide cracks on Concrete Pavement	Not Required to monitor cracks on Concrete Pavement
007	Front ground of Law Ancestral Hall	Wide cracks on Concrete Pavement	Not Required to monitor cracks on Concrete Pavement
009	In Front of Law Ancestral Hall (East side)	Wide cracks on Concrete Pavement	Not Required to monitor cracks on Concrete Pavement
010	In Front of Law Ancestral Hall (East side)	Wide cracks on Concrete Pavement	Not Required to monitor cracks on Concrete Pavement
015	Inside Law Ancestral Hall	Spalling on the Wall near the	Defect found to be spalling instead of crack. Thus,

Window	crack monitoring is not required (Point C1) (Please refer to the minutes of liaison meeting held on 9 June 2021- Appendix H)
021	Inside Law Ancestral Hall	Wide cracks on the Brick Column of the Building	Crack monitoring on <u>monthly basis</u> is recommended (Point C2)
023	Inside Law Ancestral Hall	Wide cracks on the Brick Column of the Building	Crack monitoring on <u>monthly basis</u> is recommended (Point C3)
038	Behind of Law Ancestral Hall (West Side)	Wide cracks on the wall	Crack monitoring on <u>daily basis</u> is recommended (Point C4)
039	Behind of Law Ancestral Hall (West Side)	Wide cracks on the wall	Crack monitoring on <u>daily basis</u> is recommended (Point C5)

Photo description:
Spalling on
the wall near the window
(indicated by red circle in
the photo)
(Point C1)

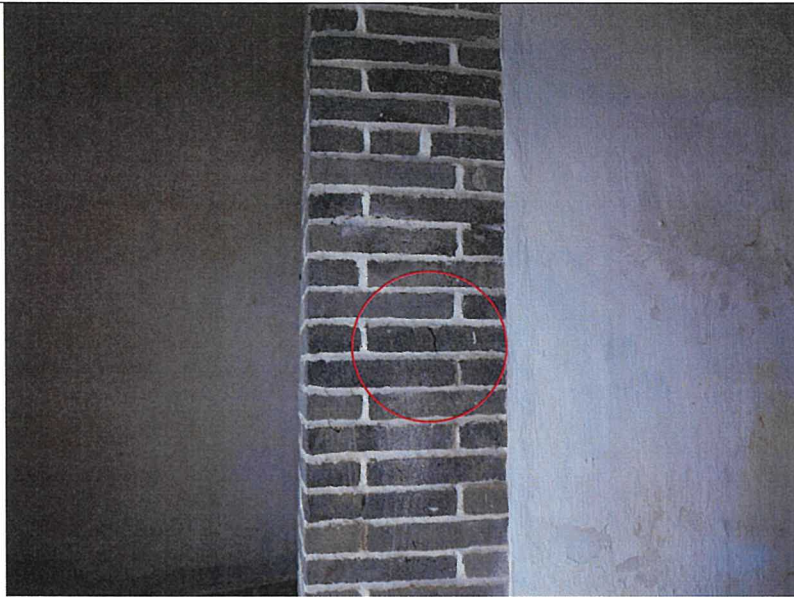
Photo No:
021

Photo description:
Wide cracks are identified
on the brick column of
the building
(indicated by red circle in
the photo)

***[Crack Meter is
recommended for crack
monitoring]
(Point C2)***

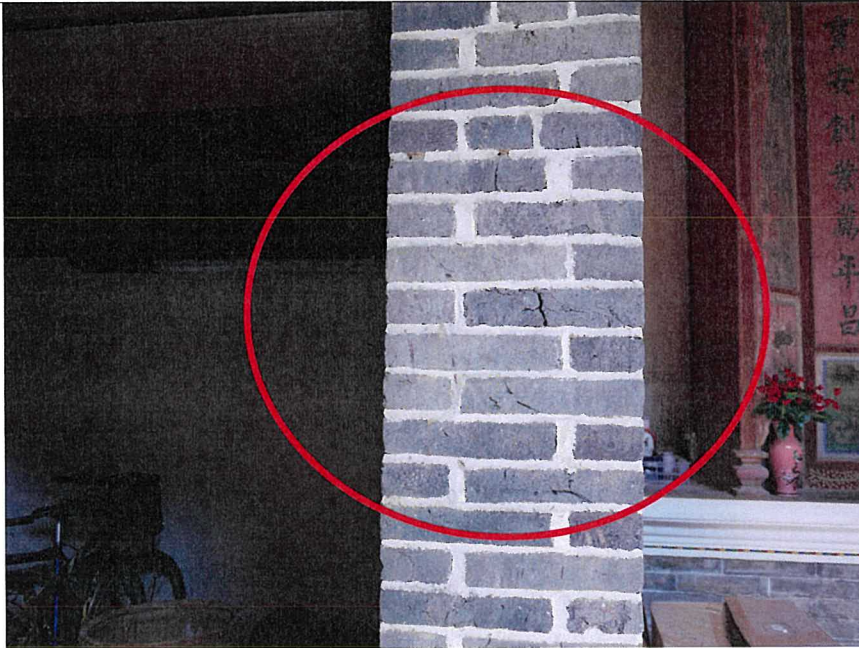
Photo No:
023

Photo description:
Wide cracks are identified
on the brick column of
the building
(indicated by red circle in
the photo)

***[Crack Meter is
recommended for crack
monitoring]
(Point C3)***

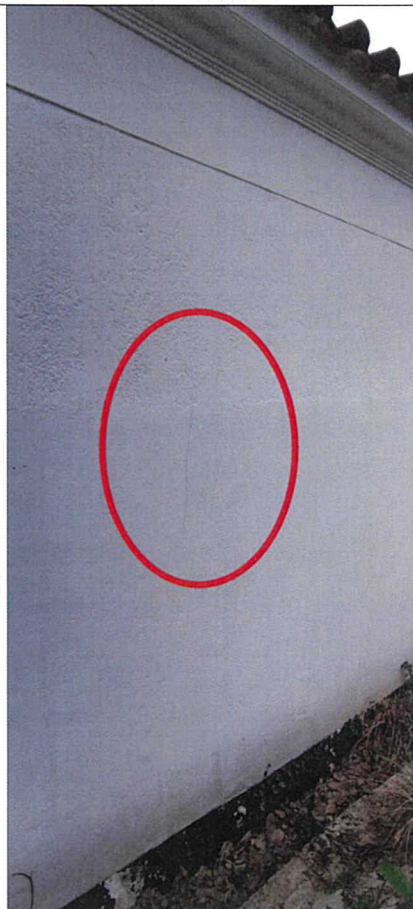
Photo No:
038

Photo description:
Wide cracks are identified
on the external wall of
the building
(indicated by red circle in
the photo)
**[Crack Meter is recommended
for crack monitoring]
(Point C4)**

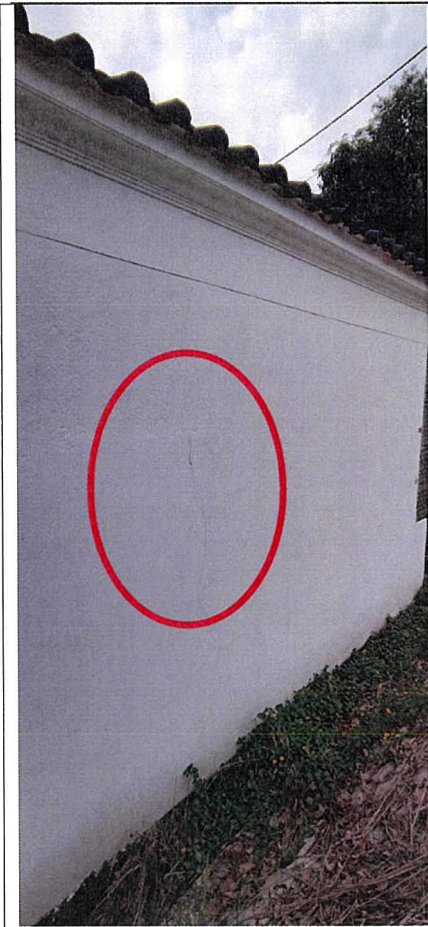
Photo No:
039

Photo description:
Wide cracks are identified
on the external wall of
the building
(indicated by red circle in
the photo)
**[Crack Meter is recommended
for crack monitoring]
(Point C5)**
