Contract No. DC/2018/02
Upgrading of Sewage Pumping
Stations and Sewerage Along
Ting Kok Road

Condition Survey Report on a
Grade 3 Historical Building
(Yu Cheung Tong)

P19076/CSR/002 (Issue 7)

June 2021

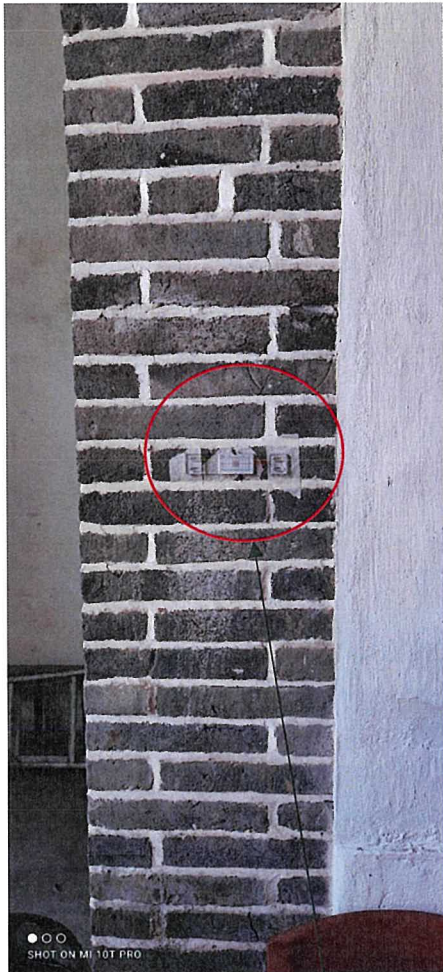
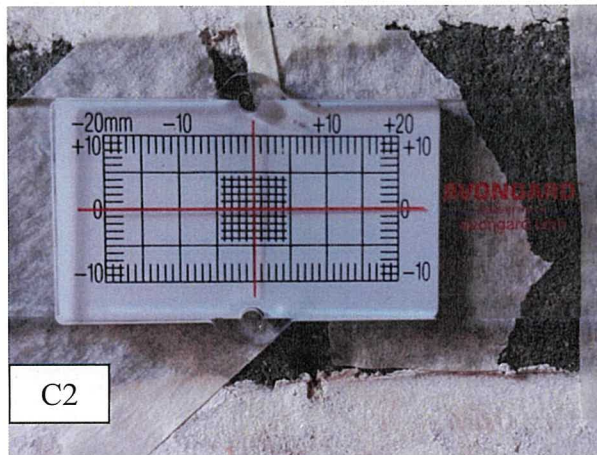
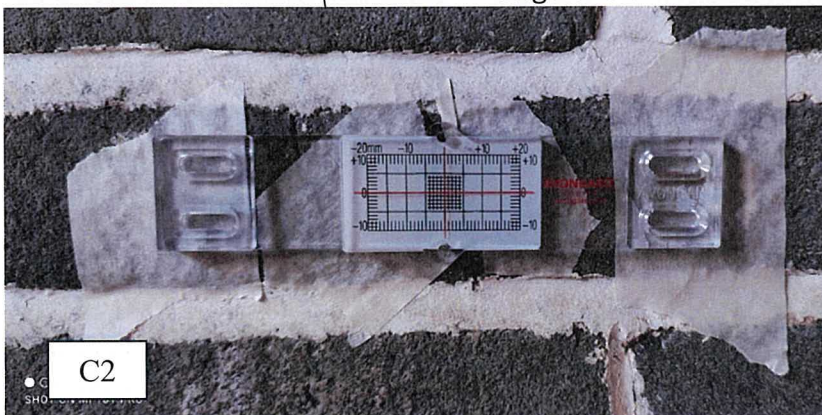
Location: Inside Law Ancestral Hall
Crack Meter No.: C2

Original Crack Width – 4mm

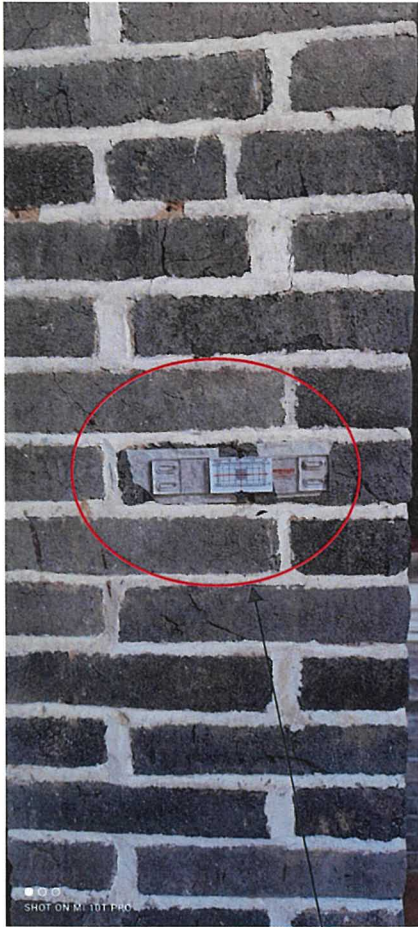
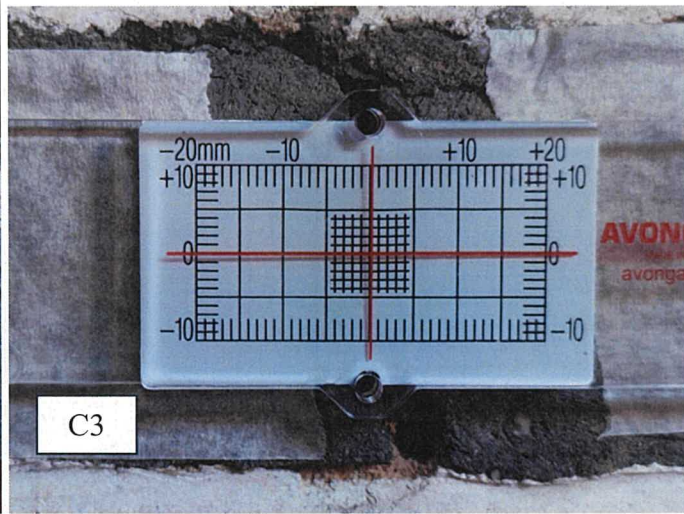
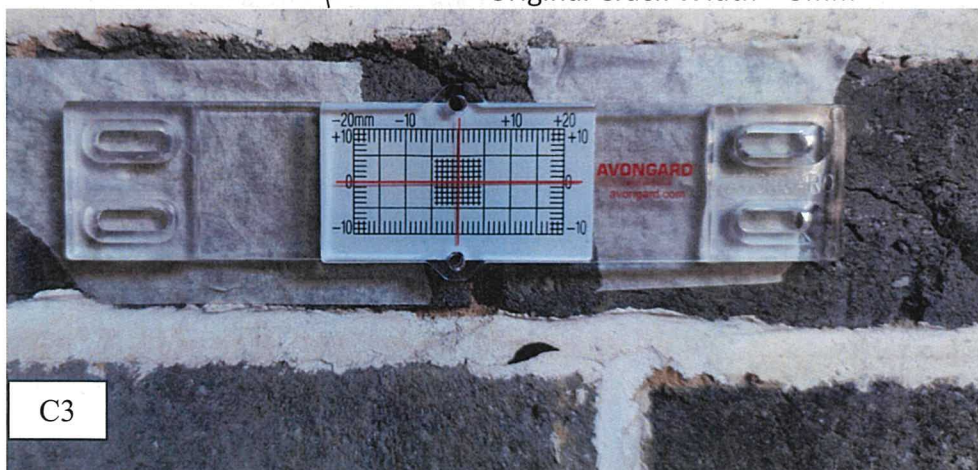
Location: Inside Law Ancestral Hall
Crack Meter No.: C3

Original Crack Width – 5mm

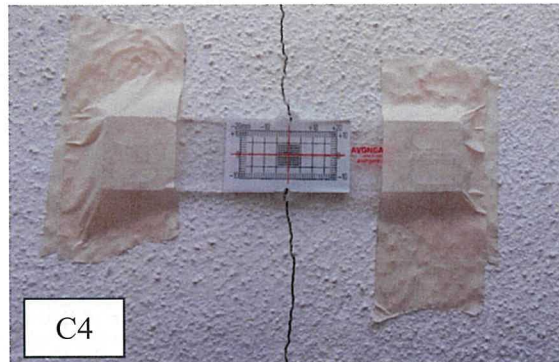
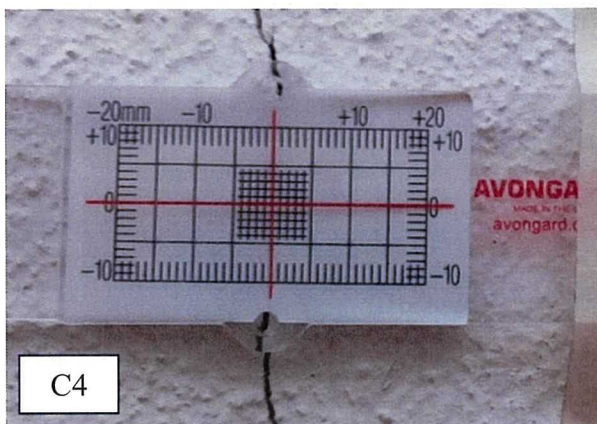
Location: Inside Law Ancestral Hall
Crack Meter No.: C4

Original Crack Width – 1mm

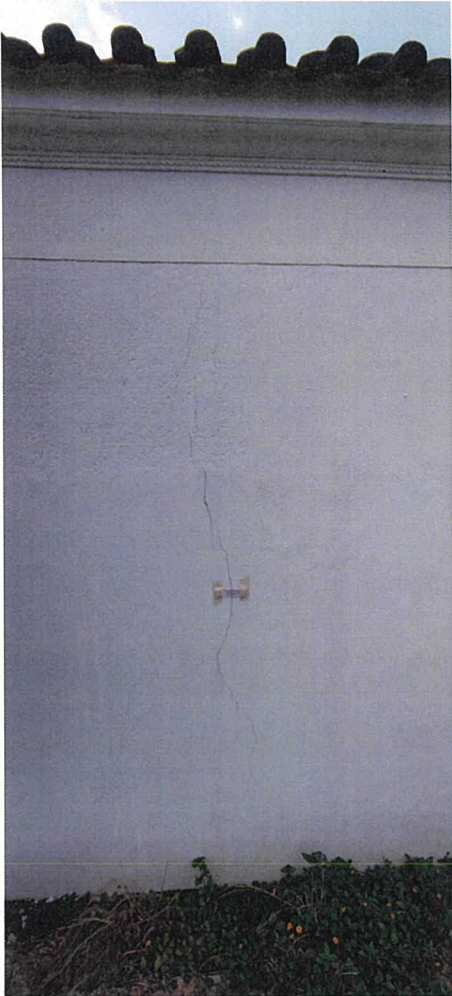
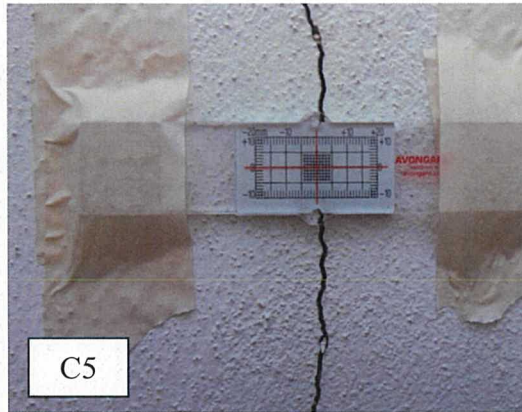
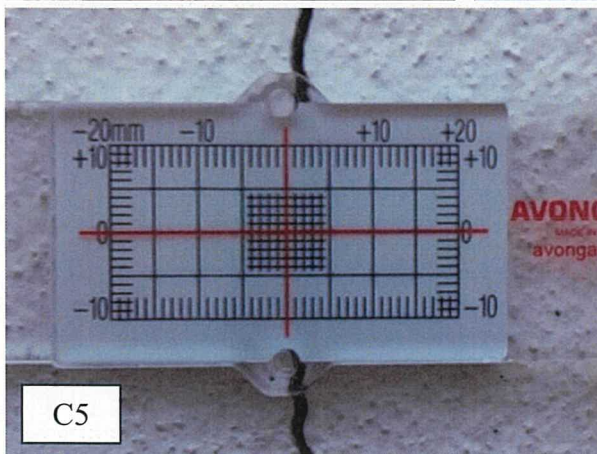
Location: Inside Law Ancestral Hall
Crack Meter No.: C5

Original Crack Width – 3mm

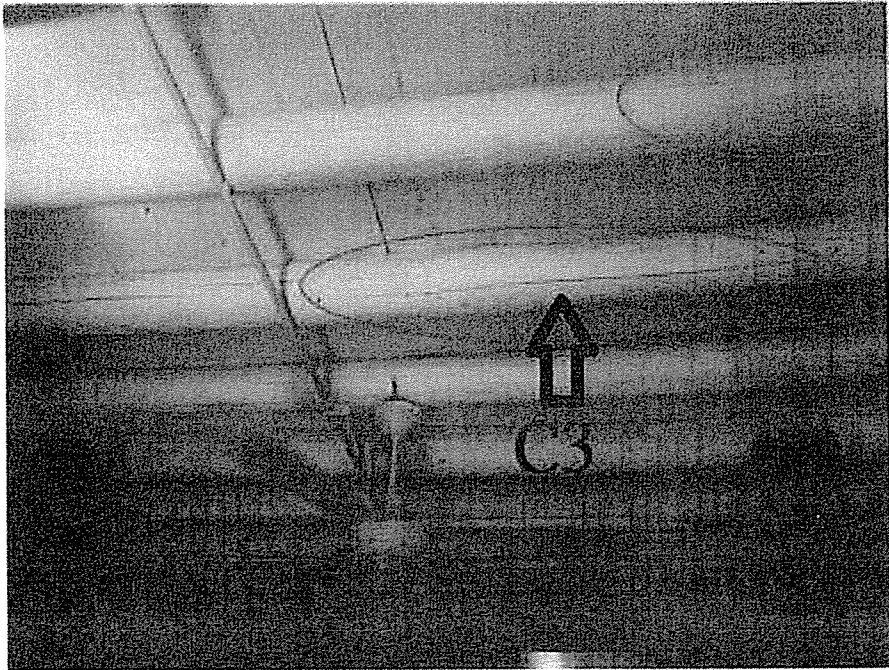
相片 C3 (豫章堂 1 號屋內)

1.5.2	羅先生擔心安裝裂紋監察儀(詳見附件相片 007)會對天花上的橫樑造成損害，因此不同意在豫章堂三號屋內安裝裂紋監察儀以監察附件相片 C3 至 C9 所示之裂紋。他希望工程團隊能使用其他方法進行監察。		
1.5.3	上海建工提出在工程開展前在各裂紋監察位置量度及記錄裂紋闊度和長度以代替安裝裂紋監察儀。

1.6.2	經了解後，羅先生認同安裝裂紋監察儀較為穩妥，並同意在附件相片 C1 至 C9 所示位置安裝裂紋監察儀進行裂紋監察。		
1.6.3	上海建工提出在工程開展前需在各裂紋監察位置安裝裂紋監察儀及量度及記錄裂紋闊度和長度。		
1.6.4	由於需進入屋內範圍進行安裝，羅先生表示工程團隊需提早兩日通知安裝監察裝置以便作出安排。

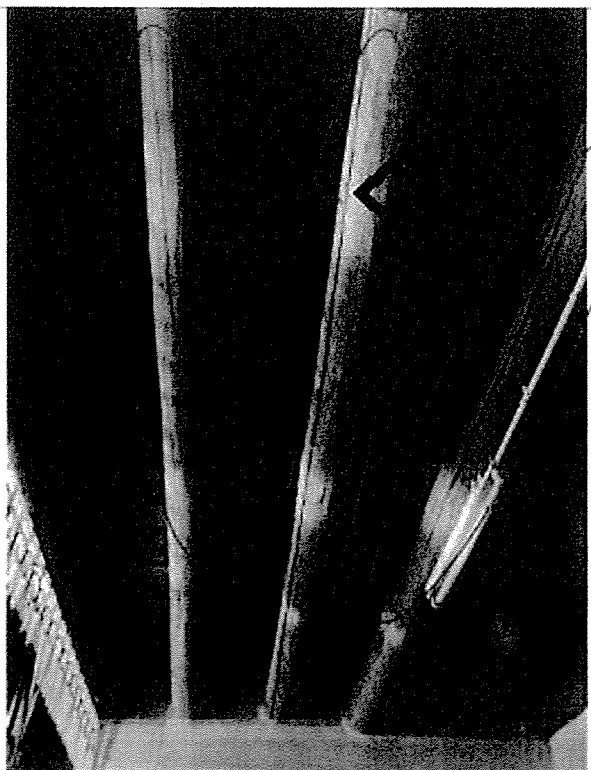
相片 C6 (豫章堂 1 號屋內)

於 2021 年 3 月 15 日下午 2 時在豫章堂進行安裝裂紋監察儀(C1 至 C9 所示位置)，羅先生表示跟據現場所見裂紋監察儀 C6 及 C9 位置分別在睡房內及 1 樓位置。這兩個位置羅先生都不同意工程團隊進入，在以上位置安裝裂紋監察儀。而裂紋監察儀 C7 及 C8 位置現場所見為牆壁油漆剝落未發現裂縫，因此羅先生同意取消 C7 及 C8 位置安裝裂紋監察儀。

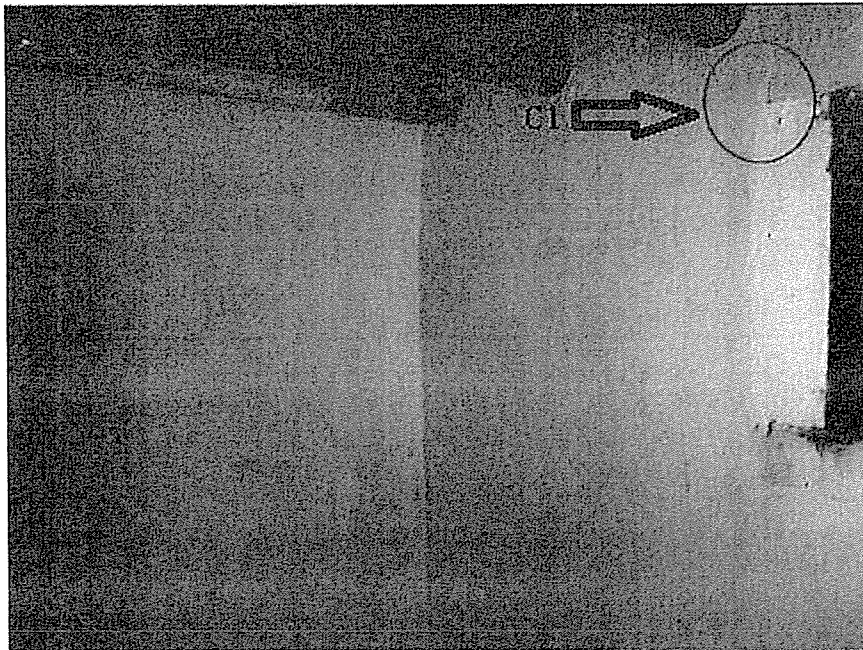
相片 LC1

2.4.3	羅先生同意上述方法。		
2.5	監察頻率		
2.5.1	上海建工指出在工程進行期間需要每日量度上述工程監察裝置的數據, 包括沉降, 裂紋及傾斜監察。		
2.5.2	羅先生對沉降監察及傾斜監察的監察頻率沒有意見。羅先生指出進入室內進行監察必須先與其聯絡安排, 為減少對其影響, 希望量度屋內裂紋(即附件相片 LC1 所示之裂紋)的監察頻率定為一個月兩次。其餘量度屋外裂紋的監察頻率則可以維持每天一次。

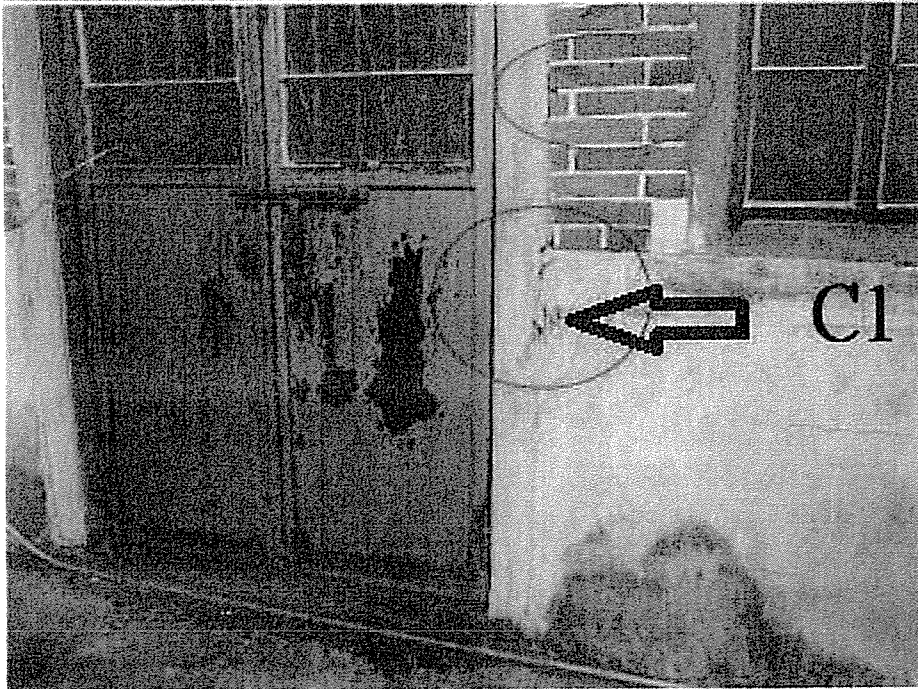
相片 C1(豫章堂 2 號屋外)

1.5.4	羅先生同意上述方法。		
1.5.5	另外上海建工向羅先生表示，經多返聯絡亦未能聯絡豫章堂一及二號屋屋主，上海建工向羅先生查詢可否聯絡到豫章堂一及二號屋屋主或負責人。羅先生表示豫章堂一及二號屋屋主已移民未能取得聯絡。		
1.5.6	上海建工就附件相片 C1 及 C2 所示豫章堂 2 號屋外位置安裝裂紋監察儀，羅先生表示沒有意見。

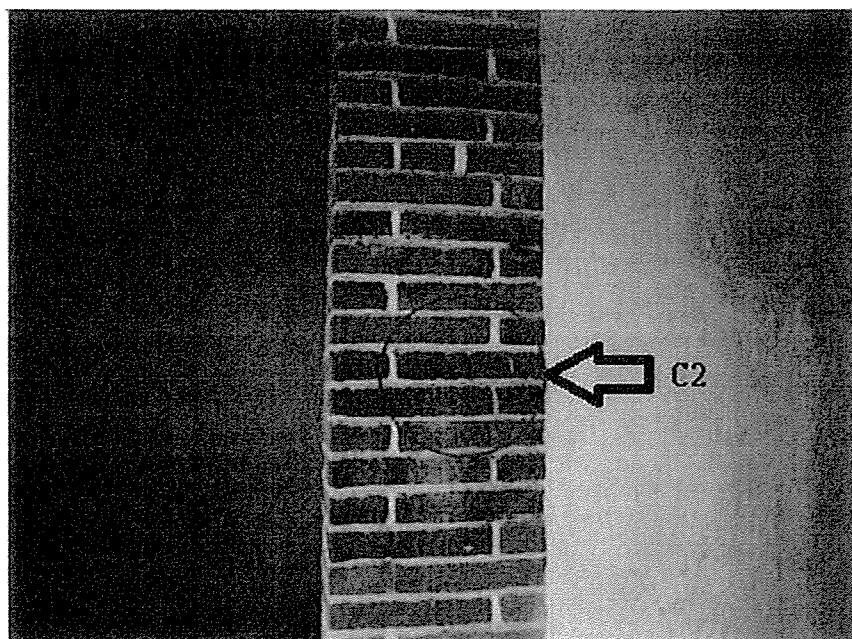
相片 LC2

2.2.2	羅先生同意。		
2.3	裂紋監察		
2.3.1	承上次會議所述，上海建工希望羅先生能考慮讓工程團隊在附件相片 LC1 至 LC3 所示屋內位置安裝裂紋監察儀，並現場展示裂紋監察儀樣板相片(詳見附件相片 007)。		
2.3.2	經了解後，羅先生認同安裝裂紋監察儀較為穩妥，並同意在附件相片 LC1 至 LC3 所示位置安裝裂紋監察儀進行裂紋監察。		
2.3.3	上海建工提出在工程開展前需在各裂紋監察位置安裝裂紋監察儀及量度及記錄裂紋闊度和長度。		
2.3.4	羅先生表示希望工程團隊安排與豫章堂同日安裝裂紋監察儀。		
2.3.5	上海建工同意。		
2.4	裂紋監察頻率		
2.4.1	因應古物古蹟辦事處的建議，上海建工詢問可否增加屋內裂紋 (即附件相片 LC1 至 LC3 所示)的監察頻率，一個月兩次增加為每日一次。羅先生提出因需要進入羅家祠內進行監察，其本人必須陪同工程人員入內，因此要求與豫章堂同日進行裂紋監察，頻率改為一個月一次。與豫章堂情況一樣，建議如工程團隊發現裂紋監察點出現明顯變化，再與其相討增加監察頻率。		
2.4.2	建議如工程團隊發現裂紋監察點出現明顯變化，再與其相討增加監察頻率。		
2.5	總結		
2.5.1	AECOM 及上海建工明白羅先生的要求並表示工程團隊會進一步提交以上建議予有關部門再作審批。		
	會議結束

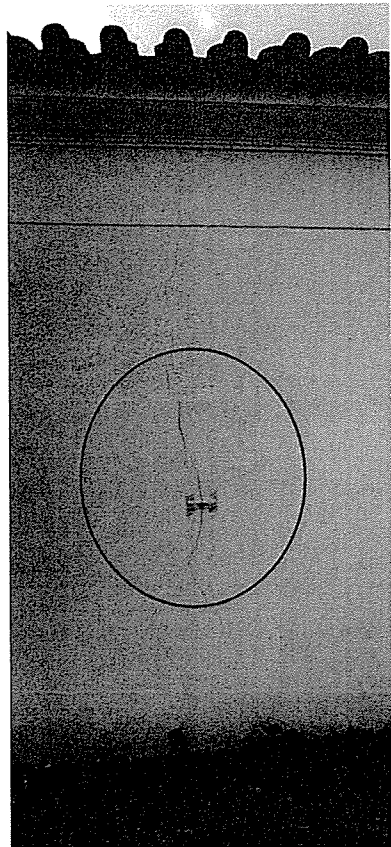
相片 LC4

於 2021 年 4 月 14 日上午 10 時與羅先生相討在羅家祠外牆發現的新裂縫，需另行安裝裂紋監察儀 C4 及 C5。羅先生同意加裝 C4 及 C5 裂紋監察儀，並同意 C4 及 C5 裂紋監察儀在工程期間每日進行量度。
