# Kowloon-Canton Railway Corporation

## West Rail

## Pre-operation Environmental Audit Report

### December 2003

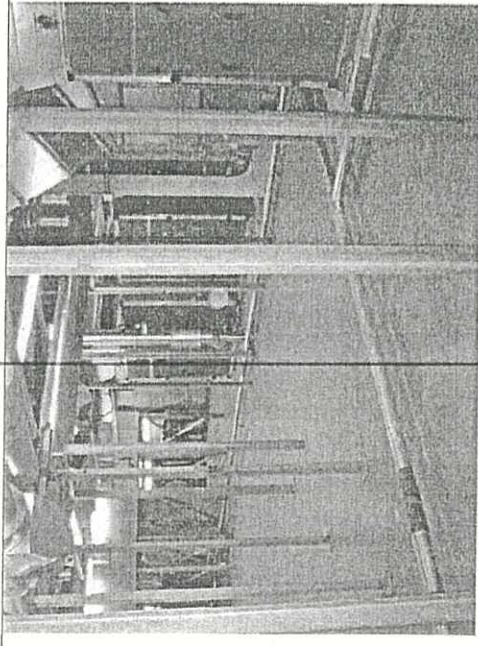
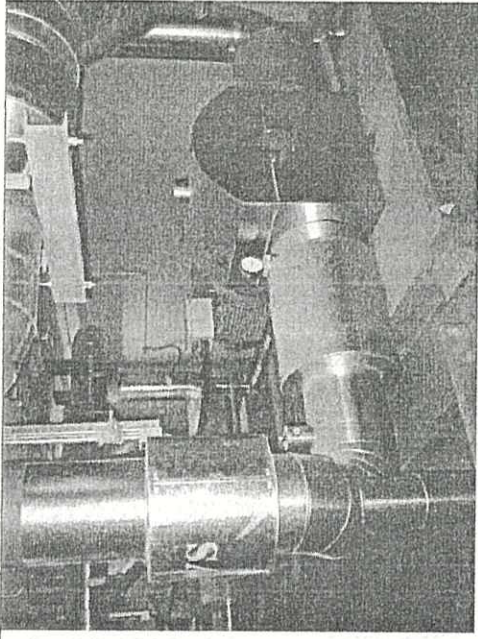
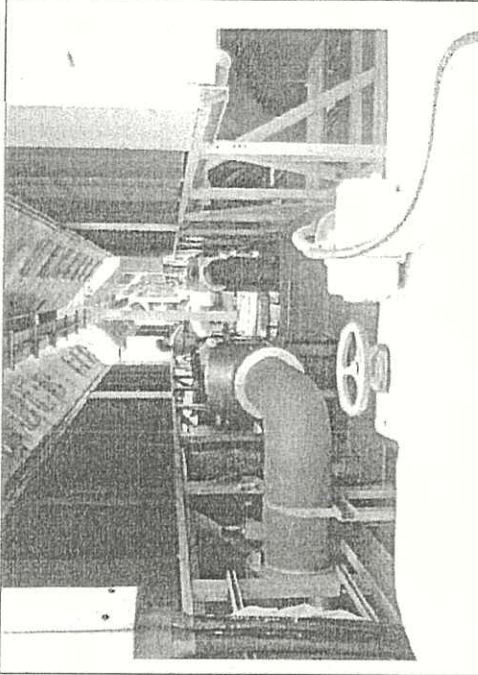
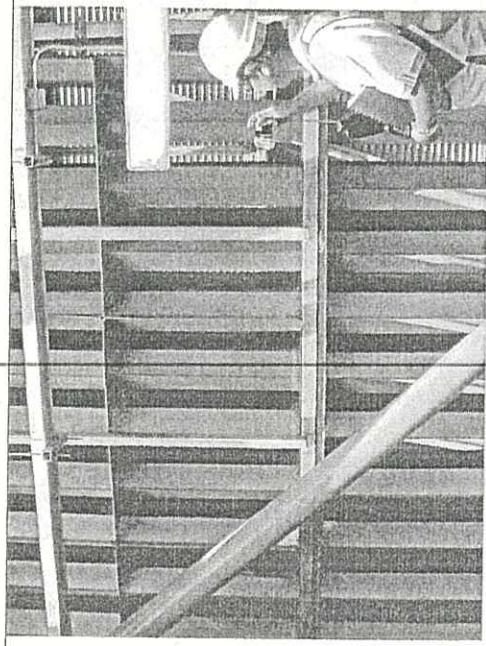
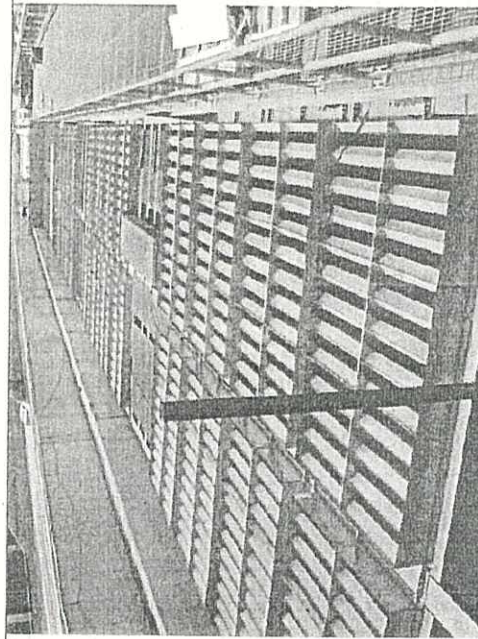
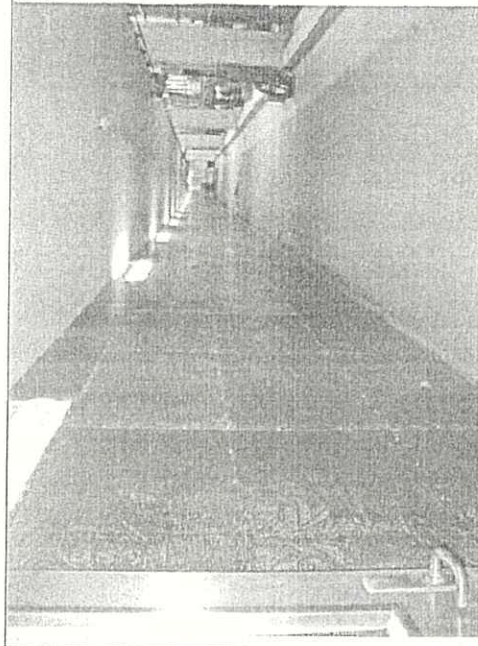
The chiller plant for Nam Cheong Station is located on the roof. There are silencers and acoustic panels installed above and on the sides of the plant. The chiller pumps are also located in the chiller pump room on the top floor of the station. No significant noise emanated from the pump room to the surrounding has been noticed. Other chiller systems include the Environmental Control System (ECS) are located in enclosed areas (See Photos 2.1-2.6 in Annex 2).

Photo 2.1: ECS Room

Photo 2.2: Chiller Pump Room

Photo 2.3: Chiller Plant

Photo 2.4: Silencers for the Chiller Plant

Photo 2.5: Silencers on the top of the Chiller Plant

Photo 2.6: Acoustic panels alongside of the Chiller plant Room

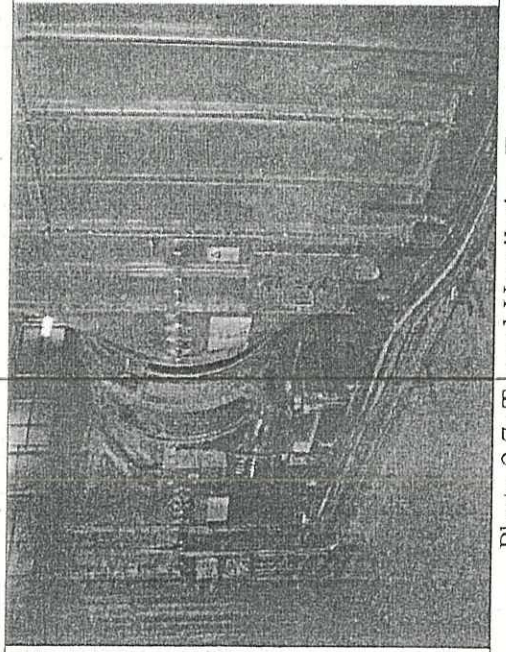
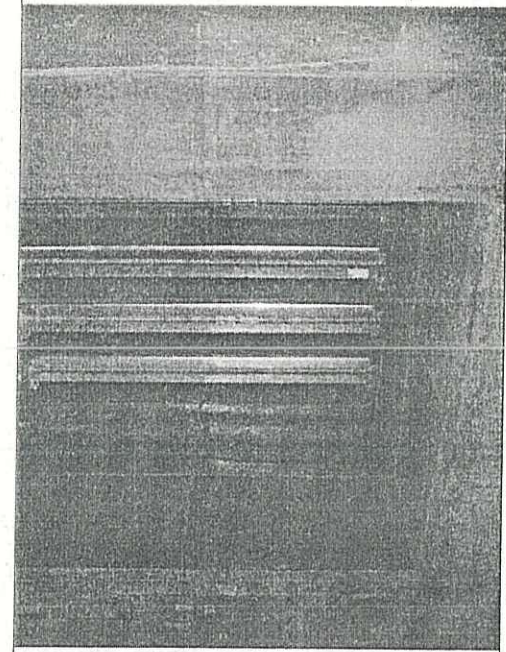
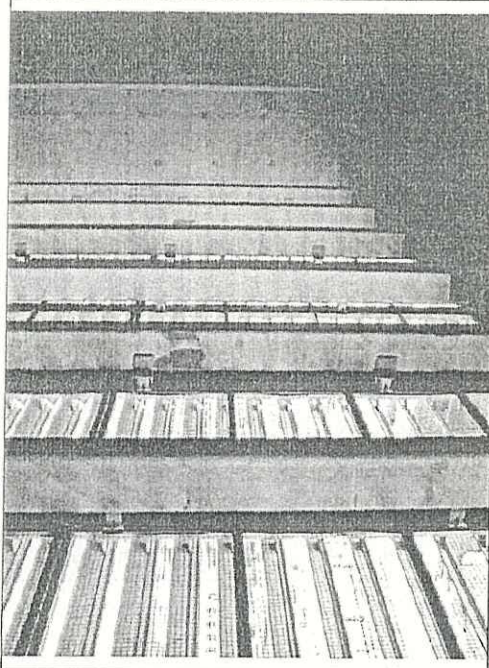
The tunnel ventilation fans are in enclosed areas. The ventilation fans are equipped with silencers. There is no equipment installed in the ventilation shaft (See Photos 2.7-2.9 in Annex 2).

Photo 2.7: Tunnel Ventilation Fan

Photo 2.8: Silencers for the ventilation fan

Photo 2.9: Interior of Ventilation Shaft

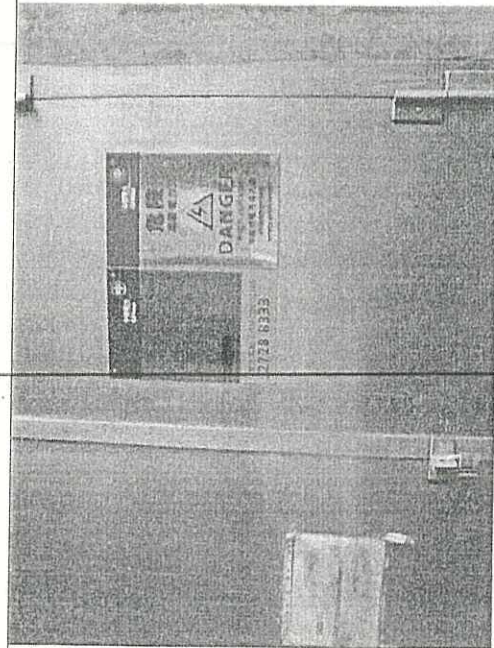
The transformer rooms have been completed and are controlled by China Light Power. Inspection of the interior of the rooms cannot be performed during the audit since no access can be provided. By observation, the rooms are enclosed and no significant noise has been noticed from the exterior of the rooms (See Photo 2.10 in Annex 2).

Photo 2.10: Transformer Room

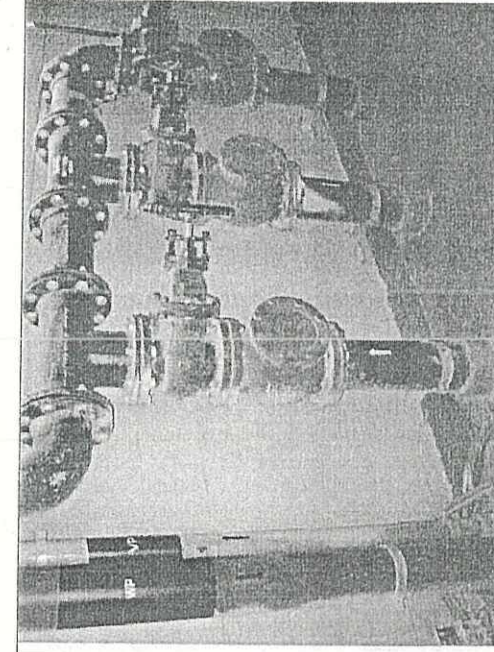
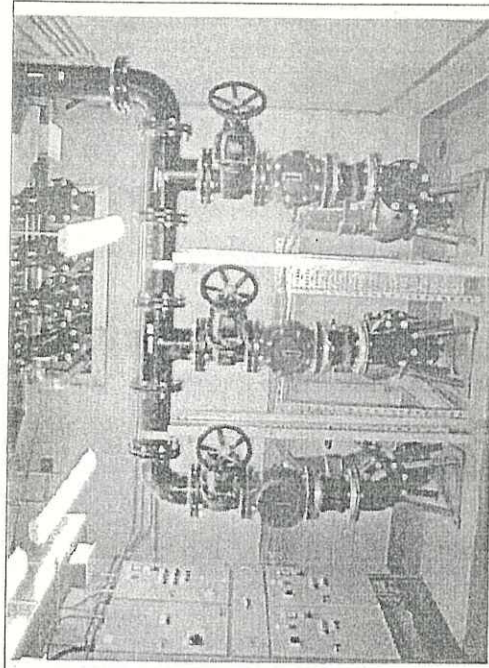
The sump pump rooms including plain water pumps and sewage water pumps are all located in the basement of the station. The rooms are fully enclosed and no noise has been noticed during the audit (See Photos 2.11-2.12 in Annex 2).

Photo 2.11 Sump pump for Foul Sewage

Photo 2.12 Sump pump for foul sewage

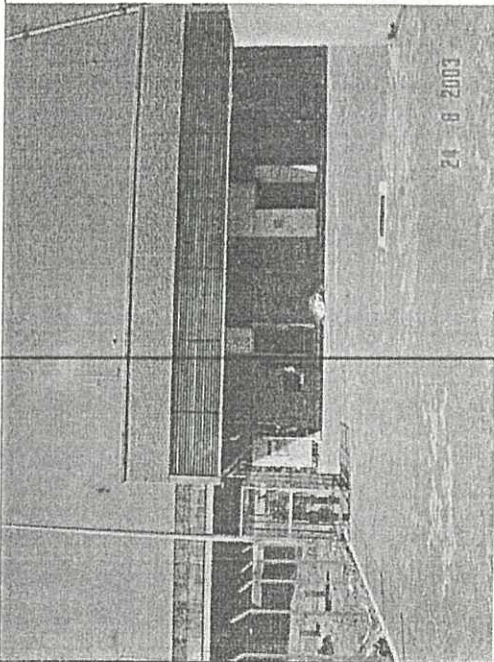
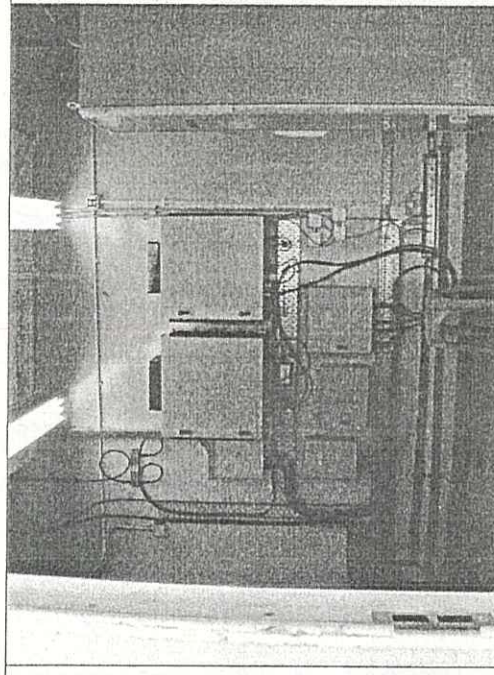
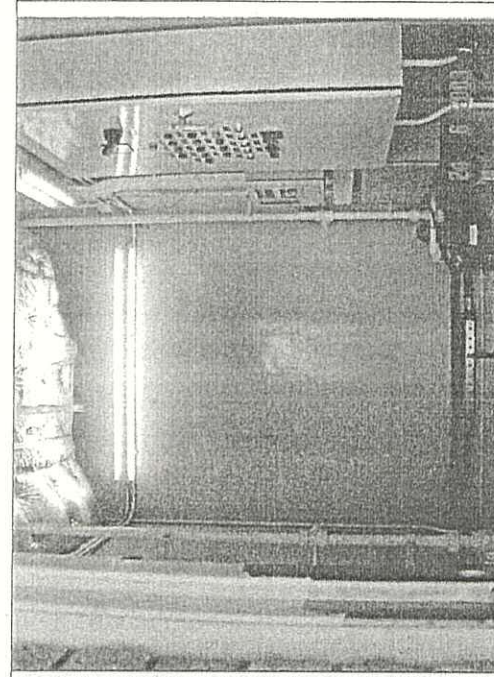
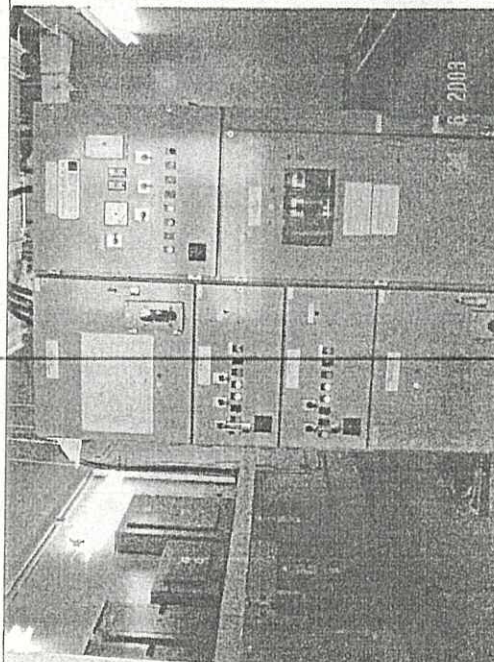
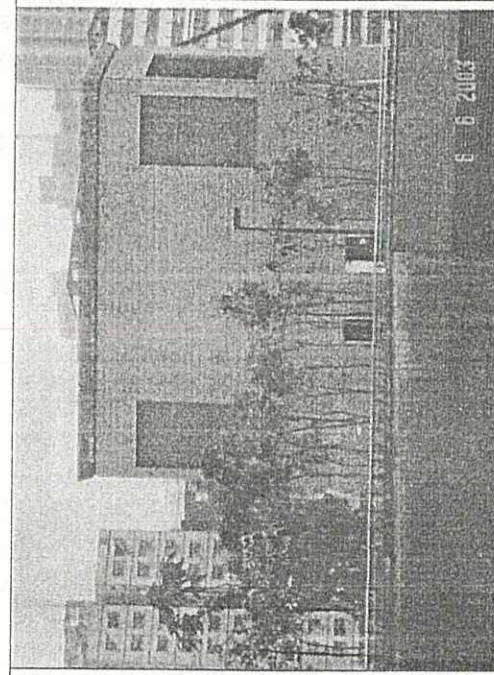
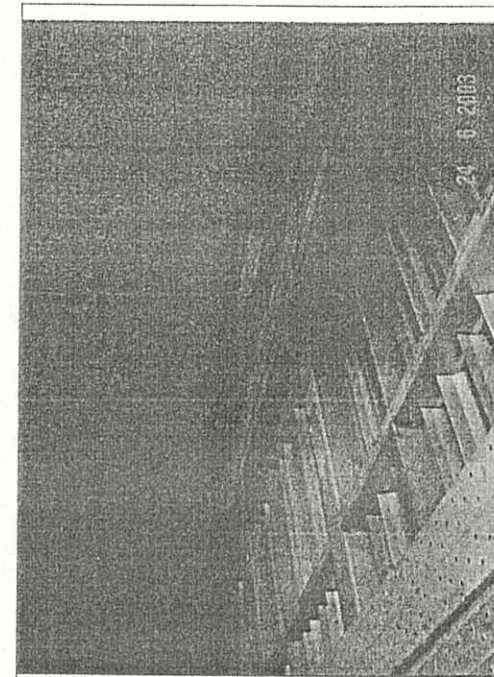
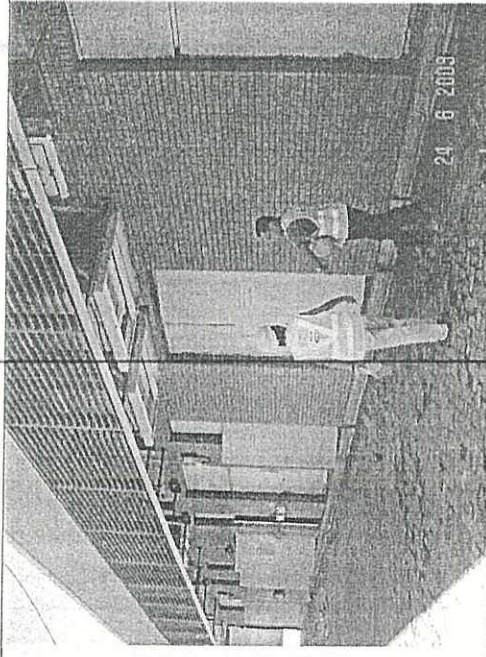
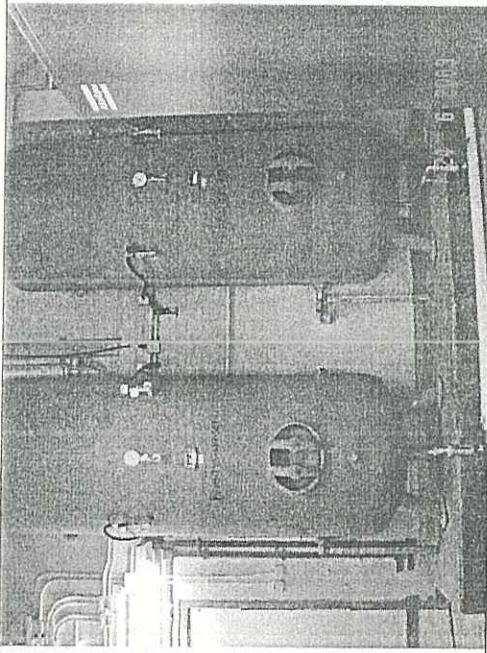
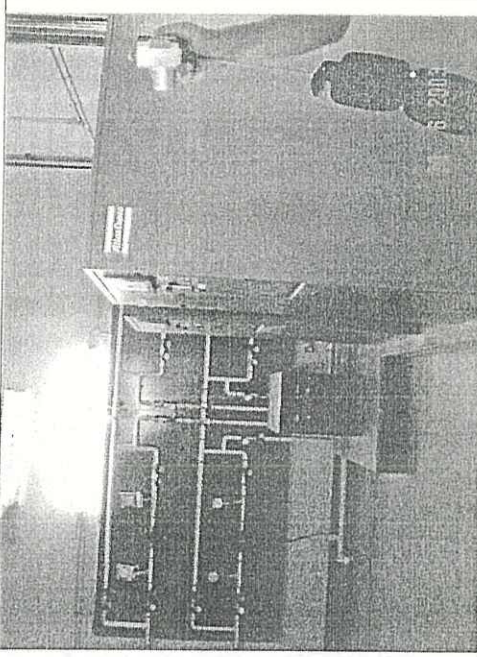
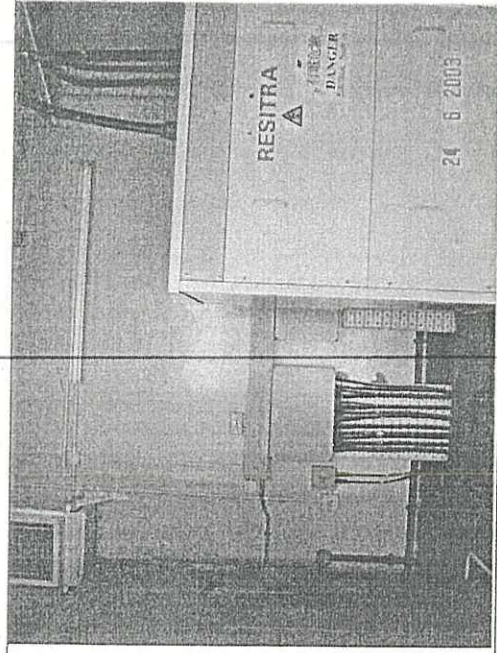
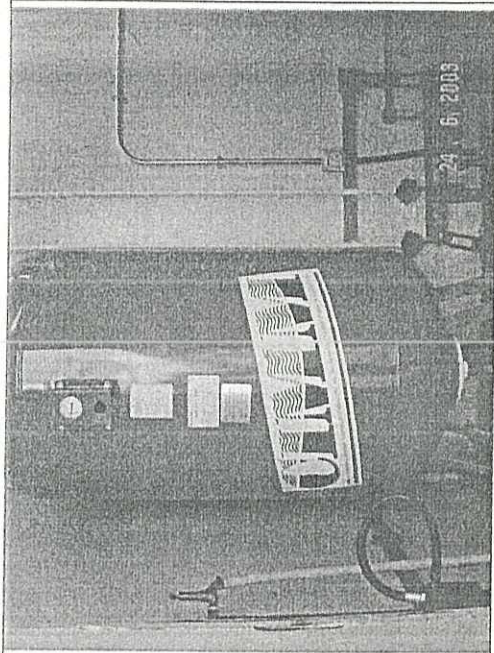
Prince Edward Ventilation Building and Lai Wan Chiller Plant Building for the tunnel section between Mei Foo to Nam Cheong have been inspected. There is no noisy equipment neither installed nor operated in these areas (See Photos 2.13 – 2.23 in Annex 2).

<p>Photo 2.13: Lai Wan Chiller Plant Building</p>	<p>Photo 2.14: Tunnel Signalling (TS) and Telecommunication Equipment Room (TER)</p>	<p>Photo 2.15: Control Room for TS, TER and battery room</p>

<p>24 6 2003</p>
<p>Photo 2.16: Transformer Room</p>	<p>Photo 2.17: Prince Edward Ventilation Building</p>	<p>Photo 2.18: Vent Shaft</p>

Photo 2.19: Equipment Rooms at Prince Edward Ventilation Building

Photo 2.20: Air compressor room

Photo 2.21: Air compressor room

Photo 2.22: Transformer Room

Photo 2.23: Cleansing Water Pump Room

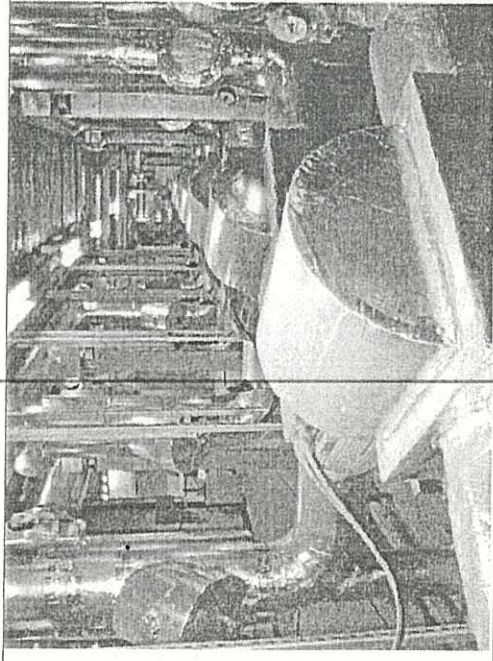
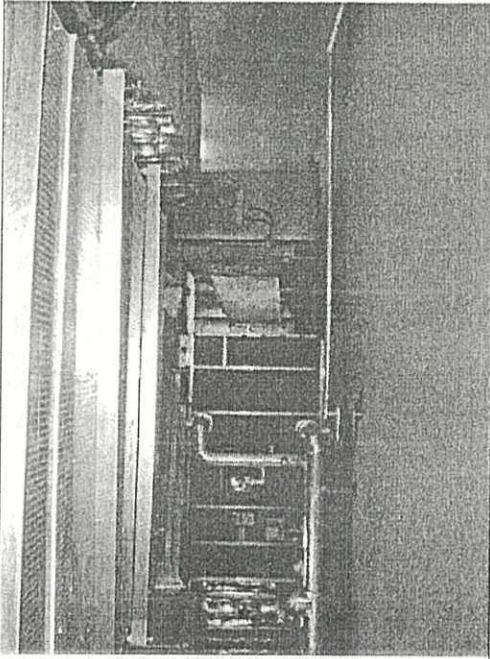
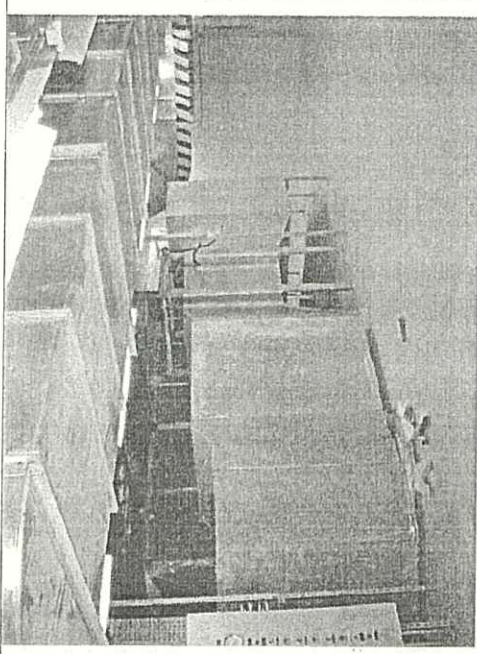
The chiller systems including the Environmental Control System (ECS) and fans are all installed in enclosed rooms. There are silencers installed together with the equipment. Since the equipment is protected with linings, it is unable to inspect the silencers. However, no noise has been noticed during the audit (See Photos 2.24-2.26 in Annex 2).

Photo 2.24: Chiller pump room

Photo 2.25 ECS Room

Photo 2.26: ECS Room

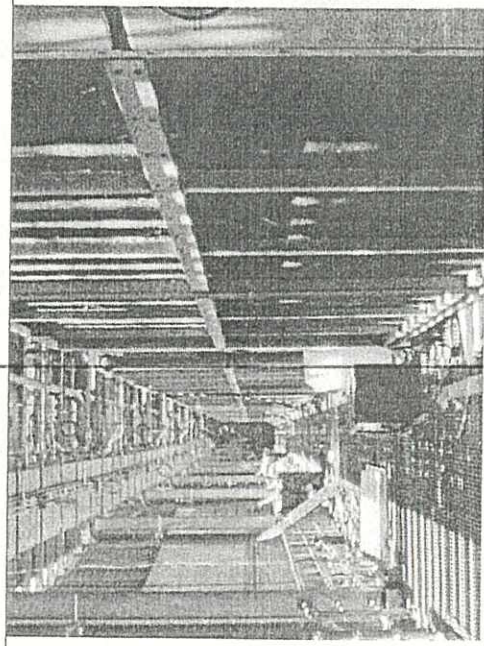
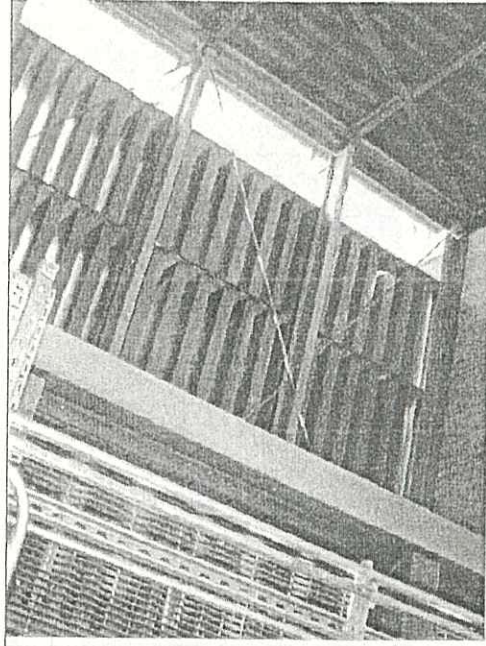
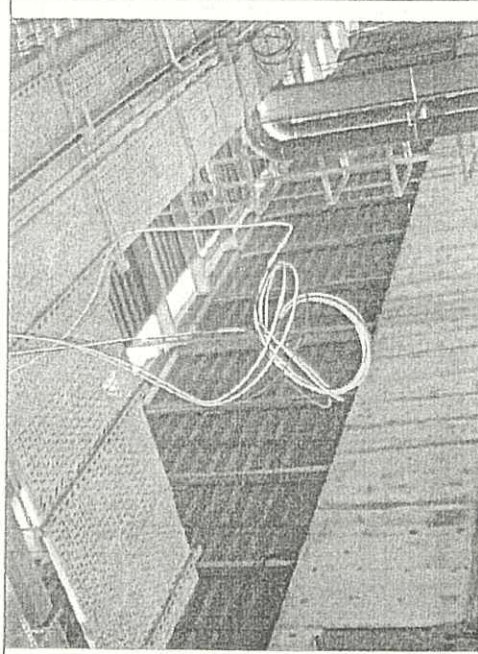
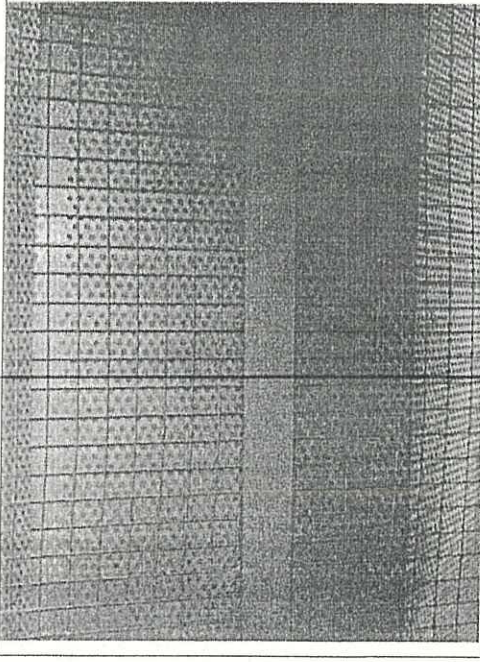
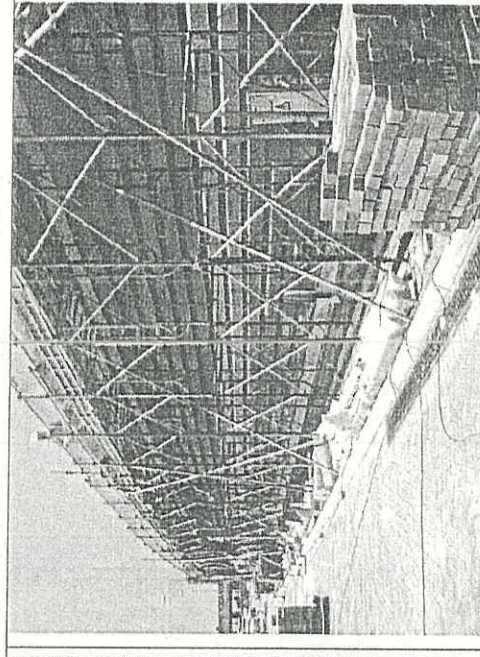
Remote radiator building contains radiators which are part of the chiller systems. The roof of the building is equipped with silencers. Silencers and acoustic louvers are also installed at the side of the building (See Photos 2.27-2.31 in Annex 2).

Photo 2.27: Radiator

Photo 2.28: Silencers on top of the Radiator Building

Photo 2.29: Silencers alongside of the Radiator Building

A photograph of a large, cylindrical industrial fan or ventilation unit. It has a prominent circular opening at one end and various pipes and electrical conduits attached to its side.
<p>Photo 2.30: Acoustic Panels for the Radiator Building</p>	<p>Photo 2.31: Exterior of the Radiator Building</p>	<p>Photo 2.32: Tunnel Ventilation Fan</p>

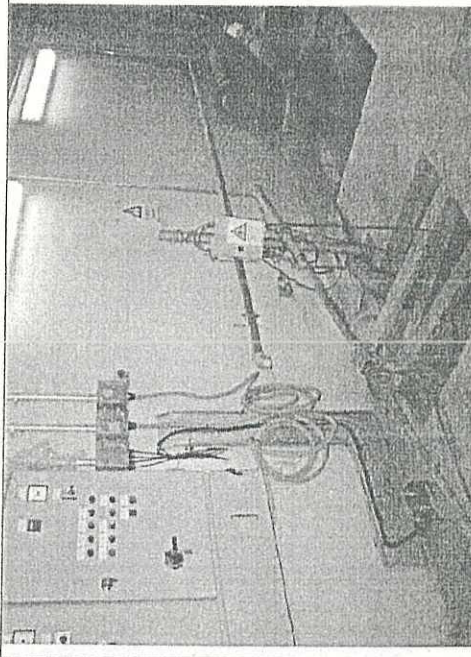
The sump pump rooms including plain water pumps and sewage water pumps are all located in the basement of the station. The rooms are fully enclosed and no noise has been noticed during the audit (See Photos 2.34 in Annex 2).

<p>Photo 2.33: Ventilation Shaft</p>	<p>Photo 2.34: Plain water and foul sewage sump pump rooms</p>

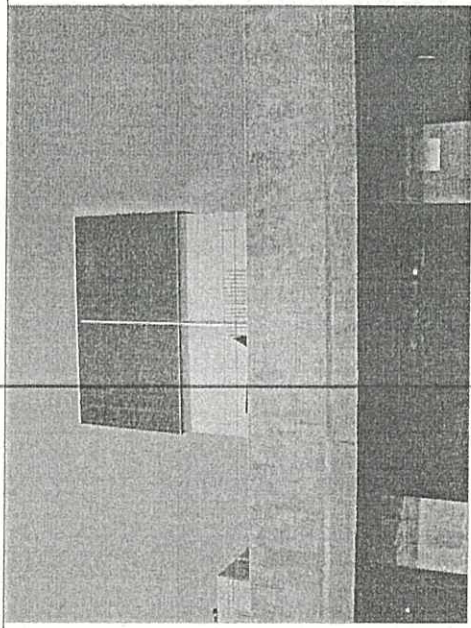
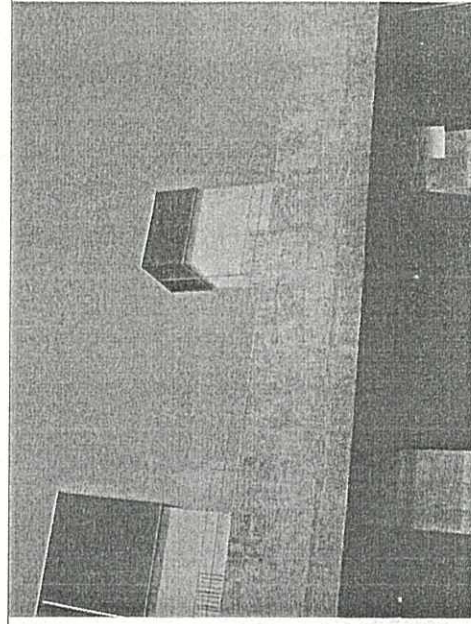
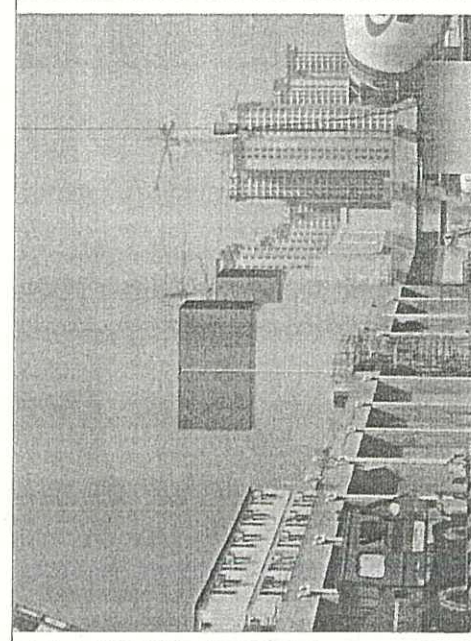
All vent structures are located on the roof of the station. The exterior of the shaft integrates with the station and the structures are sited without any visual intrusion to the surrounding community (See Photos 2.35—2.37 in Annex 2).

Photo 2.35: Vent Shaft of Nam Cheong Station

Photo 2.36: Vent Shafts of Nam Cheong Station

Photo 2.37: Vent shaft structures of Nam Cheong Station

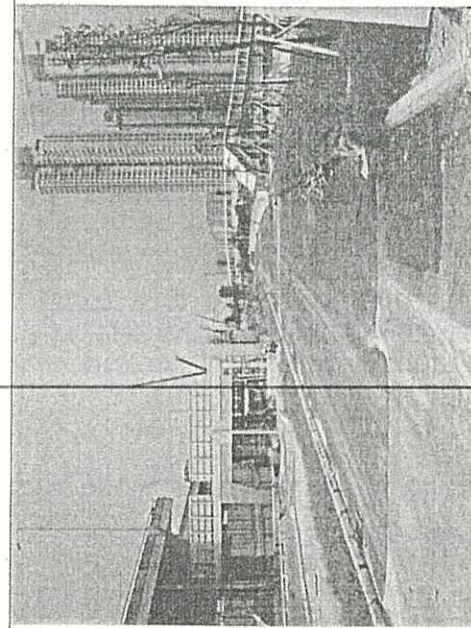
Some of the landscaping works at Nam Cheong Station were outstanding during the first audit. A re-audit on the outstanding works was conducted on 10 September 2003. As seen, some of the works were still ongoing. About 90% of the embankment along Road P1 were hydroseeded. Landscaping on external perimeter of the station along Sham Mong Road was ongoing, while the landscaping works in the middle and on the side of Sham Mong Road near the residential area was completed. The landscaping works in the west side of the station, Tonkin Street and Yen Chow Street West were ongoing. The remaining works will be finished by the end of October 2003 (See Photos 2.38—2.46 in Annex 2).

Photo 2.38: Hydroseeding along the Road P1

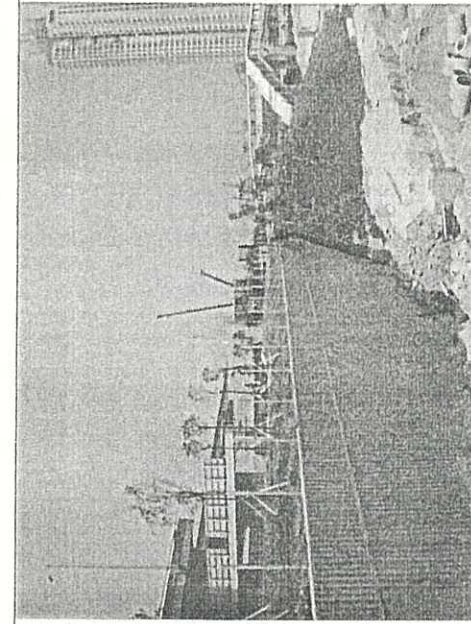
Photo 2.39: Hydroseeding on slope along Road P1

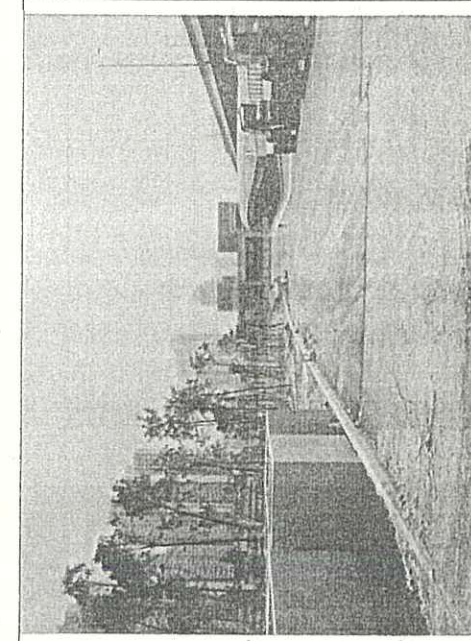
Photo 2.40: Tree planting along Road P1

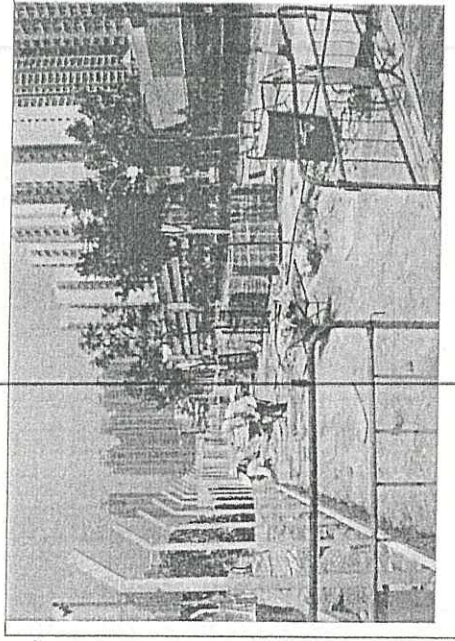
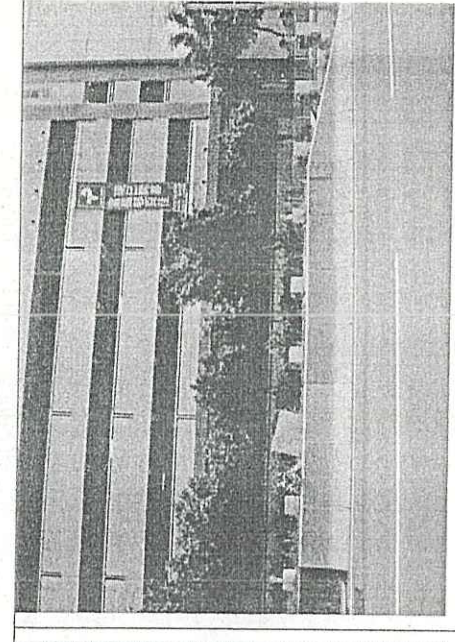
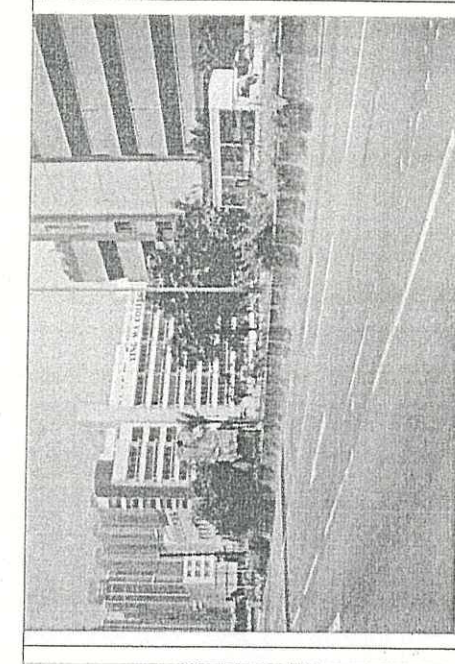
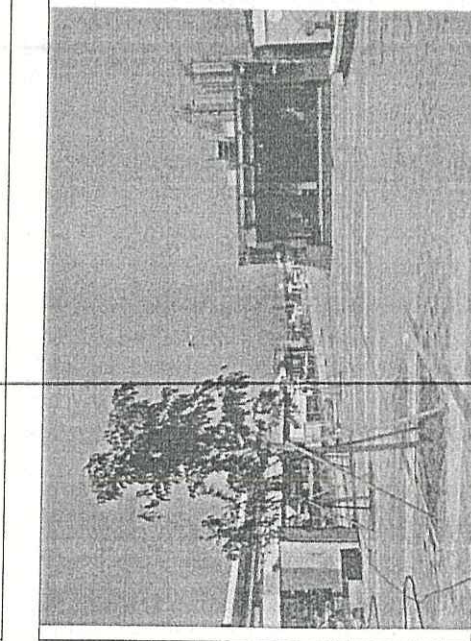
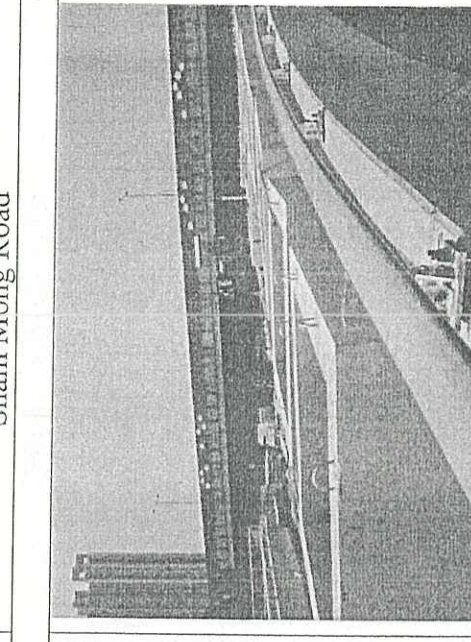
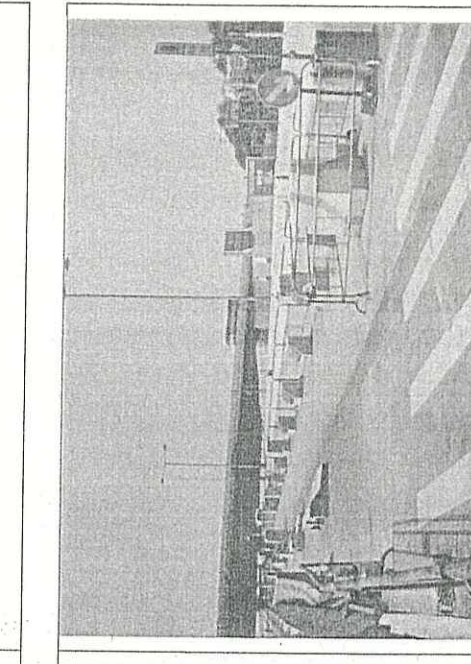
<p>Photo 2.41: Ongoing paving works on the pavement near the station at Sham Mong Road</p>	<p>Photo 2.42: Completed landscaping works along the pavement near the residential area of Sham Mong Road</p>	<p>Photo 2.43: Completed landscaping works along the middle of Sham Mong Road</p>

<p>Photo 2.44: Completed Landscaping works outside the Western Exit of NAC Station (Near the Fish Wholesale Market)</p>	<p>Photo 2.45: Planting area along Yen Chow Street West</p>	<p>Photo 2.46: Planting area at the middle of Tonkin Street</p>

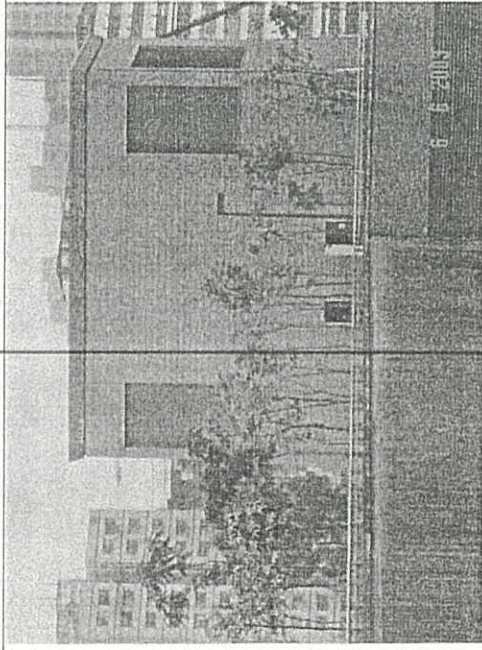
Vent structure for the tunnel section at Prince Edward Roundabout are designed to integrate with surrounding environment. It blends with the landscape design of Nam Cheong Park which causes minimal visual intrusion (See Photos 2.47 in Annex 2).

Photo 2.47: Vent shaft structure at Prince Edward Roundabout.

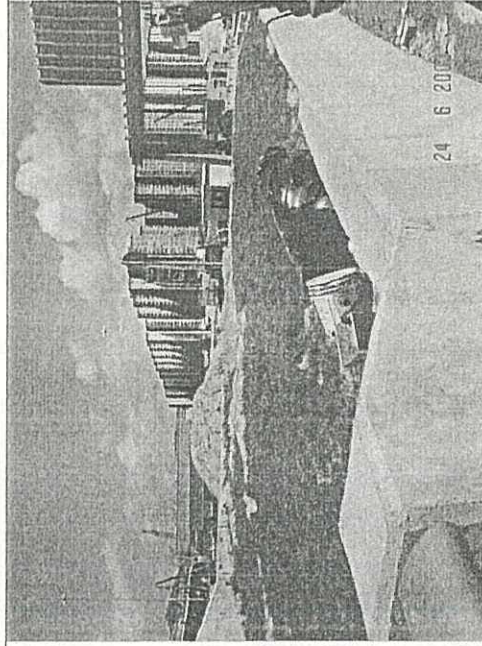
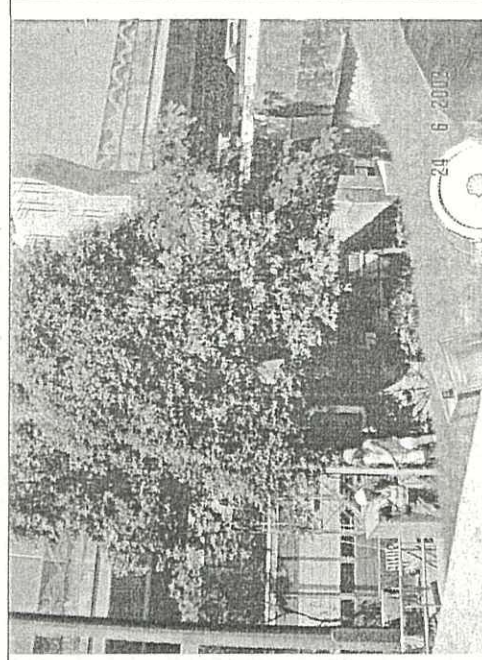
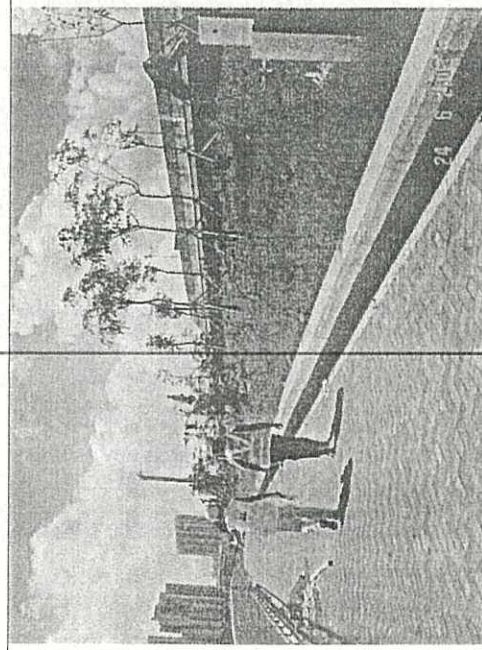
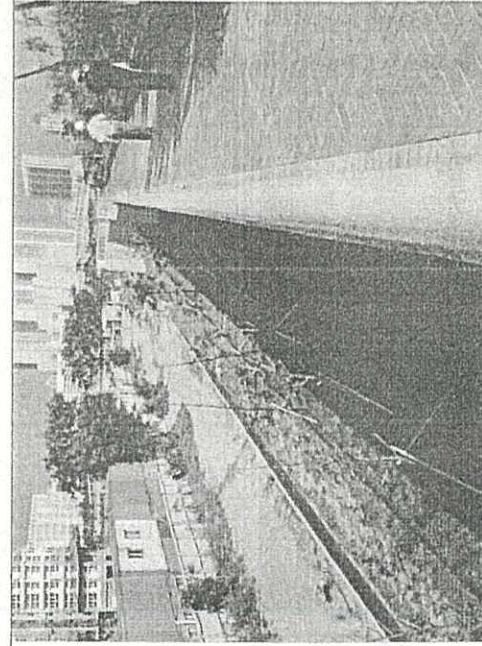
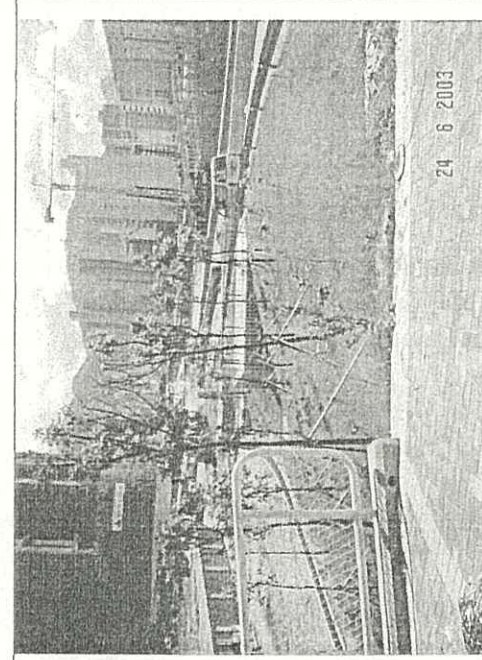
Landscape works above the tunnel section between Nam Cheong and Mei Foo have been inspected. The tunnel is fully contained in a cut & cover tunnel structure and is covered by the landscaped earth mound. All landscaping works in Nam Cheong Park and Site 10 have been completed (See Photos 2.48–2.60 in Annex 2).

Photo 2.48: Landscape works at Area 10

Photo 2.49: Landscape at Area 10

Photo 2.50: Landscape at Area 10

Photo 2.51: Landscape at Area 10

Photo 2.52: Landscape at Area 10 along Road D5

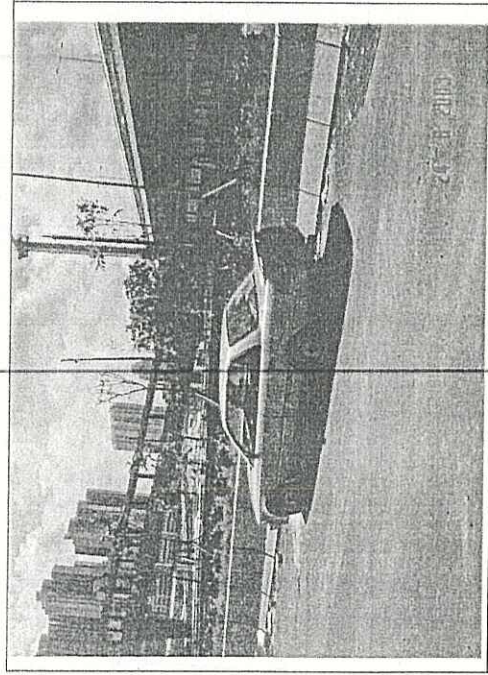
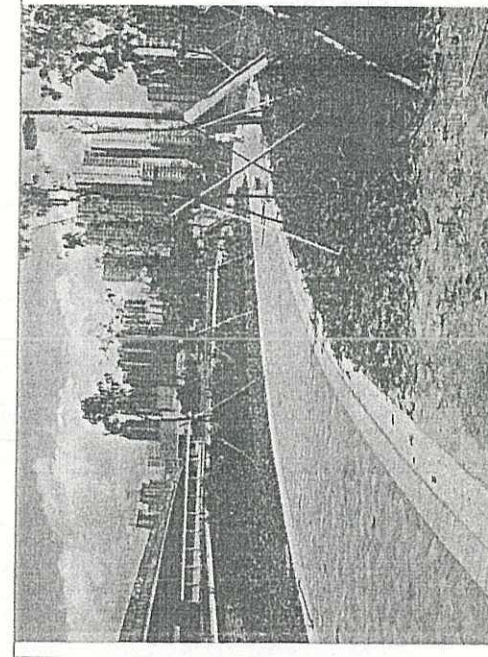
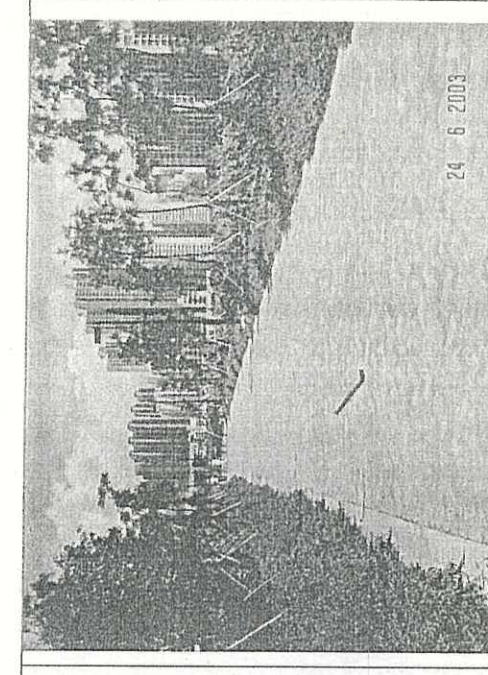
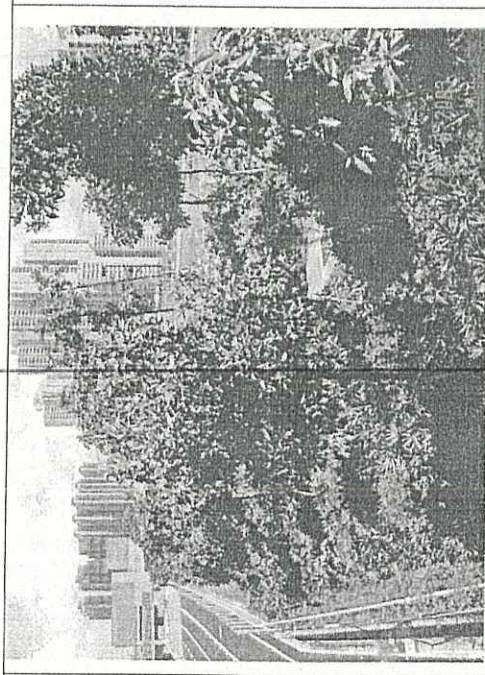
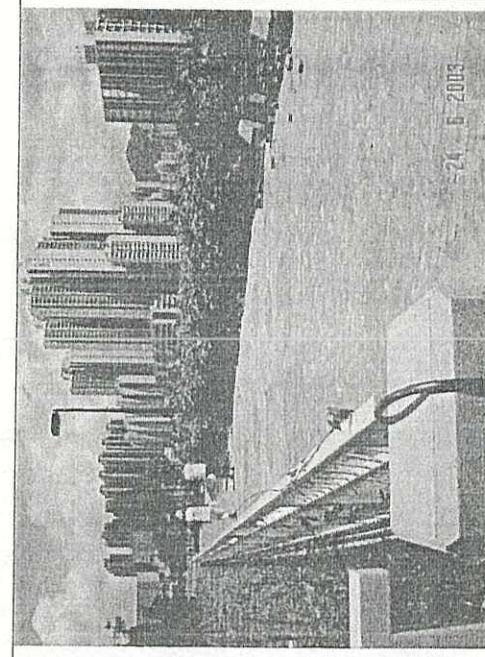
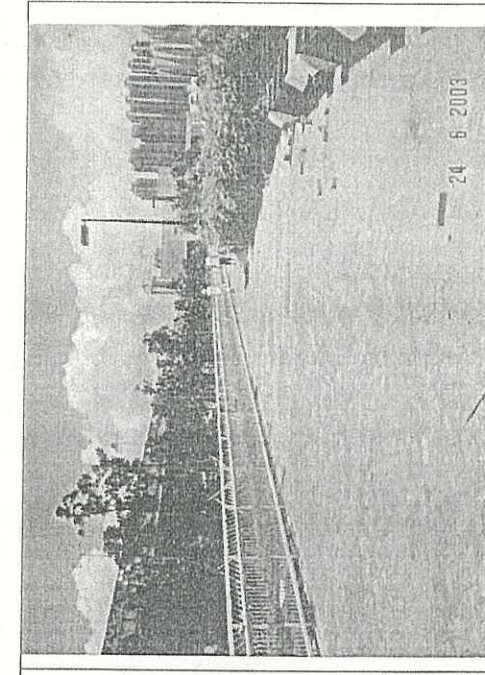
<p>Photo 2.53: Landscape at Road D5</p>	<p>Photo 2.54: Landscape at Nam Cheong Park</p>	<p>Photo 2.55: Landscape at Nam Cheong Park</p>

<p>Photo 2.56: Landscape at Nam Cheong Park along Route 9.</p>	<p>Photo 2.57: Landscape at Nam Cheong Park</p>	<p>Photo 2.58: Landscape at Nam Cheong Park</p>

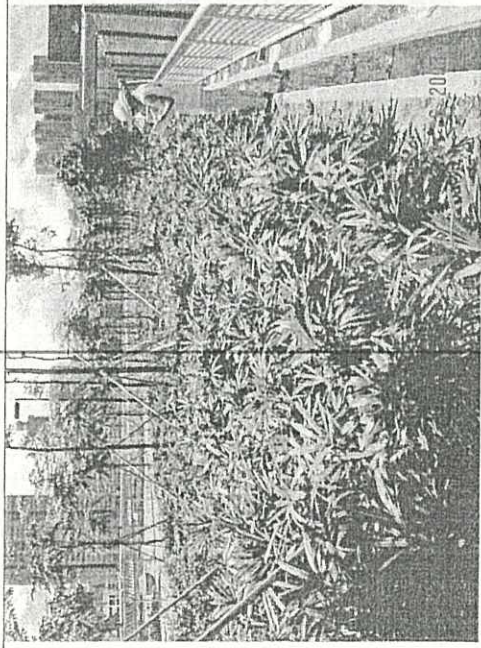
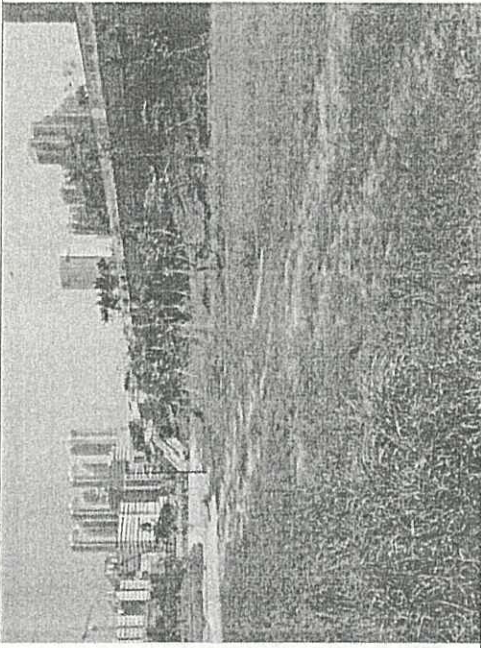
Photo 2.59: Landscape at Nam Cheong Park

Photo 2.60: Hydroseeding and wood mix planting at Nam Cheong Park.

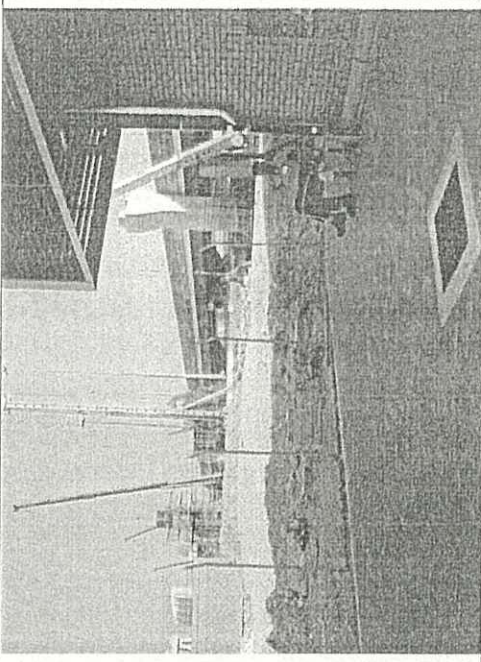
Landscaping works at Lai Wan Interchange site is still outstanding since the works area is handed to the Route 9 Contractor. The Route 9 Contractor will be responsible for reinstatement of the landscape works after completion of their construction works (See Photo 2.61 in Annex 2).

Photo 2.61: Construction works at Lai Wan Chiller Plant Building undertaken by Route 9 Contractors. Landscape works will resume afterwards.

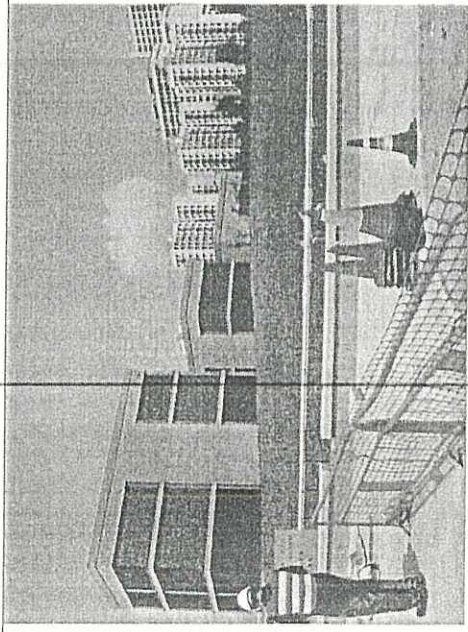
Vent structures for Mei Foo Station are located at the roof of the station which is part of the Lai Chi Kok Park. The structures are designed with similar features to the amenities of the Park. There is no visual intrusion to the surrounding environment (See Photo 2.62 in Annex 2).

Photo 2.62: Vent shaft structures of Mei Foo Station

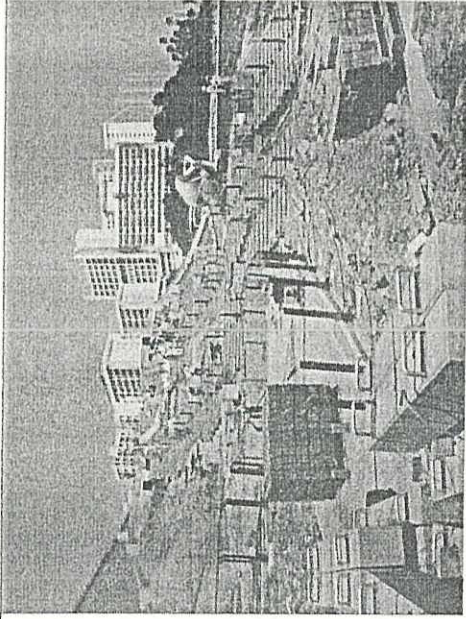
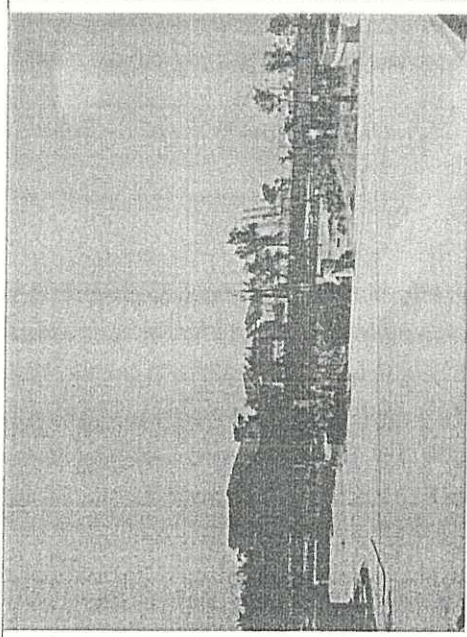
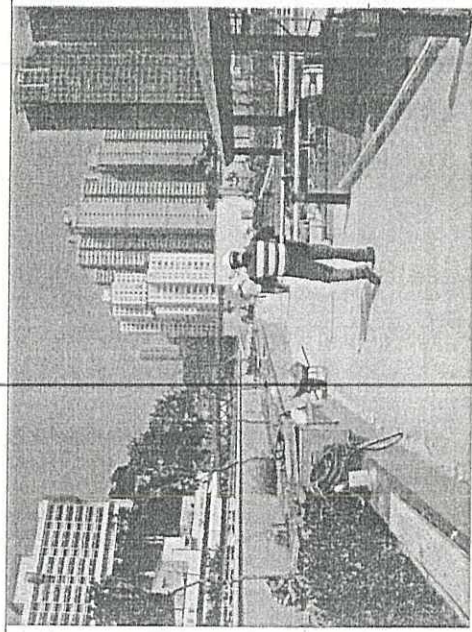
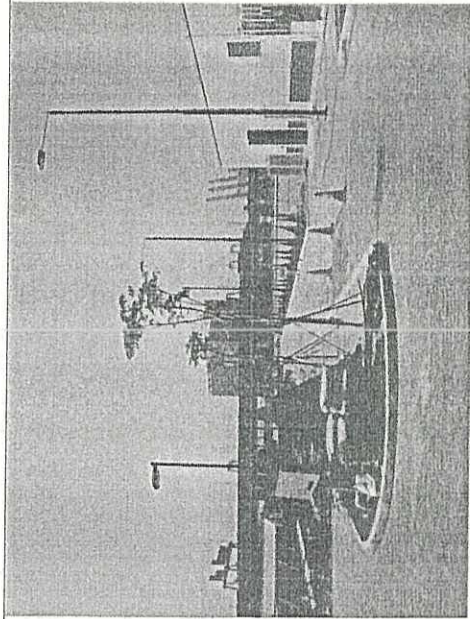
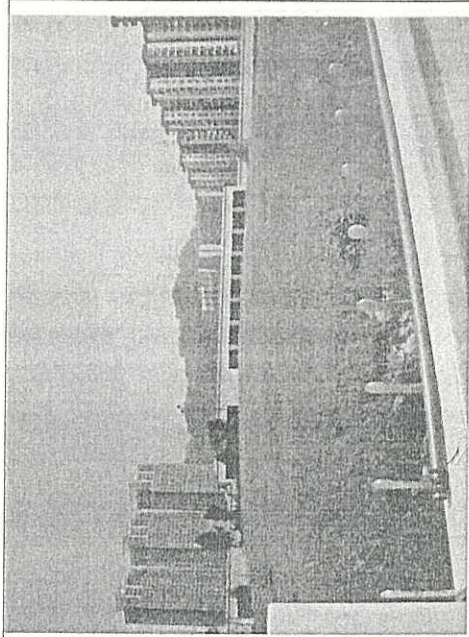
Re-audit was conducted on 19 August 2003. Landscaping works at Mei Foo Station were still on-going. The landscaping works on the roof of MEF Station are anticipated to be completed by the end of October 2003, whereas works in the southern part of Lai Chi Kok Park are anticipated to be completed by the end of November 2003 (See Photos 2.63-2.69 in Annex 2).

Photo 2.63: Ongoing landscaping works at the Northern end of MEF Station.

Photo 2.64: Part of Lai Chi Kok Park on the roof of MEF Station

Photo 2.65: Landscaping works in Lai Chi Kok Park

Photo 2.66: Landscaping works in Lai Chi Kok Park

Photo 2.67: Completed hydroseeding in Lai Chi Kok Park
