# Kowloon-Canton Railway Corporation

## West Rail

## Pre-operation Environmental Audit Report

### December 2003

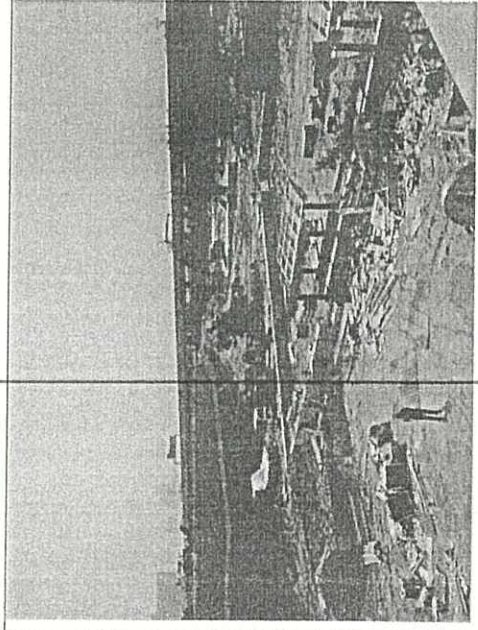
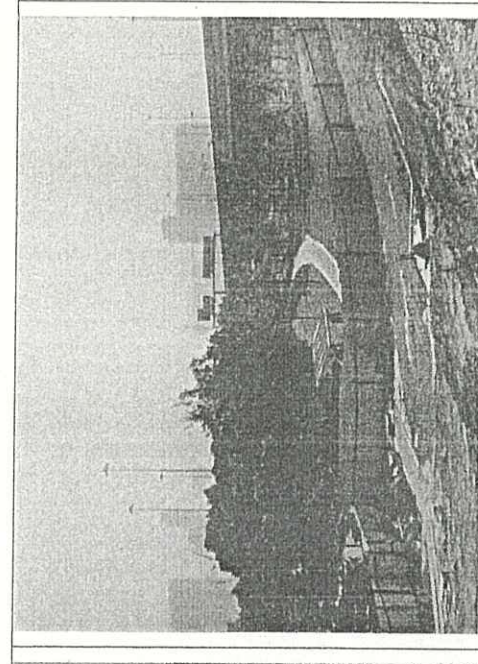
Re-audit was conducted on 19 August 2003. Landscaping works at Mei Foo Station were still on-going. The landscaping works on the roof of MEF Station are anticipated to be completed by the end of October 2003, whereas works in the southern part of Lai Chi Kok Park are anticipated to be completed by the end of November 2003 (See Photos 2.63-2.69 in Annex 2).

<p>Photo 2.68 Ongoing works of Lai Chi Kok Park recreation area</p>

<p>Photo 2.69 Completed landscaping works in Lai Chi Kok Park</p>

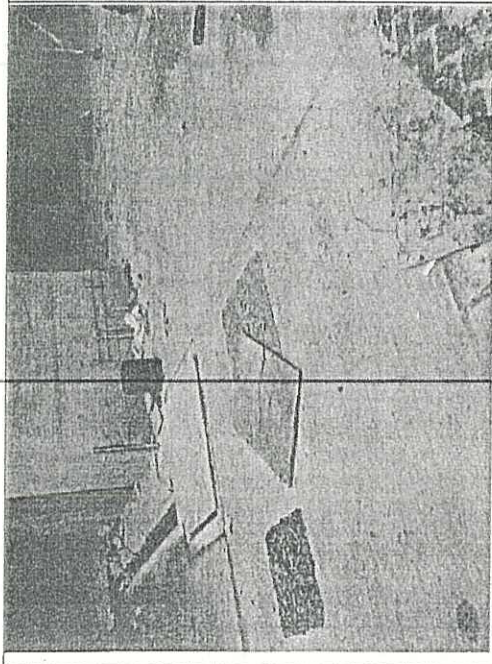
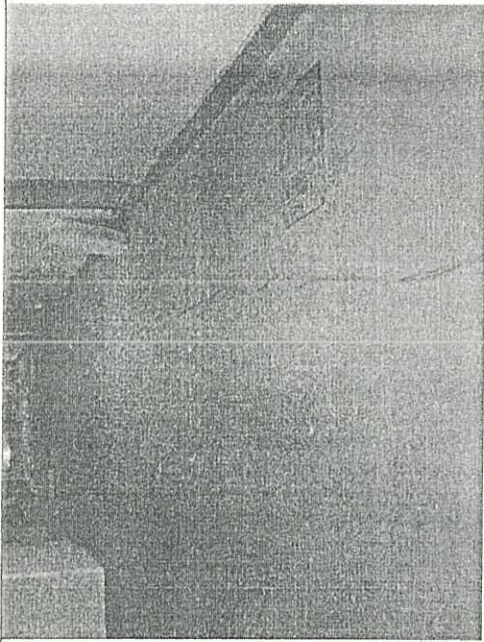
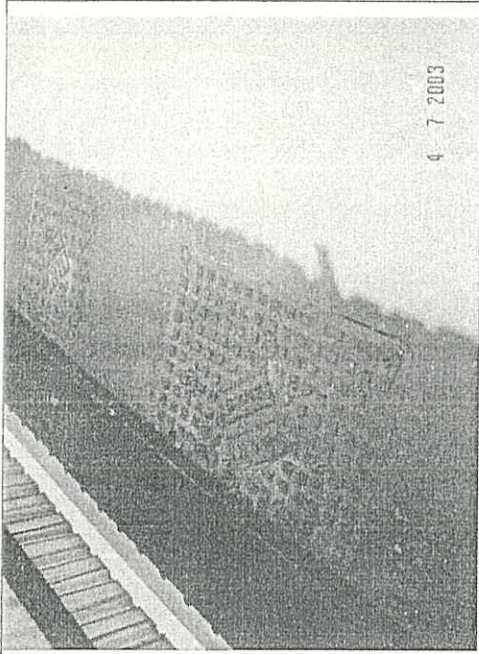
Sewage and plain water are collected in the sump pits located in the basement of the station before discharged to the public foul sewer and storm water drainage systems respectively. There are oil interceptors installed to treat water from the station, tunnels, and the surface runoff at the exterior of the station (See. Photos 2.70-2.72 in Annex 2).

Photo 2.70 Oil interceptor outside the station

Photo 2.71: Oil interceptors inside the station

Photo 2.72: Oil interceptors for the tunnel box

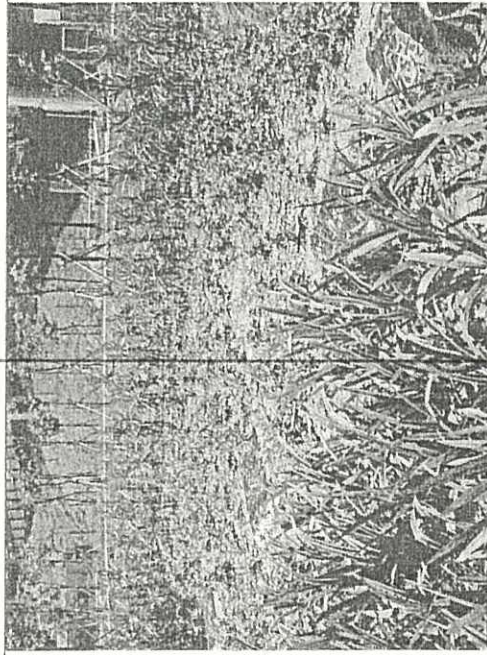
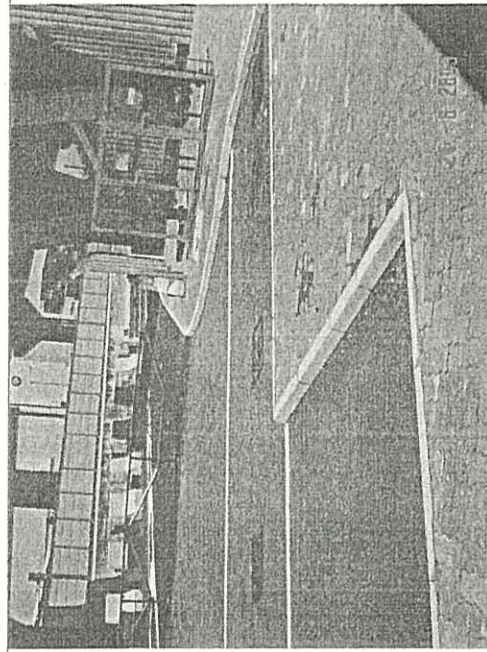
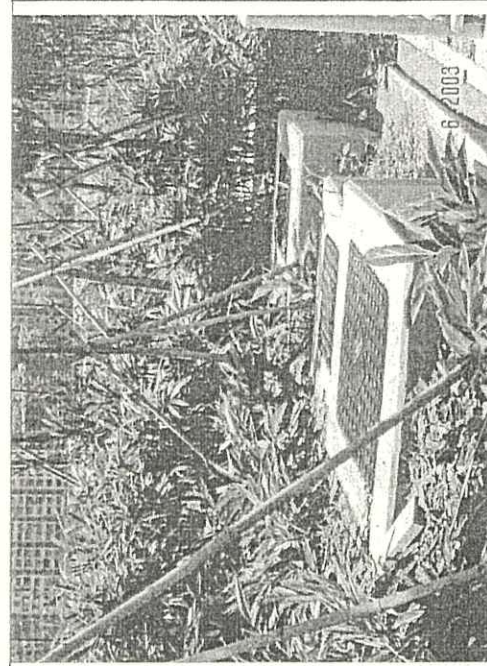
Oil interceptors for the tunnels between Mei Foo and Nam Cheong have been inspected. The interceptors are located inside Lai Chi Kok Park, Nam Cheong Park, Area 10 and in the Emergency Vehicle Access near Price Edward Ventilation Building (see Photos 2.73-2.75 in Annex 2).

Photo 2.73: Oil interceptors in Lai Chi Kok Park

Photo 2.74: Oil interceptor for pump sump located in the tunnel section near Prince Edward Ventilation Building

Photo 2.75: Oil interceptor for pump sump in the tunnel, located in Nam Cheong Park.

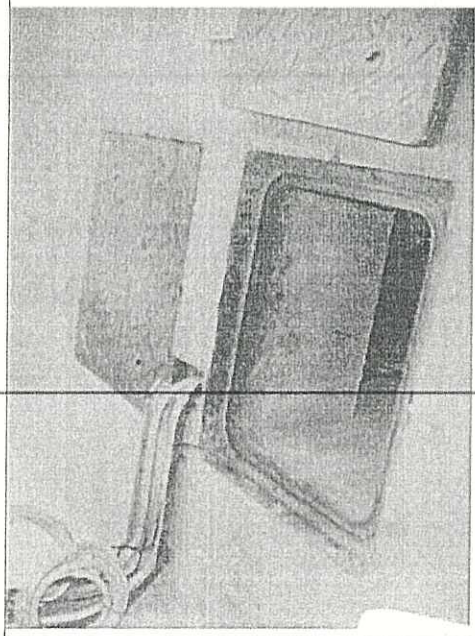
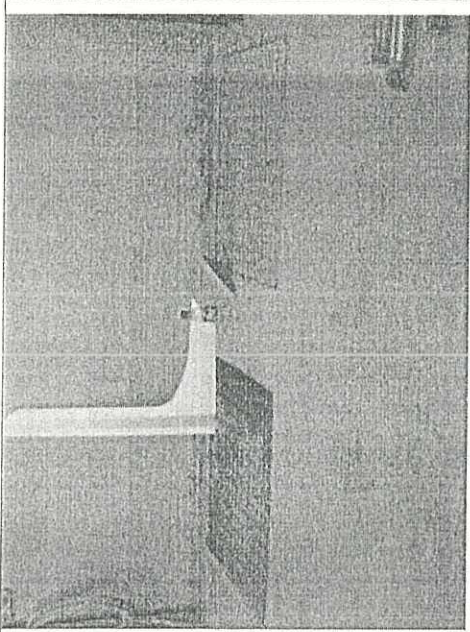
Plain water, including rain water, and sewage are collected in the sump pits located in the basement of the station. After collection, the water is pumped to the public storm water drainage system and the foul sewer drainage for discharge. No oil interceptors have been installed in the station (see Photos 2.76-2.77 in Annex 2).

Photo 2.76 Plain water and sewage sump pit

Photo 2.77: Plain water and sewage sump pit

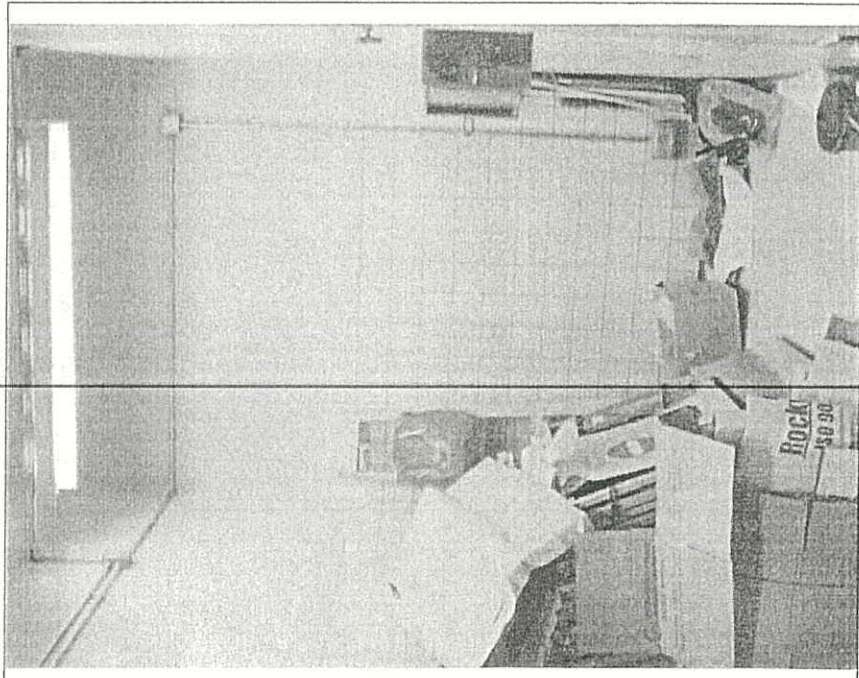
General waste generated from the stations are to be stored at the refuse rooms for collection. (See photos 2.78 in Annex 2)

Photo 2.78: Refuse Room at Mei Foo Station

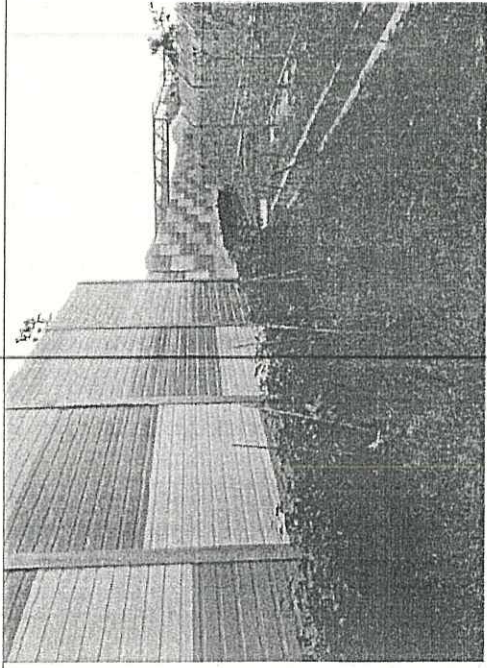
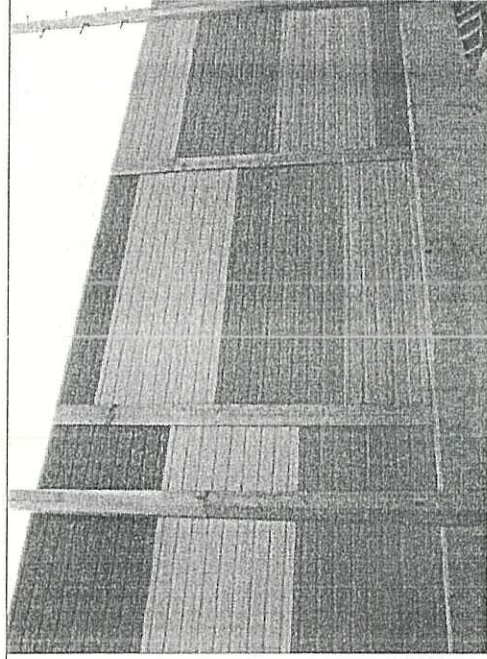
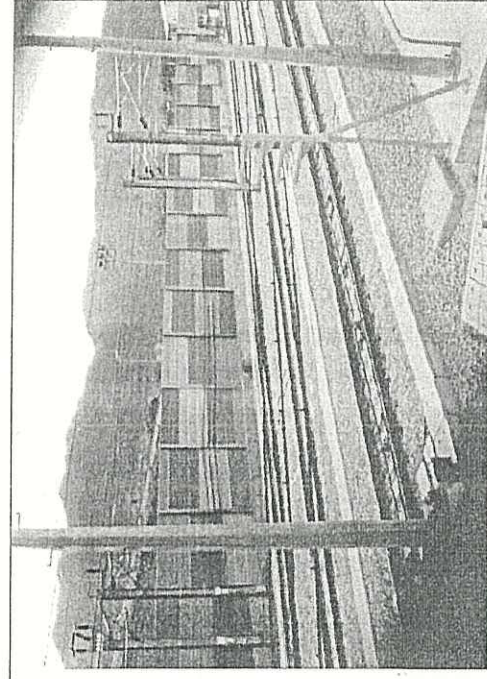
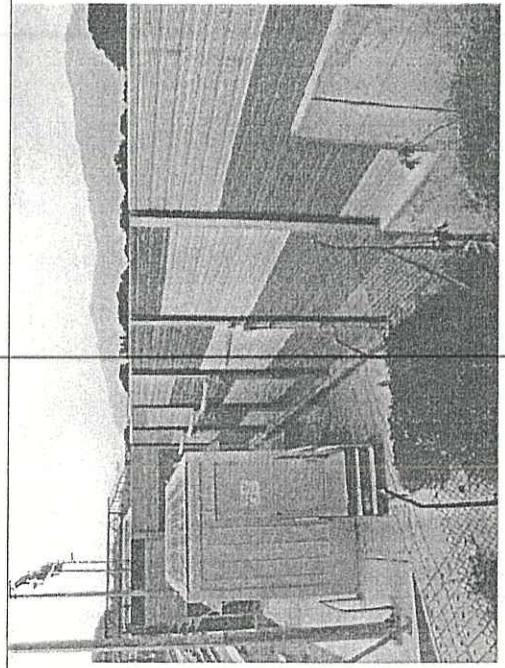
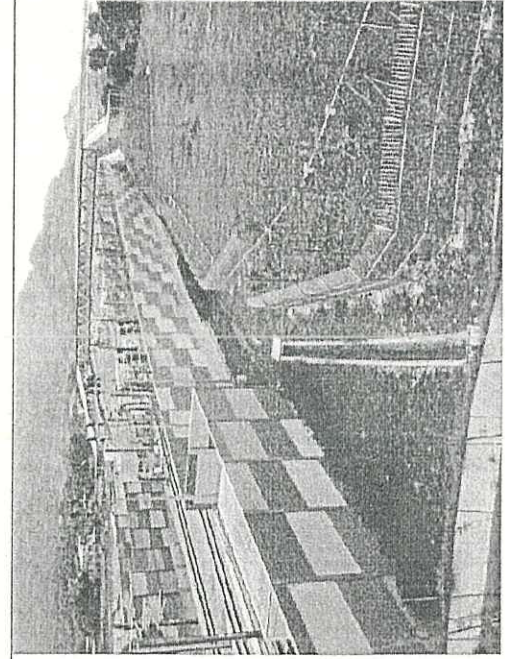
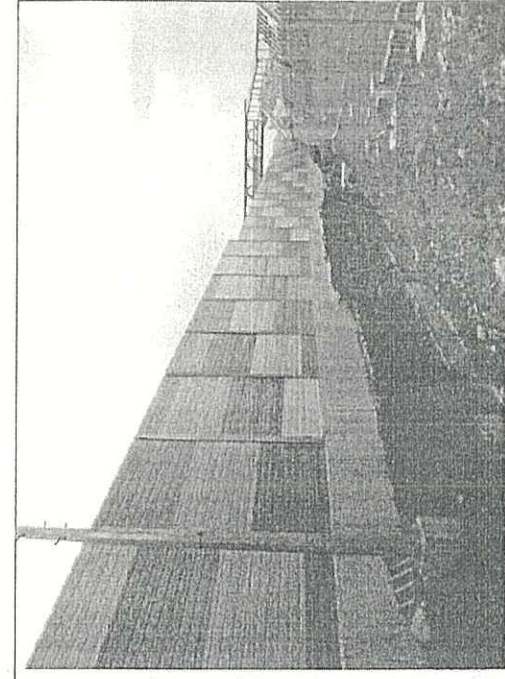
The details of the barriers, namely locations, height and length were checked against the layout drawings submitted to EPD as per the West Rail Environmental Permit. It has been confirmed during the site audit in the presence of IEC that all the barriers are constructed as per the layout drawings (see Photos 3.1–3.6 in Annex 2).

Photo 3.1: Noise barriers near the northern portal of Tai Lam Tunnel

Photo 3.2: Noise barriers near the northern portal of Tai Lam Tunnel

Photo 3.3: Noise barriers near the northern portal of Tai Lam Tunnel

Photo 3.4: Noise barriers near the northern portal of Tai Lam Tunnel

Photo 3.5: Noise barriers near the northern portal of Tai Lam Tunnel

Photo 3.6: Noise barriers near the northern portal of Tai Lam Tunnel

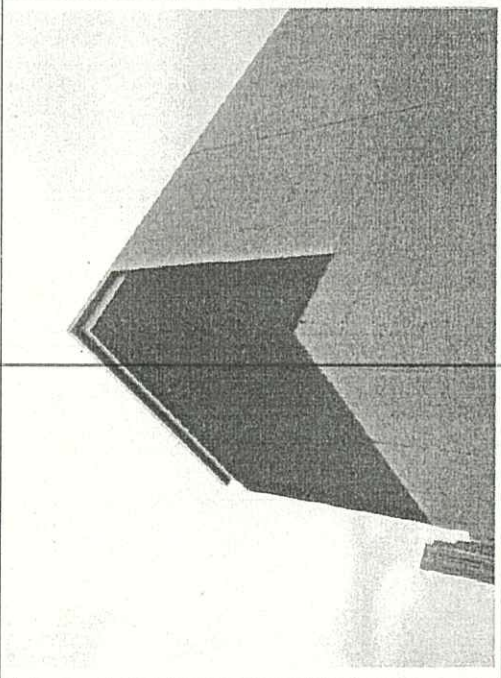
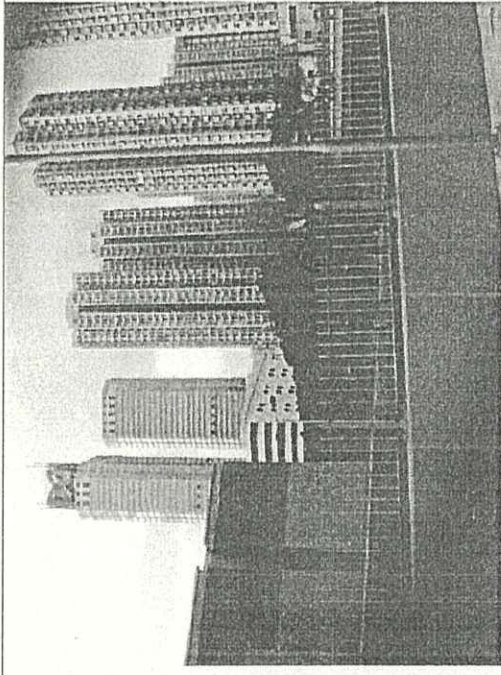
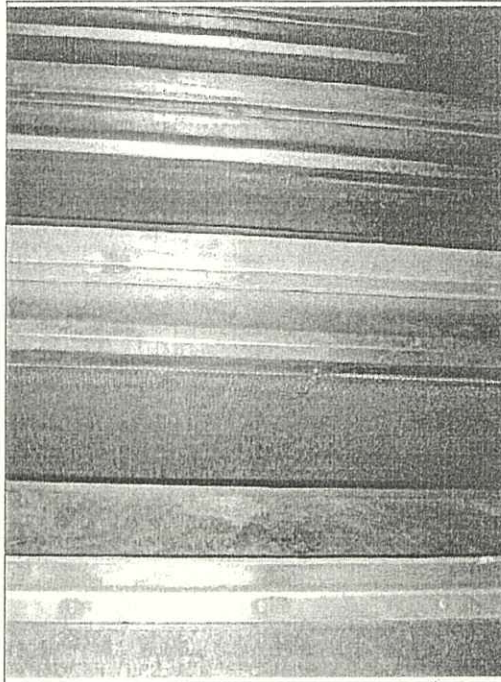
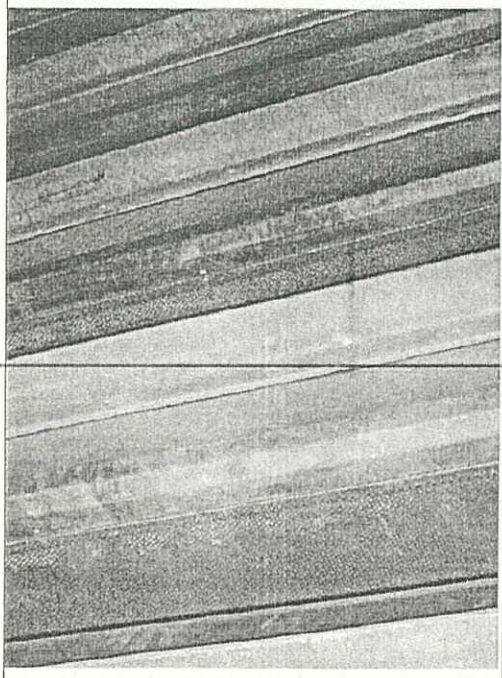
Vent shafts and the associated fans enclosed inside the Kwai Fong Ancillary Building and the vent equipment were inspected. The inspections indicated that essential silencers were all installed and fitted to the vent fans. The vent openings are all facing away from NSRs (see Photos 3.7–3.10 in Annex 2).

<p>Photo 3.7: Kwai Fong Ancillary Building (ventilation outlet)</p>	<p>Photo 3.8: Ventilation outlet away from sensitive receivers</p>	<p>Photo 3.9: Silencers installed inside ventilation systems</p>

<p>Photo 3.10: Silencers installed inside the ventilation systems</p>	<p>Photo 3.11: CLP Traction substation</p>	<p>Photo 3.12 CLP Traction substation</p>

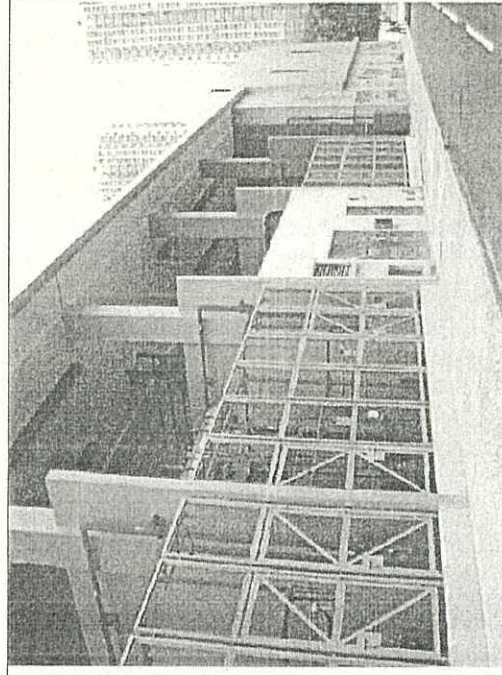
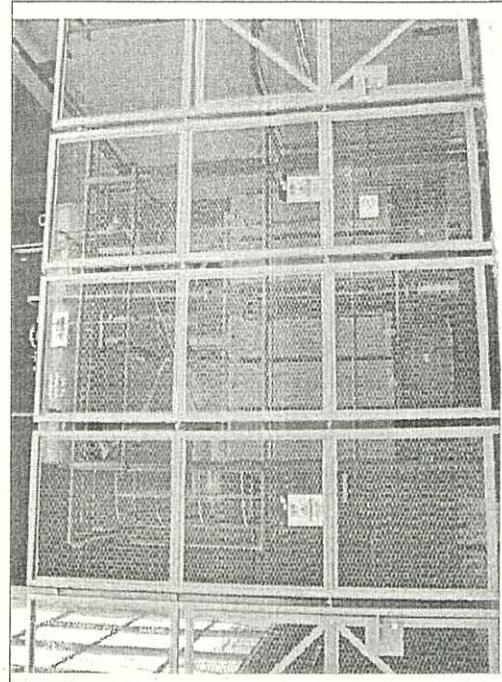
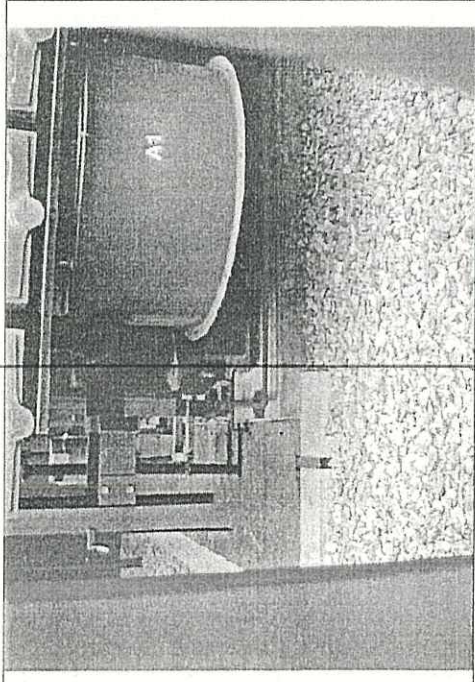
the sub-station is located far away from NSRs, there is no potential noise impact anticipated (see Photos 3.11–3.13 in Annex 2).

Photo 3.13 CLP Traction substation – close-up of the damper system

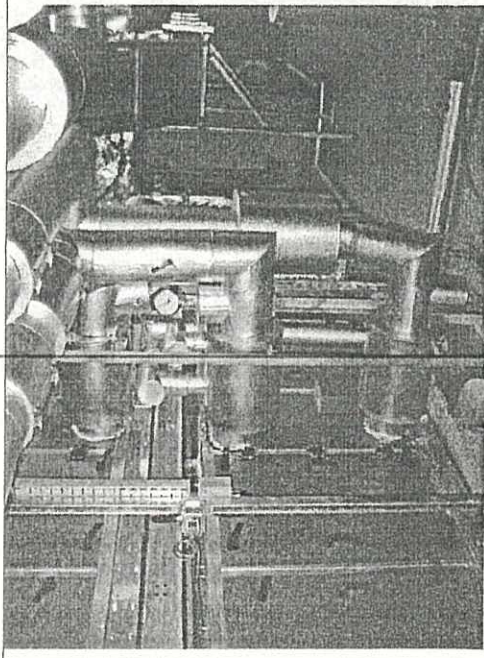
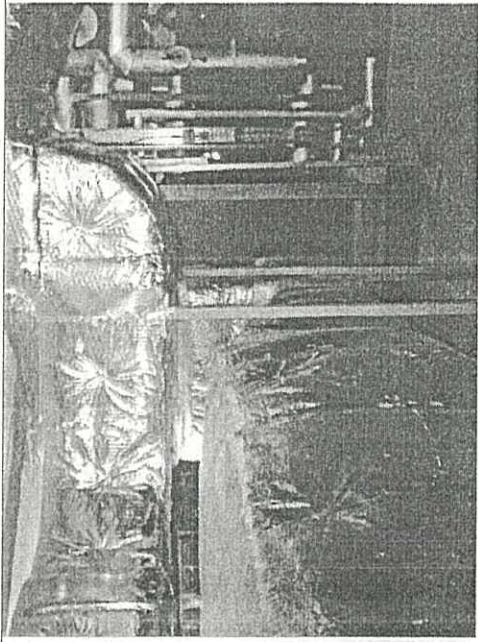
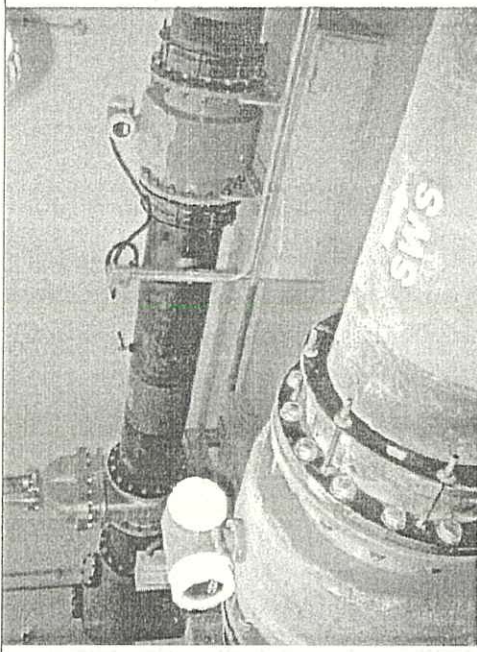
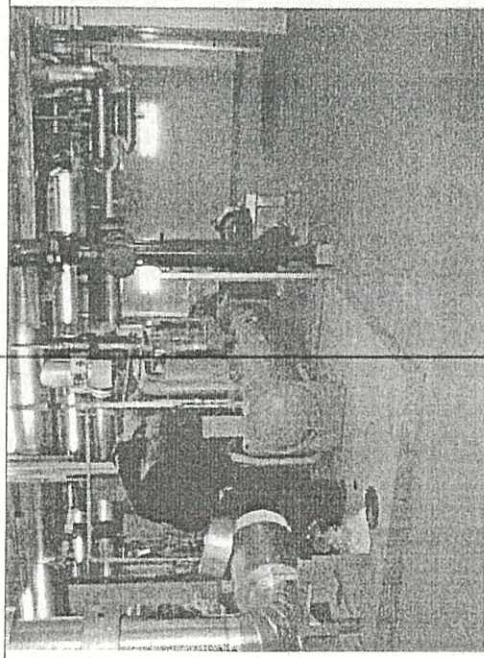
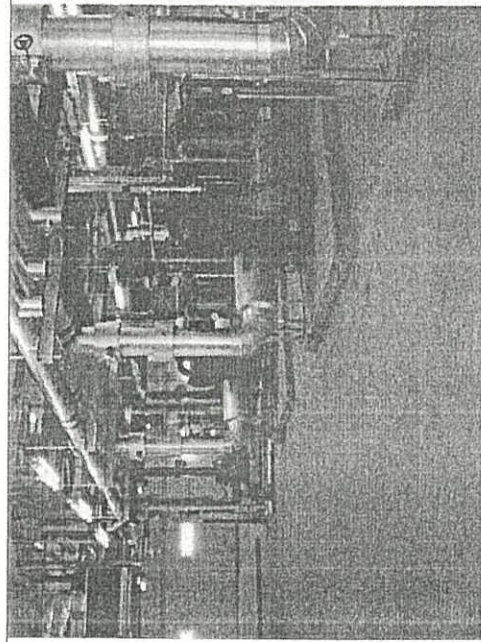
The chiller plant room and the ECS room of the station are located in enclosed areas on the platform areas (see Photos 3.14-3.15 & 3.17-3.18 in Annex 2). The cooling water station is located in a separate location in which the seawater cooling system is enclosed (see Photos 3.16 in Annex 2). No noticeable noise has been detected during the audit.

Figure 3.14 ECS Room

Figure 3.15 ECS Room

Figure 3.16 Cooling Water Plant Room

Figure 3.17 Chiller Plant Room

Figure 3.18 Chiller Plant Room

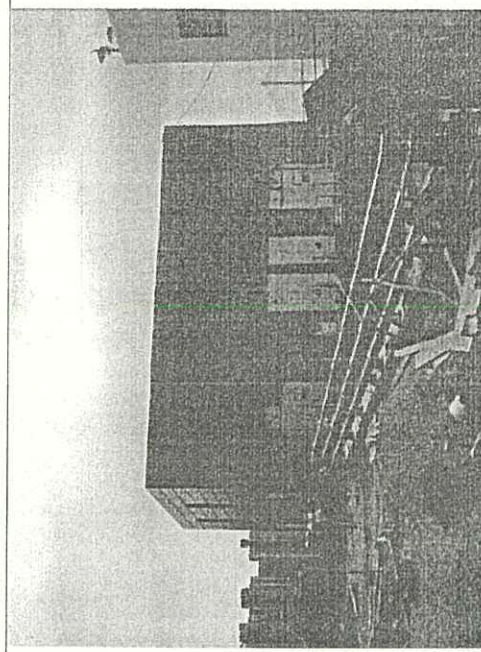
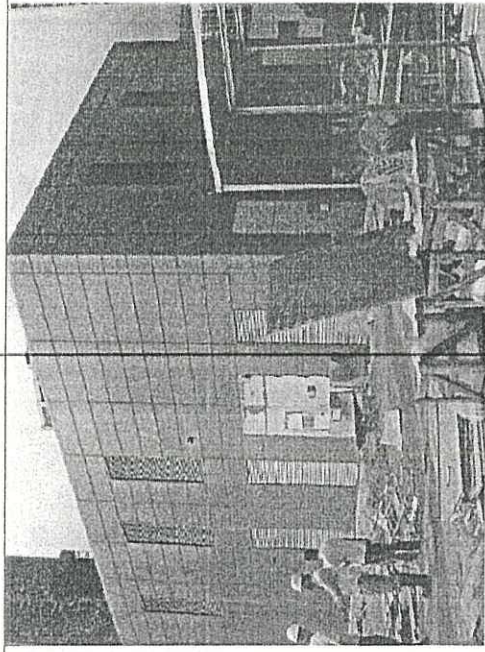
The transformer rooms have been completed and handed over to the China Light & Power. No access can be provided during the site audit for inspection. By observation, there is no noticeable noise detected from the exterior of the rooms (see Photos 3.19-3.20 in Annex 2).

Figure 3.19 Transformer Room

Figure 3.20 Transformer room

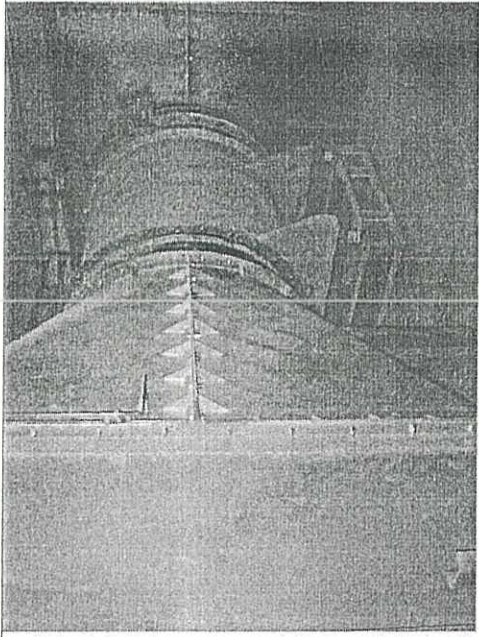
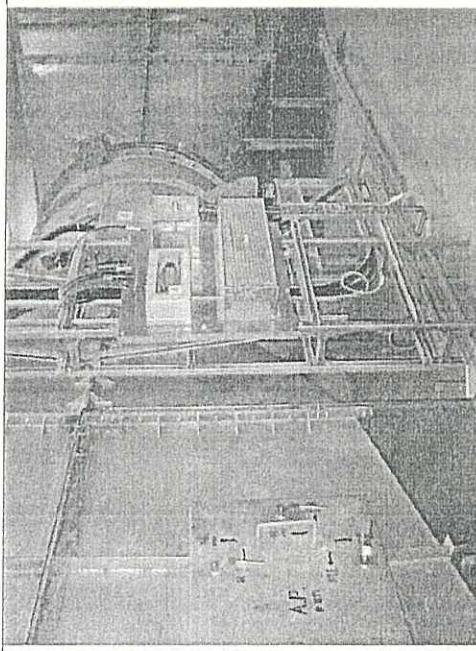
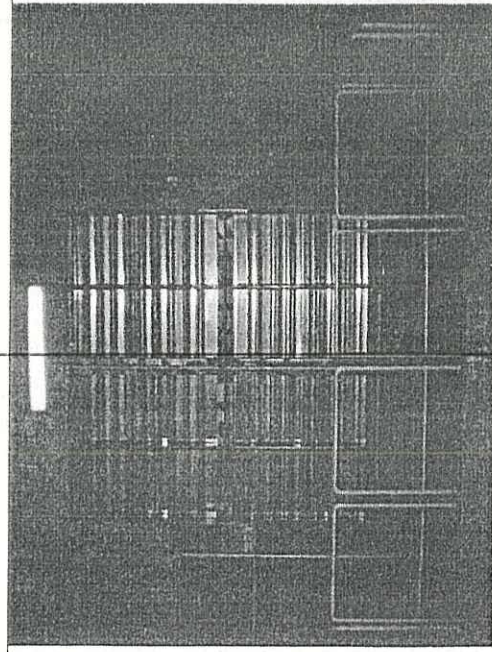
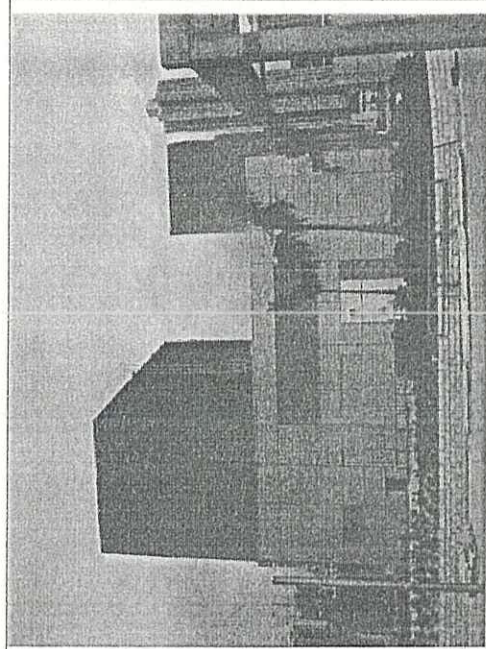
The tunnel ventilation systems are installed in enclosed areas. Silencers are equipped inside the ventilation fans. There is no noisy equipment in the ventilation shaft (see Photos 3.21-3.24 in Annex 2).

Figure 3.21 Tunnel Ventilation Fan

Figure 3.22 Tunnel Ventilation Fan

Figure 3.23 Plenum of the tunnel ventilation fan with silencers equipped inside

Figure 3.24 Tunnel ventilation Shaft

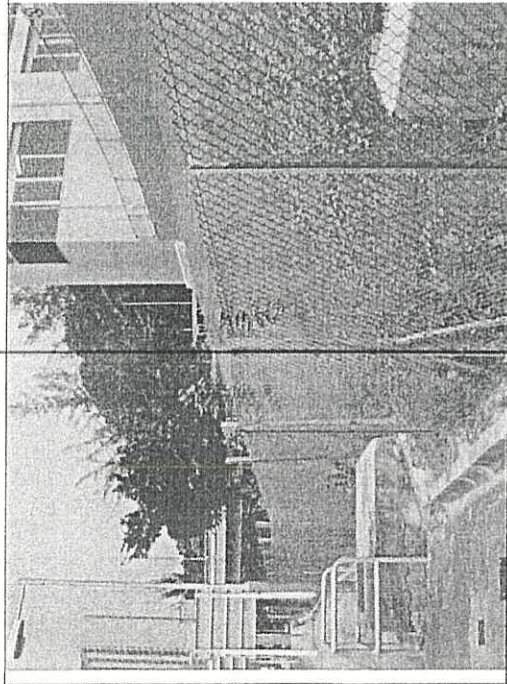
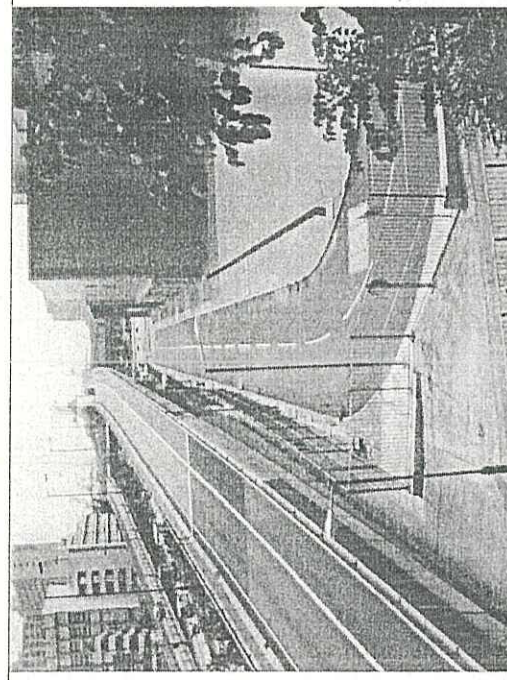
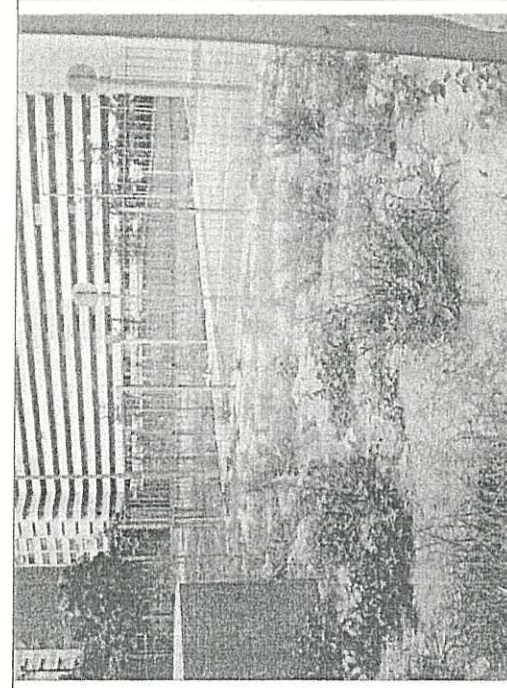
The landscaping works as proposed in the approved Detailed Landscape Drawings have been audited at on-site. Landscaping and hydroseeding for the Kwai Tsing Tunnel was largely completed with minor outstanding works at several locations (see Photos 3.30-3.32 in Annex 2). Remaining works include tree planting at Area E and G10 (above the Kwai Tsing Tunnel) will commence once the approval from LCSD is obtained.

<p>Photo 3.30: Hydroseeding at Area D of Kwai Tsing Tunnel</p>	<p>Photo 3.31: Outstanding landscaping works area at Area E of Kwai Tsing Tunnel</p>	<p>Photo 3.32: Outstanding landscaping works area at Area G10 of Kwai Tsing Tunnel</p>

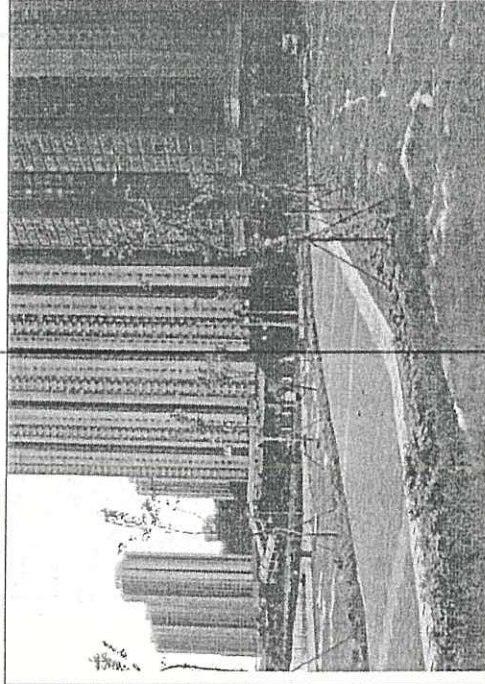
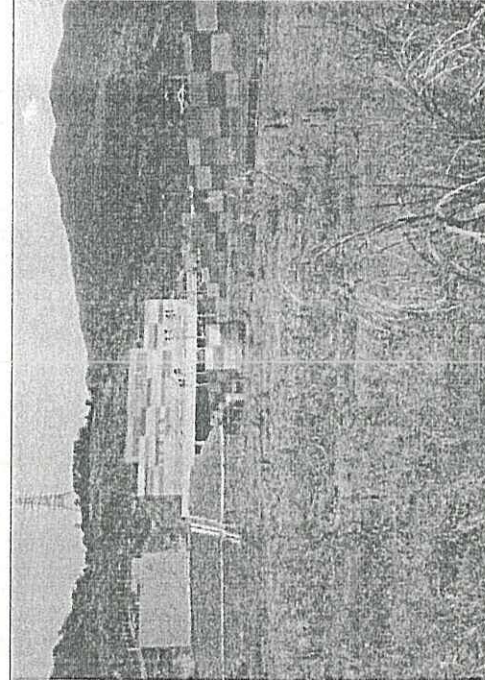
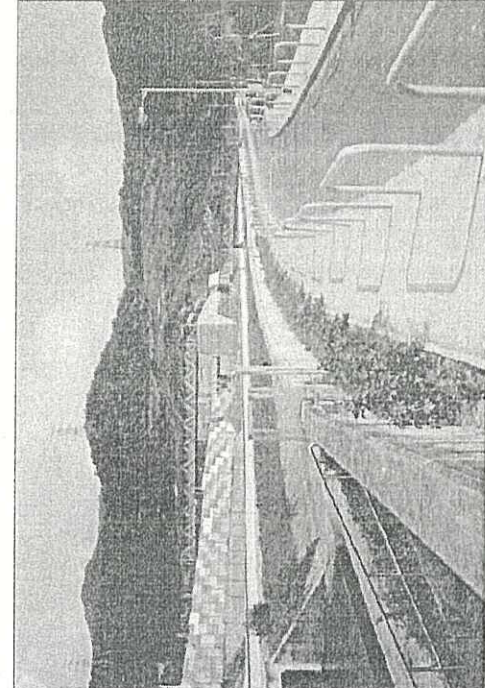
The landscaping works at and around the northern and southern portals of Tai Lam Tunnels and at the waterfront areas along Hoi On Road near the southern portal of Tai Lam Tunnel have been completed (see Photos 3.33-3.35 in Annex 2).

<p>Photo 3.33: Landscaping work at the south portal of Tai Lam Tunnel</p>	<p>Photo 3.34: Landscaping work at the north portal of Tai Lam Tunnel</p>	<p>Photo 3.35: Landscaping work at the north portal of Tai Lam Tunnel</p>

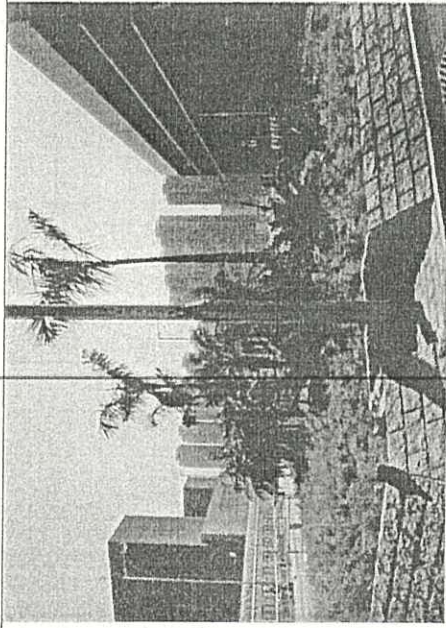
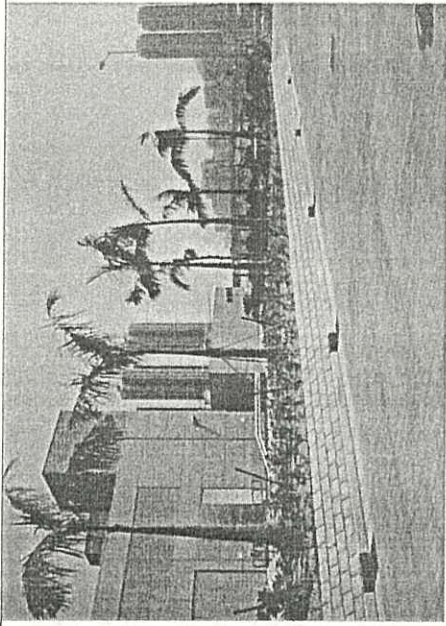
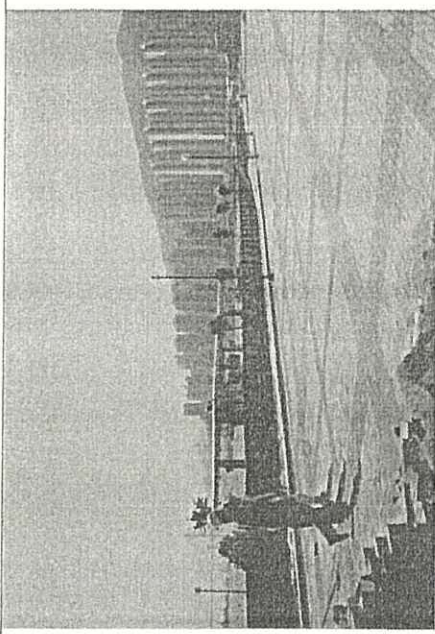
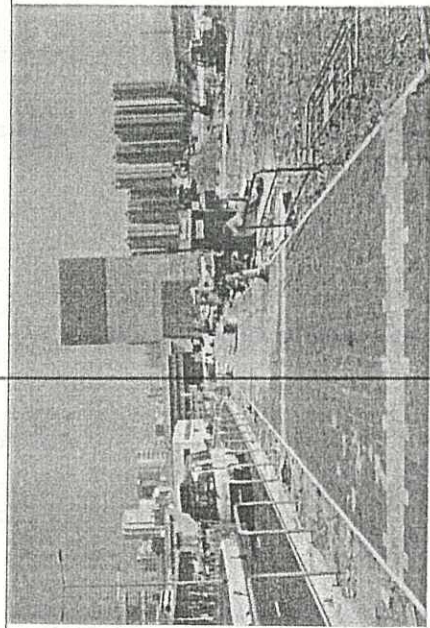
An audit on the landscaping works for Tsuen Wan Station was conducted on 19 September 2003 and it was observed that landscaping works outside the public transport interchange for Tsuen Wan West Station were completed (see Photos 3.36-3.37). The landscaping works at the Promenade and along Hoi Hing Road were also completed (see Photos 3.38-3.39). The works including Tsuen Wan District Open Space Area 35 and water front promenade Phase 2 were still under construction.

Photo 3.36: Landscaping outside the PTI

Photo 3.37: Landscaping outside the PTI

Photo 3.38: Completed landscaping works at the Promenade.

Photo 3.39: Landscaping works on Hoi Hing Road

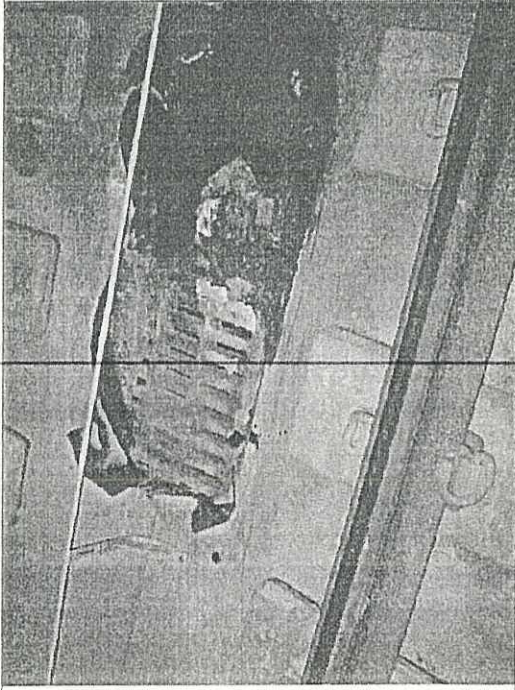
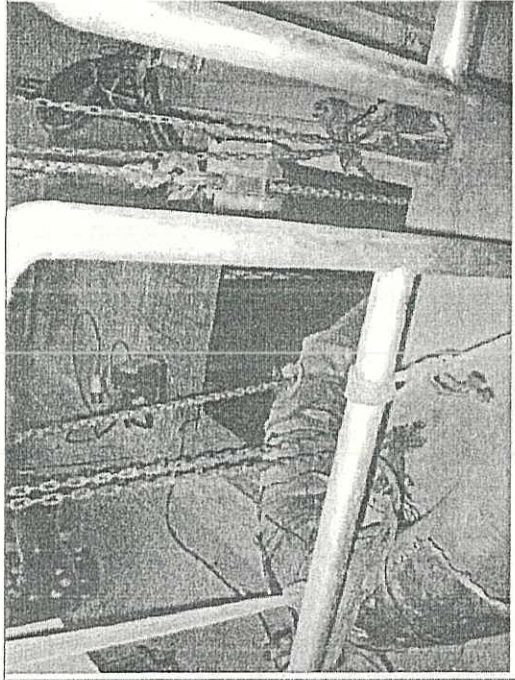
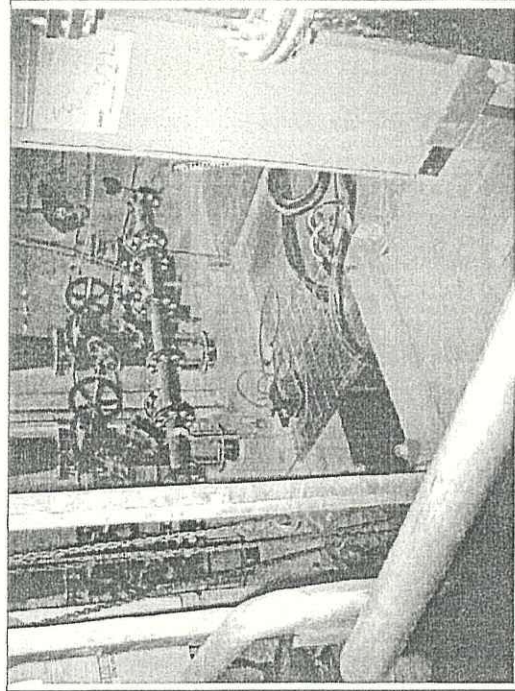
During the site audits taken for the tunnels and station, the drainage systems have been inspected. Silt interceptors and oil interceptors were observed in Area E of Kwai Tsing Tunnel and at Tsuen Wan West Station were also inspected (see Photos 3.40-3.42, 3.42a, 3.42b in Annex 2).

Photo 3.40: Silt trap in Kwai Tsing Tunnel

Photo 3.41: Sump pit inside Tai Lam Tunnel to collect tunnel seepage

Photo 3.42: Sump pit and the associated pumping pipes inside Tai Lam Tunnel

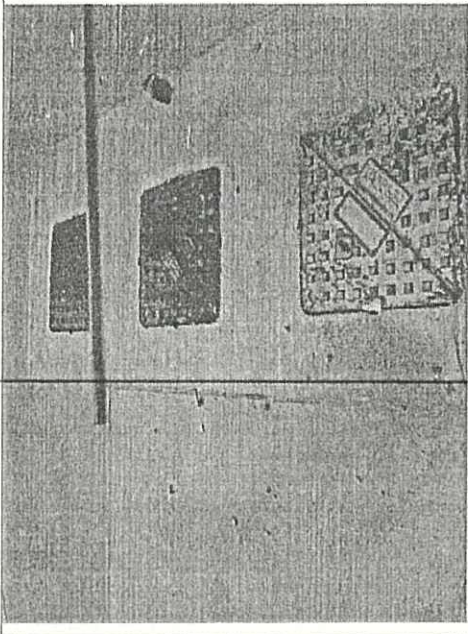
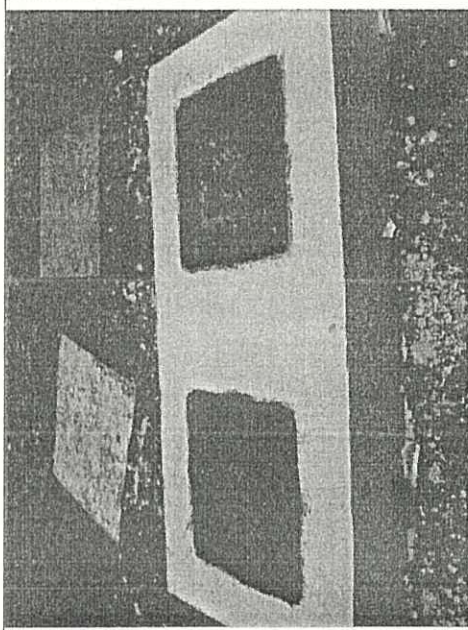
Figure 4.42a Oil interceptors for the station

Figure 4.42b Oil interceptors for the station

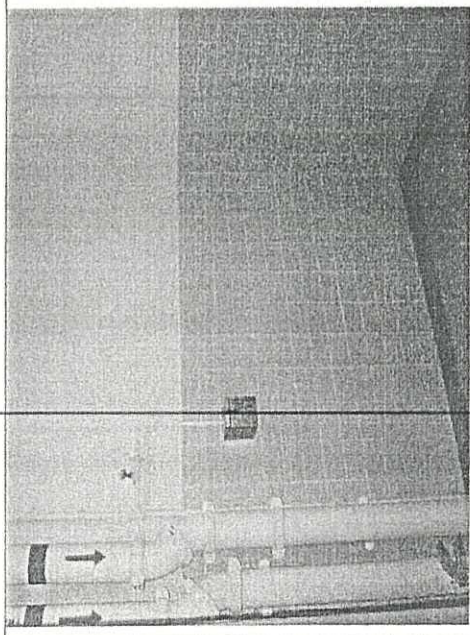
Refuse room is provided in Tsuen Wan West Station for general waste storage. (See Photo 3.43-3.44 in Annex 2)

Figure 3.43 Refuse room

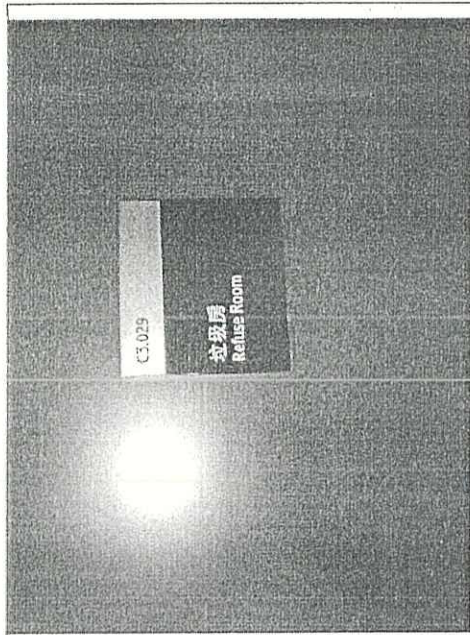
Figure 3.44 Refuse Room

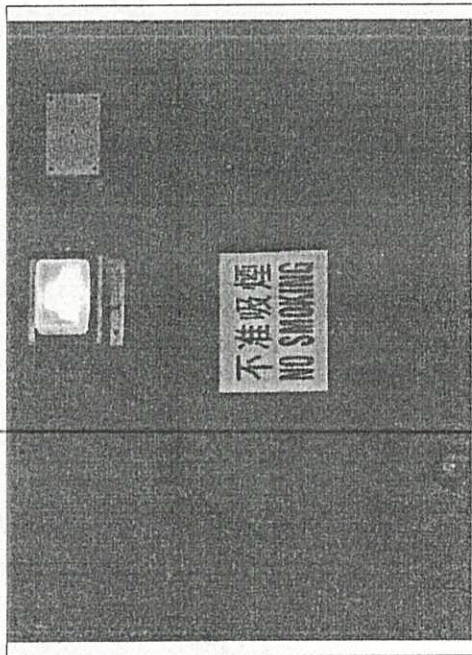
Figure 3.45 “No Smoking” reflective sign in Kwai Tsing Tunnel

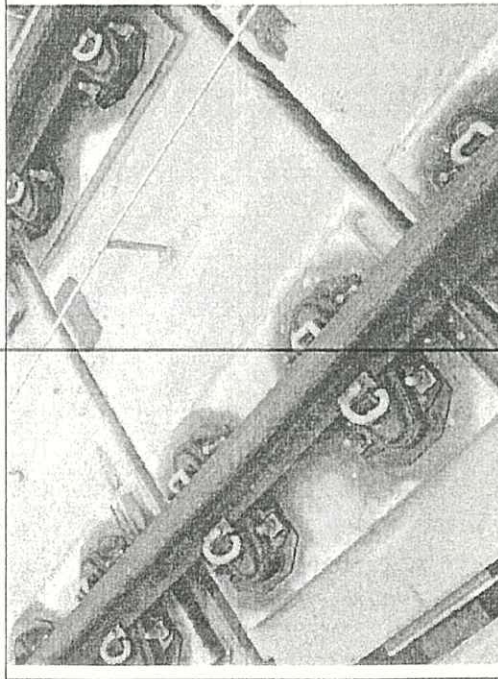
- Installed the specified resilient rail baseplates in accordance with West Rail EIA's recommendation for track on viaduct to reduce vibration transmission to the viaduct structure and thereby reduce re-radiated noise from the viaduct structure between Kam Sheung Road Station and Yuen Long Station and within Kam Sheung Road Station (see Photos 4.10 & 4.35 in Annex 2);

Photo 4.10: Rail Mounted on Baseplate at Floating Slab

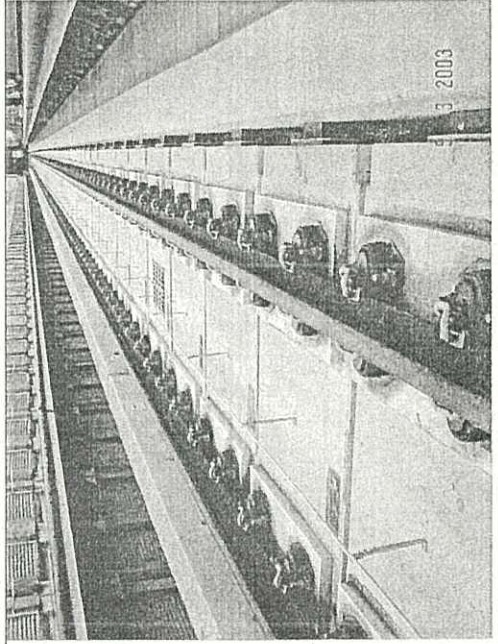
- Mounted the specified track on a floating slab system baseplates in accordance with West Rail EIA's recommendation to further reduce vibration transmission to the viaduct structure between Kam Sheung Road Station and Yuen Long Station and within Kam Sheung Road Station (see Photos 4.11 & 4.35 in Annex 2);

Photo 4.11: Rail Mounted on Baseplate at Floating Slab

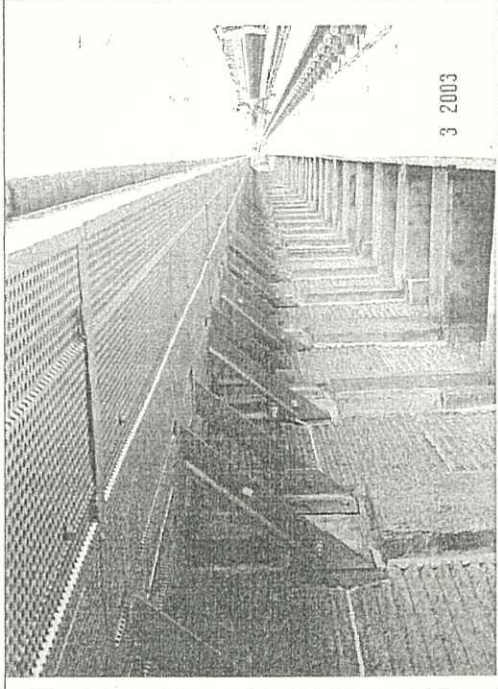
- Created the second acoustic plenum on both side of the car, using walkway at the side of the track along the viaduct alignment between Kam Sheung Road Station and Yuen Long Station and lined absorptive material under the walkway (see Photos 4.12 in Annex 2).

- 1.2m high noise barrier was erected and lined with sound absorptive material in accordance with West Rail EIA's recommendation onto the parapet walls along the viaduct structure between Kam Sheung Road Station and Yuen Long Station and within Kam Sheung Road Station (see Photos 4.12 – 4.13 & 4.34 in Annex 2). The Detailed Design Consultant has also indicated that the edge barrier can be extended on single track viaduct and to full noise enclosures on twin track viaduct with the exception of a few locations as a result of site constraints, e.g. long span over main drainage channel. The high barrier or full noise enclosure are omitted because the long span structure will be adversely affected by typhoon loading. Nevertheless, there are no turnouts (which is expected to be noisier and centre wall of the multi-plenum system cannot be implemented) or sensitive receivers now or in the future that adverse noise impact is not anticipated. Moreover, additional support to the viaduct for the future noise barrier/enclosure or enhancement to the multi-plenum system will be considered to mitigate noise impact at future developments where appropriate.

Photo 4.12: SAM on Parapet (Lower Section) & Below Walkway

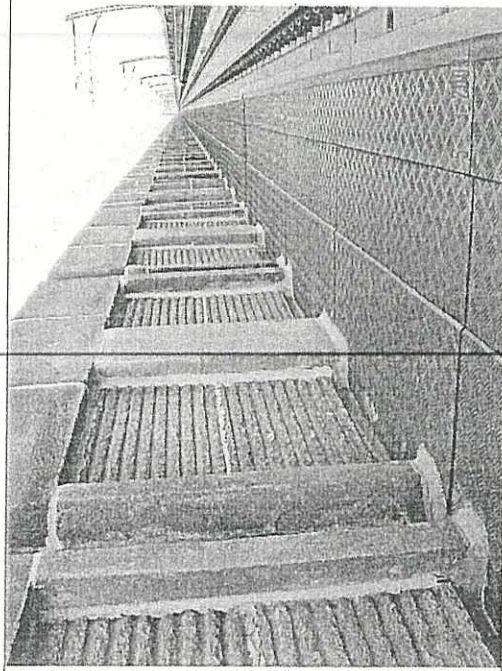
Photo 4.13: Sound Absorptive Material (SAM) on Parapet Wall

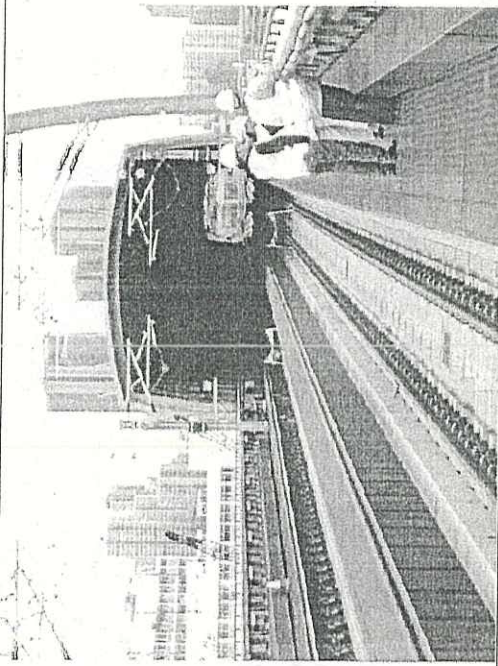
- Installed the noise enclosures to reduce the airborne noise radiated from crossover near Pok Oi Hospital (see Photos 4.14 – 4.15 in Annex 2) with the full length of 220m according to West Rail EIA's recommendation. In addition, acoustic panels are installed inside the noise enclosure (see Photo 4.15). However, observation was made by the IEC on the small gaps at the side (see Photo 4.16 in Annex 2) and at the roof in a size of approx. 5cm x 9cm (see Photo 4.18 in Annex 2) at the noise enclosure near Pok Oi Hospital.

Photo 4.14: MPS & Noise Enclosure at Pok Oi Hospital

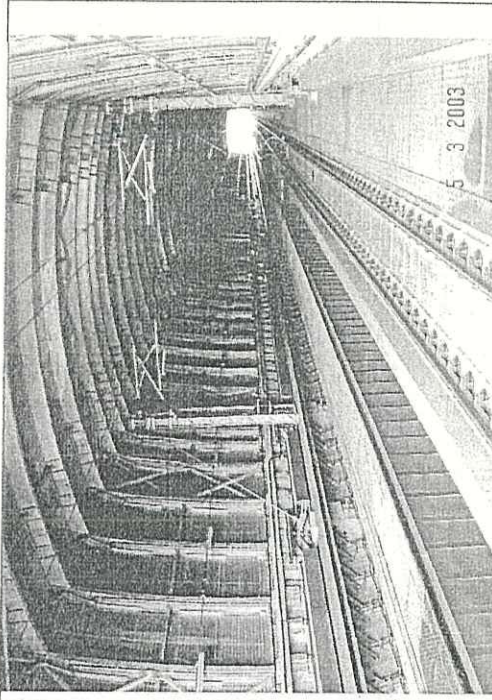
Photo 4.15: Inside Noise Enclosure at Pok Oi Hospital

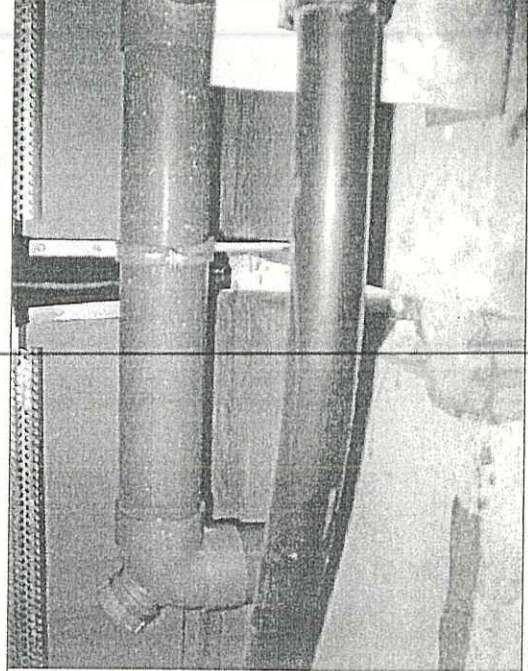
Photo 4.16: Gap Identified Inside Noise Enclosure (Side) at Pok Oi

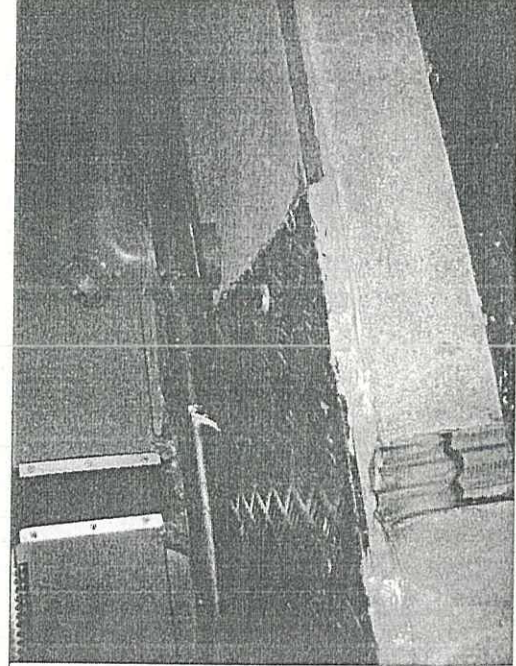
A re-audit was undertaken by IEC, Engineer and KCRC Environmental Team on 22 May to confirm the rectification of the observations on noise enclosure made during the audit. During the audit, IEC has confirmed the gap identified in the noise enclosure at Pok Oi was mostly filled with acoustic material (see Photo 4.17 and 4.20

Photo 4.17: Gap Filled Inside Noise Enclosure (Side) at Pok Oi
