# Kowloon-Canton Railway Corporation

## West Rail

## Pre-operation Environmental Audit Report

### December 2003

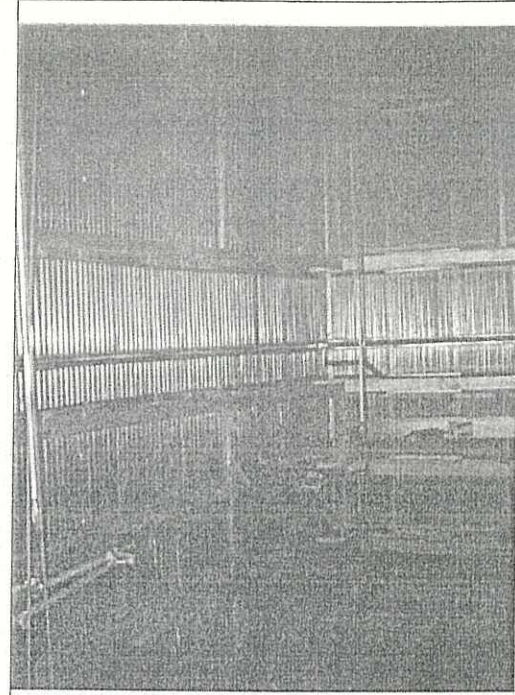
- Installed the noise enclosures to reduce the airborne noise radiated from crossover near Pok Oi Hospital (see Photos 4.14 – 4.15 in Annex 2) with the full length of 220m according to West Rail EIA's recommendation. In addition, acoustic panels are installed inside the noise enclosure (see Photo 4.15). However, observation was made by the IEC on the small gaps at the side (see Photo 4.16 in Annex 2) and at the roof in a size of approx. 5cm x 9cm (see Photo 4.18 in Annex 2) at the noise enclosure near Pok Oi Hospital.

Photo 4.18: Gap Identified Inside Noise Enclosure (Roof) at Pok Oi

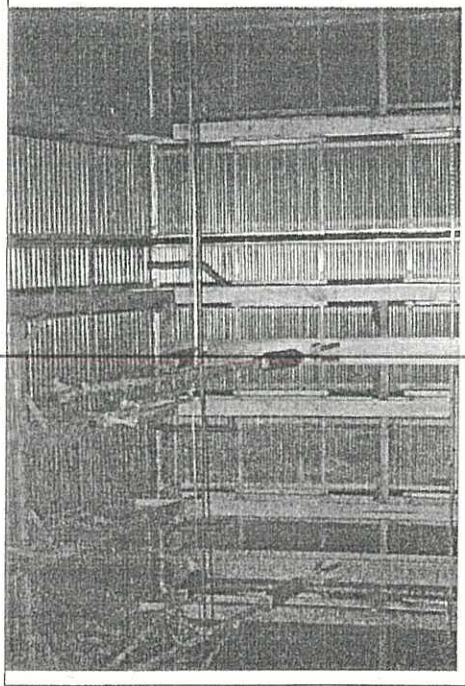
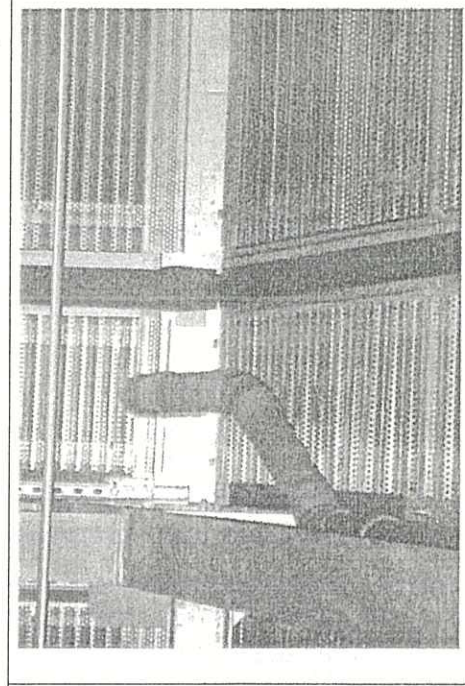
A re-audit was undertaken by IEC, Engineer and KCRC Environmental Team on 22 May to confirm the rectification of the observations on noise enclosure made during the audit. During the audit, IEC has confirmed the gap identified in the noise enclosure at Pok Oi was mostly filled with acoustic material (see Photo 4.17 and 4.20

<p>Photo 4.19: Gap was Filled But Further Filling is Required to Completely Seal the Gap</p>	<p>Photo 4.20: Gap was Completely Filled with Acoustic Material</p>	<p>Photo 4.21: MPS on Twins Viaduct Approaching Yuen Long</p>

in Annex 2). However, IEC requested the Engineer to ensure more acoustic materials is to be applied and evidence shall be submitted to IEC to confirm the completion of the works. Engineer confirmed the completion of the remedial works on 29 May and the gap identified in Pok Oi noise enclosure was completely filled with acoustic materials (see Photo 4.20). No further action is therefore required.

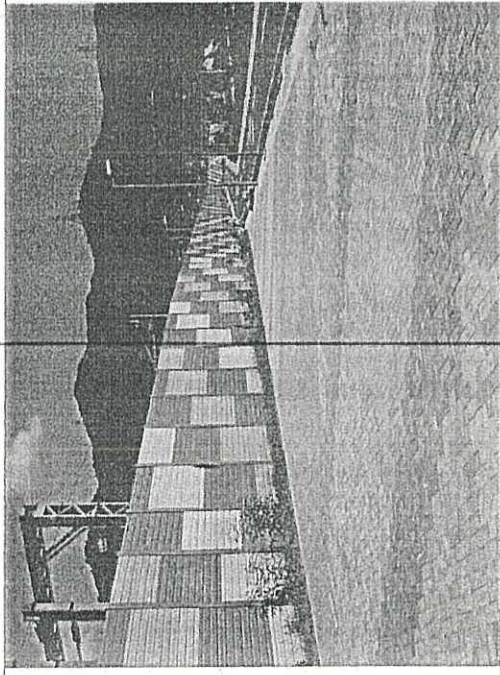
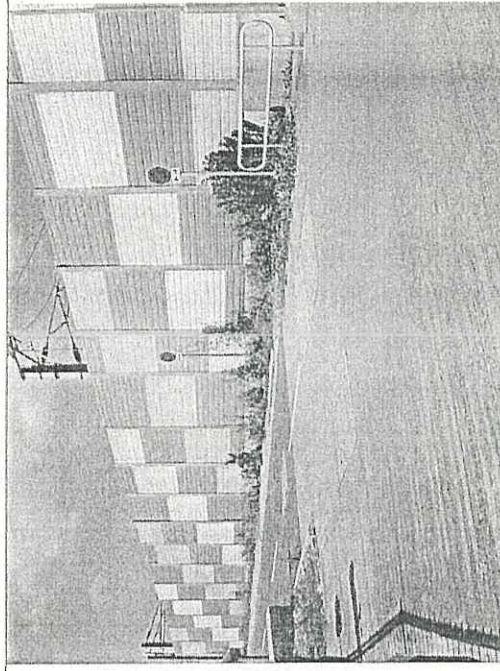
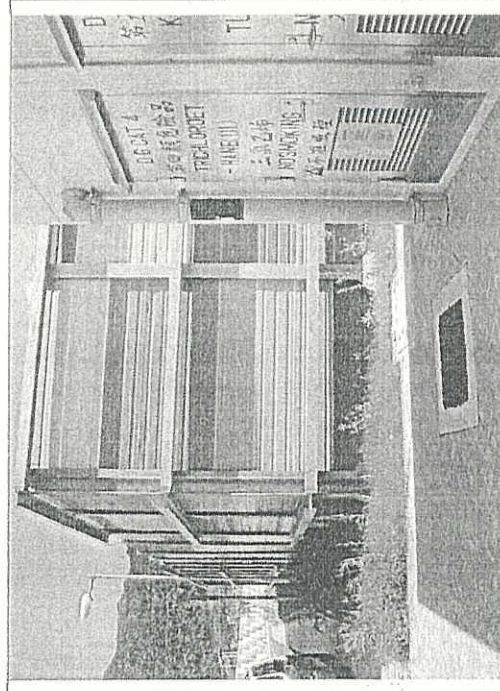
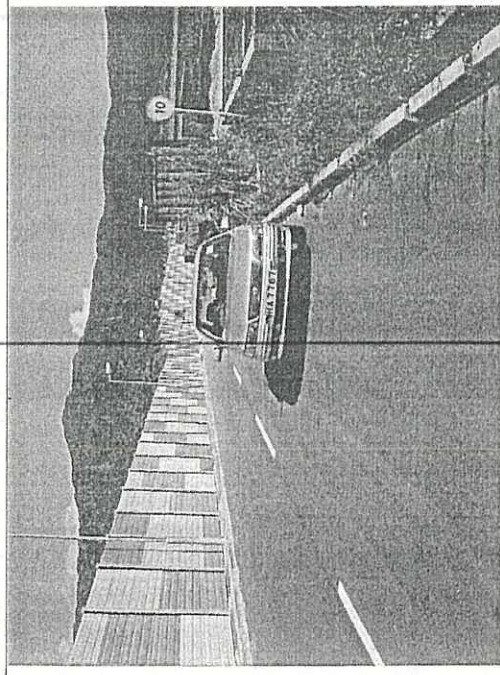
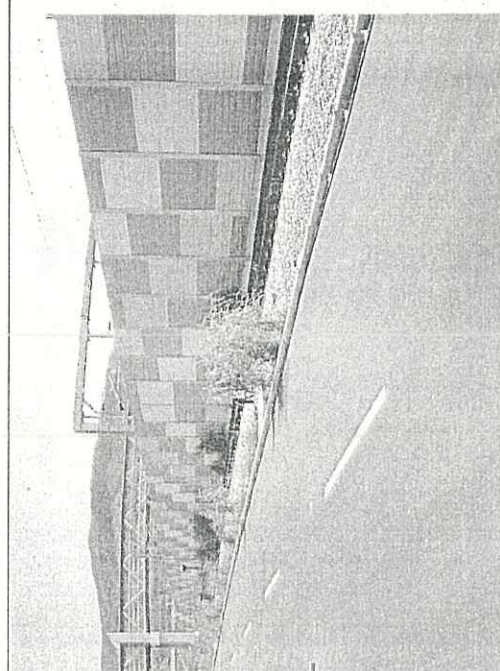
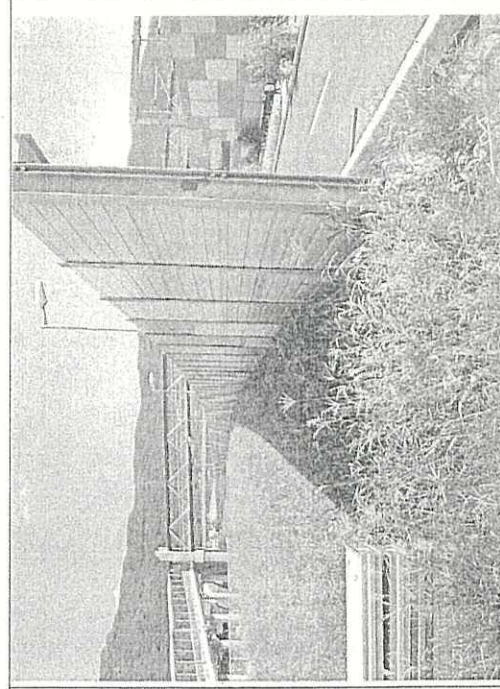
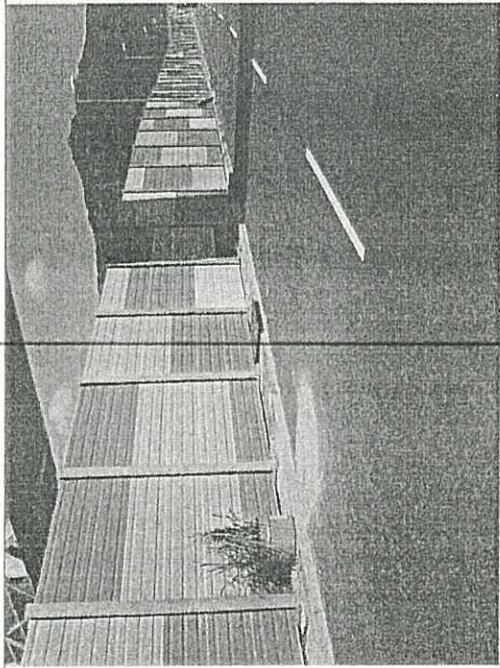
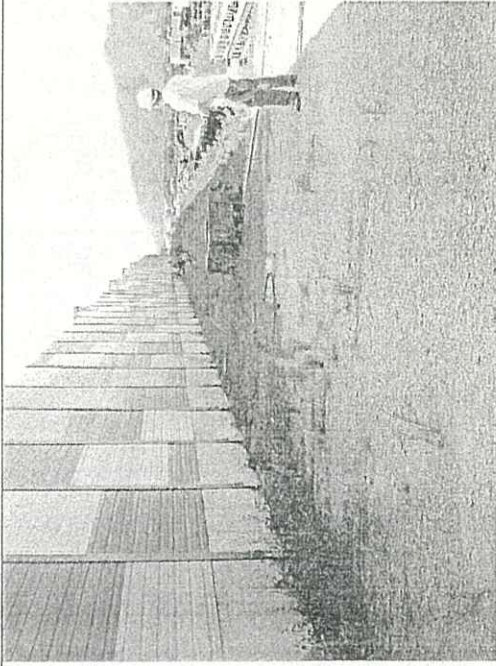
An inspection audit was held on 29 August 2003. It was observed that all noise barriers are installed. The heights and locations of all the noise barriers are in accordance with the recommendations of the EIA study and the subsequent VEP application (See Photos 4.22-4.29 Annex 2).

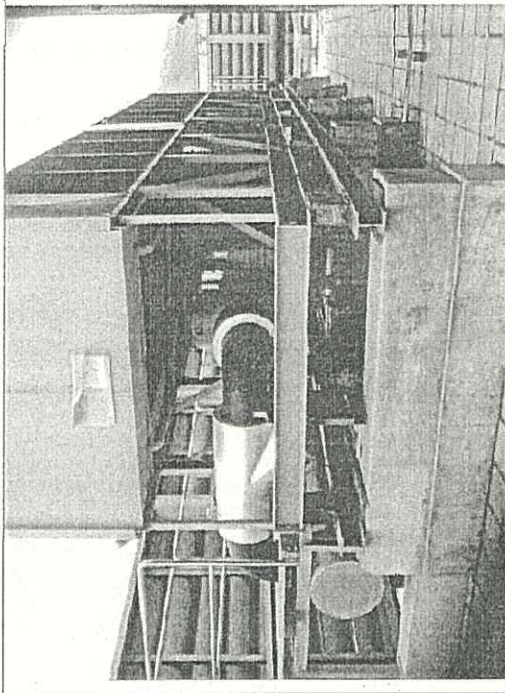
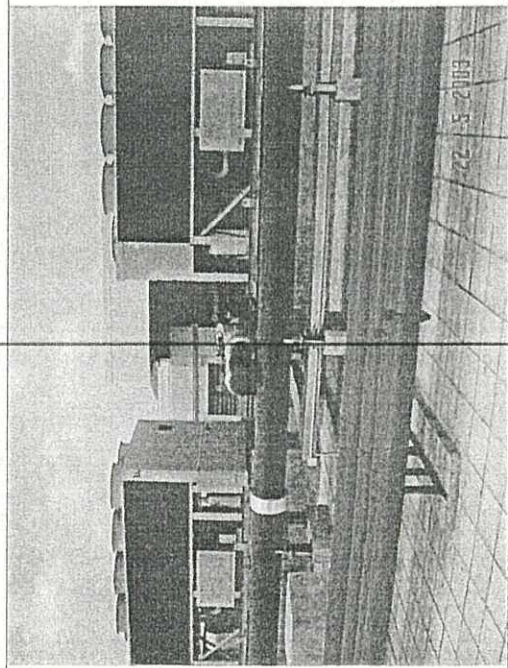
Chillers were installed at the roof floors of the KSR, the WRB and the PMC. It was found that the chillers are surrounded by solid walls (see Photos 4.30 - 4.31 in Annex 2).

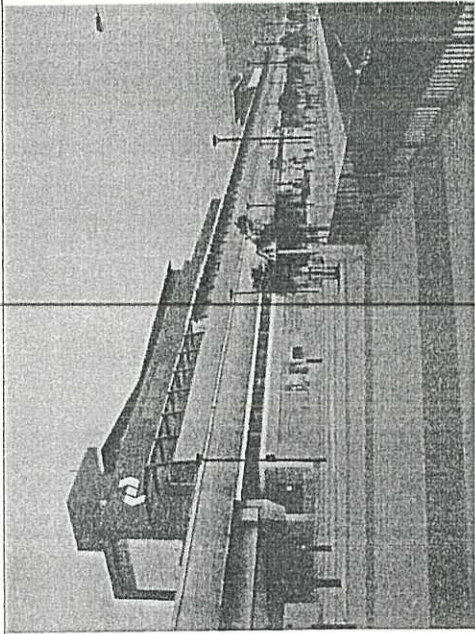
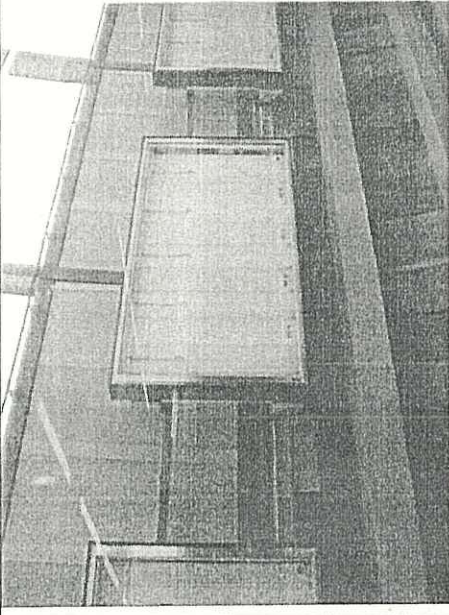
- Regarding the second plenum within the station areas at the stations in the Northern Section, i.e. Kam Sheung Road Station, high-side wind shield with absorptive lining was erected along the station as a purpose-built construction/alternative arrangement (see Photos 4.32 & 4.34 in Annex 2). Whilst it is considered that the alternative design could mitigate the noise impact, the use of these measures is not strictly in compliance with the environmental permit condition as they are not second plenum. Therefore, it is necessary to apply for a Variation to Environmental Permit (VEP) to seek EPD's approval.

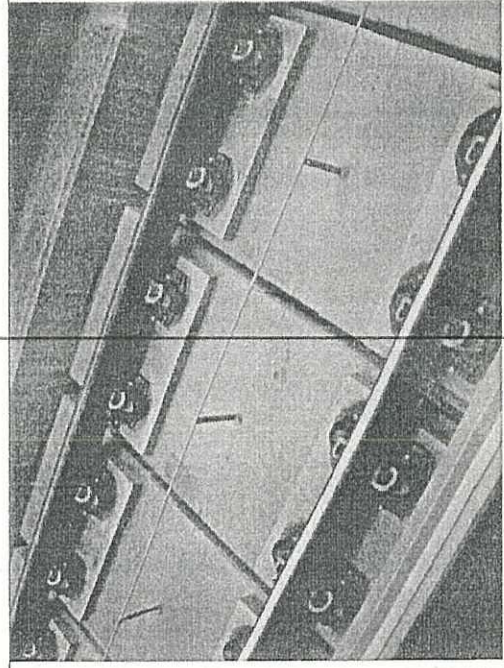
- Installed the specified resilient rail baseplates in accordance with West Rail EIA's recommendation for track on viaduct to reduce vibration transmission to the viaduct structure and thereby reduce re-radiated noise from the viaduct structure between Kam Sheung Road Station and Yuen Long Station and within Kam Sheung Road Station (see Photos 4.10 & 4.35 in Annex 2);

- Mounted the specified track on a floating slab system baseplates in accordance with West Rail EIA's recommendation to further reduce vibration transmission to the viaduct structure between Kam Sheung Road Station and Yuen Long Station and within Kam Sheung Road Station (see Photos 4.11 & 4.35 in Annex 2);

Photo 4.35 Floating slab and resilient baseplate at KSR

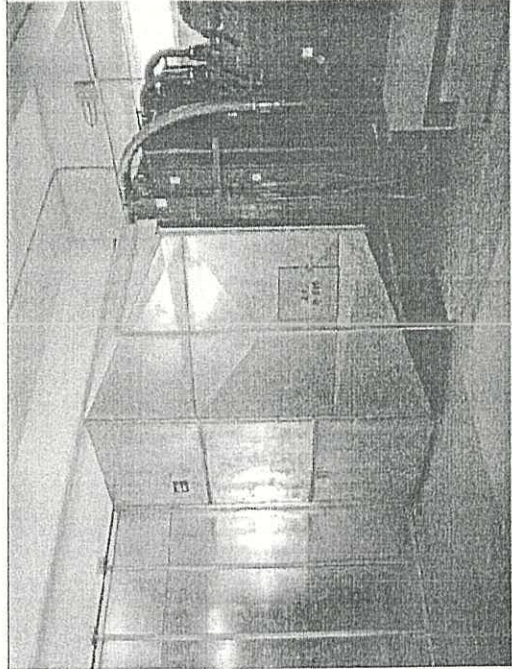
Ventilation systems at the KSR and the PMC were also installed. All ventilation fans are equipped with appropriate silencers and the associated vent ducts are enclosed (see Photos 4.36 - 4.38 in Annex 2).

Photo 4.36 Ventilation system of KSR

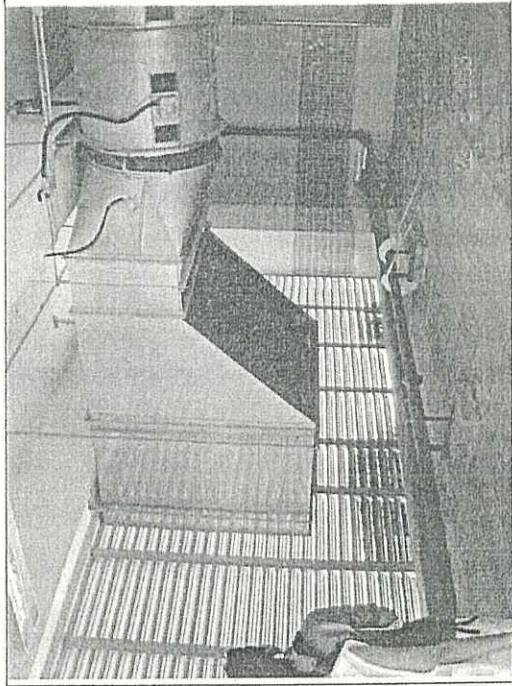
Photo 4.37 Ventilation of KSR

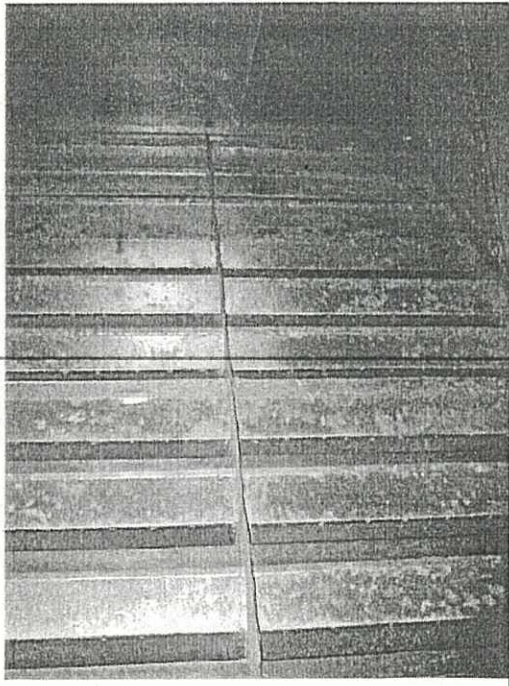
Photo 4.38: Silencers installed within the ventilation system

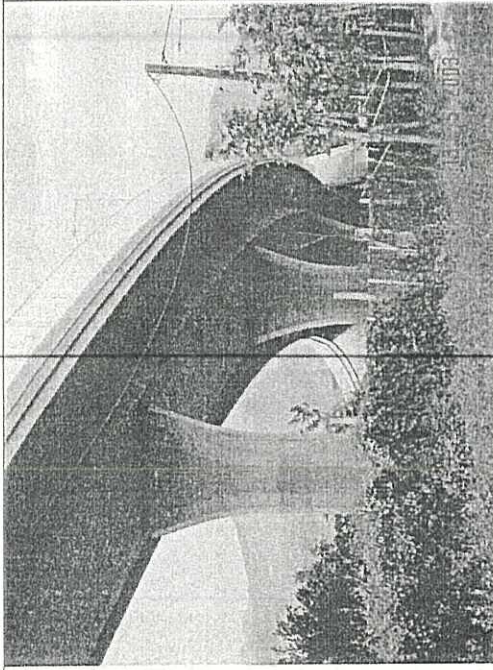
- Pat Heung Road is on viaduct. The parapet wall is in curvilinear form and all the support columns are rounded shape to create streamline image and minimise visual impact (see Photo 4.39 in Annex 2).

Photo 4.39 Viaduct section of Pat Heung Road.

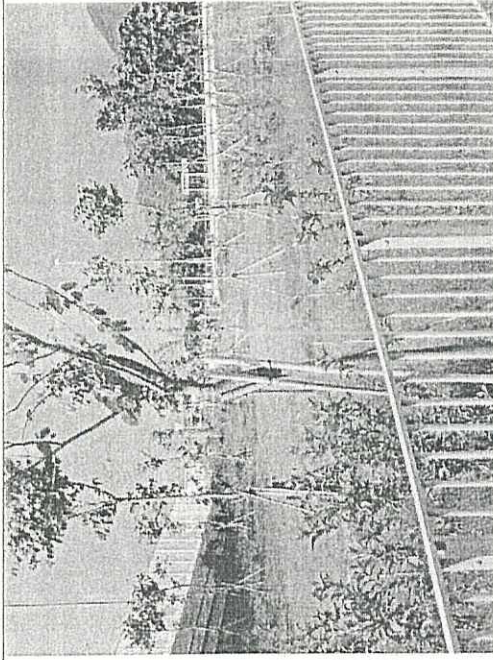
- The middle part of Pat Heung Road is above the main line and stabling tracks of West Rail such that planting is not possible. While the two ends of Pat Heung Road are on embankment with trees planted (see Photos 4.40 – 4.41 in Annex 2).

Photo 4.40: Landscape at the end of Pat Heung Road

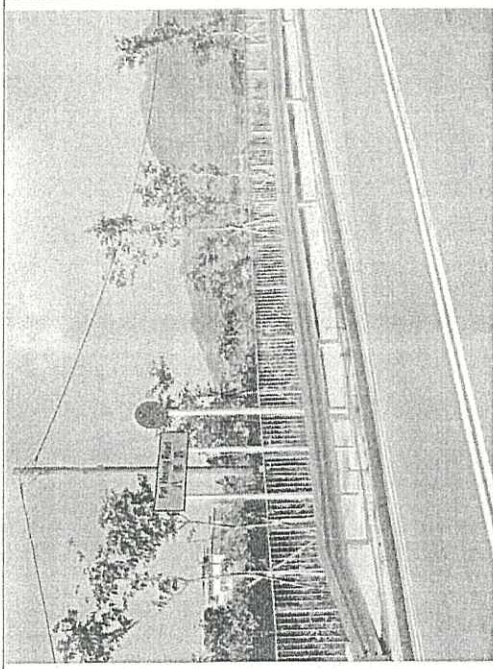
Photo 4.41: Landscape along Pat Heung Road.

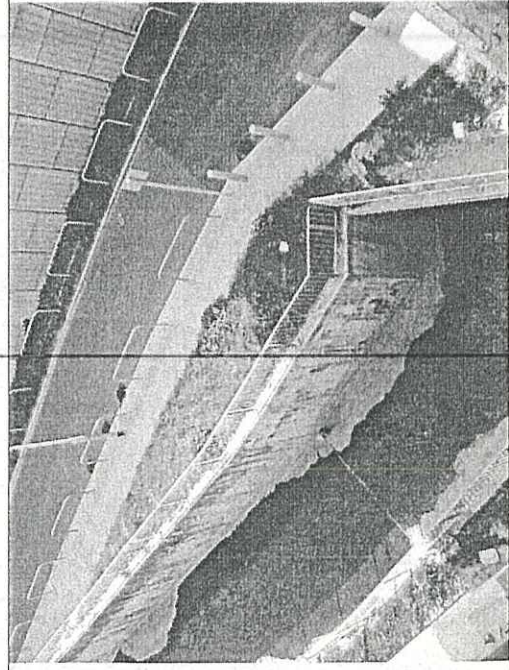
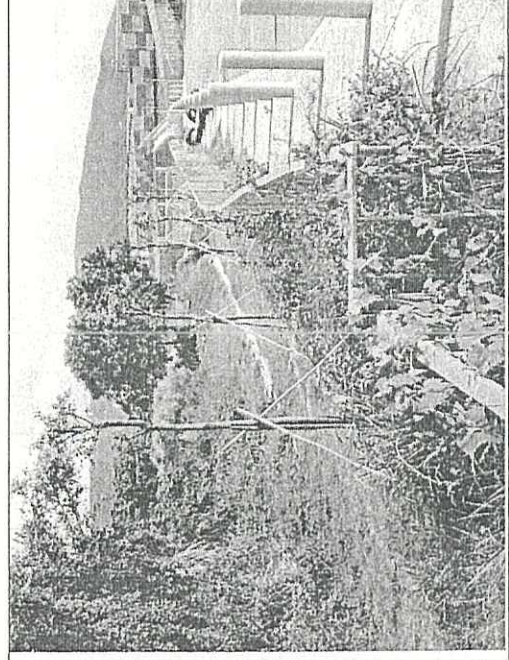
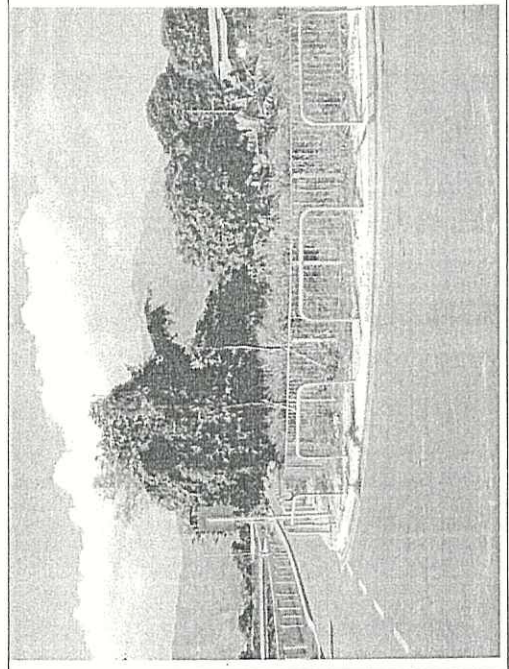
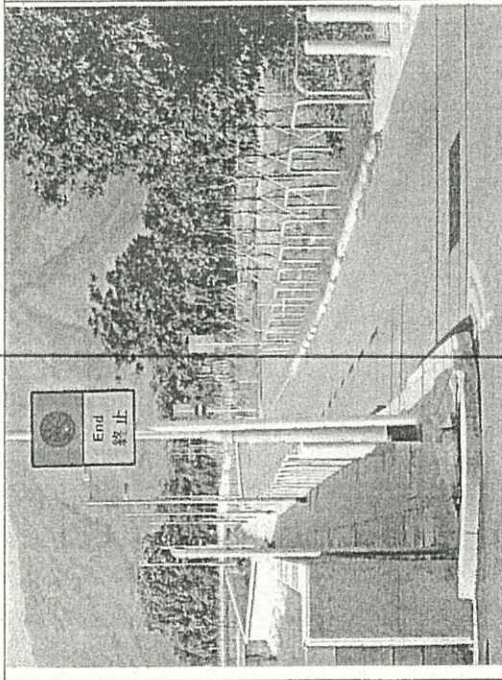
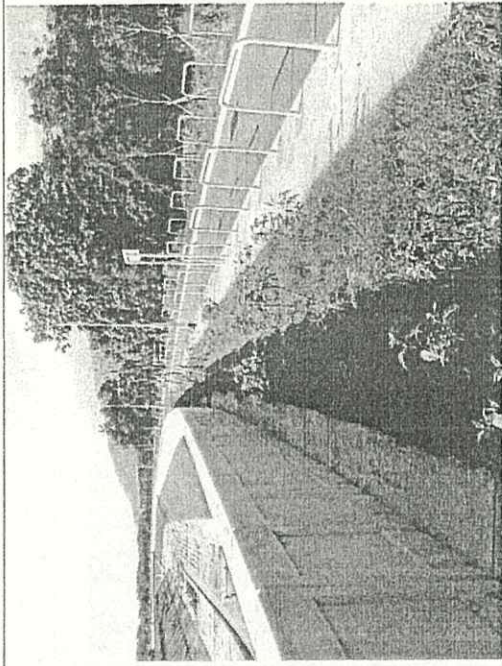
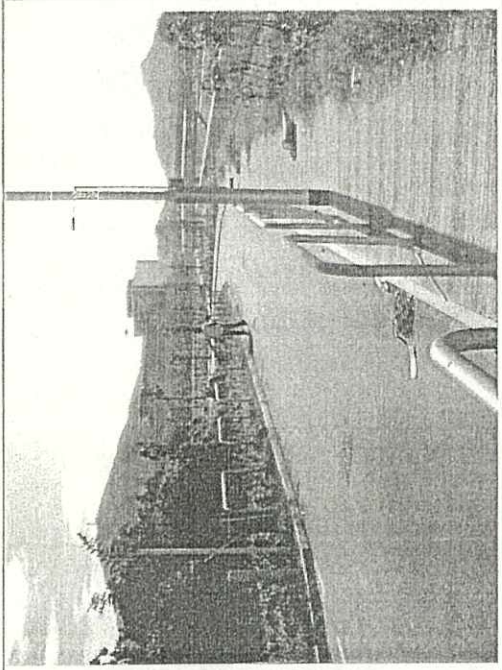
- The embankments and cuttings of both the railway and the new roads, namely Kam Hoi Road (formerly known as Western Perimeter Road) and Kam Po Road (formerly known as Eastern Perimeter Road) at two sides of PMC are planted with dense trees (see Photos 4.42 – 4.50 in Annex 2).

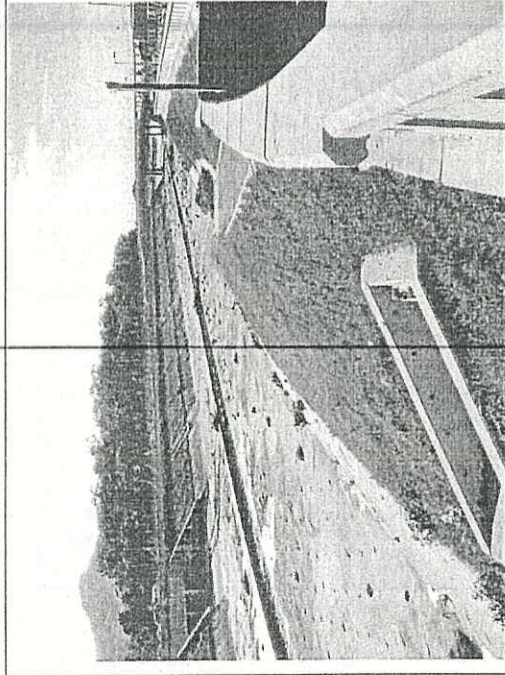
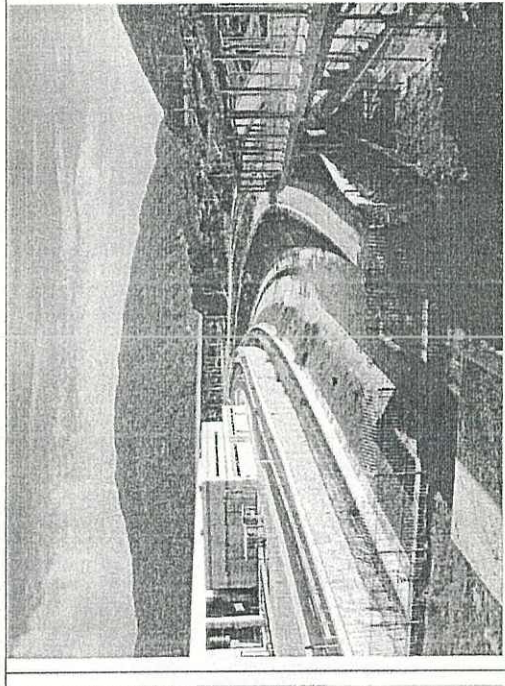
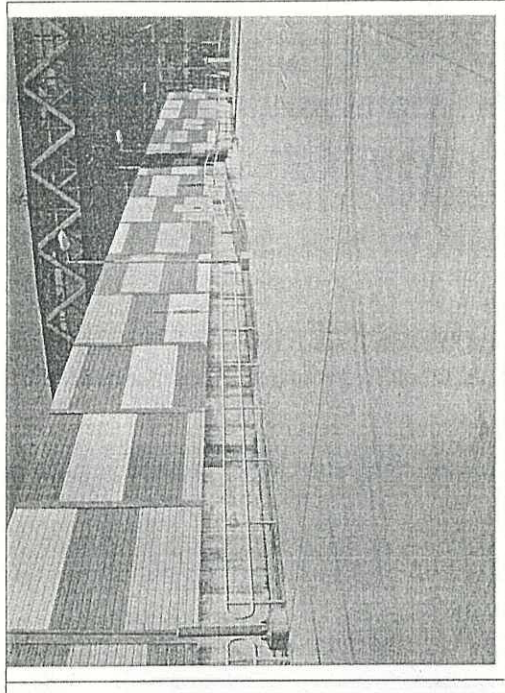
- Grasscrete has been installed inside the Main Drainage Channels as an environmental-friendly design (see Photos 4.51 -4.52 in Annex 2).
- Lighting at the depot is specially designed to light directly onto the ground (see Photo 4.53 in Annex 2);

<p>Photo 4.51: Grassy area along the MDC.</p>	<p>Photo 4.52: Grassy area along the MDC.</p>	<p>Photo 4.53: Lighting at Depot.</p>

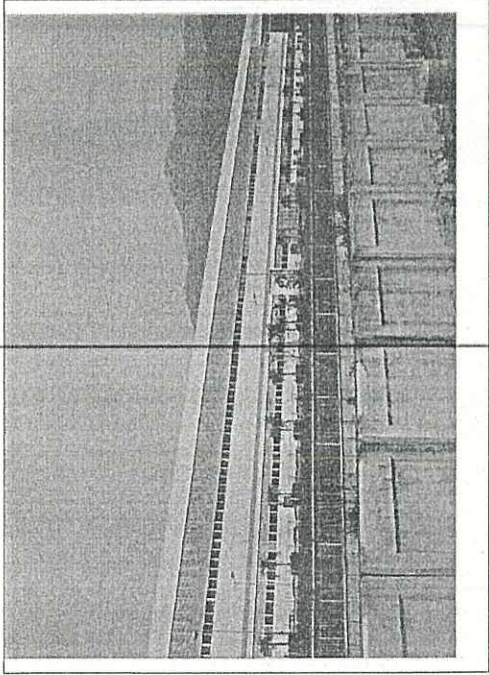
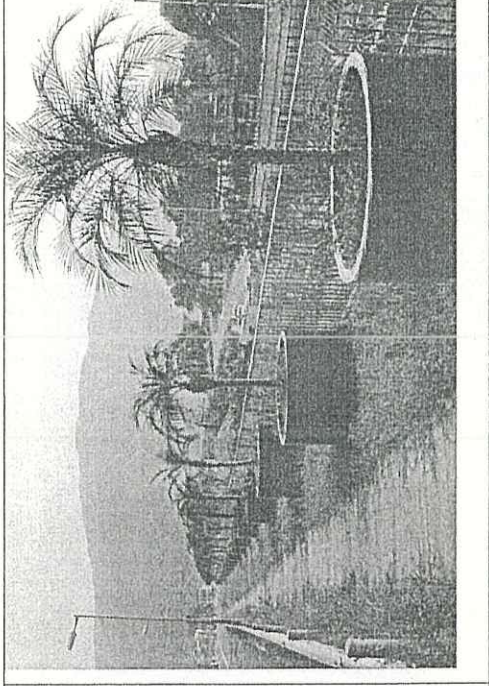
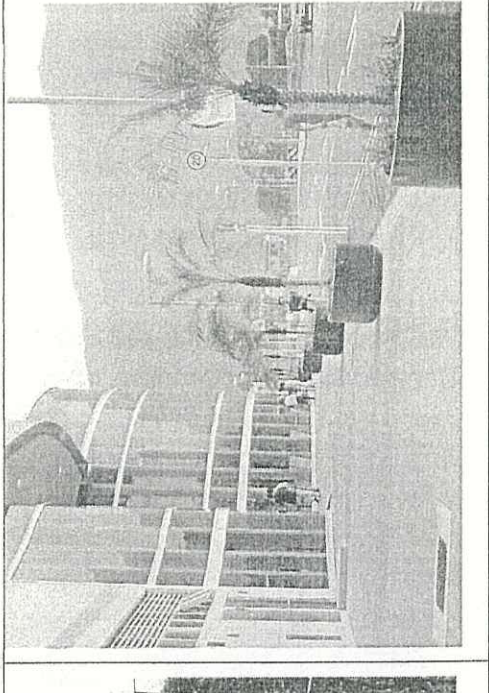
<p>Photo 4.53a: Planting along F100 Road adjacent to EMU Building</p>	<p>Photo 4.53b: Planting along F100 Road</p>	<p>Photo 4.53c: Planting at the front door of EMU Building</p>

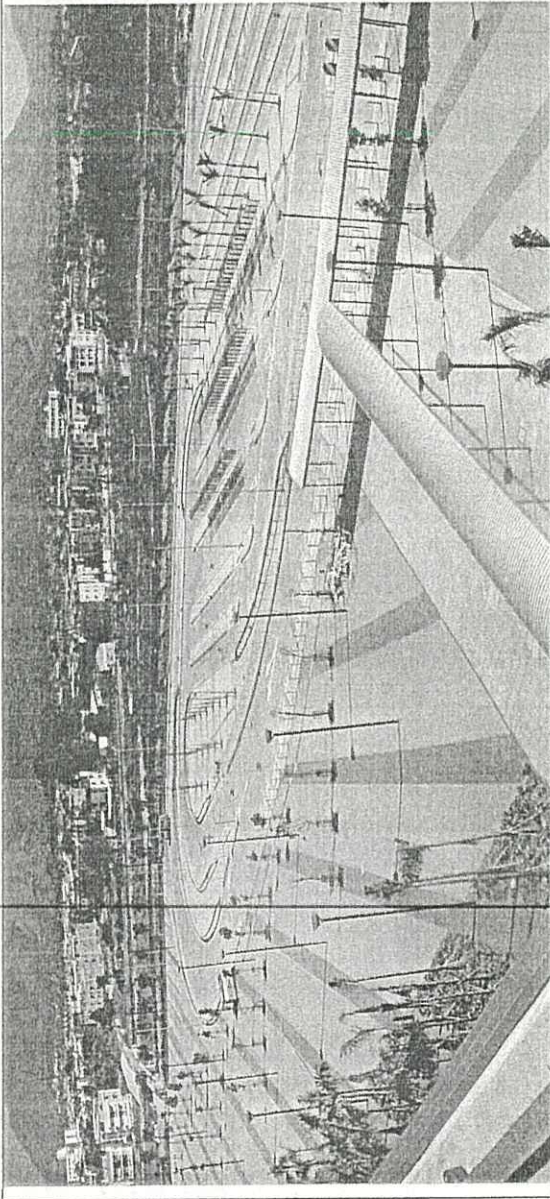
- the areas of Public Transport Interchange and the Park and Ride areas near KSR (see Photo 4.54-4.55 in Annex 2).

Photo 4.54: Eastern PTI of KSR

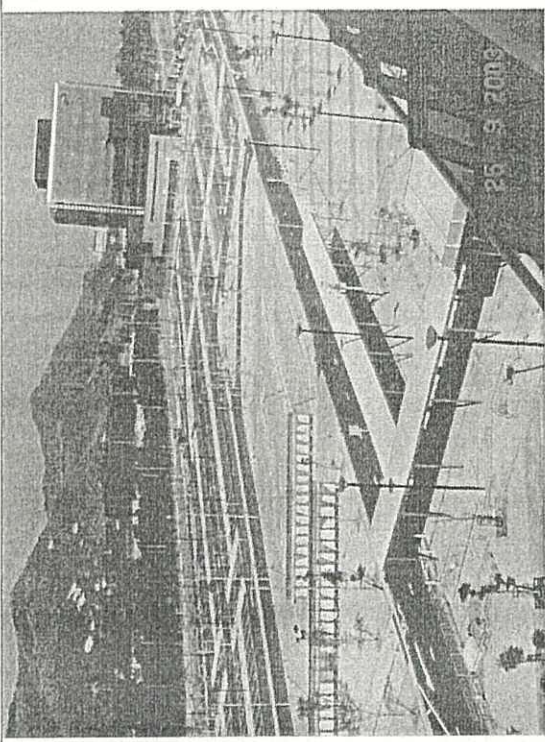
Photo 4.55: Western PTI and Park and Ride area

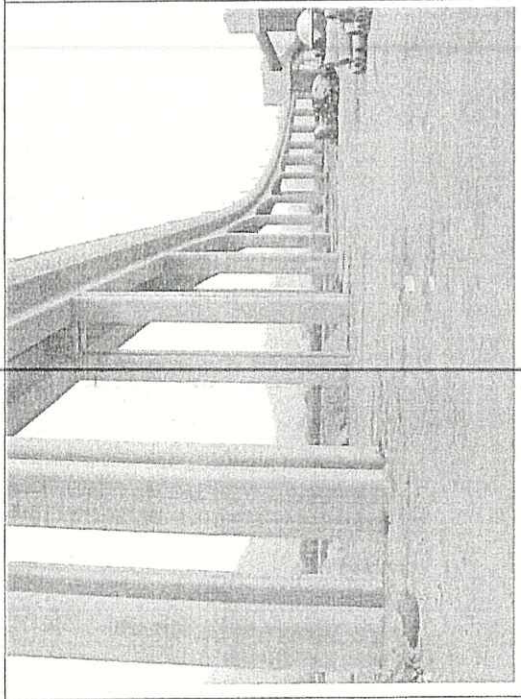
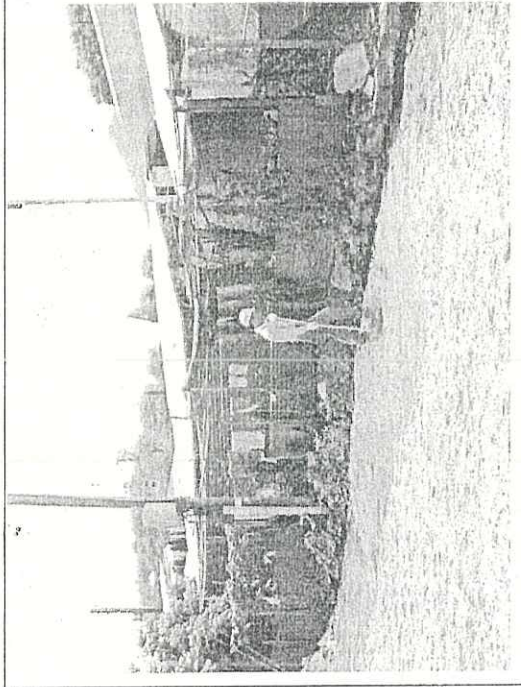
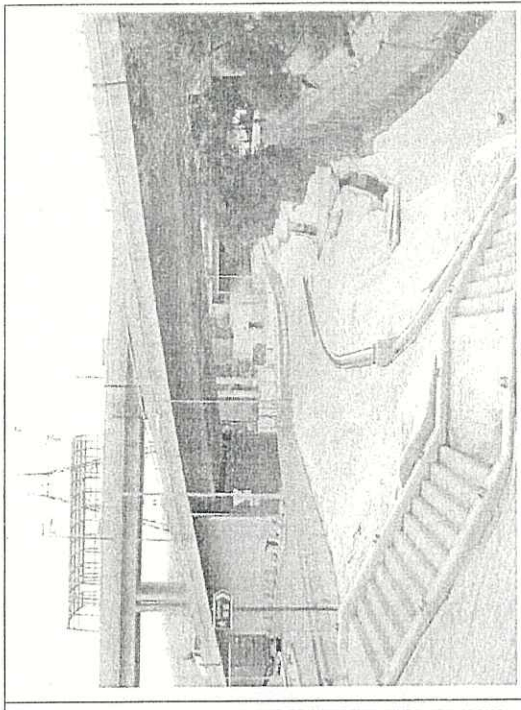
- Hydroseeding has been successfully applied to all areas below the viaduct and within the West Rail gazetted boundary during the first audit on landscape on 26 March (see Photos 4.58, 4.59, 4.60 & 4.63 in Annex 2);
- Native whip mix in hydroseeding and shrub mix has also been applied in most areas below the viaduct and within the West Rail gazetted boundary (see Photos 4.60 & 4.63 in Annex 2). While planting of seasonal native whip mix and shrub mix on the following areas below the viaduct would be completed in June:-
  - Kam Tin: Piers 242 to 250 to the north of MDC (see Photo 4.56)
  - Yuen Long: Piers 262 to 270 and 273 near Pok Oi Hospital (see Photos 4.57 & 4.61)
- Planting of the native climber along the viaduct supporting columns has commenced and would continue throughout the planting season.

<p>Photo 4.56: Ongoing Landscaping Works at Kam Tin (Piers 242-250)</p>	<p>Photo 4.57: Preparation Works for Planting of Seasonal Native Whip Mix near Tung Shing Lei</p>	<p>Photo 4.58: Landscape Planting at EVA16</p>

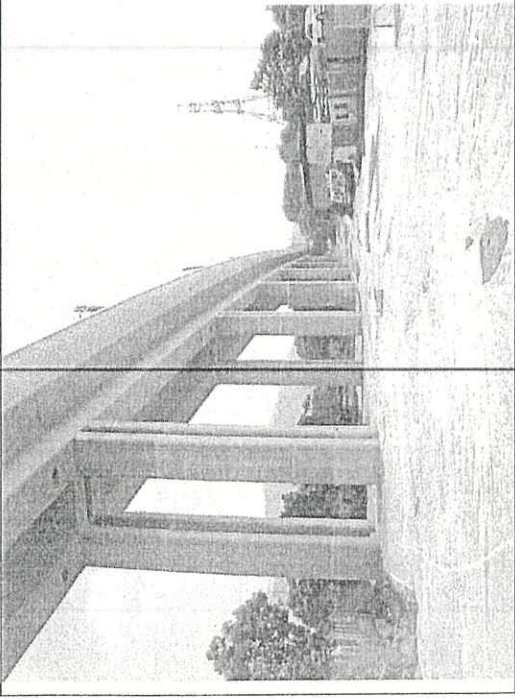
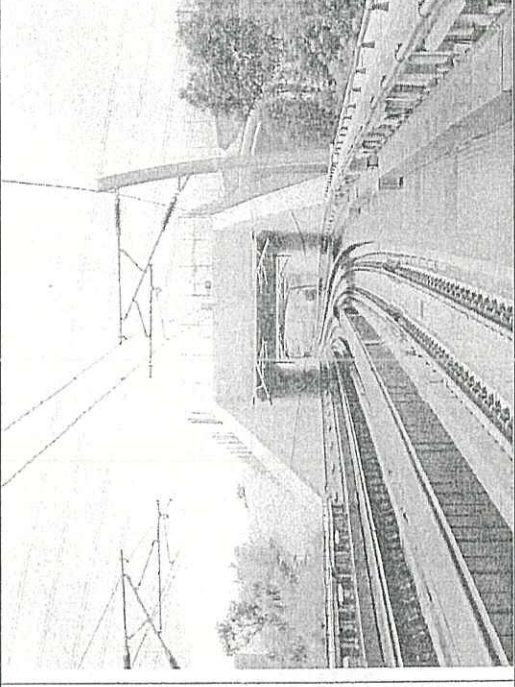
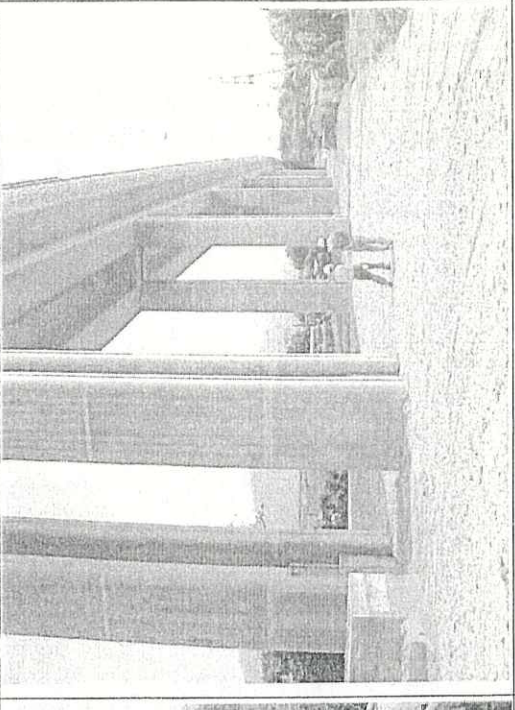
<p>Photo 4.59: Landscape Planting at Tung Shing Lei (Piers 256-261)</p>	<p>Photo 4.60: Completion of Landscaping Works at Au Tau</p>	<p>Photo 4.61: Ongoing Landscaping Works at Pok Oi (Piers 262-265)</p>

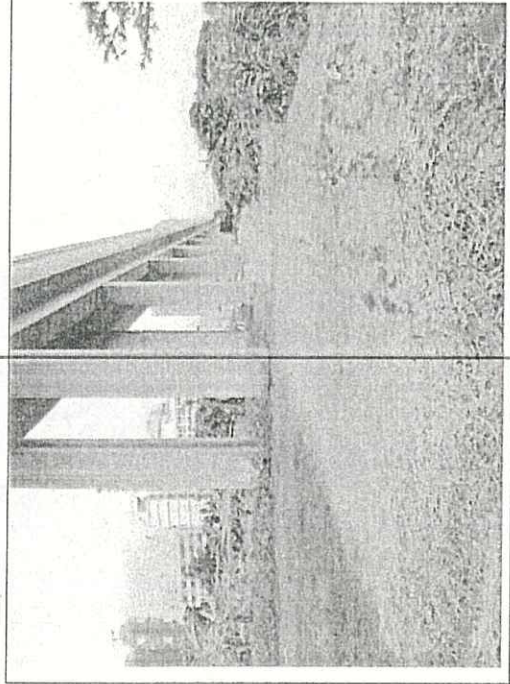
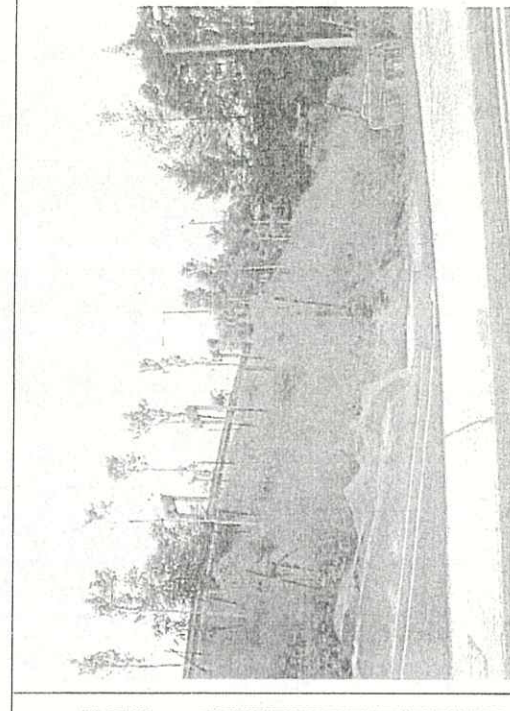
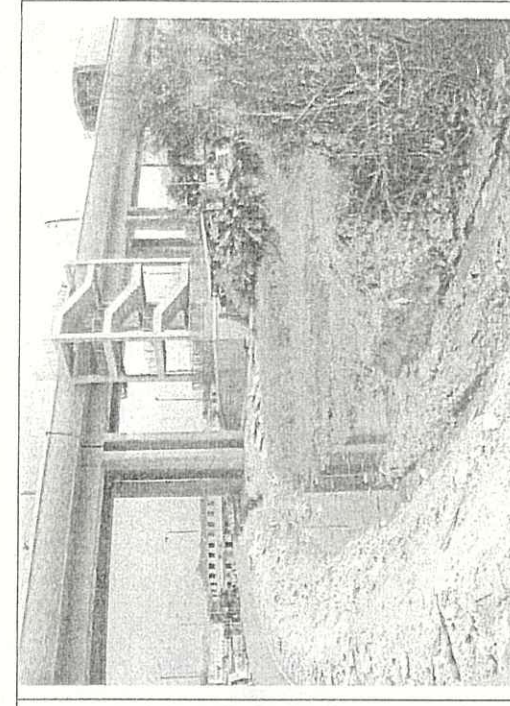
A re-audit was undertaken by IEC on 27 June, to confirm the completion of the seasonal landscaping works and the reverting of the temporarily occupied area. IEC has confirmed the completion of the landscaping works at Yuen Long (Piers 262 to 270) (see Photos 4.62) and the reverting works near *Poon Uk Hakka Mansion* in Yuen Long back to the original condition (see Photo 4.65). Planting of the native climber along the viaduct supporting columns has also been completed. However, the minor reverting and landscaping works at Kam Tin near Piers 242 to 250 are still ongoing and would be completed by October 2003 towards the end of its leasing period. Therefore, as agreed by IEC, Engineer and Resident Landscape Architect, that contractor shall submit evident for verification upon the completion of these works at Kam Tin.

<p>Photo 4.62: Completion of Landscaping Works at Pok Oi (Piers 262-265)</p>	<p>Photo 4.63: Landscape Planting near Pok Oi</p>	<p>Photo 4.64: Outstanding Reverting Works Adjacent to Poon Uk Hakka Mansion Temporarily Occupied Area (TOA) near EVA17</p>

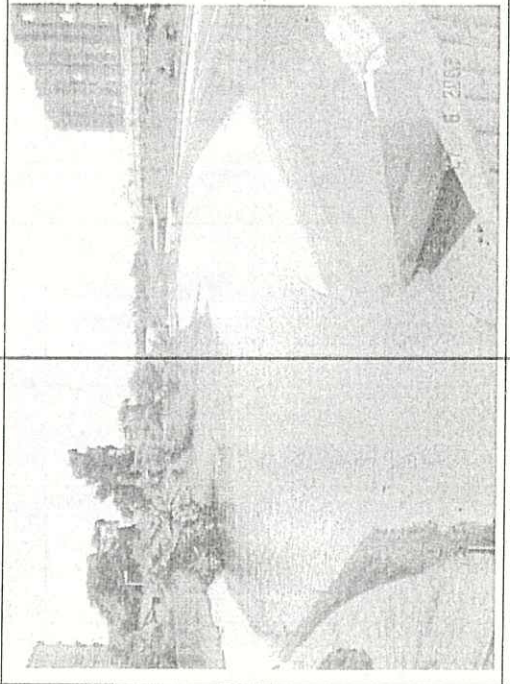
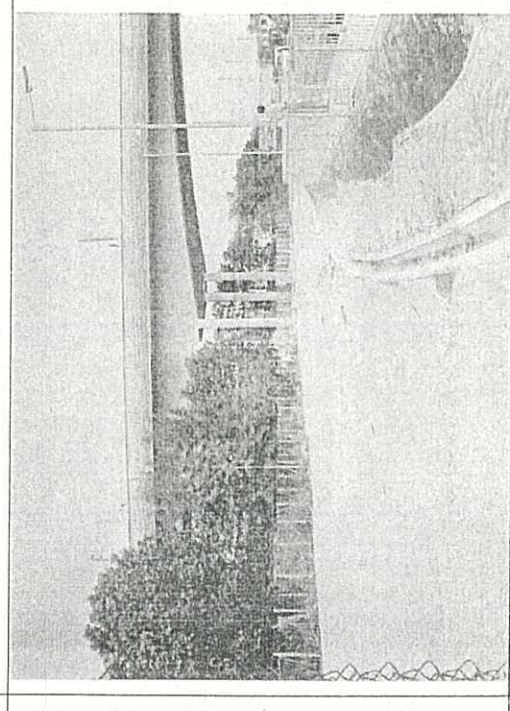
<p>Photo 4.65: Completion of Reverting Works Adjacent to Poon Uk Hakka Mansion TOA near EVA17</p>	<p>Photo 4.66: Completion of Landscaping Works near Small Trader New Village</p>

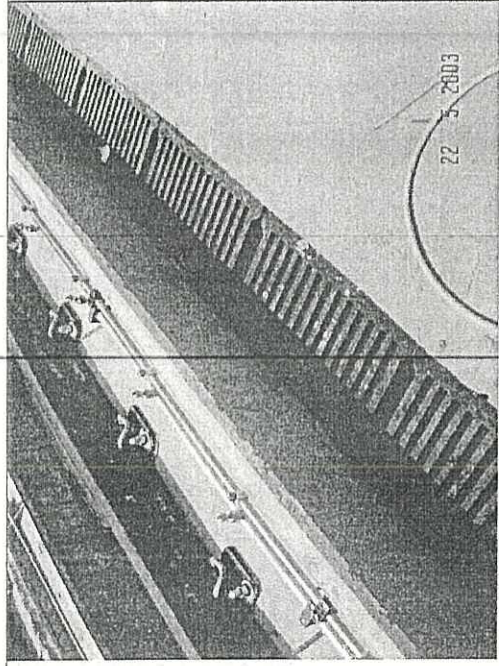
- Wastewater produced from car and bogie wash will be treated before recycled and discharged. Wastewater produced at the Car Wash Facilities will be diverted to sedimentation tanks through surface drain. The primary-treated wastewater will be recycled for washing under-car surfaces and the wastewater produced at this stage will undergo biological treatment and partially discharged before recycling. Water used for washing bogie will be recycled. The pH value of consumed water will be checked before discharge and neutraliser will be added when needed. Sludge produced from the wastewater treatments will be collected by licensed waste collectors. (see Photos 4.67 – 4.71 in Annex 2)

Photo 4.67: Surface drainage for trackside run-off at Car Wash Facilities.

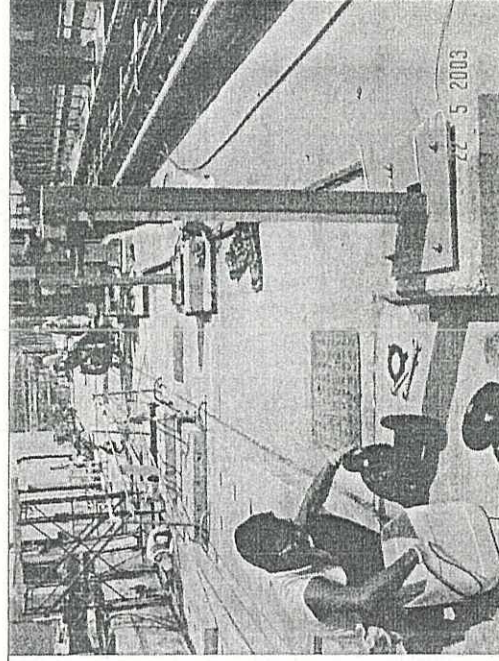
Photo 4.68: Oil interceptor for Car Wash Facilities

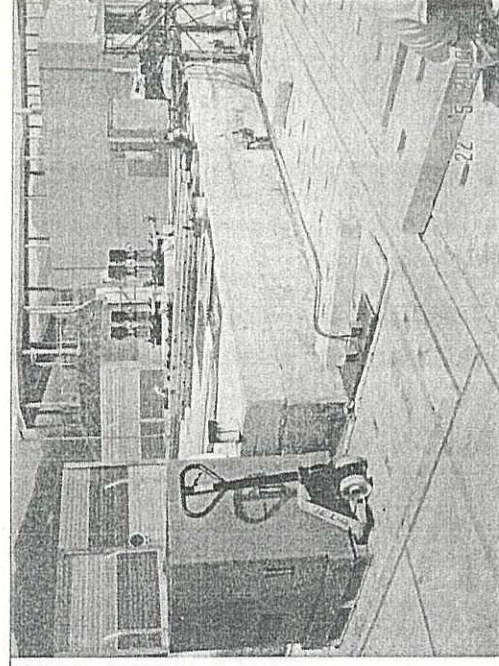
Photo 4.69: Sedimentation Tanks

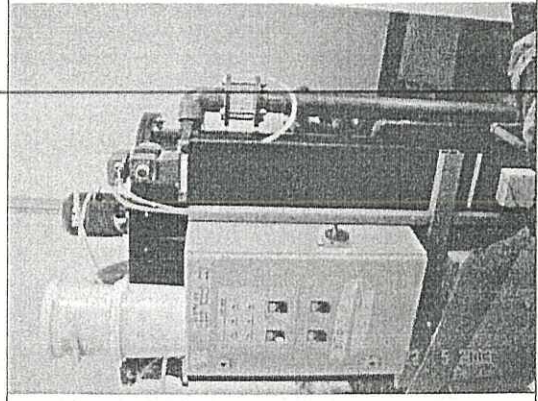
Photo 4.70: Biological Filter

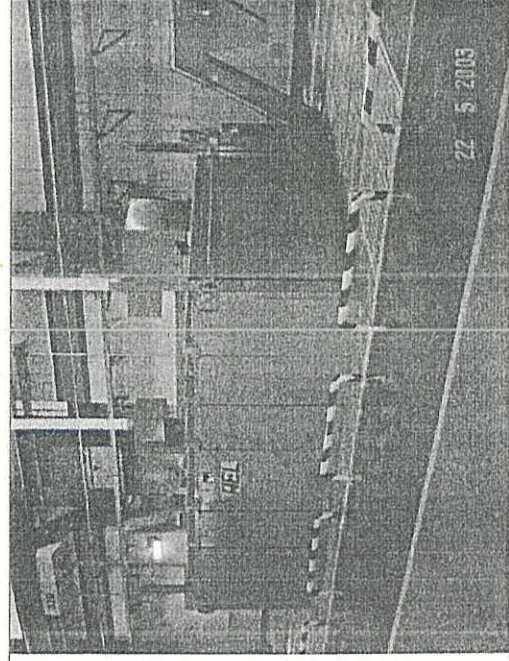
Photo 4.71: Bogie Wash

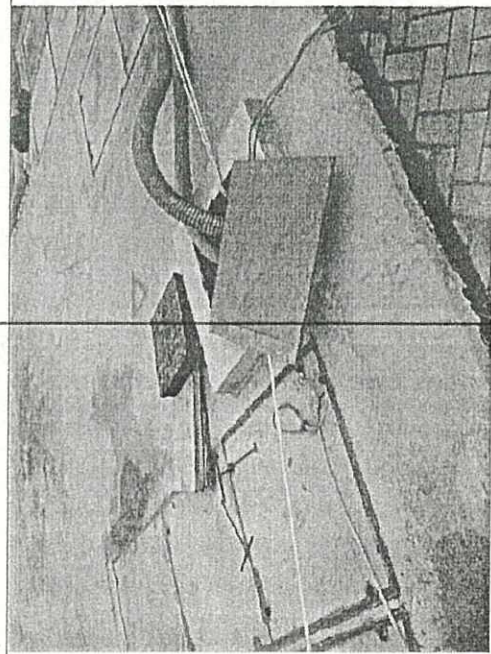
Photo 4.73: Underground sewage storage tank for KSR and WRB

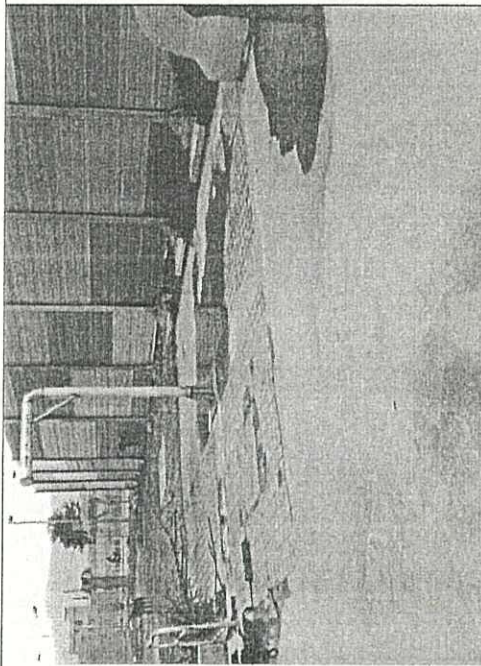
Photo 4.74: Underground sewage storage area for PMC

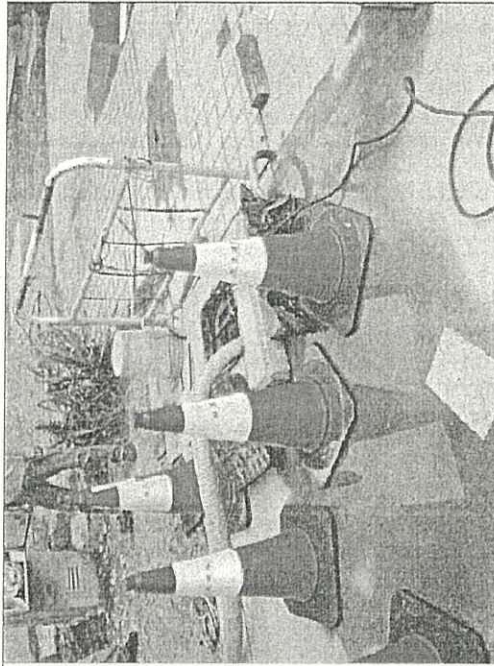
Photo 4.75: Sewage collection.

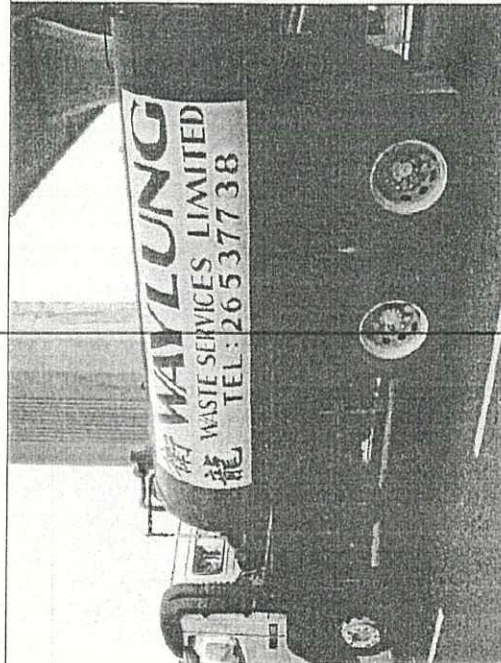
Photo 4.76: Sewage collector

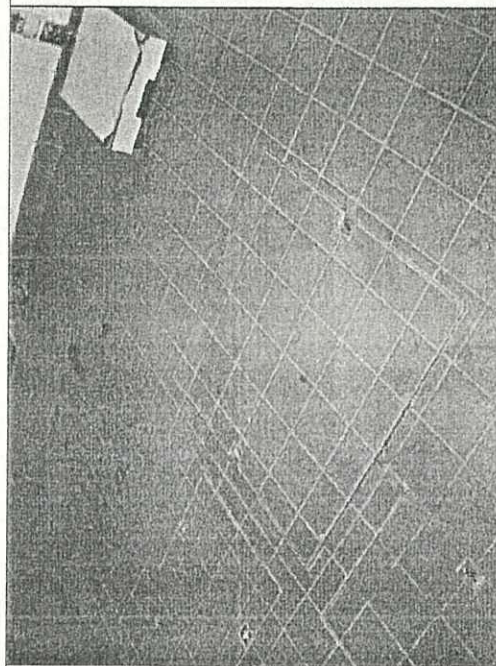
- Oil interceptors have been installed at the WRB and PMC. There is also a petrol interceptor at the petrol station. A licensed collector has been employed to clean the interceptors on a monthly basis and dispose of the oil contents properly. (see Photos 4.77 – 4.80 in Annex 2)

Photo 4.77: Oil interceptor for kitchen in WRB.

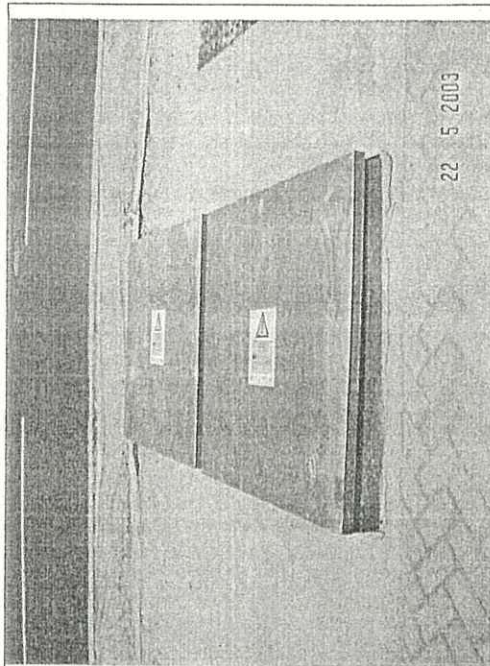
Photo 4.78: Oil interceptors for PMC.

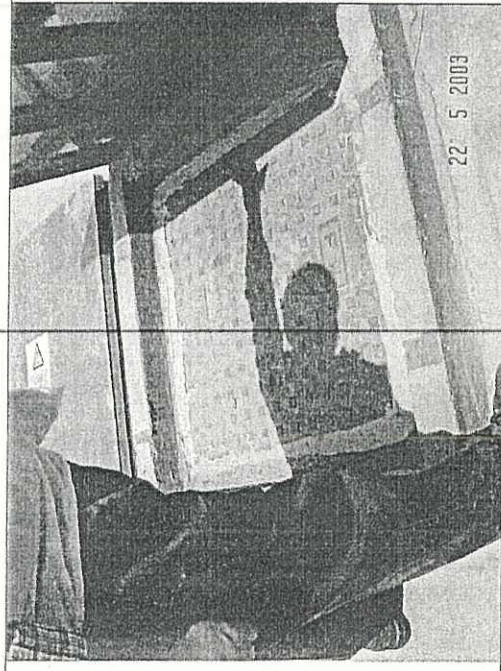
Photo 4.79: Oil interceptor for PMC
