# Kowloon-Canton Railway Corporation

## West Rail

## Pre-operation Environmental Audit Report

### December 2003

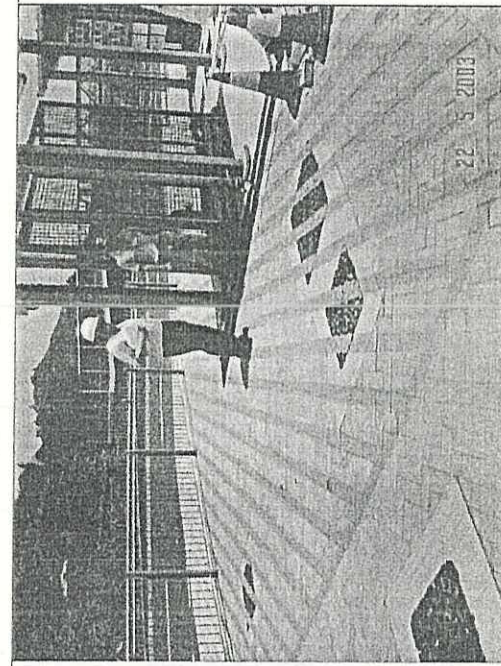
- Oil interceptors have been installed at the WRB and PMC. There is also a petrol interceptor at the petrol station. A licensed collector has been employed to clean the interceptors on a monthly basis and dispose of the oil contents properly. (see Photos 4.77 – 4.80 in Annex 2)

Photo 4.80: Oil interceptor for Petrol Station.

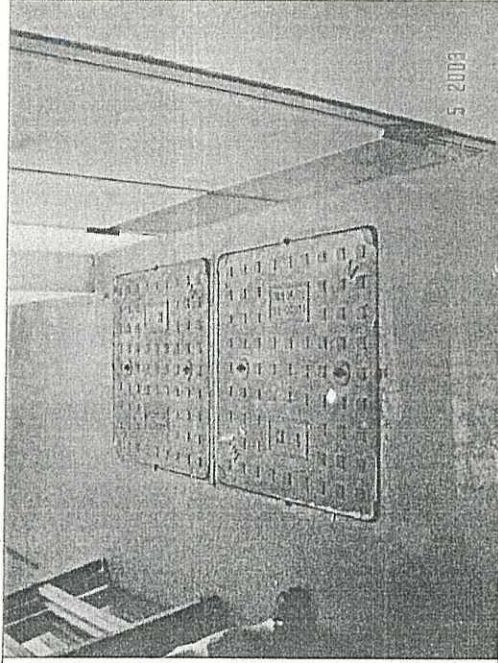
- Battery water will be collected in the neutralization tank. The pH value of the water will be checked and neutraliser will be added whenever necessary before discharge. (see Photo 4.81 in Annex 2)

Photo 4.81: Neutralization tanks for battery water.

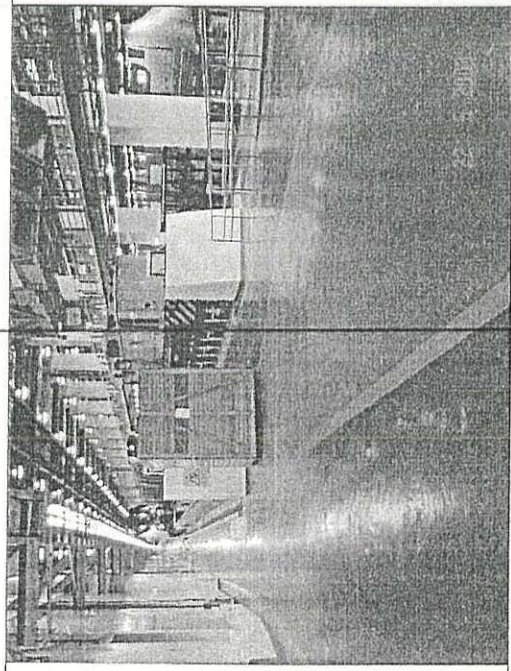
- All the maintenance activities except train wash will be carried out within the EMU Building. The floor of EMU Building is hard standing surfaces (see Photo 4.82 in Annex 2)

Photo 4.82: Floor of PMC is hard standing surface

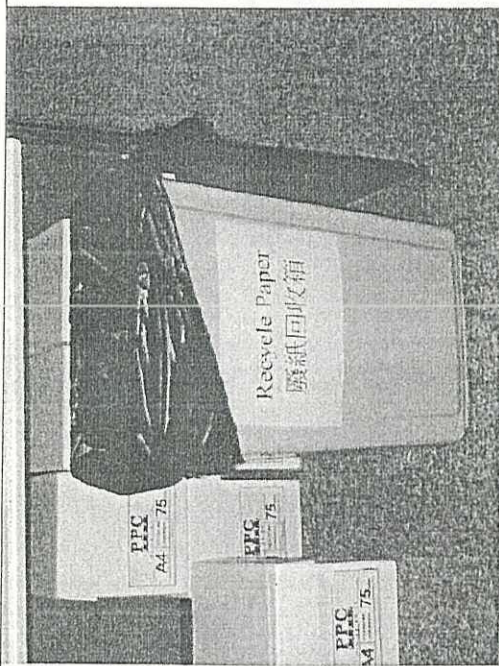
Procedures of the waste handling and disposal in the WRB was checked. The waste generated from the West Rail Building mainly includes papers and general wastes. Sorting the paper waste for recycle is encouraged and separate paper bins for recycle papers are provided in the office environment at WRB (see Photo 4.83 on recycle bin in Annex 2). Wastes generated from the WRB and PMC are daily assembled at designated collection points for further disposal by licensed collectors (see Photos 4.84 –4.85 in Annex 2).

Photo 4.83: Paper Recycle Bin for WRB.

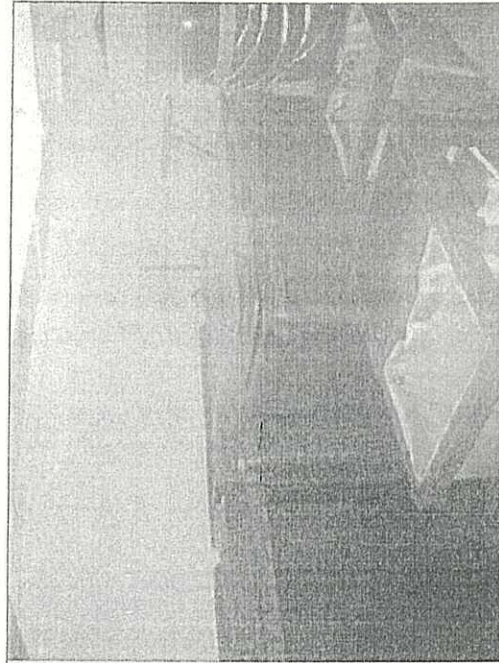
Photo 4.84: General waste collection point for WRB.

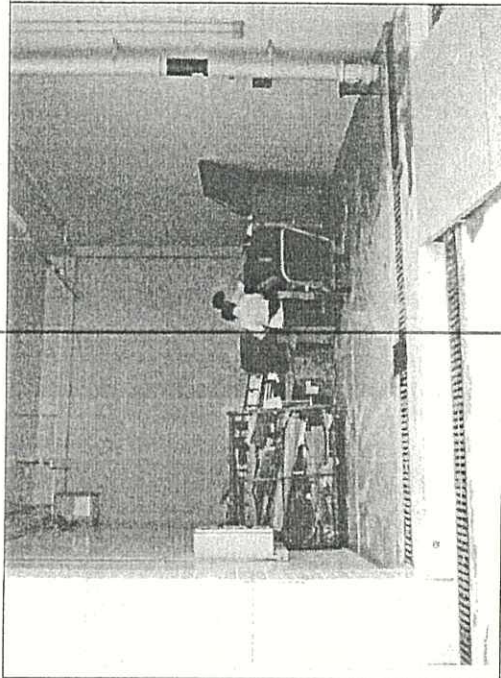
Photo 4.85: General waste collection point for PMC.

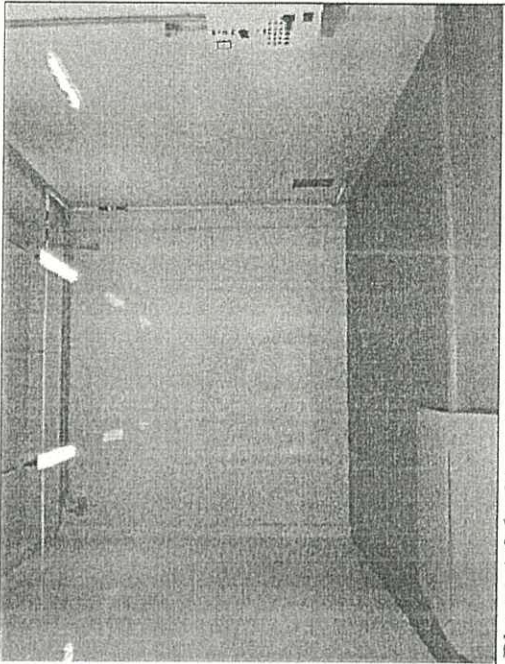
All chemical wastes generated from the West Rail, including at stations, depot, tunnels and viaducts are stored at PMC only. A separate store room with essential protective facilities has been assigned for storage of chemical wastes. The facilities include a bund on the store ground, hard and impermeable layer on the standing ground, security with key control system for access of the store room (see Photo 4.86 in Annex 2). Same as that for paper wastes, disposal of the chemical wastes are carried out regularly by licensed collectors. The liquid chemical wastes are collected and disposed of by Enviropace Limited and the solid wastes, such as battery, used cleaning cloth are collected by another licensed contractor. A trip ticket system is in place for the operational phase.

Photo 4.86: Chemical waste storage area at PMC

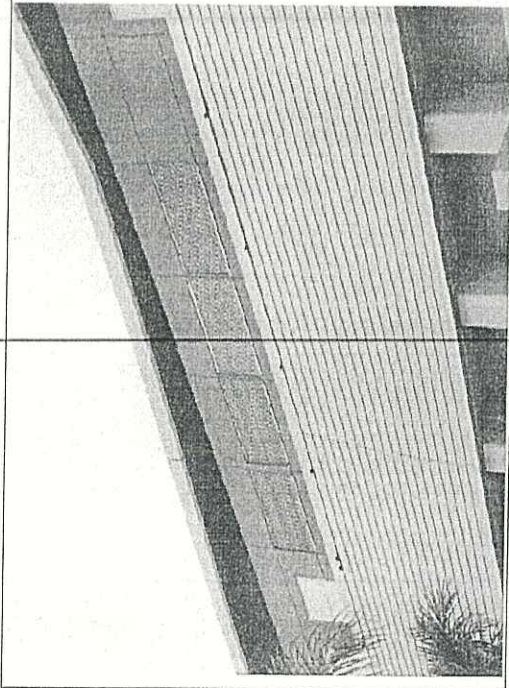
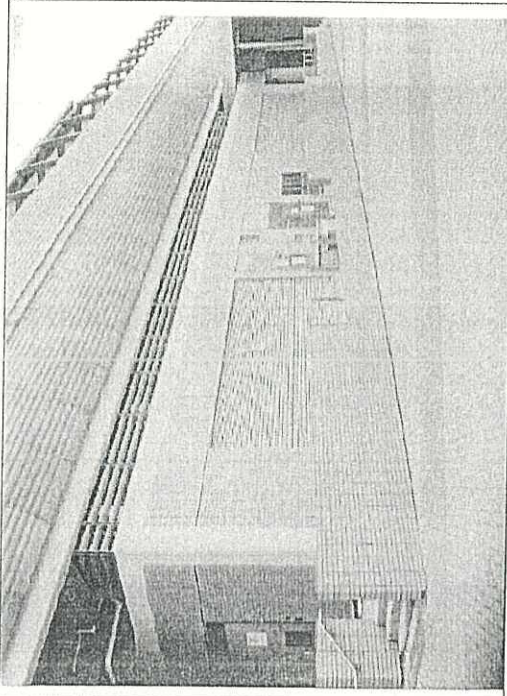
The positions of the ventilation intakes for the KSR were checked and it was found that the intakes are located high above the ground (see Photos 4.87 & 4.88 in Annex 2). The ground level of the KSR is the concourse area where shops and offices are located. The concourse area is well enclosed with transparent panels.

Photo 4.87: Intake of ventilation systems for KSR.

Photo 4.88: Intake of Ventilation systems for KSR

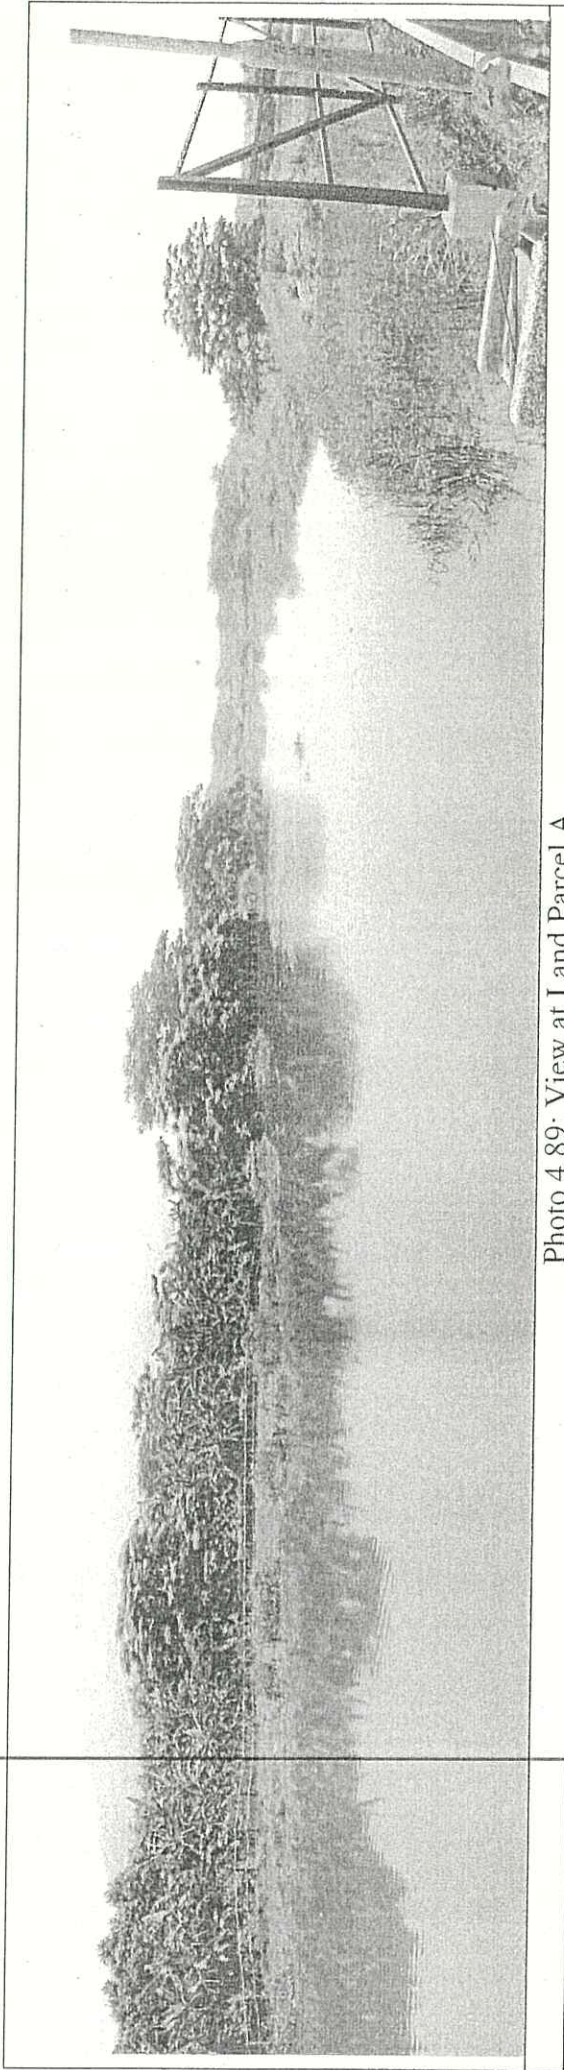
IEC has also inspected the wetland parcels individually. Parcel A has been maintained as a permanent pond and seasonal marsh area. The water source of Parcel A is dependent on the tide level of the Main Drainage Channel (see photos 4.89 in Annex 2). Various terrestrial plants are growing in the surroundings of the Parcel.

Photo 4.89: View at Land Parcel A

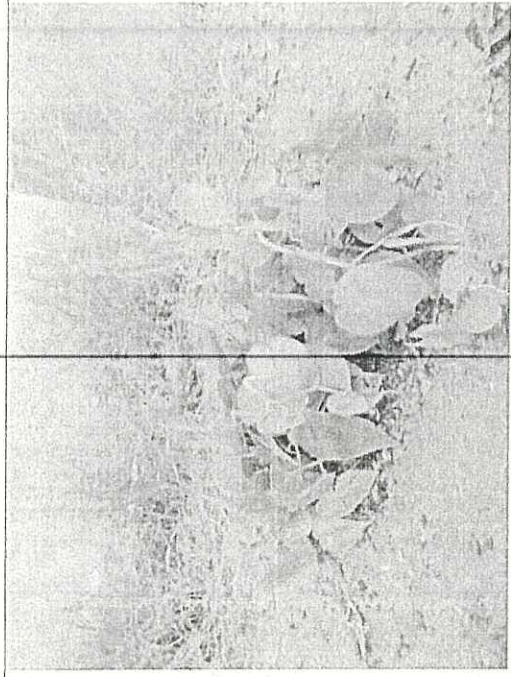
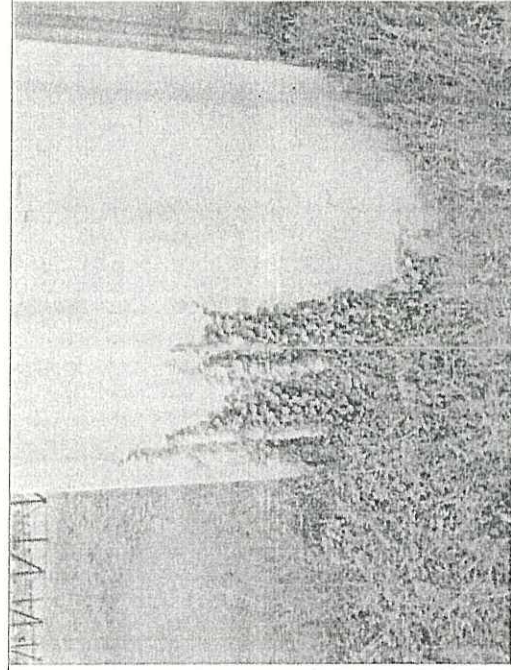
During the re-audit at Parcels B and D on 8 September, the bamboo trees were planted at various locations along the northern side of Stage I boundary (see photos 4.103 in Annex 2). Various species of junior climbing plants were also planted under the column. As the climbing plants were only planted for a short period of time, they were not fully grown on the column wall (see photos 4.101 and 4.102 in Annex 2).

Photo 4.101: Climbing Plant at Parcels B and D under the Viaduct Column

Photo 4.102: Climbing Plant at Parcels B and D under the Viaduct Column

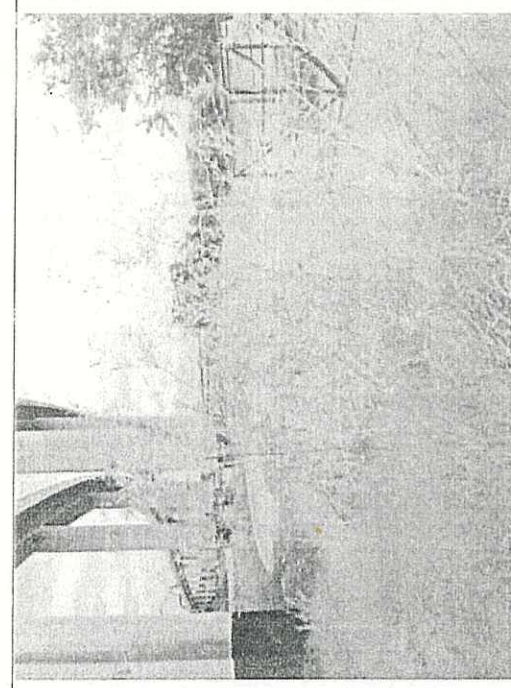
Photo 4.103: Bamboo at Parcels B and D

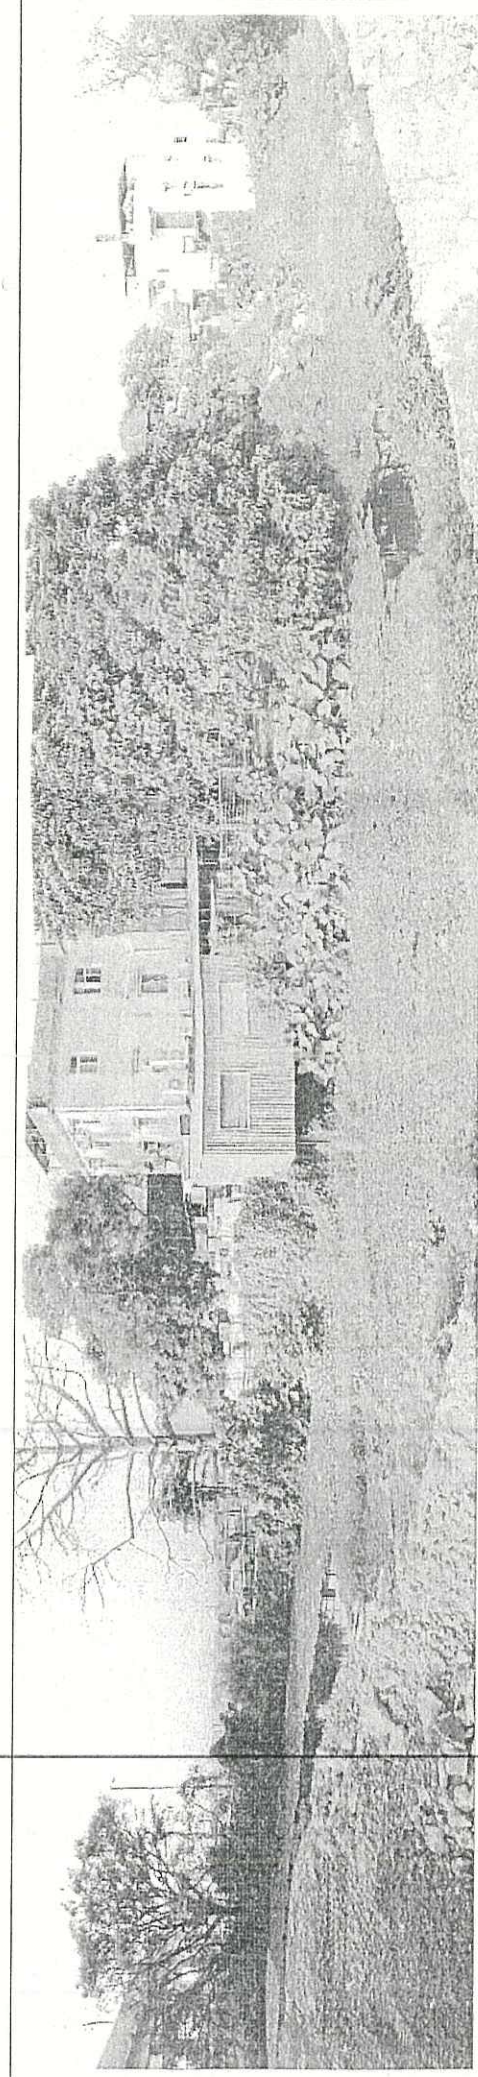
Parcel C has been maintained as a permanent pond, the total area of this parcel is approx. 0.6ha (see photos 4.104 in Annex 2). The water source of this Parcel depended on the current course of Kam Tin River. This parcel was constructed as irregular shape, which located adjacent to the Northern part of Land Parcel J and enclosed with 3 pieces of small private land. The water sources of Parcels J and C are completely separated by the wall weir.

Photo 4.104: View at Land Parcel C

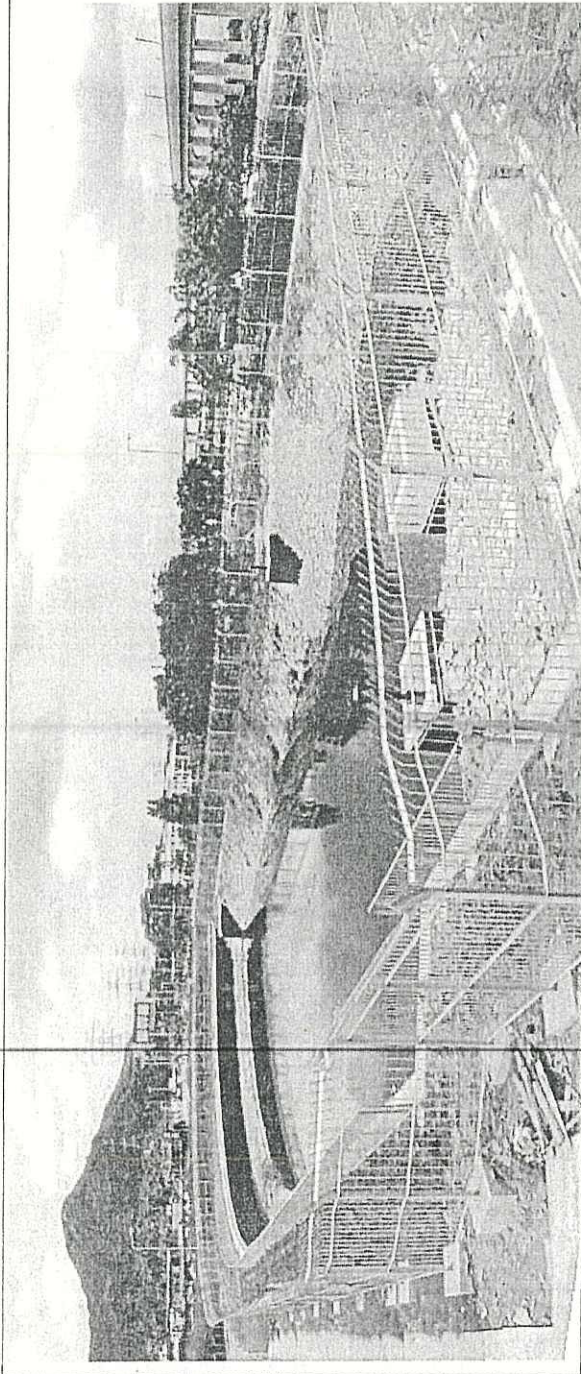
Parcel F is designed as a permanent water pond, the total area is approx. 0.4ha (see photos 4.110 Annex 2). The water sources storage in Parcel F is pumped from up stream of MDC. During the audit, IEC observed the water storage in the Parcel F is clean.

Photo 4.110: View at Water Storage Pond Land Parcel F

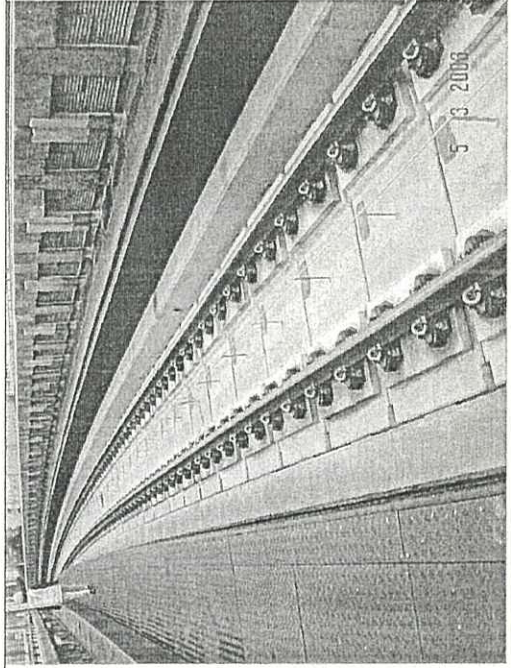
Photo 5.2: Rail Mounted on Baseplate of Floating Slab

- Mounted specified floating slab system on the track according to West Rail EIA's recommendation and KCRC's specification to further reduce vibration transmission to the viaduct structure between Yuen Long Station and Tuen Mun Station. The floating slabs installed on the viaduct section are shown in photos 5.2, 5.9, 5.15, 5.18, 5.36 & 5.40 in Annex 2. In the stations within the Western Section, the floating slab installed at the up track and down track is shown in Photos 5.56a, 5.67a, 5.76b, 5.96 and 5.104a in Annex 2;

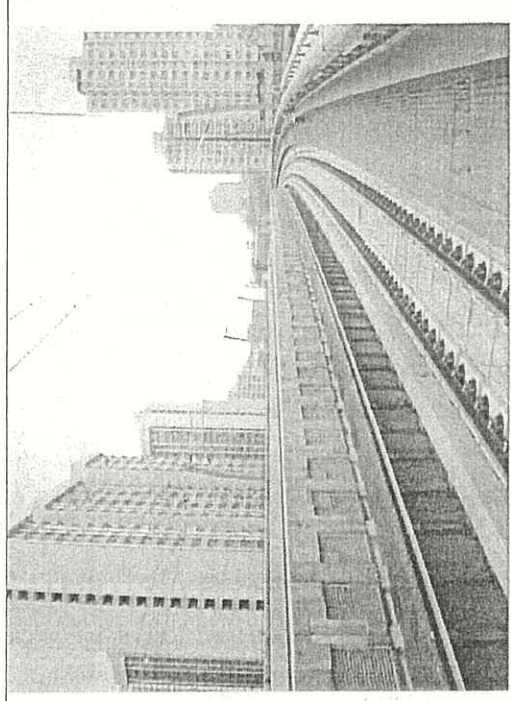
Photo 5.3: MPS at Long Ping

- 1.2m high noise barrier was erected and lined with sound absorptive material onto the parapet walls along the viaduct structure according to West Rail EIA's recommendation from Yuen Long Station and Tuen Mun Station (see photos 5.3, 5.19, 5.28 & 5.40 in Annex 2). The Detailed Design Consultant has also indicated that the edge barrier can be extended on single track viaduct and to full noise enclosures on twin track viaduct with the exception of a few locations as a result of site constraints, e.g. long span over main drainage channel. The high barrier or full noise enclosure are omitted because the long span structure will be adversely affected by typhoon loading. Nevertheless, there are no turnouts (which is expected to be noisier and centre wall of the multi-plenum system cannot be implemented) or sensitive receivers now or in the future that adverse noise impact is not anticipated. Moreover, additional support to the viaduct for the future noise barrier/enclosure or enhancement to the multi-plenum system will be considered to mitigate noise impact at future developments where appropriate.

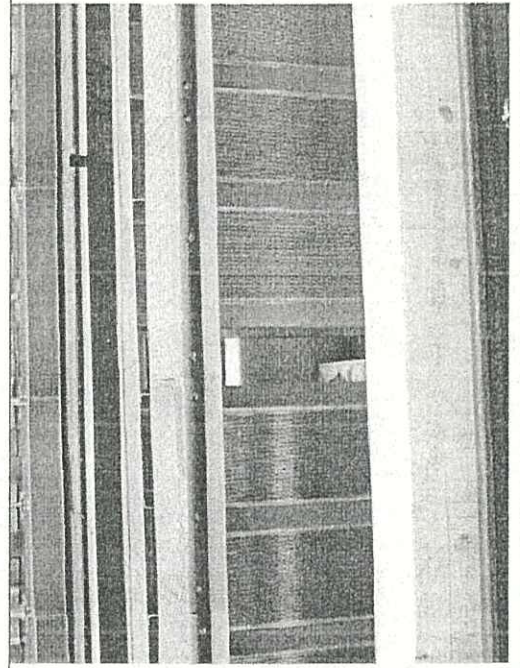
- Small gap observed at the central plenum near chainage U9 28+925 (see photos 5.5 in Annex 2) near Tin Shui Wai;

Photo 5.5: Gap Identified at Central Plenum (U9 28+925)

A re-audit was undertaken by IEC, Engineer and KCRC Environmental Team on 22 May to confirm the rectification of the observations on central plenum and noise enclosure made during the audit at the section between Yuen Long and Siu Hong Stations. During the audit, IEC has confirmed the gap identified in the central plenum at chainage U9 28+925 (see photo 5.6 in Annex 2) and noise enclosure at Lam Tei was filled with acoustic material (see photos 5.22 & 5.24 in Annex 2). Therefore, no further action is required.

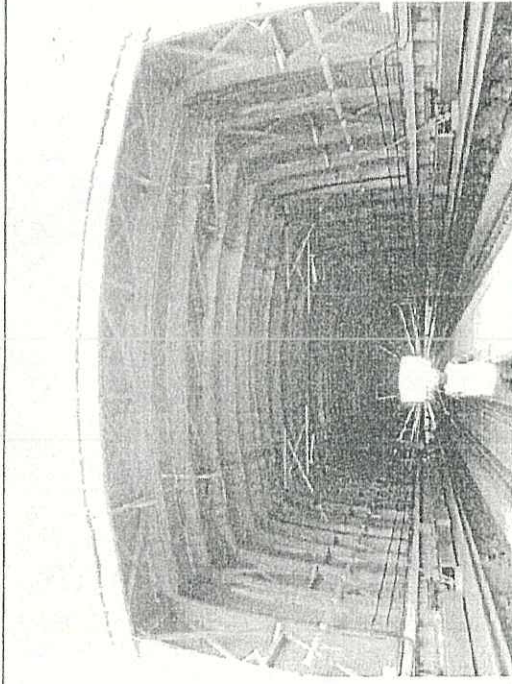
Photo 5.20: Noise Enclosure at Lam Tei

- 180m and 260m noise enclosures have been installed to reduce the airborne noise radiated from crossover near Lam Tei (see photos 5.20 & 5.25 in Annex 2) and near Tuen Mun Station (see photos 5.45, 5.46, 5.47 & 5.48 in Annex 2) in accordance with the EIA recommendation. In addition, acoustic panels are installed inside the noise enclosures (see Photos 5.20, 5.21, 5.47). However, observation was made by the IEC on four small gaps in a size of approx. 5cm x 9cm at the upper section (see photo 5.21 in Annex 2) and at the edge (see photo 5.23 in Annex 2) of the noise enclosure near Lam Tei. Similar situations were also observed in the noise enclosure in Tuen Mun; gaps were observed at the movement joint on the top between the parapet walls (see photo 5.49 in Annex 2), the sealant between parapets wall was damaged (see photo 5.51 in Annex 2) and gaps were found on the edge of the noise enclosure ceiling (see photo 5.52 in Annex 2).

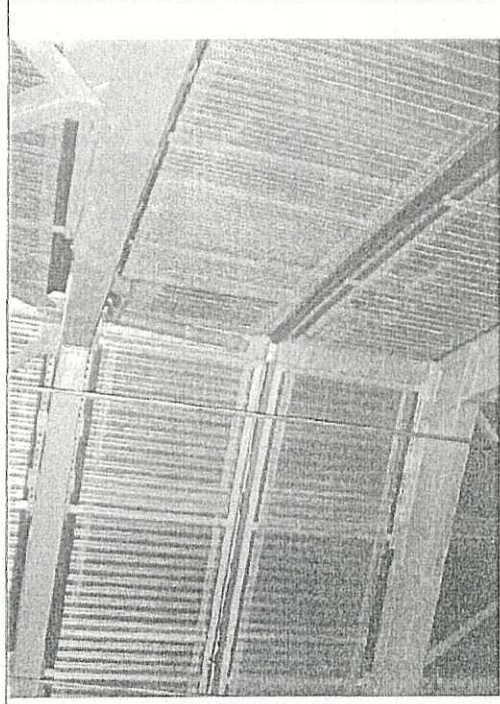
Photo 5.21: Gap Identified Inside Enclosure (Roof)

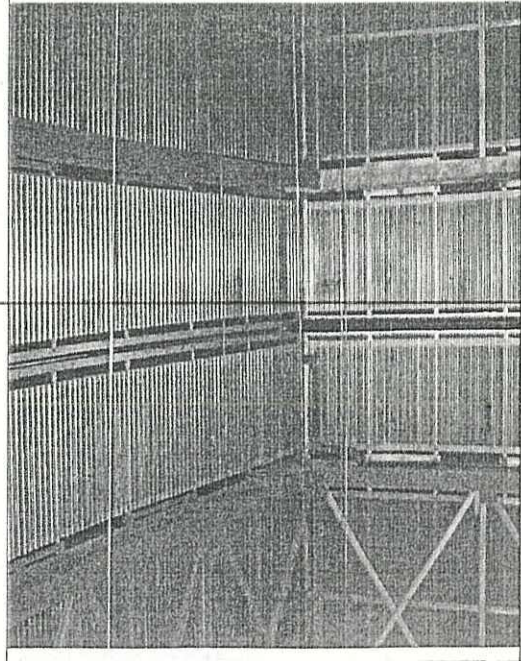
Photo 5.22: Gap was Filled Inside Enclosure (Roof)

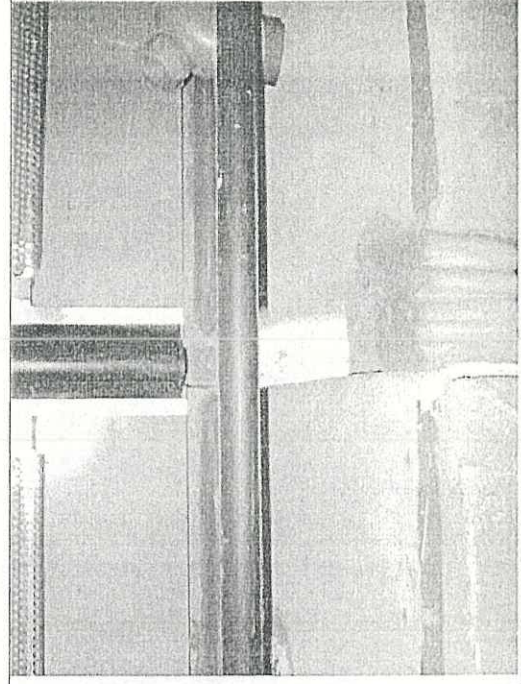
Photo 5.23: Gap Identified Insider Enclosure (Side)

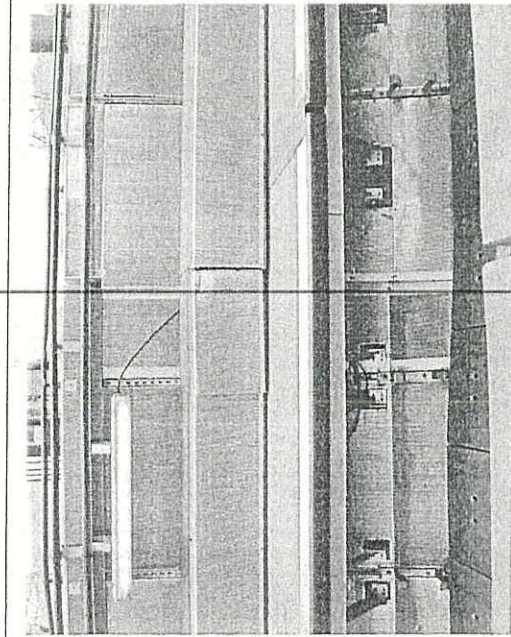
- Acoustic panels on the walkway were not properly installed at CH35+218 (see photos 5.31 in Annex 2) between Siu Hong and Tuen Mun viaduct;
  - A gap observed at the central plenum near Siu Hong Station at CH35+216 (see photos 5.34 in Annex 2)

Photo 5.31: Acoustic Panels were not properly installed at CH35+218

Between Siu Hong Station and Tuen Mun Station viaduct, the re-audit has been taken on 18 Aug 2003 to inspect the remedial works on central plenum and noise enclosure. Acoustic panels at CH35+218 on the walkway was replaced and installed properly (see photos 5.32 in Annex 2). IEC confirmed the gap identified in the central plenum at CH35+216 and the nosing bay at CH 36+965 and CH36+914 were filled with the acoustic panels (see photos 5.34a, 5.42 and 5.44 in Annex 2). The rubber band has been installed underneath of the plenum (see photo 5.33) The movement joint between the parapet walls in the noise enclosure was filled with acoustic material and sealed (see photos 5.50 in Annex 2). The gap on the edge of enclosure ceiling and between the parapets and noise barrier has been sealed (see photo 5.52a, 5.53 and 5.54 in Annex 2). Therefore, no further action is required.

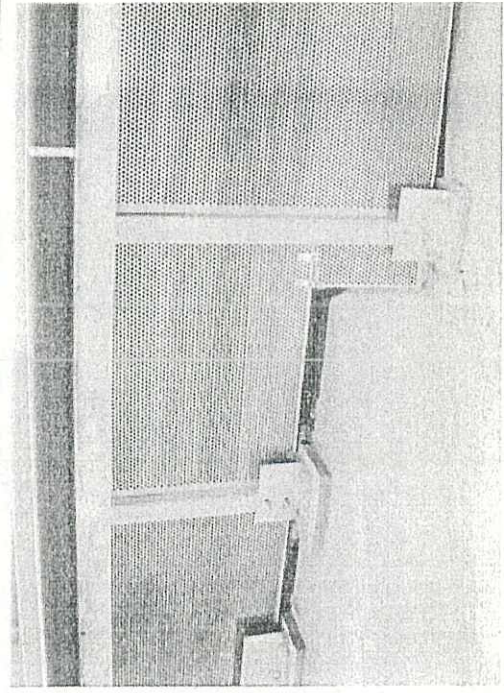
- A hole observed between the concrete kerb and the metal stand at the central plenum of nosing bay at CH 36+965 and CH36+914 (see photos 5.41 and 5.43 in Annex 2) near Tuen Mun Station. Rubber band was also observed not installing underneath of the plenum at CH36+914.

Photo 5.43: Hole at Nosing Bay CH36+965 was Filled with Acoustic Panel

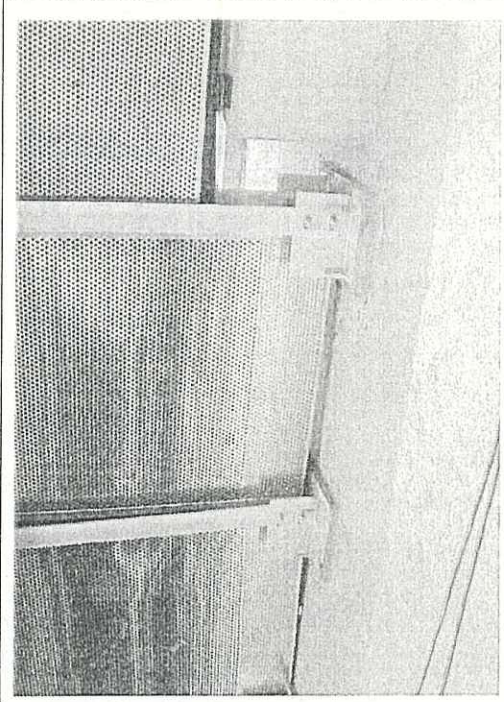
Photo 5.42: Hole Identified at Nosing bay CH36+914

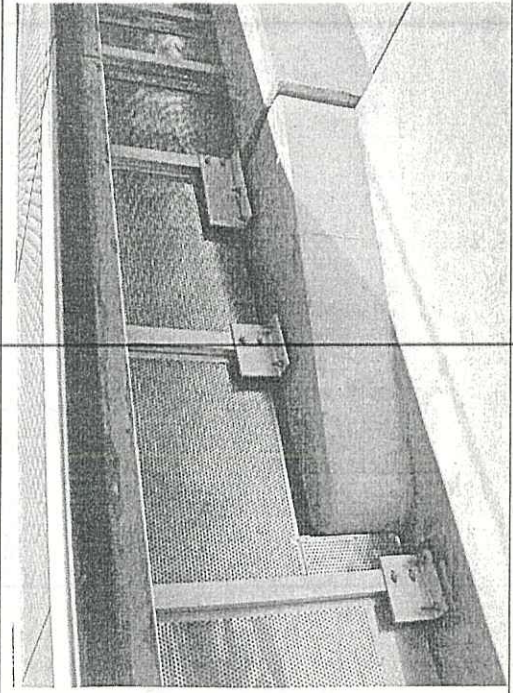
Photo 5.44: Hole at Nosing Bay CH36+914 was Filled with Acoustic Panel

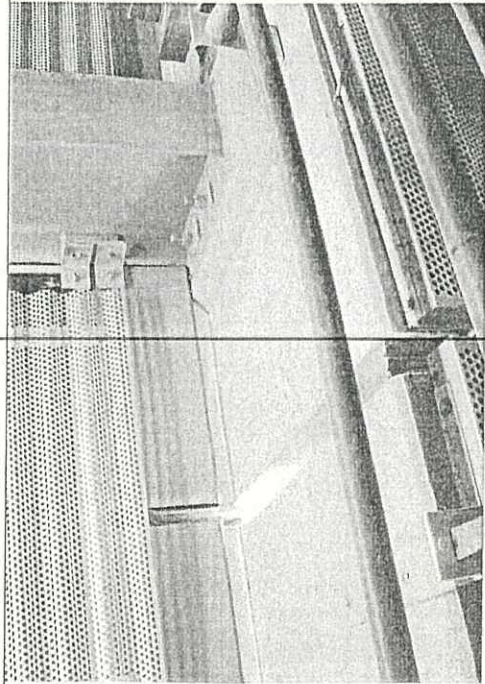
Photo 5.49: Gap Identified Insider at TUM Enclosure

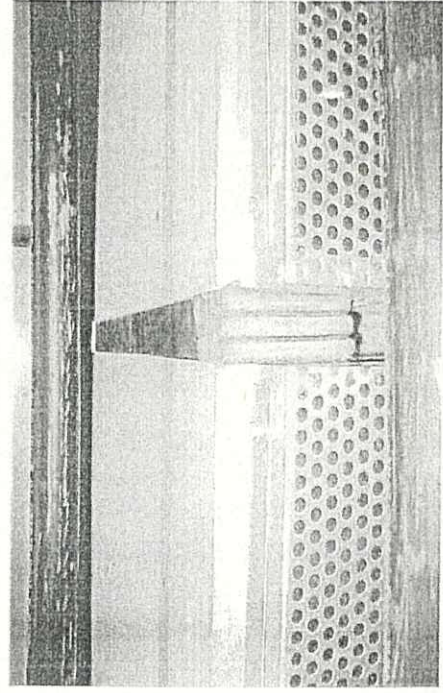
Photo 5.50: Gap was Filled Insider Enclosure

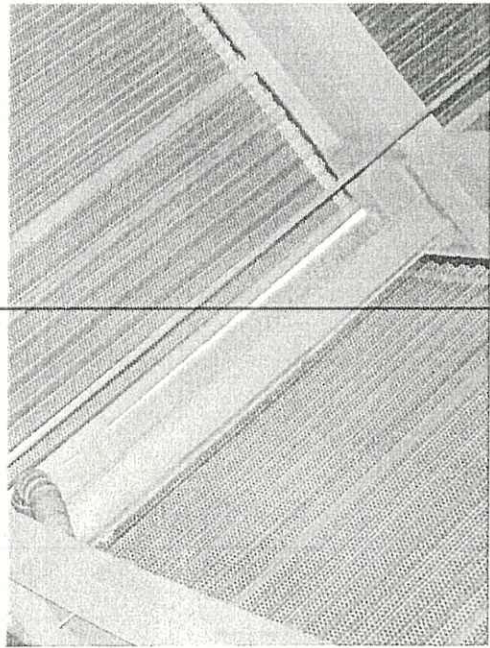
Photo 5.52: Gaps Identified Insider of the TUM Noise Enclosure Ceiling.

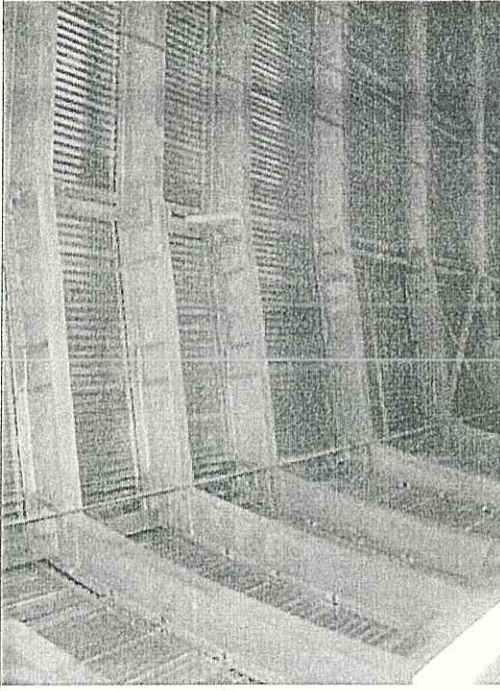
Photo 5.52a: Gaps Identified Insider of the TUM Noise Enclosure Ceiling was sealed.

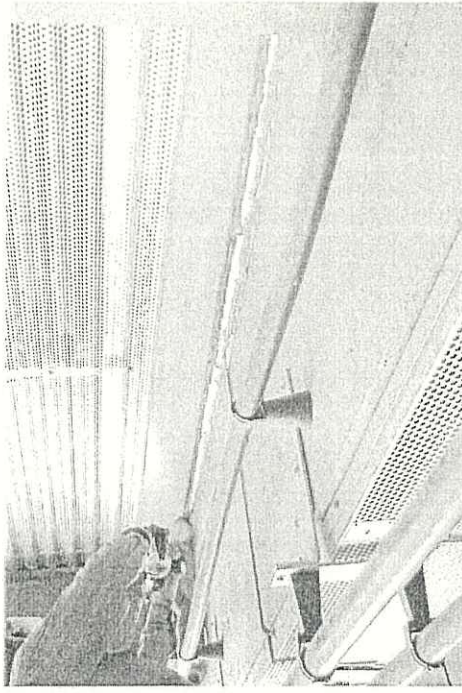
Photo 5.53: Gap was Sealed with Joint Sealant

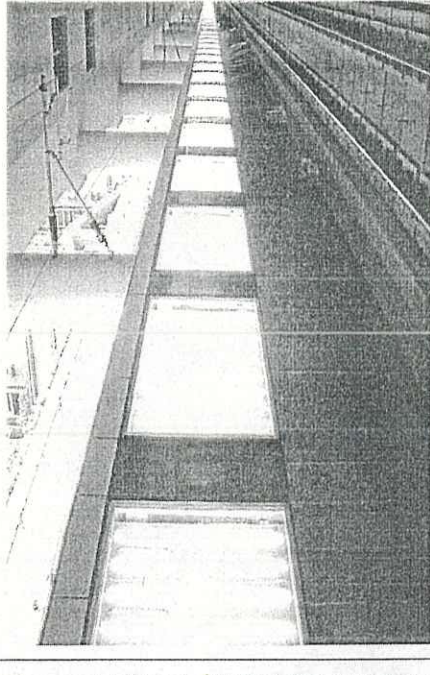
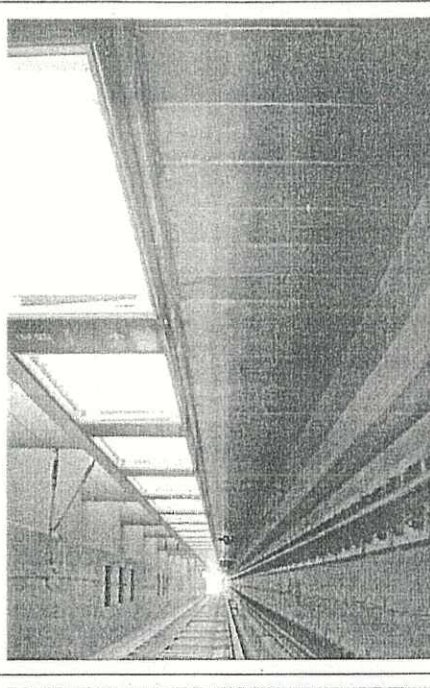
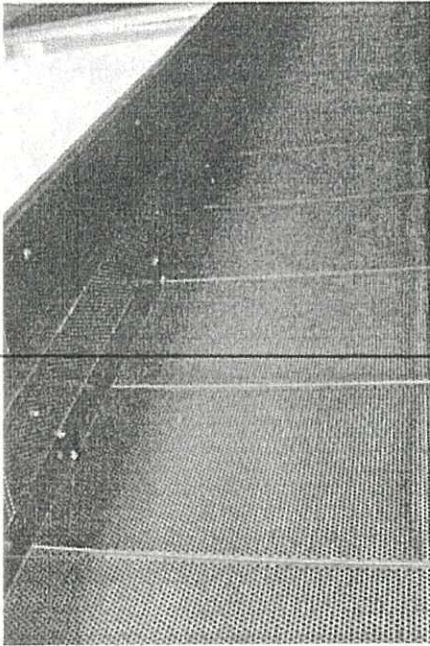
- The trackside parapet walls at up track of Yuen Long Station, Long Ping Station and Tin Shui Wai Station are installed with sound absorption material in accordance with West Rail EIA's recommendation (see photos 5.56c, 5.67a and 5.76a in Annex 2).

<p>Photo 5.55 West of Yuen Long Station (YUL)</p>	<p>Photo 5.56 East of YUL Station</p>	<p>Photo 5.56a: Floating Slab at YUL Station</p>
<p>Photo 5.56b: Baseplates of Floating Slab at YUL</p>	<p>Photo 5.56c: Trackside Noise Barrier with Advertising Panel at YUL</p>	<p>Photo 5.56d: Trackside Noise Barrier with Advertising Panel at YUL</p>

<p>Photo 5.56e: All gap under the Advertising Panel was sealed</p>	<p>Photo 5.57: Chiller of YUL</p>	<p>Photo 5.58: Noise Acoustic Louvers in YUL Chiller Plant Room</p>

- ❖ Installed acoustic panels from trackslab to underside of the advertising panels; and
      - ❖ Installed horizontal panels under the trackside advertising panels (see photos 5.56c, 5.56d, and 5.56e in Annex 2).

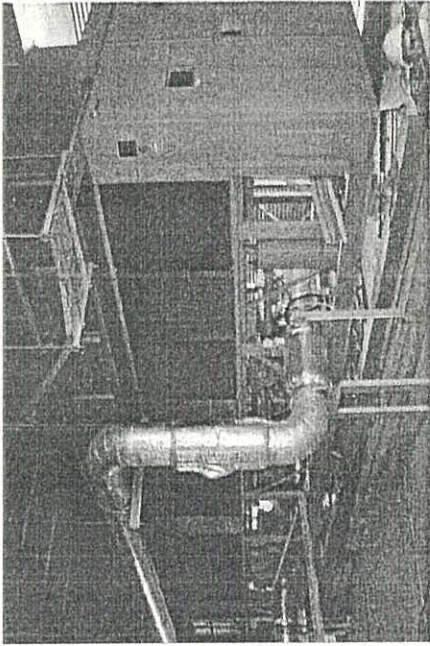
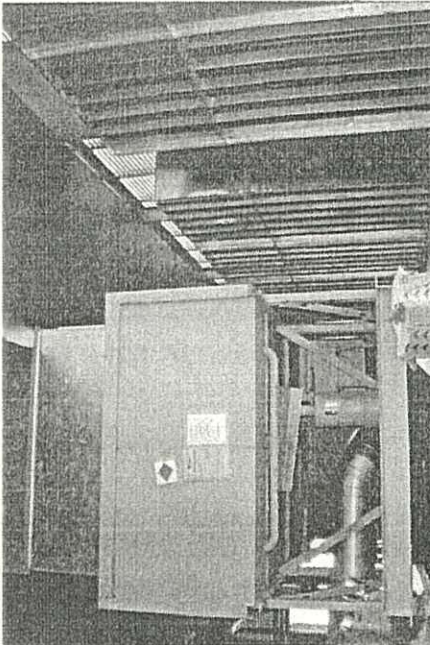
The chillers at Yuen Long Station (YUL) and Siu Hong Station are installed on the ground level and concourse level respectively whilst the chillers at Long Ping Station (LOP), Tin Shui Wai Station (TIS) and Tuen Mun Station (TUM) are located on the platform floor (see Photos 5.57, 5.68, 5.77, 5.97 and 5.105 in Annex 2).

The 2<sup>nd</sup> audit was undertaken by IEC, Engineer and KCRC Environmental Team on 18 September 2003 at Yuen Long and Long Ping Stations and on 23 September 2003 at Siu Hong Station. During the audit, the installation works of acoustic louvers on the top of the chillers and the ventilation louvers at the side of the chillers plant rooms have been completed (see Photos 5.58, 5.69, 5.70, 5.97 and 5.98 in Annex 2). Therefore, no further action is required.

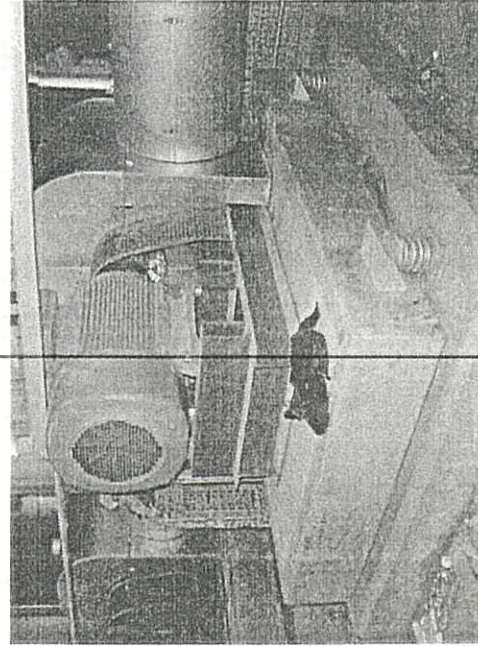
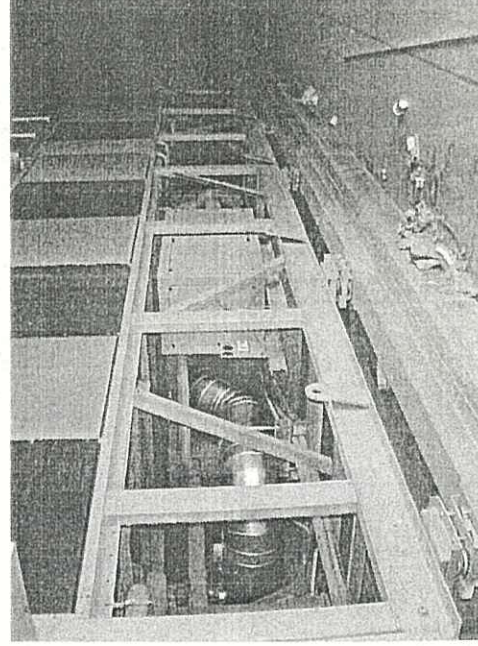
In addition to enclosing the chillers inside plant rooms which are installed either with full height acoustic louvers or concrete wall, the chillers and water pumps for the cooling system are installed with spring system at the footing to minimise vibration noise (see Photos 5.59, 5.60, 5.71, 5.72, 5.77, 5.99 and 5.107 in Annex 2).

<p>Photo 5.59: Vibration Absorption Spring of YUL Chiller Water Pump</p>	<p>Photo 5.60: Vibration Absorption Spring of YUL Chillers</p>	<p>Photo 5.61 Ventilation Intake and Exhaust Louvers at YUL</p>

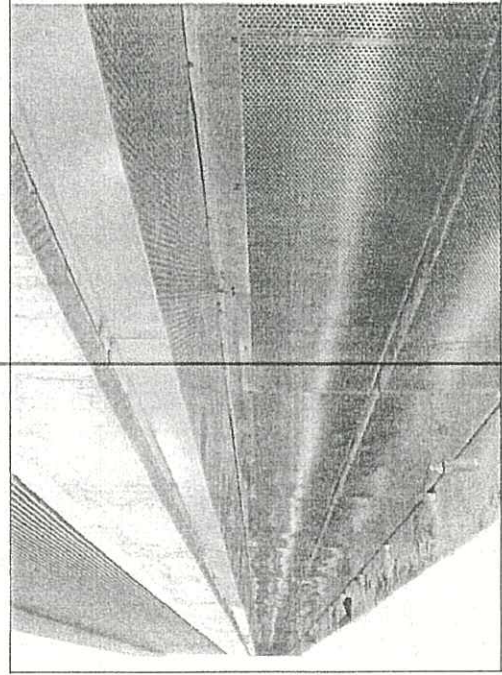
- ❖ Applied acoustic material to the parapet inner face from trackslab to underside of the trackside advertising panels (see photos 5.67b, 5.67c and 5.67d in Annex 2); and

Photo 5.67b Noise Acoustic Panel Underside of Station Walkway at LOP

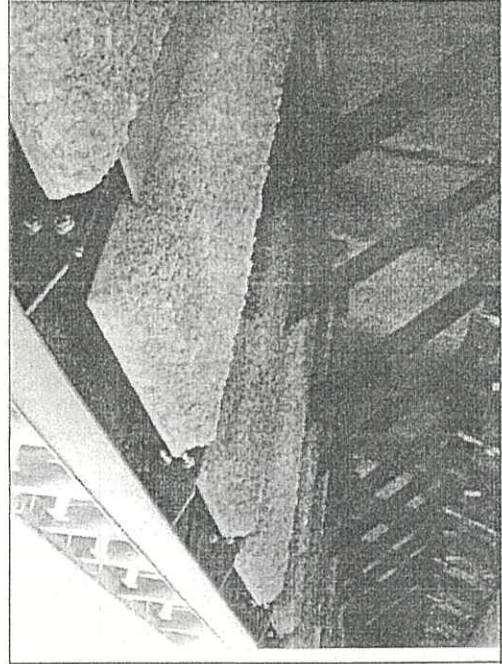
Photo 5.67c Acoustic panel at trackside walkway

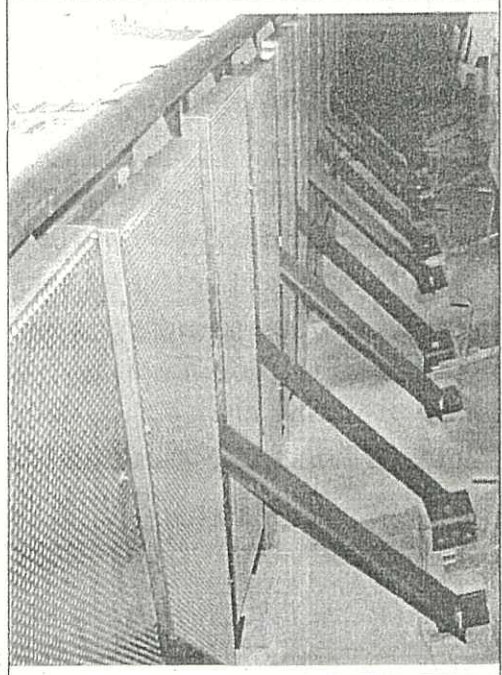
Photo 5.67d Acoustic Panels at trackside walkway

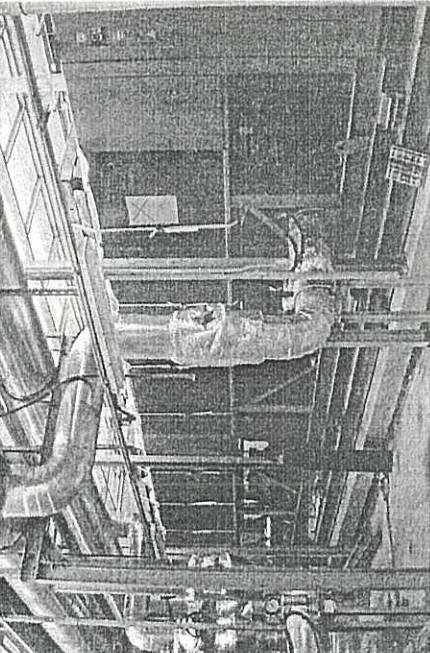
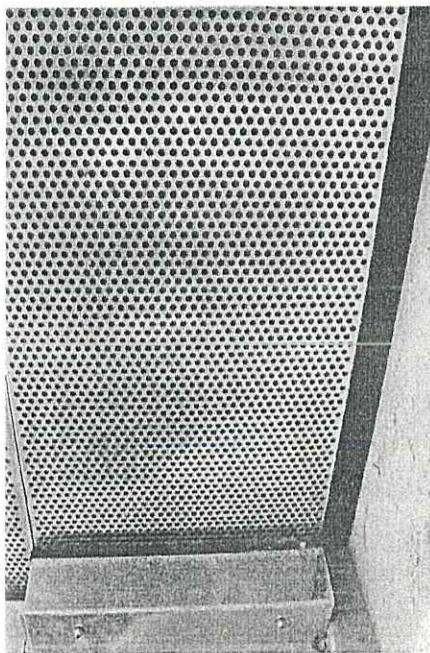
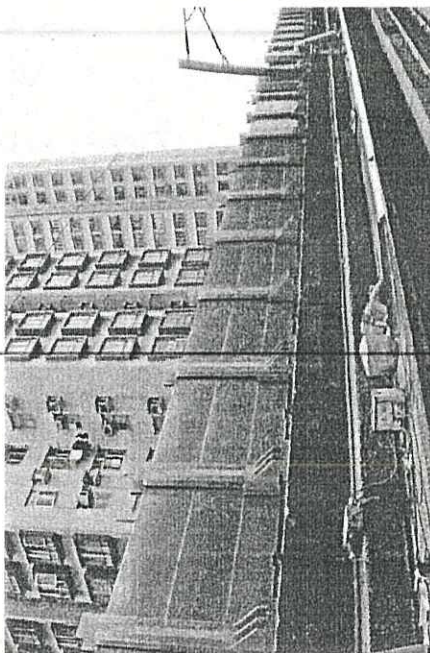
- ❖ Erected 2m high noise barriers on viaduct fronting Fu Loy Garden (see photos 5.67e and 5.67f in Annex 2).
- Down track of Tin Shui Wai (northern side) –

<p>Photo 5.67e: Noise Barriers installed above the Parapet Wall at LOP</p>	<p>Photo 5.67f: Noise Barriers installed above the Parapet Wall at LOP</p>	<p>Photo 5.67e: Noise Barriers installed above the Parapet Wall at LOP</p>

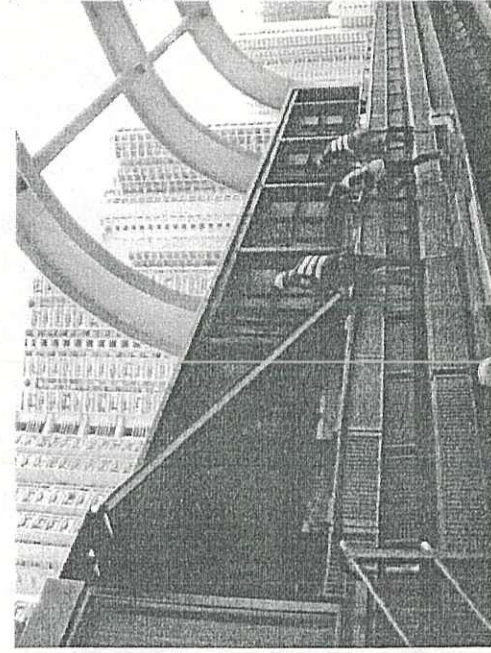
- ❖ Installed trackside advertising panels and wind shield separating the receiver and the source;
  - ❖ Installed acoustic panels underneath advertising panels (see photos 5.76c and 5.76d in Annex 2);

Photo 5.76c Advertising Panel and Wind Shield at TIS

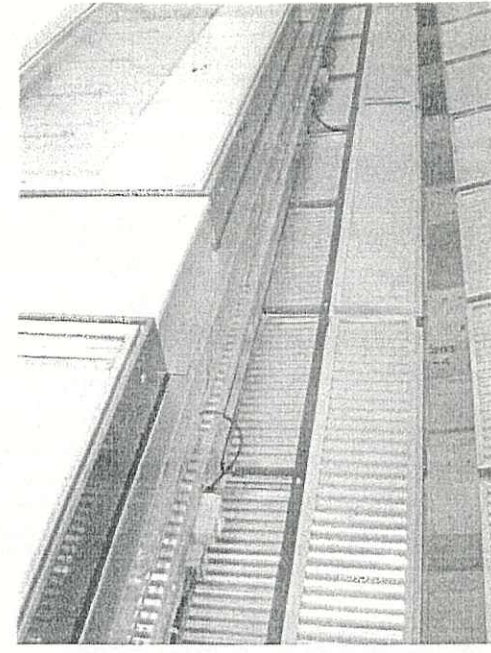
Photo 5.76d Gap under the Advertising Panels was sealed

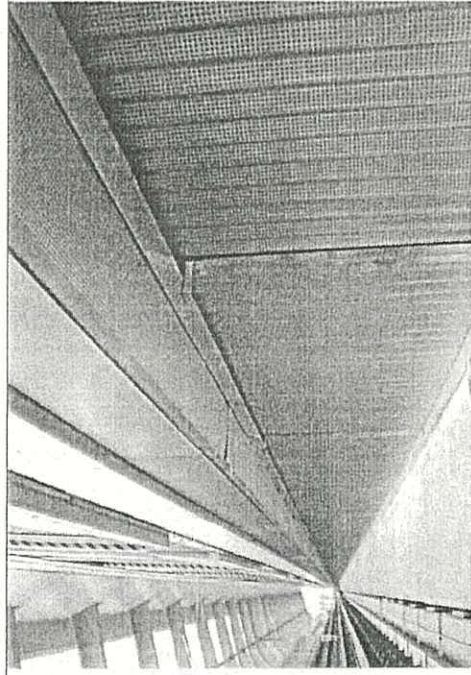
- ❖ Applied acoustic material to the parapet inner face from trackslab to underside of the trackside advertising panels; and
  - ❖ Installed acoustic panels to vertical wall beneath platform (see photos 5.76e and 5.76f in Annex 2).

Photo 5.76f Acoustic Panels Installed Underside of the Station Platform at TIS

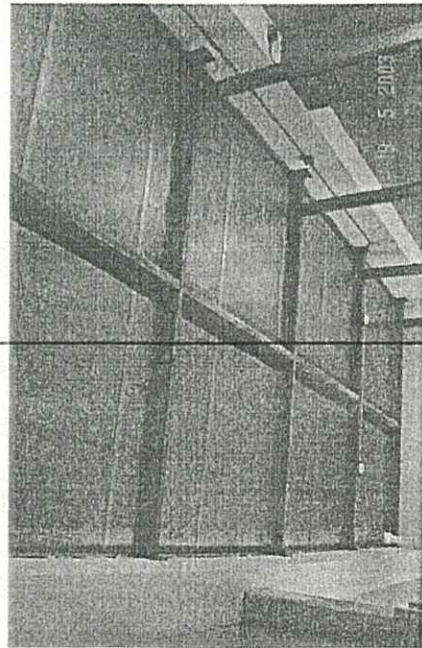
It is observed that the chillers and compressors of the chillers at TIS and TUM are enclosed in the plant rooms. The ceilings of the chiller plant rooms are installed with the acoustic louvers. The surrounding walls are either concrete walls or equipped with acoustic panel louvers. Moreover, acoustic panels are installed on top of chiller exhaust fans to minimise the noise impact (see Photos 5.78, 5.79, 5.80 and 5.106 in Annex 2).

Photo 5.78: Noise Acoustic Panel Installed on Ceiling in TIS Chiller Plant Room

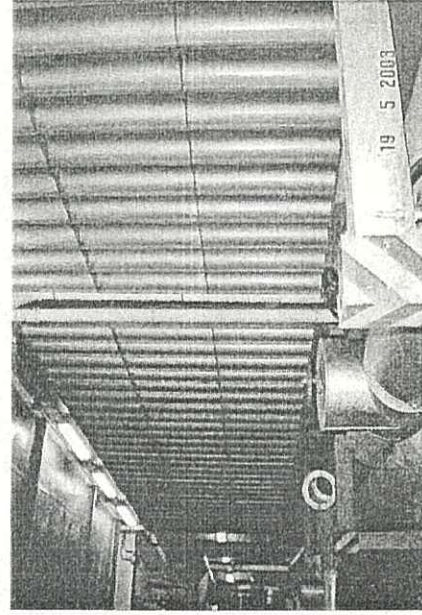
Photo 5.79: Acoustic Louvers Installed in TIS Chiller Plant Room

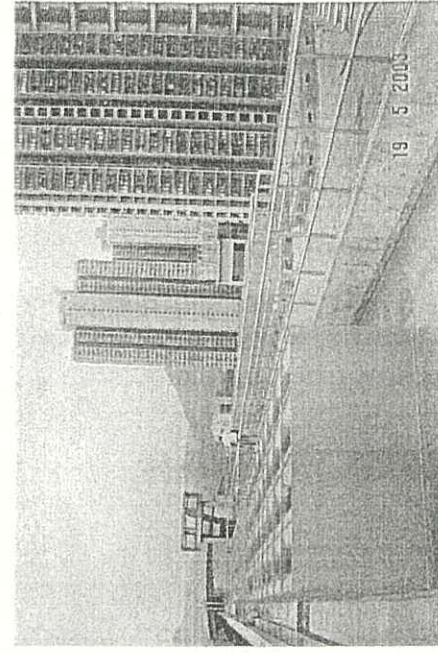
Photo 5.80: Acoustic Panel Installed on the Top of TIS Chillers

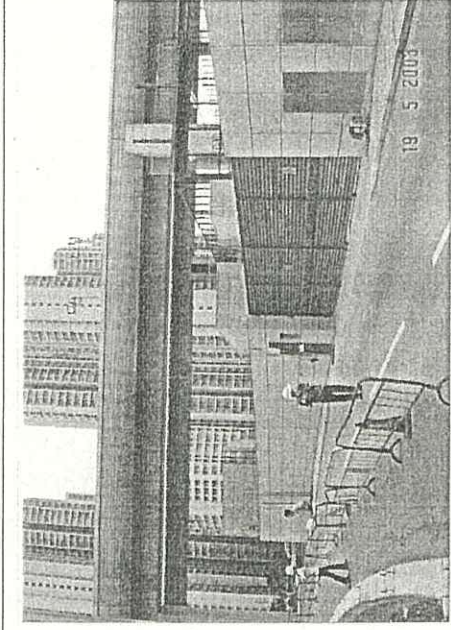
the nearest receiver is over 100m away. Moreover, the façades of substations facing Tin Tsz Estate are concrete walls (See Photos 5.90 - 5.94 in Annex 2). Three sets of transformers installed inside the substation are also under a roof cover formed by concrete. There is no potential noise impact anticipated.

Photo 5.90: Concrete Wall of TIS Feeder Substation

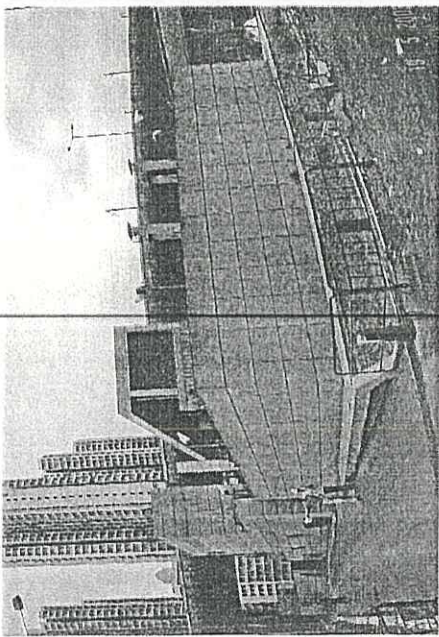
<p>Photo 5.91: Southern view of TIS Feeder Substation</p>
