# Kowloon-Canton Railway Corporation

## West Rail

## Pre-operation Environmental Audit Report

### December 2003

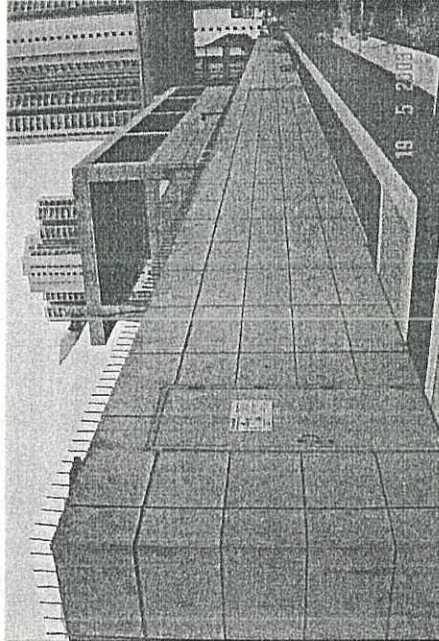
the nearest receiver is over 100m away. Moreover, the façades of substations facing Tin Tsz Estate are concrete walls (See Photos 5.90 - 5.94 in Annex 2). Three sets of transformers installed inside the substation are also under a roof cover formed by concrete. There is no potential noise impact anticipated.

<p>Photo 5.92: Eastern view of TIS Feeder Substation</p>

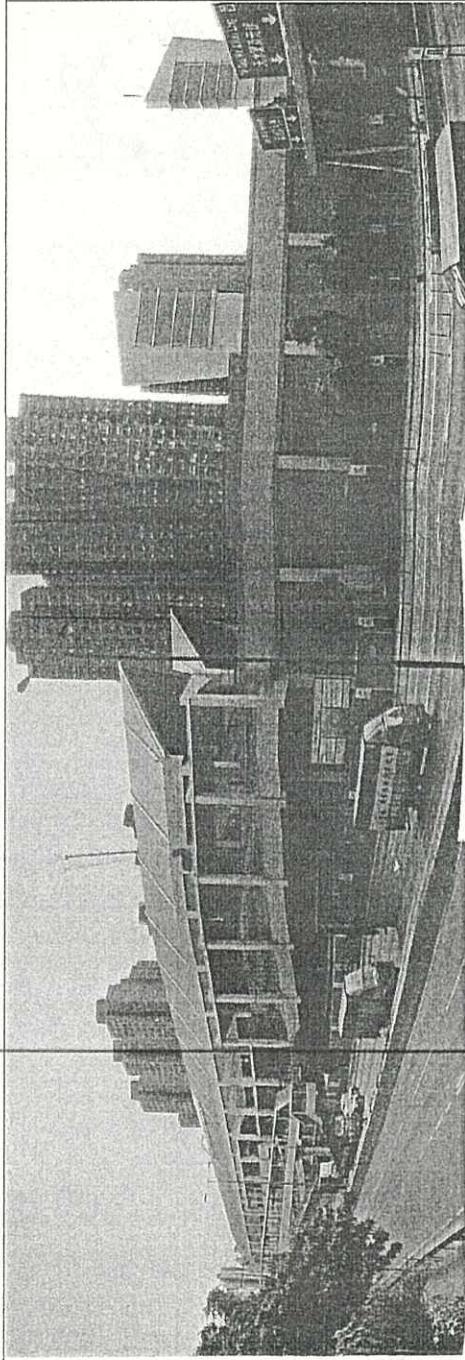
At YUL, LOP, TIS and SIH Stations (see Photo 5.55, 5.56, 5.67, 5.76 and 5.95 in Annex 2), the ECS plant are installed at both end of the stations at various levels. The exhaust duct outlets and the fresh air intake at YUL, LOP and TIS Stations are located at two ends of the stations on various floors (see Photos 5.61, 5.62, 5.73, 5.81, 5.82 and 5.83 in Annex 2). For SIH Station, two ventilation shafts for the fresh air intake and air exhaust are located on the "Kiss and Ride Area" at both end of the concourse level (see Photos 5.100 and 5.101 in Annex 2). At TUM Station (see Photo 5.104 in Annex 2), the ventilation plant are installed on the ground and roof level. The ventilation plant on the roof of TUM Station are installed in the plant rooms and covered by the louvers (see Photos 5.108 and 5.109 in Annex 2). The inspections indicate that the essential silencers are fitted inside the ventilation ducts at all stations (see Photos 5.63, 5.74, 5.75, 5.85, 5.86, 5.87, 5.102 and 5.110 in Annex 2).

Photo 5.95 Overview of Siu Hong Station (SIH)

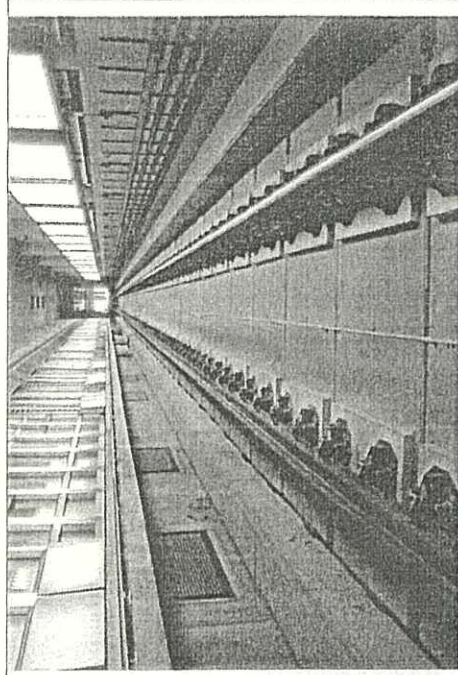
- Both up track and down track of Siu Hong Station and Tuen Mun Station and down track of Yuen Long Station are fully enclosed (see photos 5.96 and 5.104a in Annex 2).

Photo 5.96 Floating Slab at SIH Station Trackside

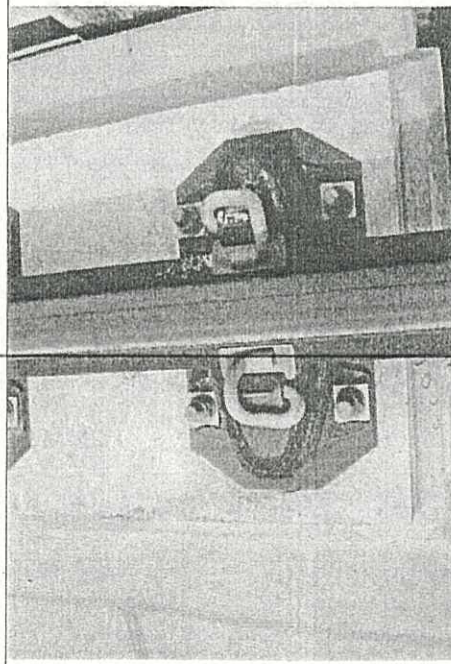
- Installed the specified resilient rail baseplates according to West Rail EIA's recommendation and KCRC's specification for track on viaduct to reduce vibration transmission to the viaduct structure and thereby reduce re-radiated noise from the viaduct structure between Yuen Long Station and Tuen Mun Station and within Yuen Long, Long Ping, Tin Shui Wai, Siu Hong and Tuen Mun Stations of the Western Section (see photos 5.1, 5.4, 5.11, 5.12, 5.35, 5.38 & 5.39 in Annex 2). At western section all five stations from Yuen Long to Tuen Mun have been fitted with the baseplates along the up and down tracks at the stations section (see photos 5.56b, 5.67a, 5.76b, 5.96a and 5.104b in Annex 2);

Photo 5.96a Baseplate of Floating Slab at SIH

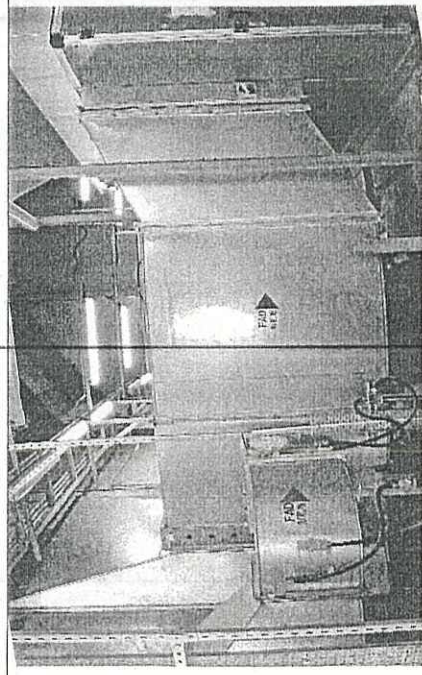
Photo 5.102: Silencers installed within the ducting of ECS at SIH

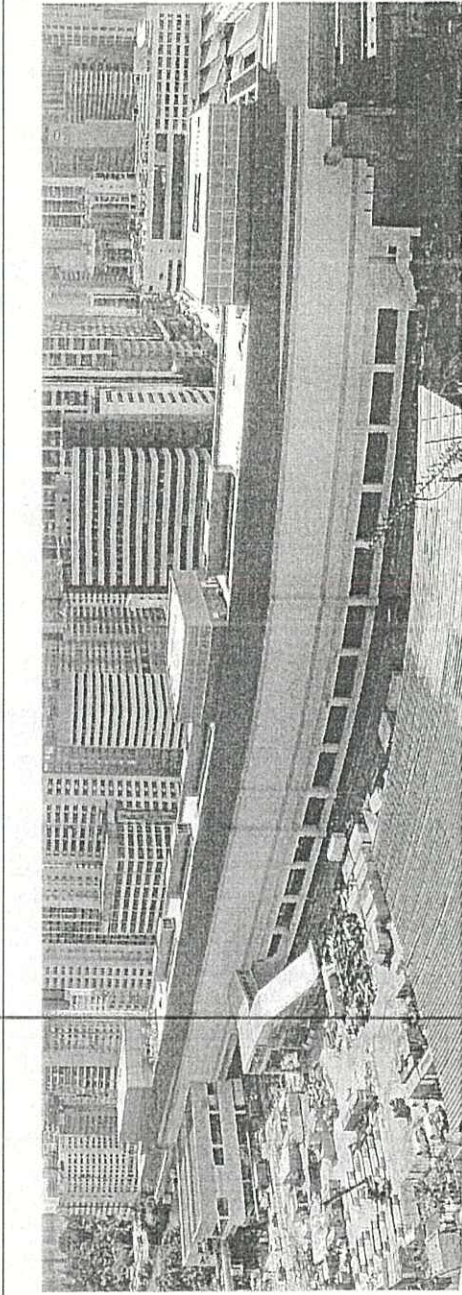
Photo 5.104 Overview of Tuen Mun Station (TUM)

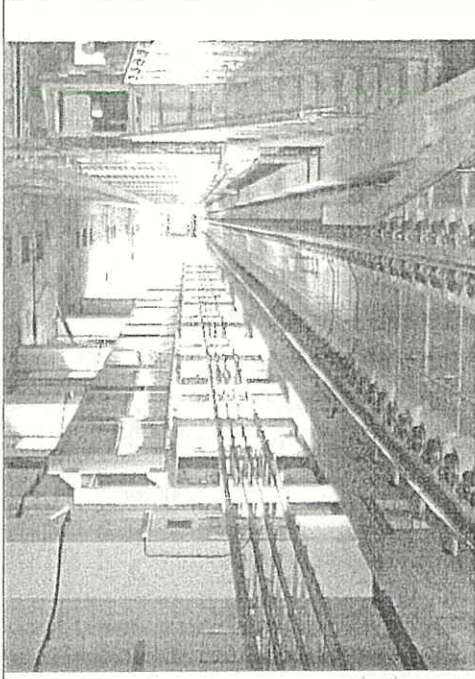
Photo 5.104a Floating Slab at TUM Trackside

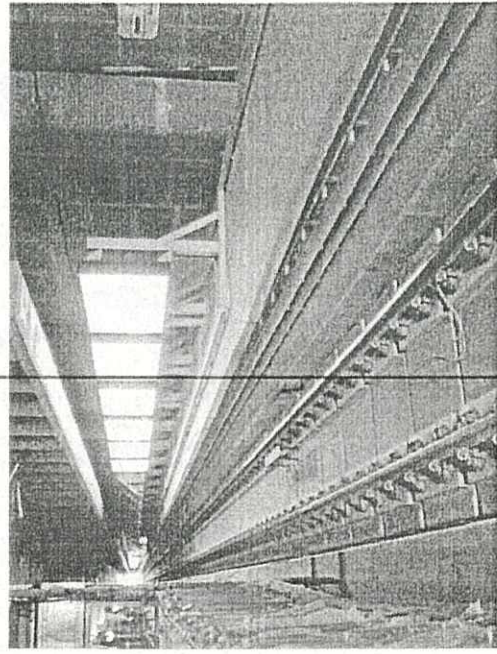
Photo 5.104b Floating Slab at TUM Trackside

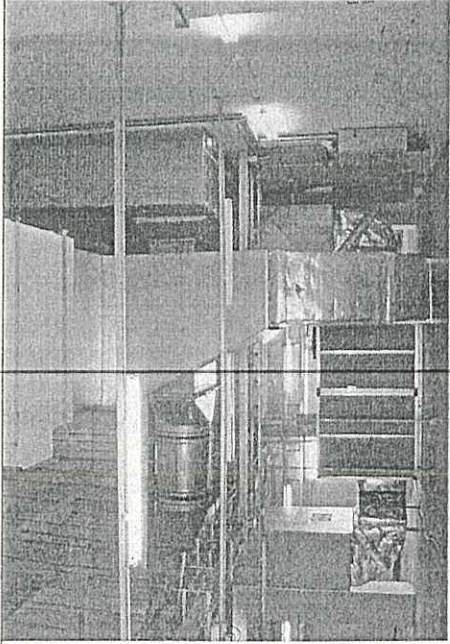
<p>Photo 5.110: Silencers installed within the ducting of ECS at TUM</p>

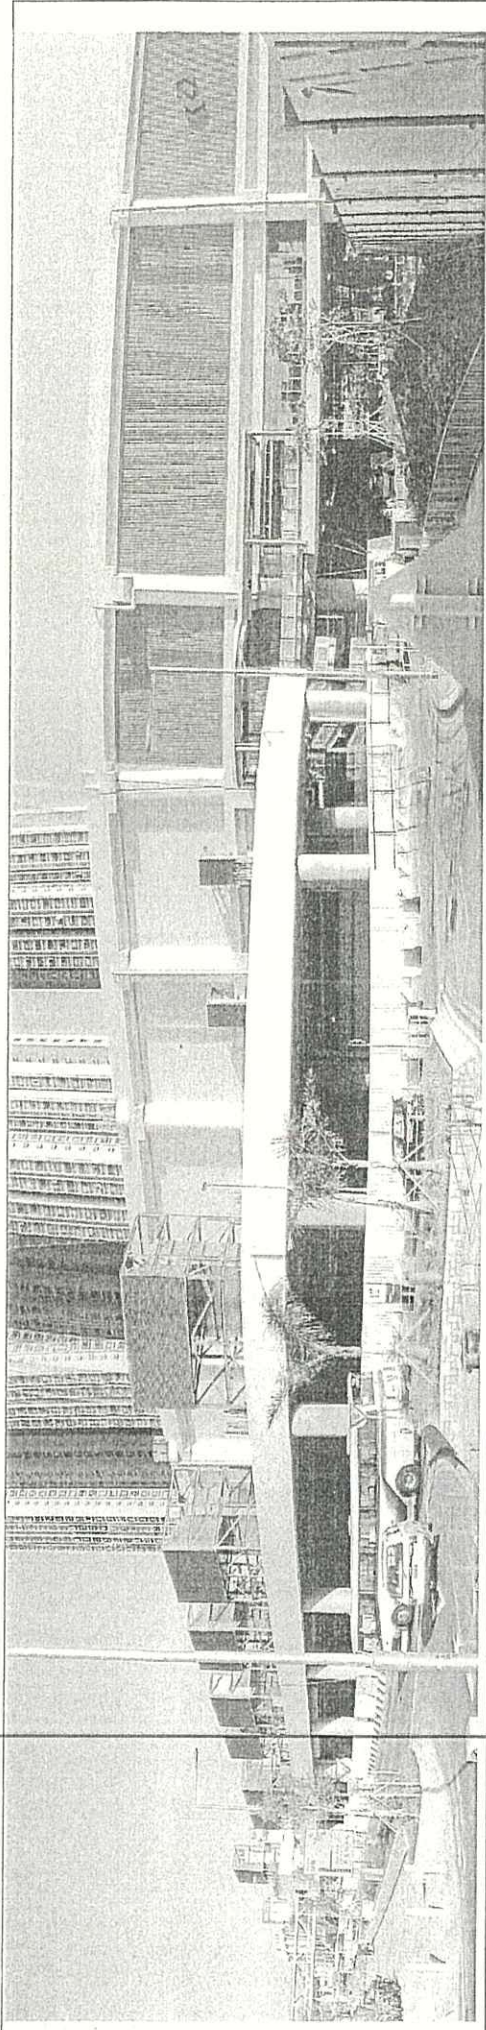
The landscape works of planter along the new road of Long Yat Road L1 and L2 at Yuen Long Station has been completed (see photo 5.137 – 5.140 in Annex 2). Most of the landscape works at eastern side of Long Ping Station is completed. The planter between Wang Tat Road and Ma Wang Road was built (see photo 5.141-5.412 in Annex 2). The remaining landscape works of station are listed as below:

Photo 5.137: Completion of Landscaping Works at New Road Long Yat Road (YUL)

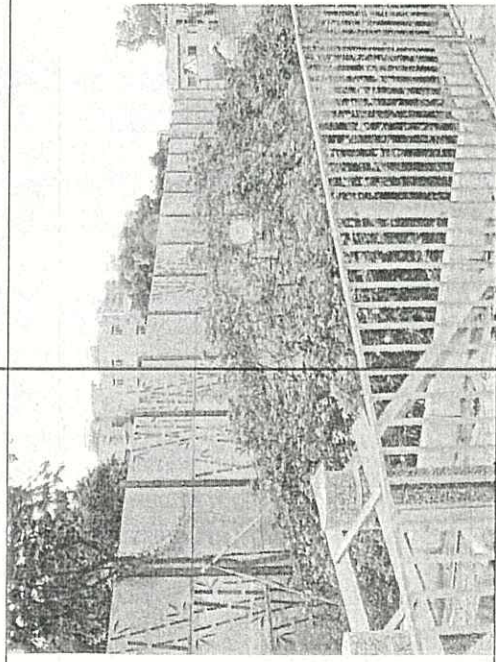
Photo 5.138: Completion of Landscaping Works at New Road L1 of Long Yat Road (YUL)

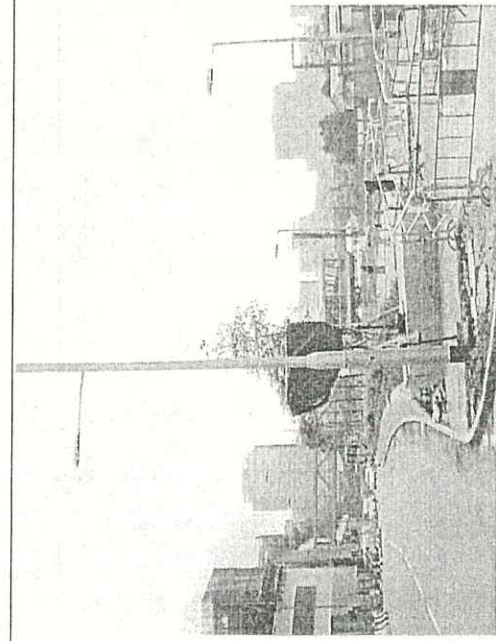
Photo: 5.139: Completion of Landscaping Works at New Road L2 of Long Yat Road (YUL)

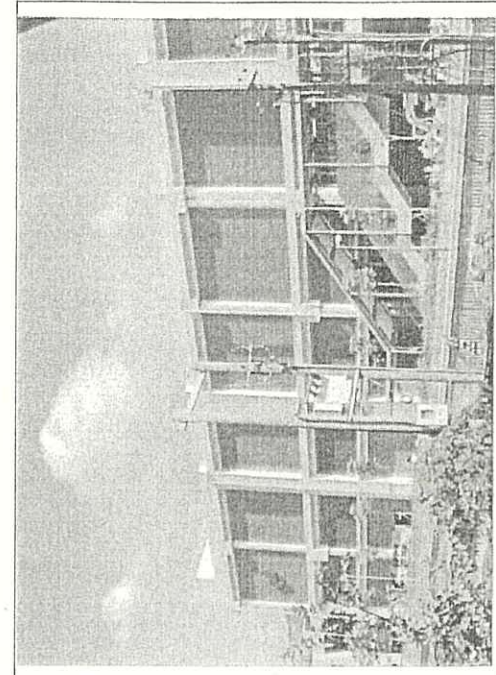
Photo 5.140: Completion of Landscaping Works at New Road L2 of Long Yat Road (YUL)

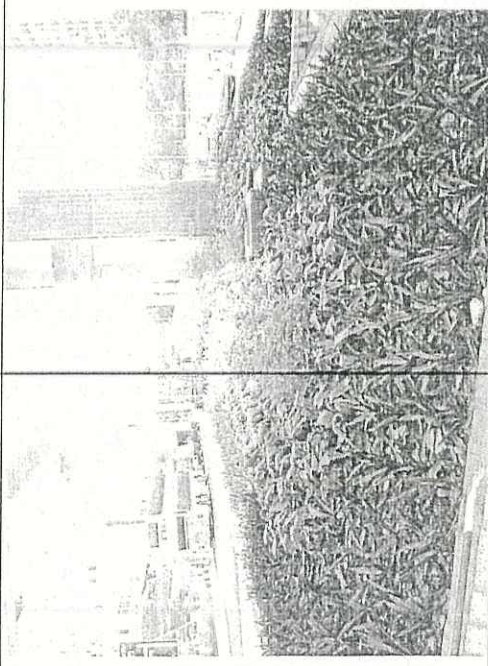
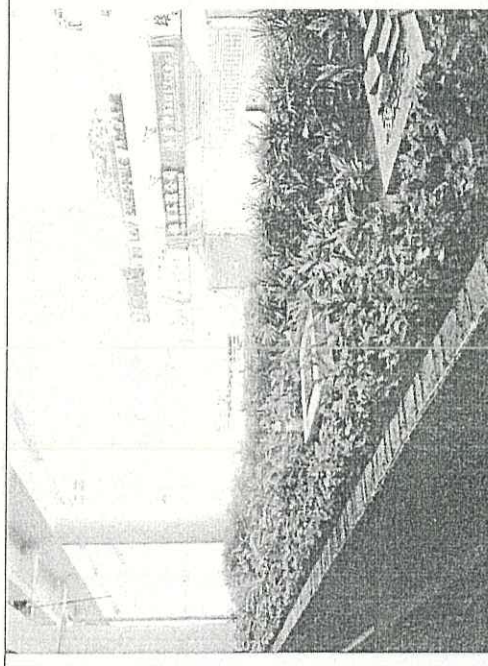
<p>Photo 5.141: Completion of Landscaping Works nearby Long Ping Estate (at east of LOP)</p>	<p>Photo 5.142: Completion of Landscaping Works nearby Fu Loy Garden (at south of LOP)</p>	<p>Photo 5.143: Outstanding Landscaping Works at Amenity Structure (at TUM)</p>

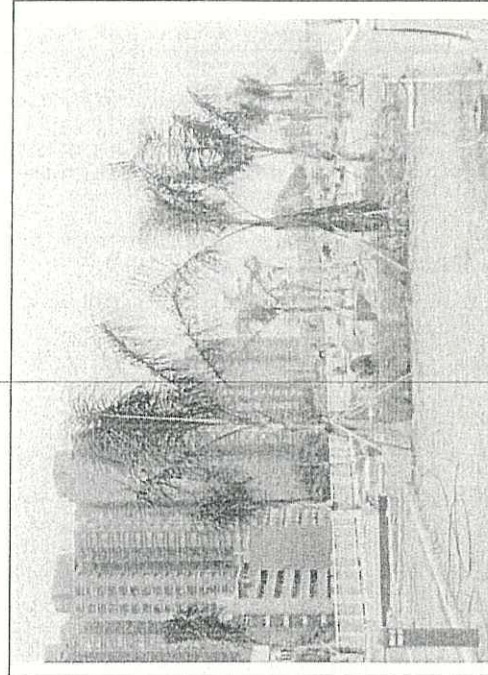
- To reinstate the car park at western side of the YUL at Wong Uk Tsuen and built the planter at Nam Pin Wai.
- To built the planters at the side of road junction Wang Tat Road and Long Yip Street at Long Ping
- To built a small park nearby Tai Kiu Tsuen and built the planter along On Lok Road at Long Ping.
- Some of the landscape works at Tin Shui Wai to build the planter along Ping Ha Road, Tin Fuk Road are still outstanding.
- The landscape at the Siu Hong Station under the Northern Access Ramp, Emergency Vehicle Access and Cycling track are not completed
- The landscape work of Amenity Structure between Tuen Mun and Siu Hong is still ongoing. Some of the planting work nearby Tuen Mun Hospital is planted (see photo 5.143 in Annex 2).

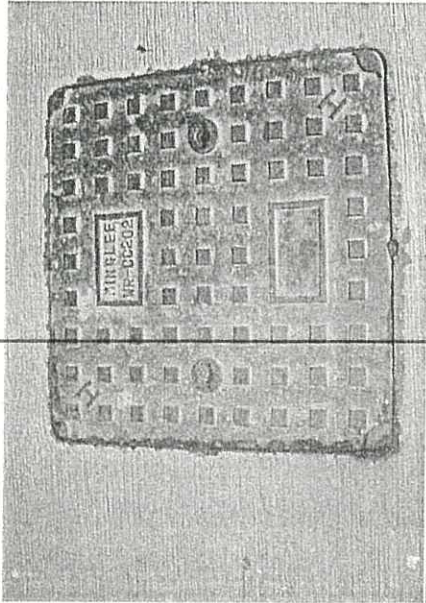
Domestic sewage generate from toilets, refuse collection rooms, battery rooms, plumbing pump rooms, ECS plant rooms, cleaner's rooms, building services rooms and corridors would discharge to the public sewage system through the terminal manhole foul (see Photos 5.190, 5.196, 5.201 and 5.203 in Annex 2).

<p>Photo 5.190: Terminal Manhole Foul at YUL nearby the Sun Yuen Long Centre</p>

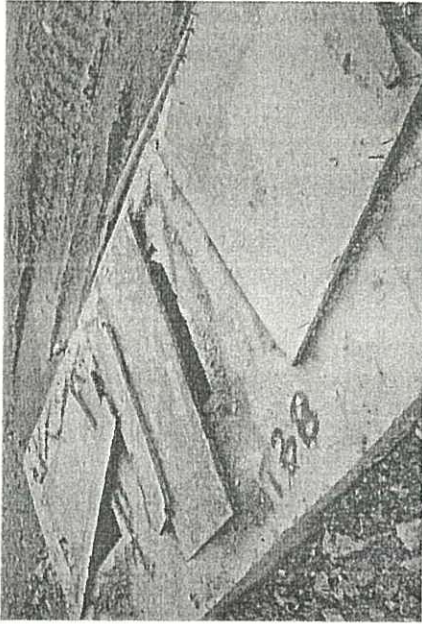
Petrol / oil interceptors installed to treated water from the stations which have been inspected (see Photos 5.191, 5.198, 5.200, 5.202 and 5.204 in Annex 2). A licensed collector has been employed to clean the interceptors and dispose the oil contents properly. The locations of the interceptors are located as following areas:

<p>Photo 5.191: Grease Trap at YUL nearby Nam Pin Wai</p>

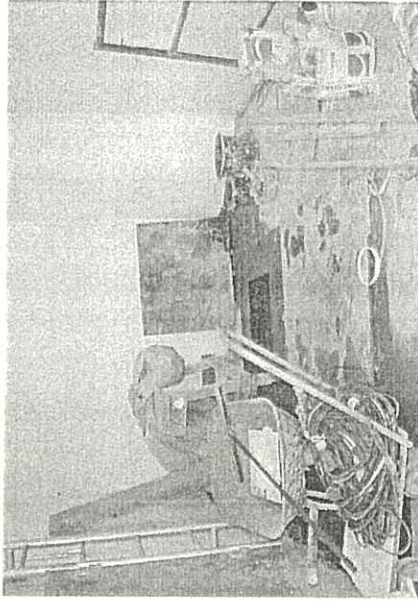
At YUL station a grease trap was built for the restaurant sewage discharge, which has been inspected by auditing team (see Photos 5.192 in Annex 2). This grease trap will maintained by the restaurant owner.

<p>Photo 5.192: Grease Trap for YUL Station Restaurant</p>

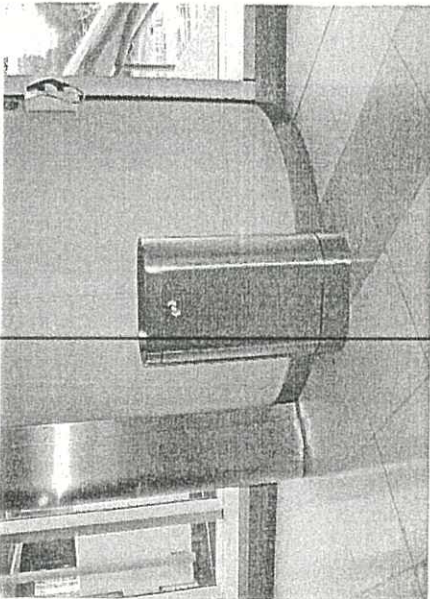
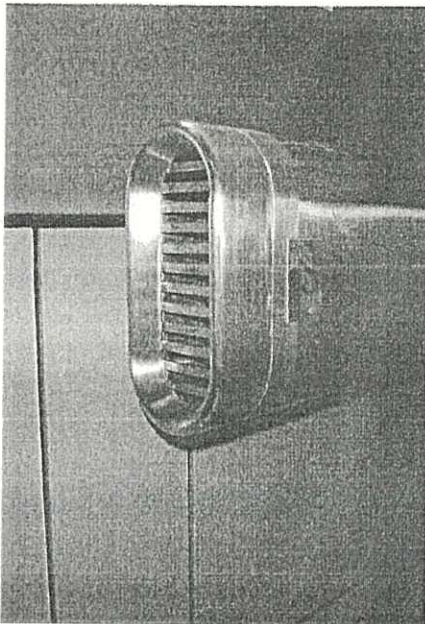
During the operation stage, waste generated from stations will mainly be papers and general refuse wastes from passengers and station staff, which will be collected by the standard steel rubbish bins (see Photos 5.193 and 5.194 in Annex 2). Wastes will be daily assembled at refuse collection room for further disposal by licensed collectors (see Photos 5.195, 5.199, 5.200, 5.205 and 5.208 in Annex 2). At all stations the refuse collection room will be cleaned regularly by fresh water supply to avoid the odour problem.

<p>Photo 5.193: Standard Rubbish Bin in WR Stations</p>

<p>Photo 5.194: Standard Ash-Tray in WR Stations</p>

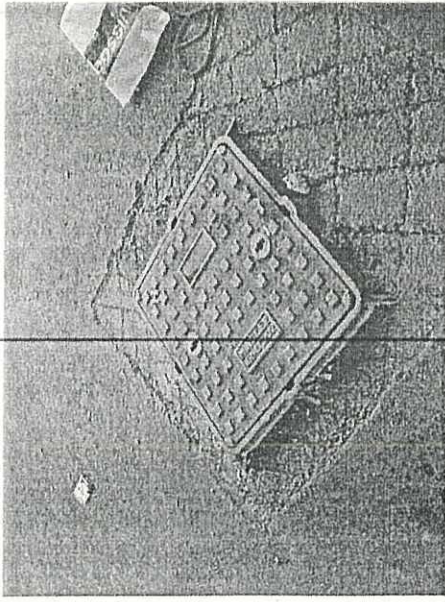
<p>Photo 5.196: Terminal Manhole Foul at LOP - Ma Wang Road</p>

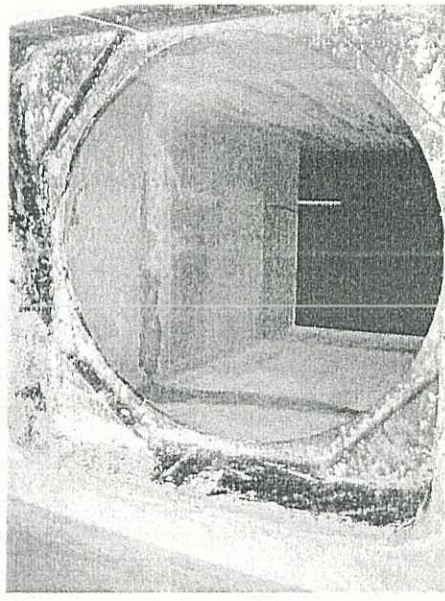
The surface water from stations would directly discharge to public storm water drainage. For LOP the storm water would discharge to Yuen Long Creek through the box culvert (see Photos 5.197 in Annex 2). The storm water from SIH and TUM would discharge to Tuen Mun River Channel (see Photos 5.206 in Annex 2).

<p>Photo 5.197: Terminal Manhole Storm at LOP - Ma Wang Road</p>

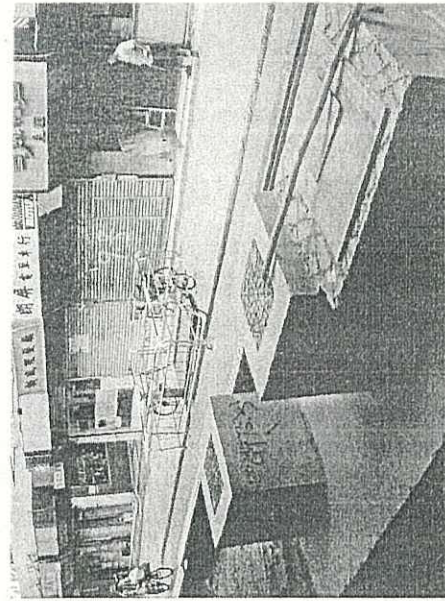
<p>Photo 5.198: Grease Trap at LOP nearby the Ma Wang Road</p>

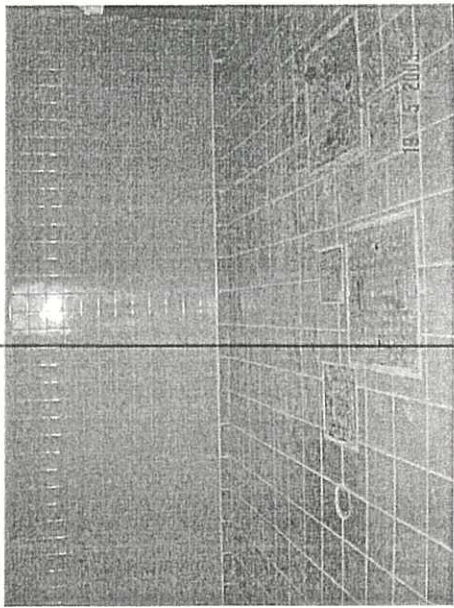
<p>Photo 5.200: Grease Trap at TIS Refuse Collection Room</p>

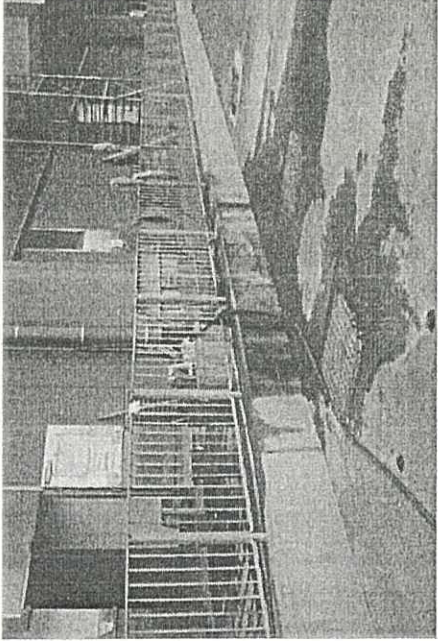
<p>Photo 5.201: Terminal Manhole Foul at TIS</p>

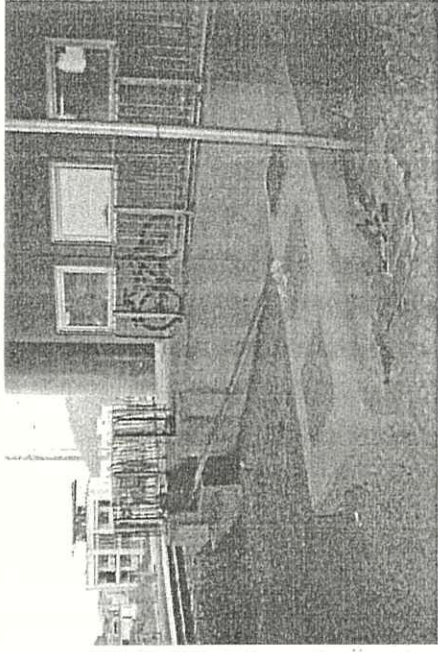
<p>Photo 5.202: Grease Trap adjacent to the LRT track under TIS Station</p>

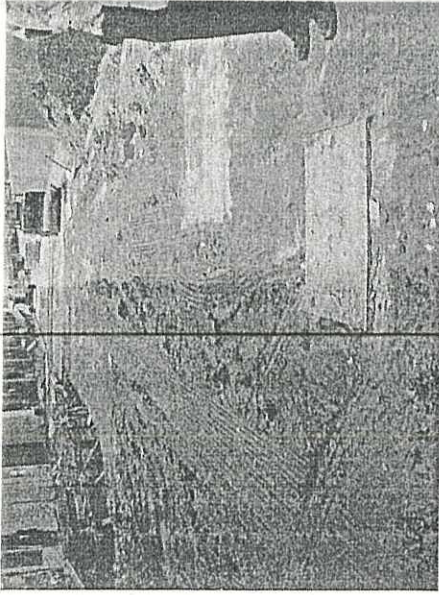
<p>Photo 5.203: Terminal Manhole Foul at SIH EVA</p>

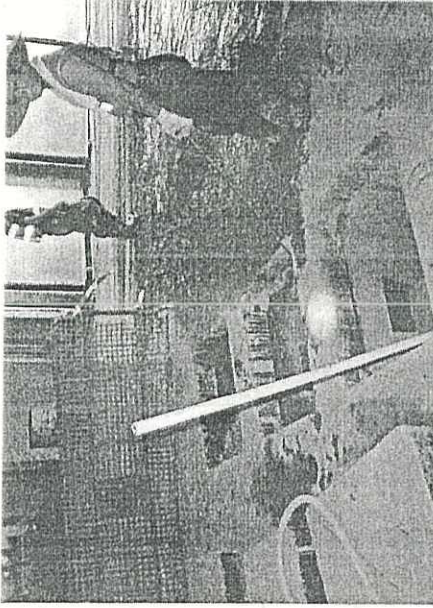
<p>Photo 5.204: Petrol Interceptor at SIH Service Road</p>

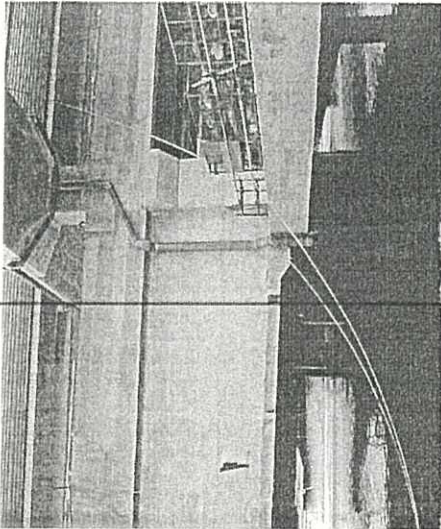
<p>Photo 5.206: Surface Water directly Discharge to TUM River from TUM Station and Viaduct</p>	<p>Photo 5.207: Petrol Interceptor at TUM</p>	<p>Photo 5.208: Refuse Collection Room at TUM</p>

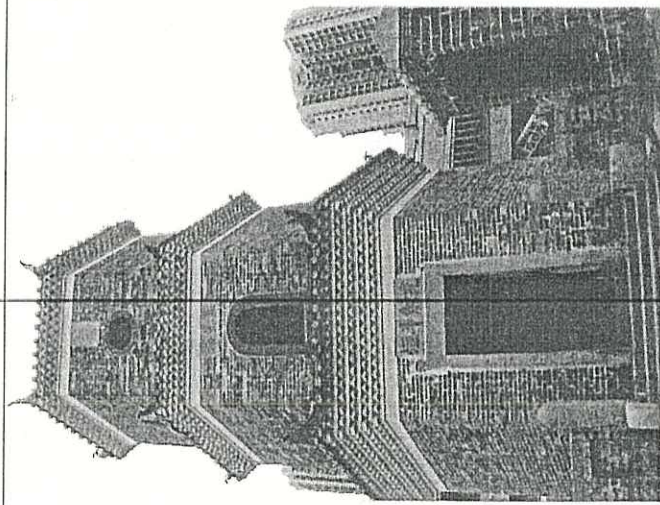
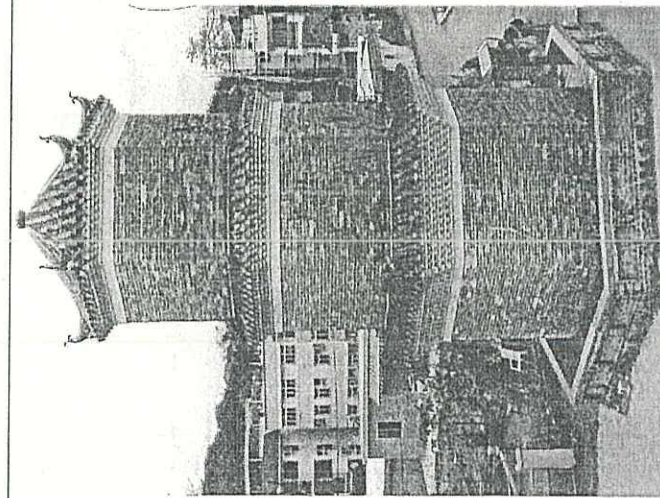
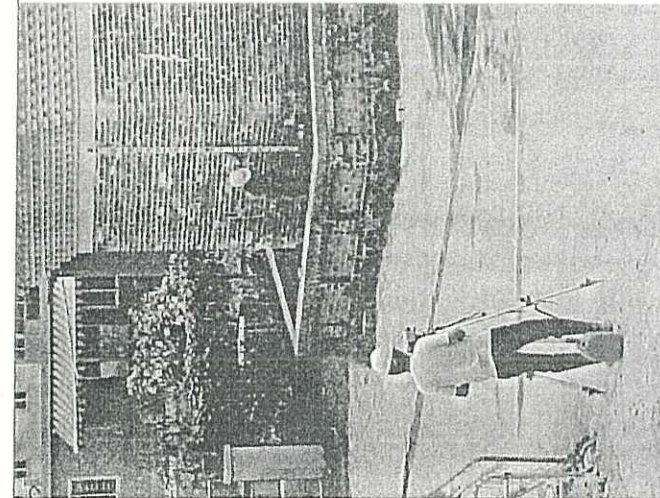
The civil works surrounding of Tsui Sing Lau Pagoda in Tin Shui Wai has been completed. According to Condition 2.12 of the Environmental Permit (no. EP-004/1998/F), Condition Surveys for Tsui Sing Lau Pagoda have been conducted prior to and following the completion of works on 14 October 1998 and 16 April 2003. The survey reports were submitted to EPD on 20 September 1999 and 29 August 2003. Only a few numbers of minor defects such as hairline cracks and minor cracks of width below 2mm were identified. Most of the cracks are observed at the brick wall on ground floor and perimeter brick parapet. These cracks are identified before the commencement of the project. Details have been included in the pre- and post-condition survey reports. No major visible structural defect was identified in the survey (see Photos 5.209, 5.210 and 5.211 in Annex 2).

Photo 5.209: Front View of Pagoda

Photo 5.210: Rear View of Pagoda

Photo 5.211: Survey taken at Pagoda

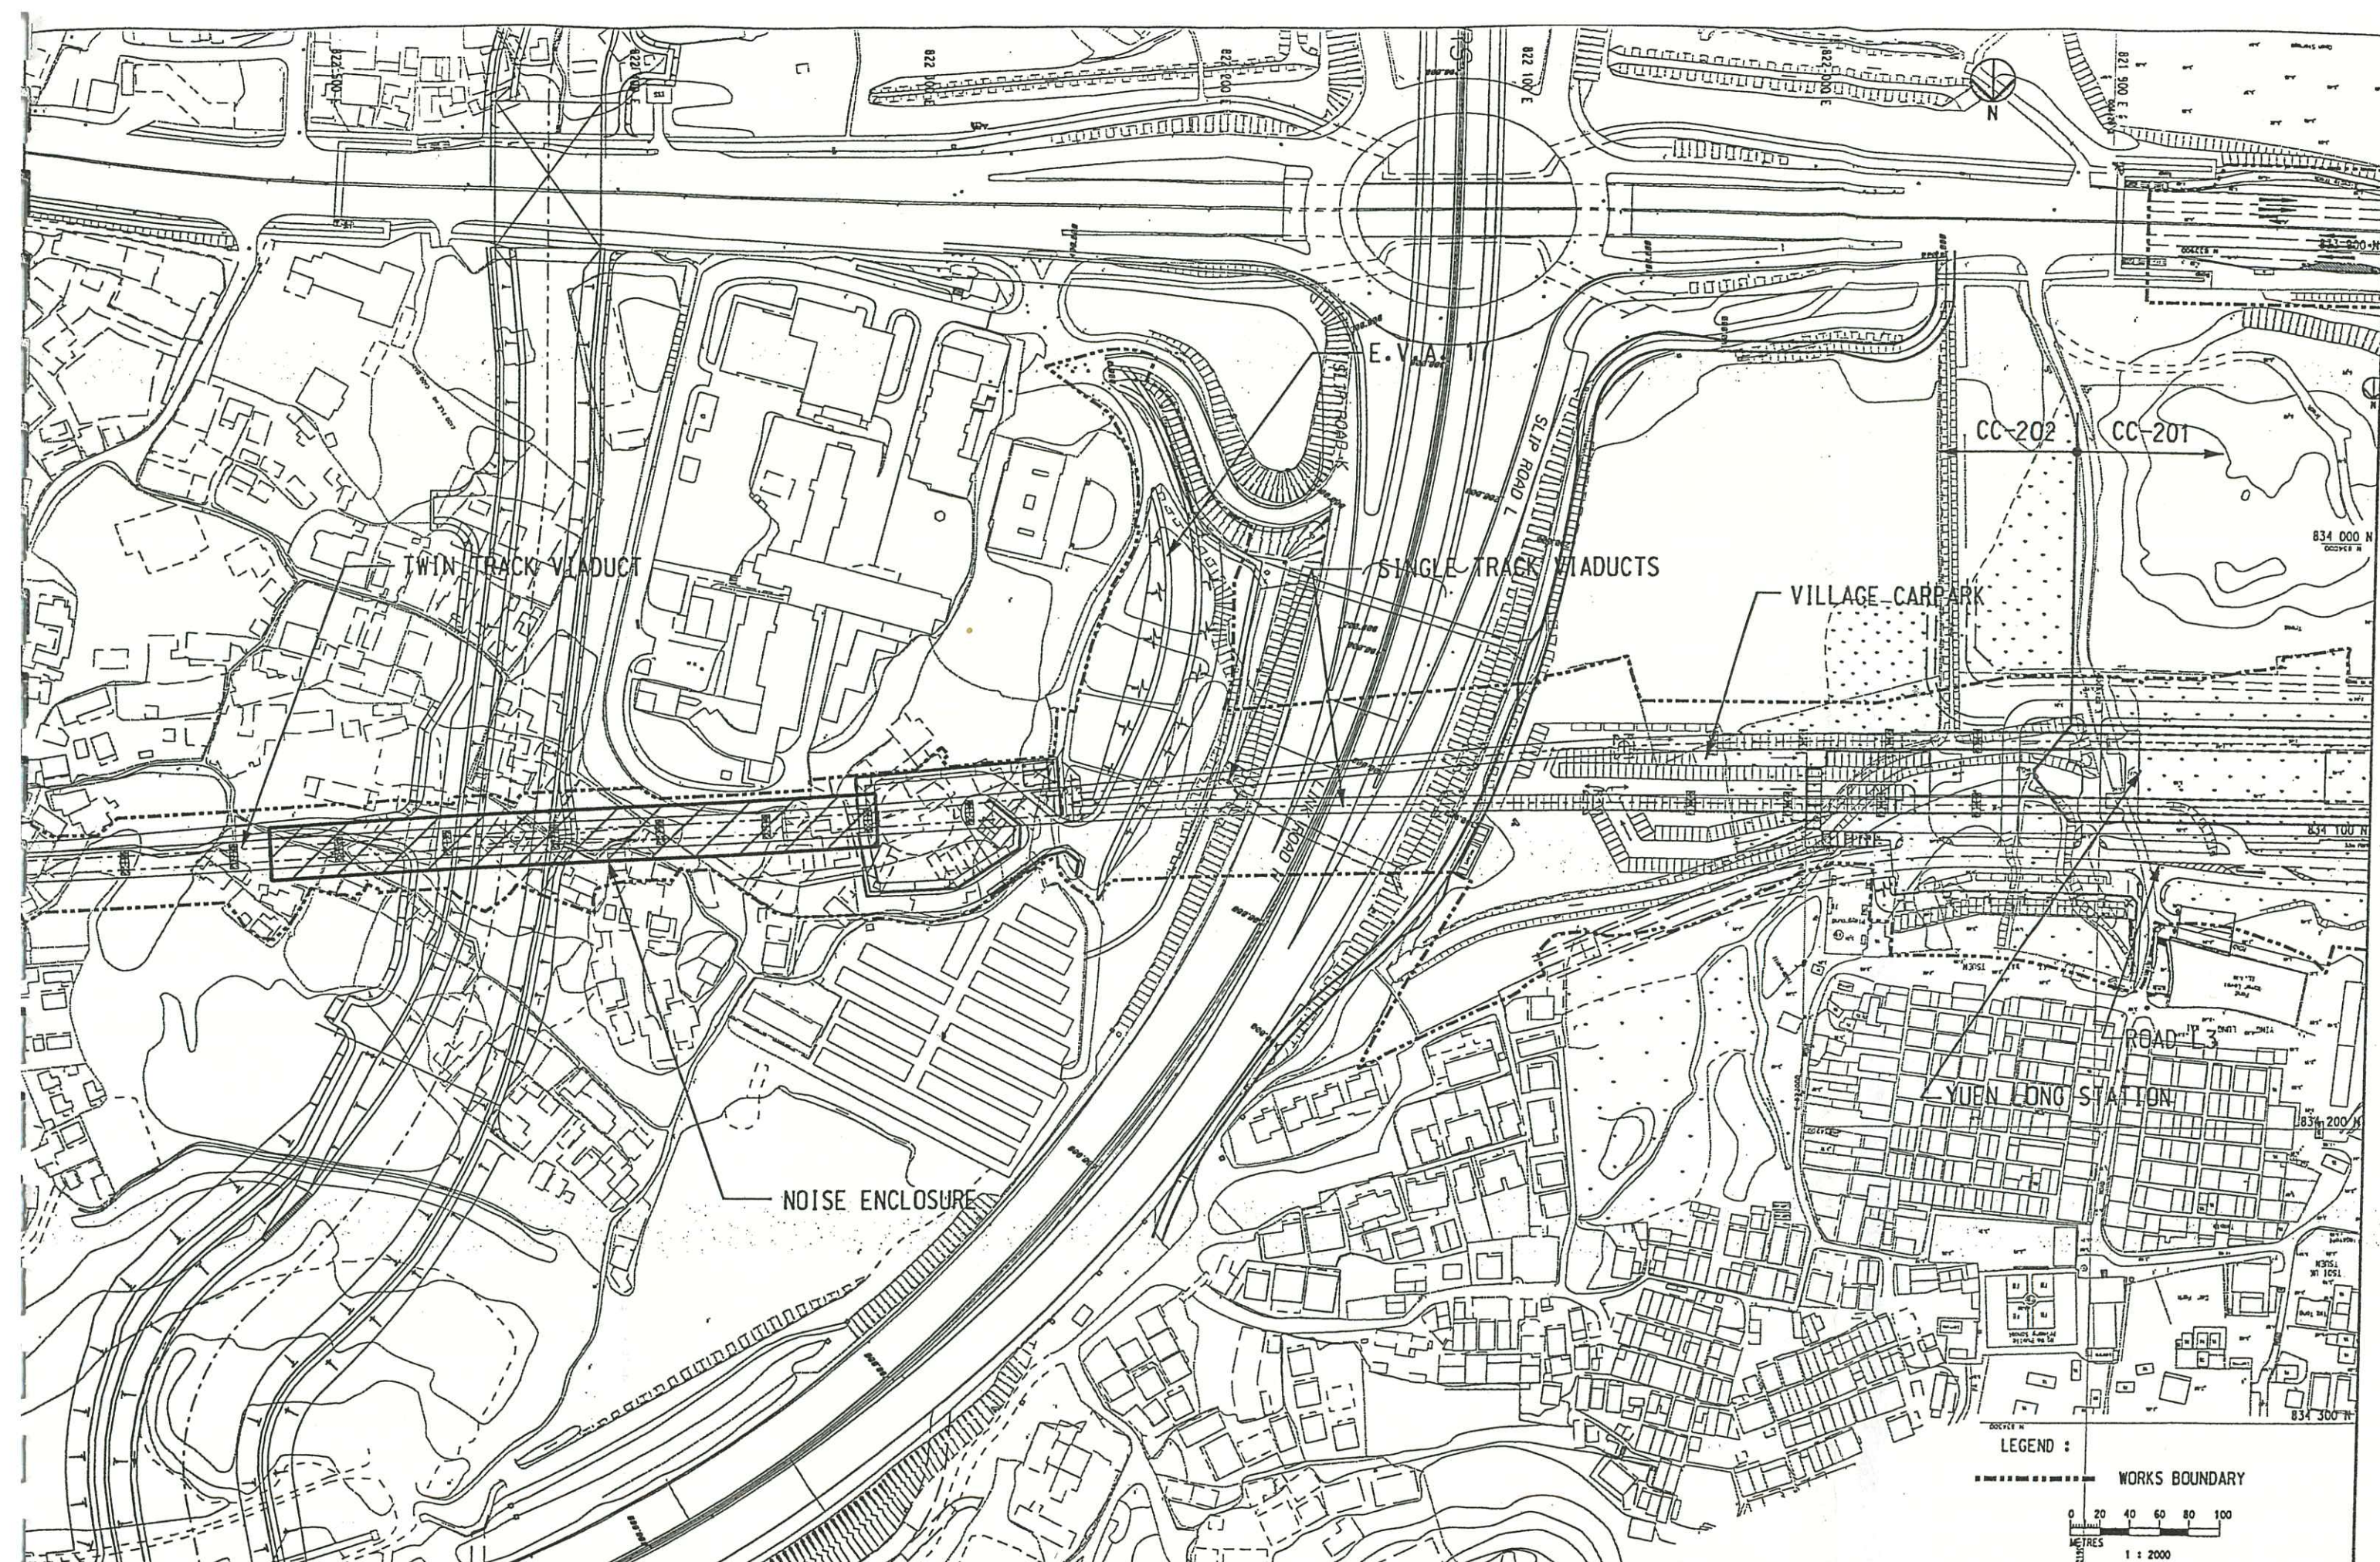
FIGURE 5  
LOCATION OF NOISE ENCLOSURE -  
POK OI HOSPITAL

recommended full noise enclosure around the crossover which is in close proximity of noise sensitive receivers. On the Northern Section, there is a crossover near Pok Oi Hospital, where full noise enclosure is required. The locations of the switch and noise enclosure are shown on Figure 5.

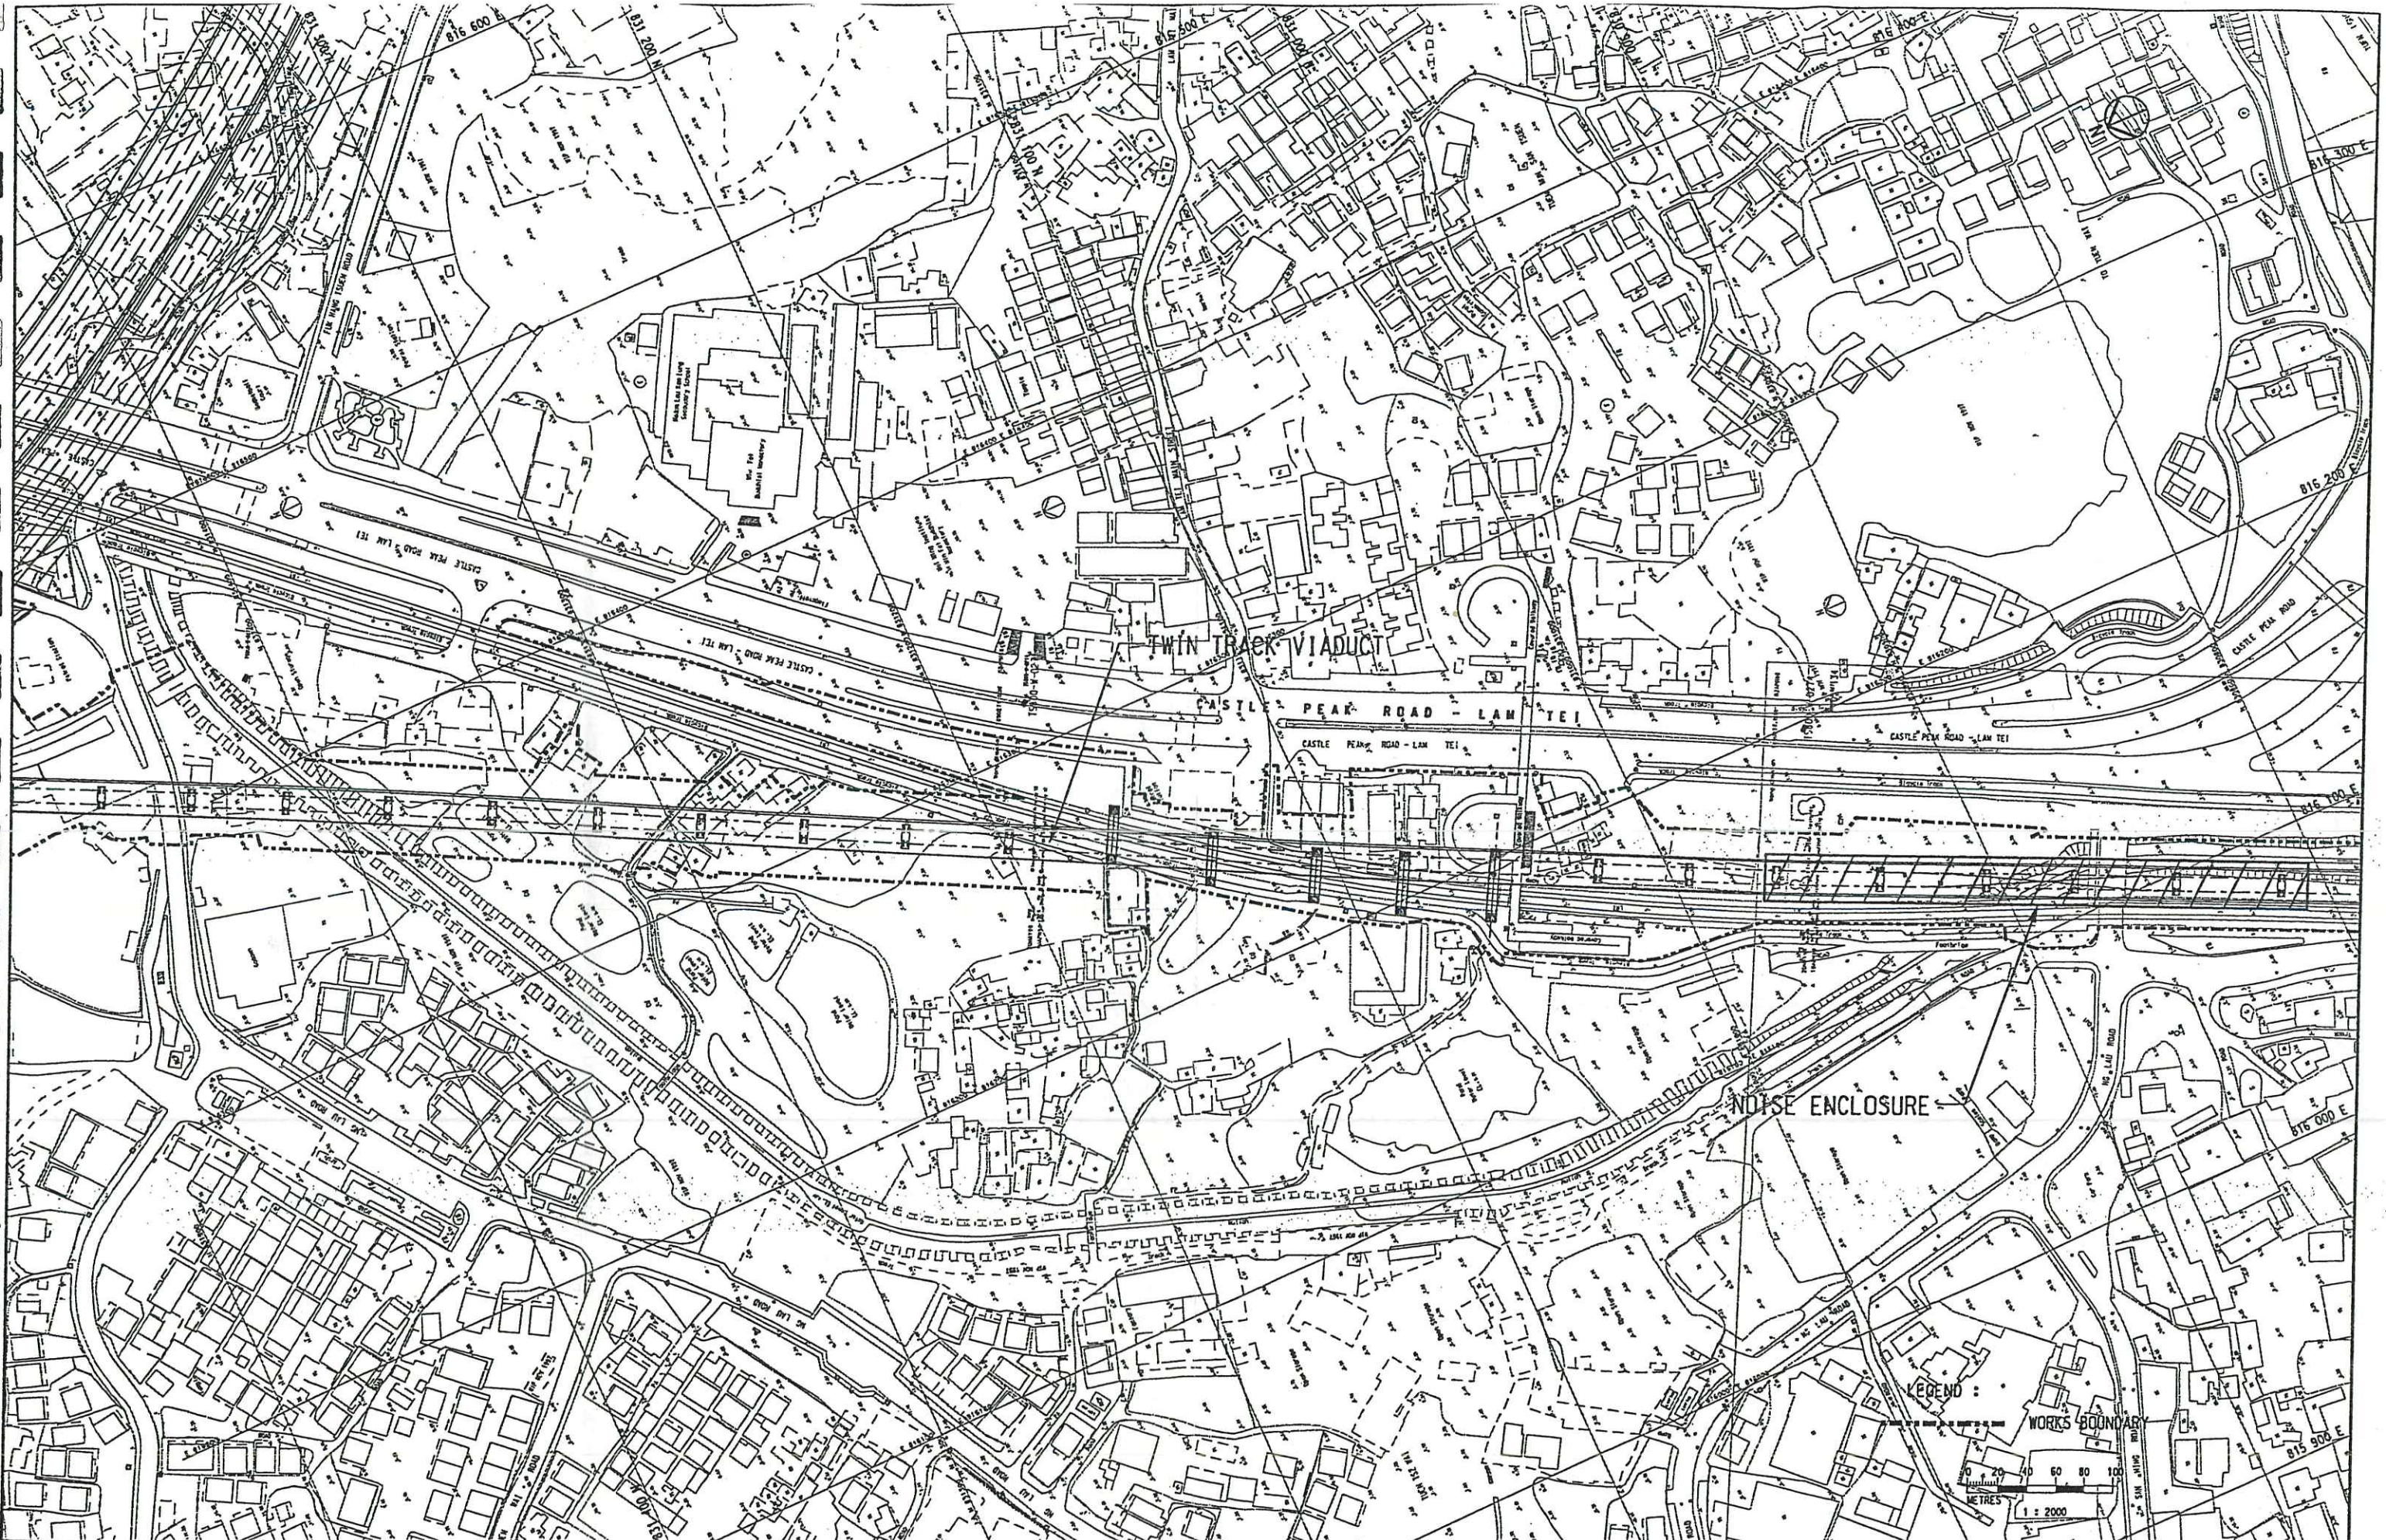
**FIGURE 6**  
**LOCATION OF NOISE ENCLOSURE -**  
**LAM TEI**

Subsequent to these changes, the location of noise enclosure at Lam Tei recommended in the EIA study has been changed slightly. In addition, the additional heights of noise barriers at Yick Yuen are not required due to the reduction of the train speed to 100km/hr. Application for the variation of the Environmental Permit (VEP-020/2000/A/EP-004) for these changes were made to EPD on 28 May 2001 and approved by EPD on 27 June 2001 and an Environmental Permit (EP-004/1998/B) was issued. The location of the noise enclosure is presented in the layout drawings submitted to EPD on 30 August 2001. For ease of reference, the location of the noise enclosure is also shown on Figure 6 annexed to this report.
